## **BREMER BAY**

### **Investigation into the Stabilisation of Fishery Beach**

Technical Report Number 471

Department for Planning and Infrastructure  
New Coastal Assets Directorate  
Marine House, 1 Essex Street, Fremantle WA  
PO Box 402 Fremantle, Western Australia 6959

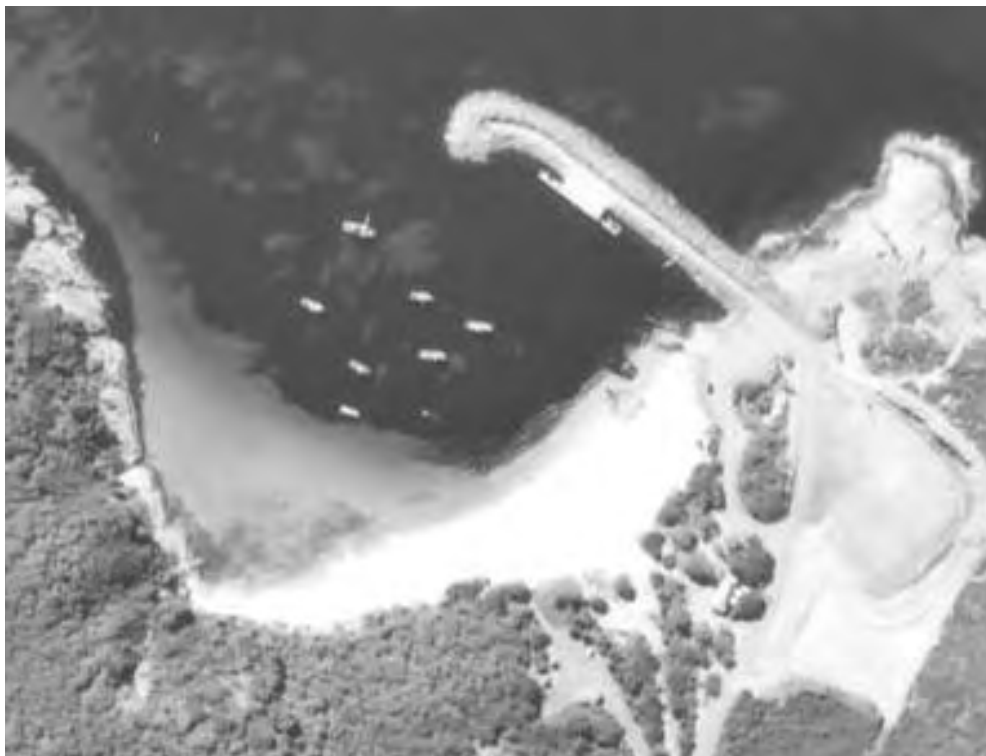
The construction of the harbour breakwater in 1996 at Bremer Bay caused the permanent realignment of Fishery Beach. The realignment resulted in the movement of sediment from the western end of the beach to the eastern end, as can be seen in Figure 2 and Figure 3. The realignment subsequently caused ongoing erosion of a dune into a scarp at the western end of the beach, and siltation of the boat ramps at the eastern end of the beach. Sand removal from the boat ramps has been undertaken, typically annually, to maintain adequate depths for boat launching. This work has been completed in partnership between DPI and the Shire of Jerramungup.

**Figure 3: Aerial photograph of Fishery Beach in April 1997, following construction of the boat harbour breakwater in 1996.**

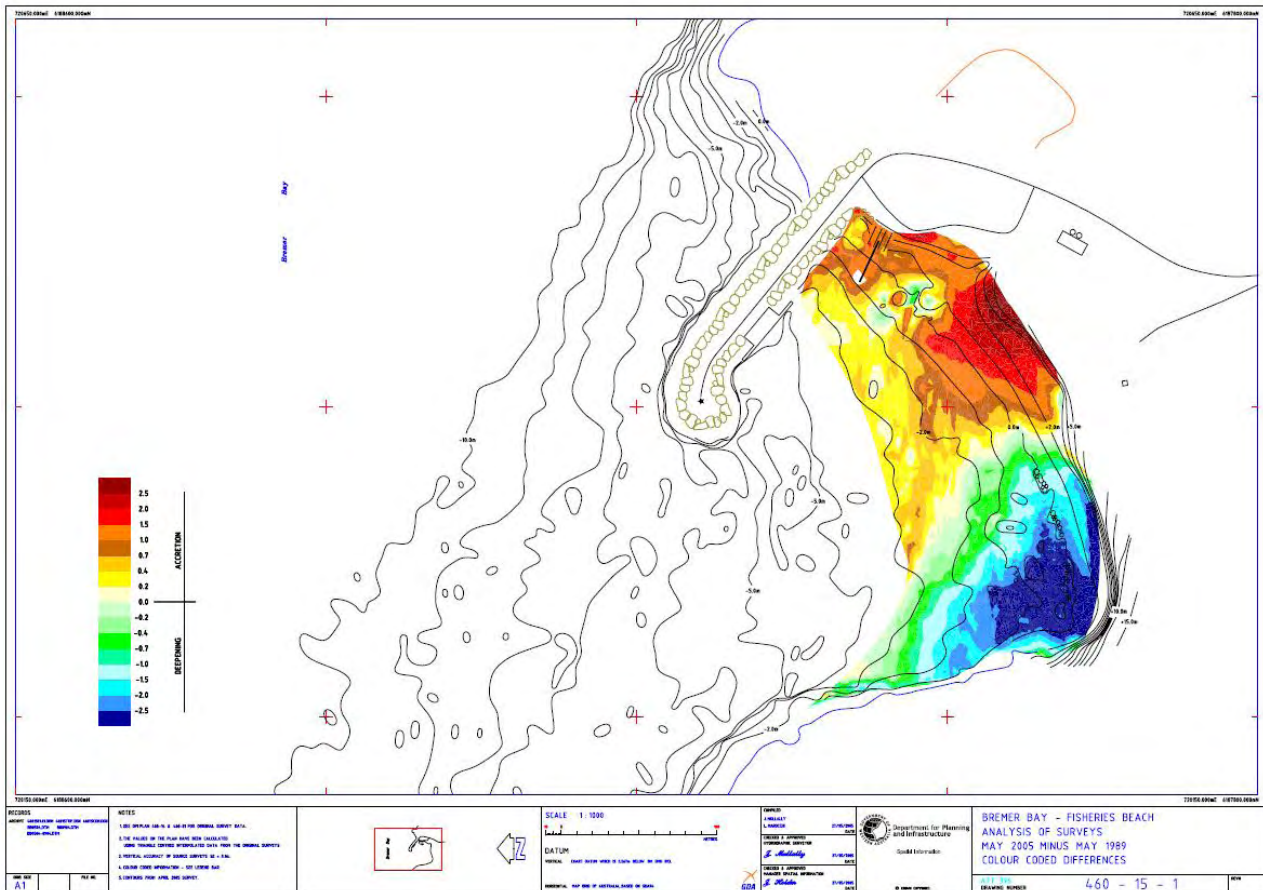
In the first six months following construction of the breakwater significant realignment of the beach occurred. Although the alignment of the beach is now more stable, ongoing erosion at the toe of the dune at the western end of the beach has caused the formation of a steep scarp. Comparison of surveys (Figure 4) indicates that this eroded sand is transported to the eastern end of the beach causing the siltation problem at the boat ramp.

**Figure 4: Survey difference plot which compares bathymetry from 1989 with data from 2005. This figure indicates that there has been a large amount of erosion of the western end of the beach (dark blue), accompanied with a large amount of accretion at the eastern end of the beach (red).**

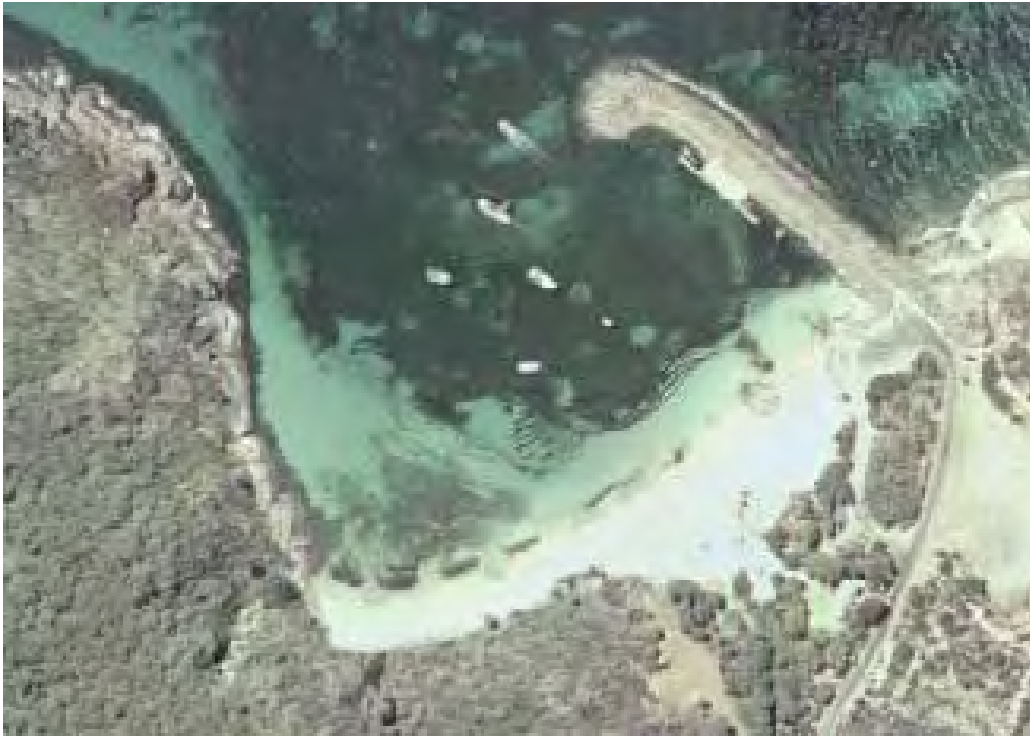
In 1999 a cheap trial solution consisting of four offshore rock breakwaters was constructed in an attempt to decrease the erosion of the western end of the beach. These structures were unsuccessful but are still visible today (Figure 5).

**Figure 5: Aerial photograph of Fishery Beach in January 2004. Note the four trial breakwater structures visible at the western end of the beach.**

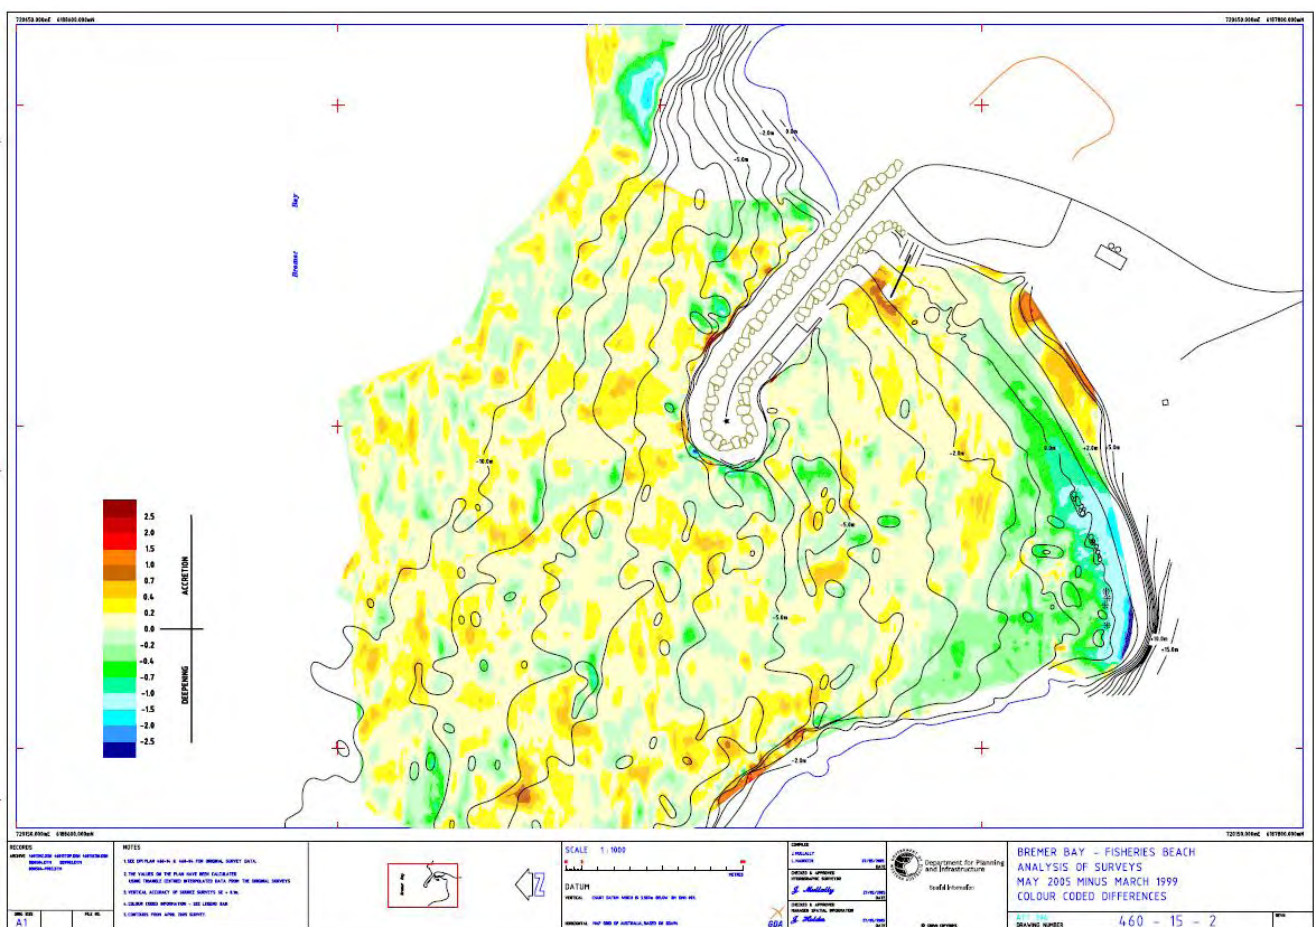
After the rapid realignment of Fishery Beach from 1996 to 1997 the beach has approached a dynamically stable alignment, but has not reached a stable equilibrium. Figure 6 shows there has been only a small amount of erosion at the western end of the beach after the initial realignment. There has been minimal net accretion at the eastern end, and this is most likely because sand has been regularly removed from the system during excavation at the boat ramps.

**Figure 6: Survey difference plot which compares bathymetry from 1999 with data from 2005. This figure indicates that there has only been a small amount of erosion of the western end of the beach (blue), accompanied with a small amount of accretion at the eastern end of the beach (brown) since the rapid beach realignment after construction of the breakwater in 1996.**

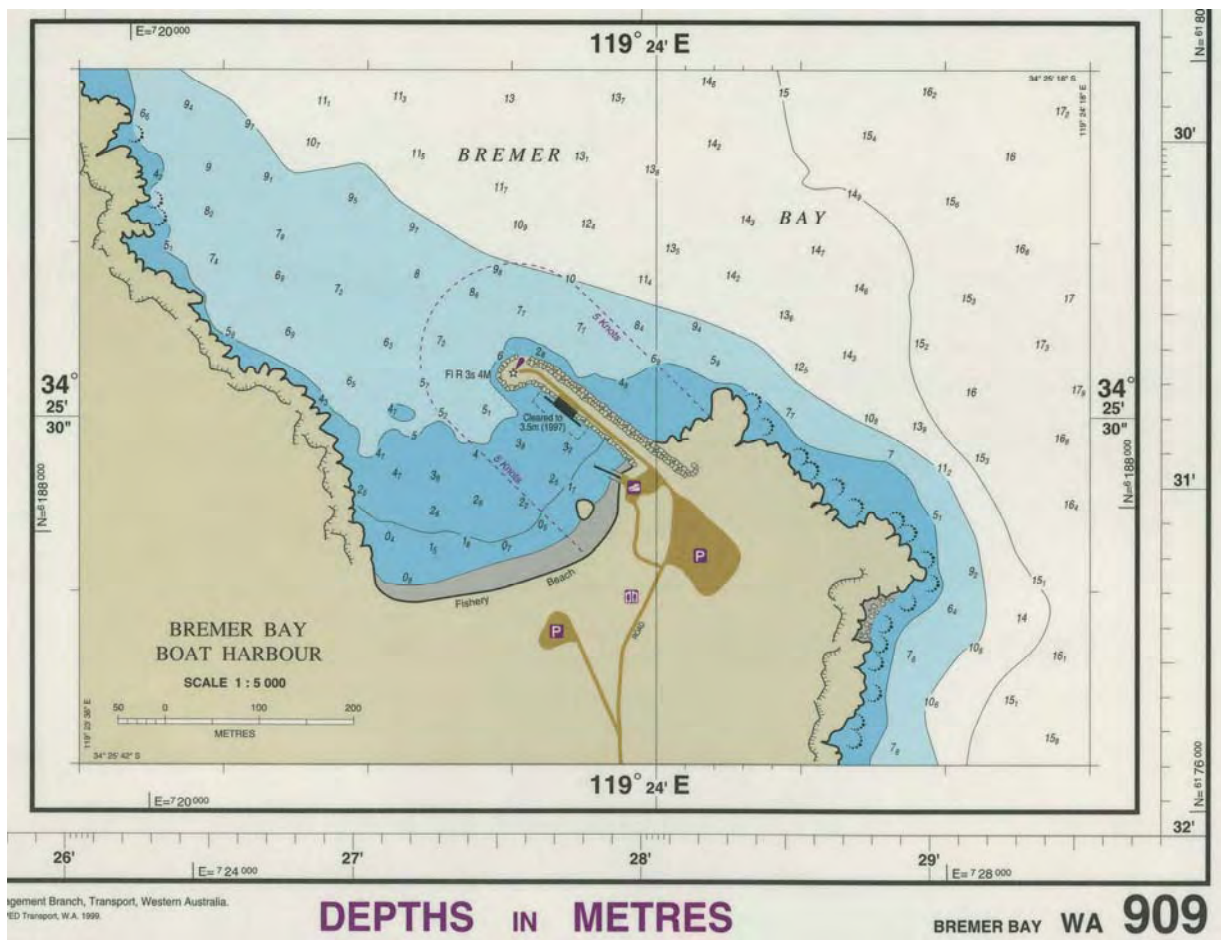
littoral sand linkage between the beaches either side of Fisheries Beach. The large granite headlands either side of the harbour extend into deep water of the order of 10m (Figure 7). These depths decrease the ability of incident waves to regularly transport sediments around the headlands. It is likely that sand available to local coastal processes inside the harbour comes from the dunes, beach, and near-shore environment within the harbour. Sand is available for redistribution, but once it is removed from the system there appears to be a net loss.

**Figure 7: Bremer Bay Hydrographic Chart Inset showing Fishery Beach and the Bremer Bay Boat Harbour. Note the headlands either side of the harbour which extend into water approaching 10m depth. These deep rocky headlands largely inhibit the movement of sediment in and out of Fishery Beach. As such, the sediment budget for the beach is believed to be contained within the confines of the harbour.**

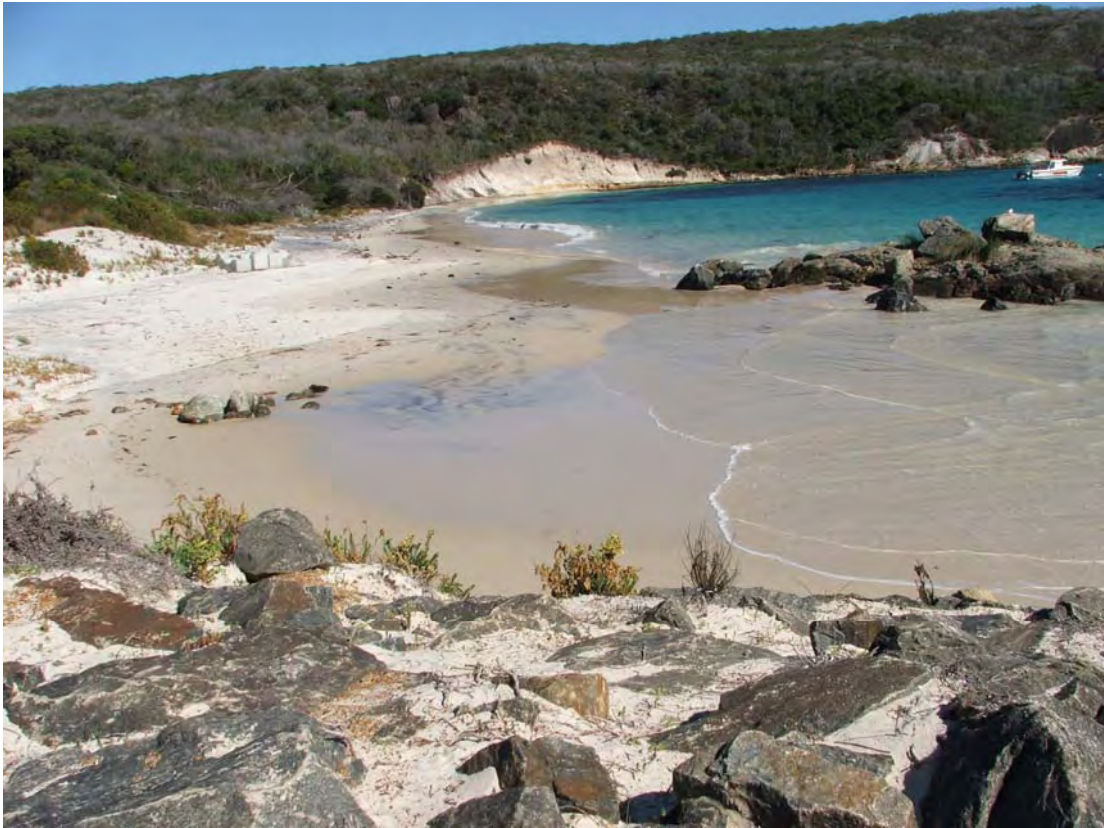
The realignment of the beach following construction of the boat harbour has driven movement of sediment from the western end of the beach to the eastern end. This sand movement has been so great as to erode the western dune into an unstable scarp (Figure 10 and Figure 10). A large part of the transported sand has been deposited on the boat ramps and been subsequently removed (Figure 11).

**Figure 9: Fishery Beach 13<sup>th</sup> August 2007, note the eroded dune at the western end of the beach.**

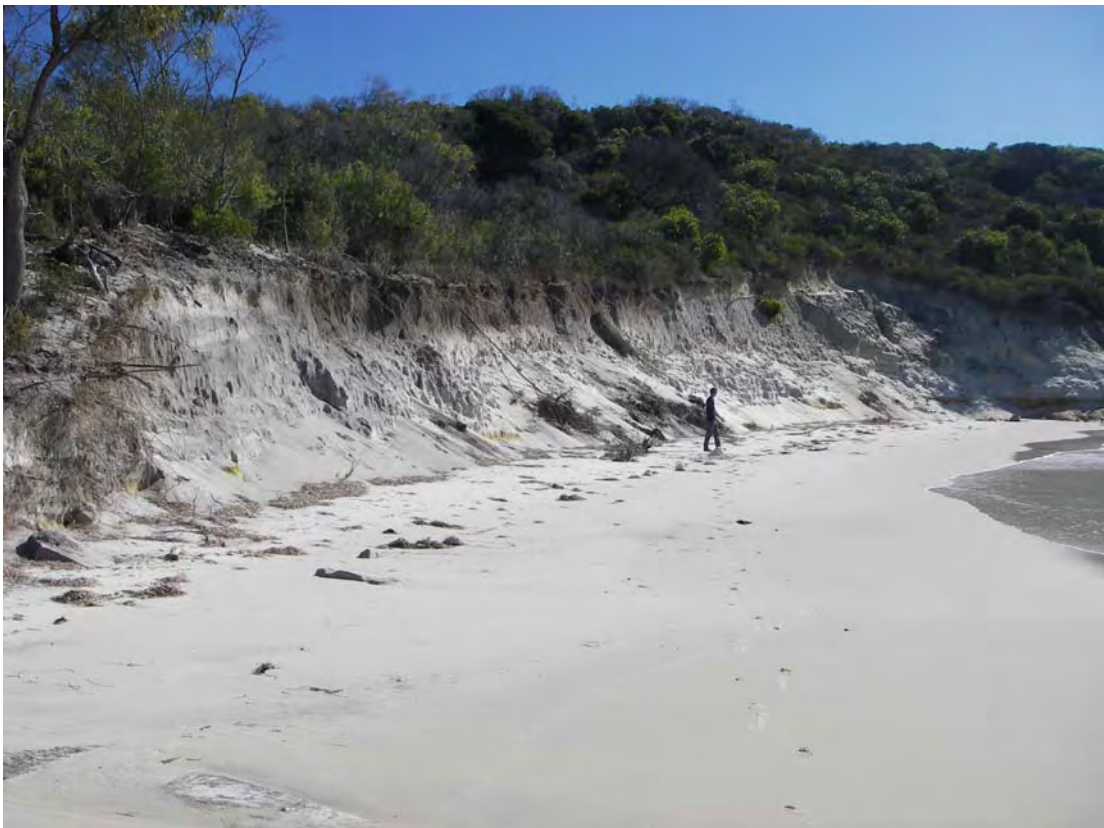
**Figure 10: Photograph of the eroded scarp at the western end of Fishery Beach, 15<sup>th</sup> March 2007.**

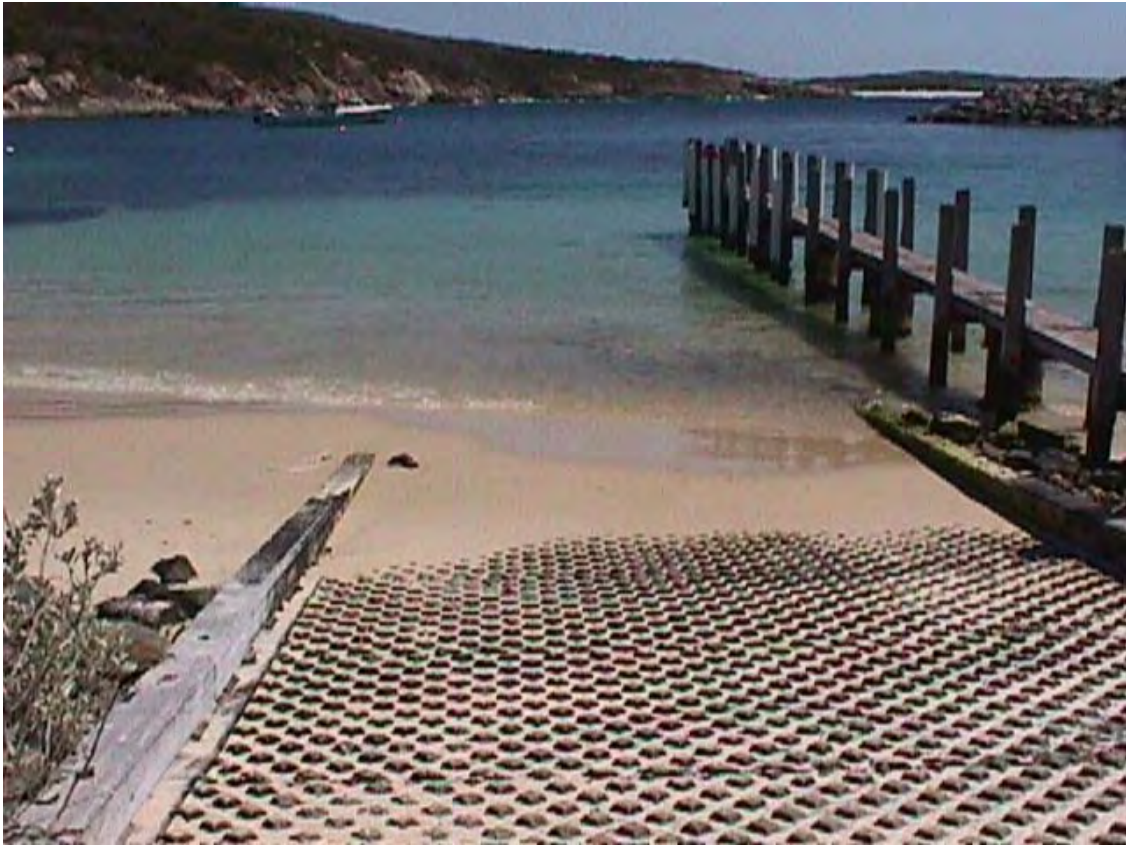
**Figure 11: September 2006, boat ramps and finger jetty located at the eastern end of Fishery Beach. These ramps are prone to siltation which makes them difficult to use.**

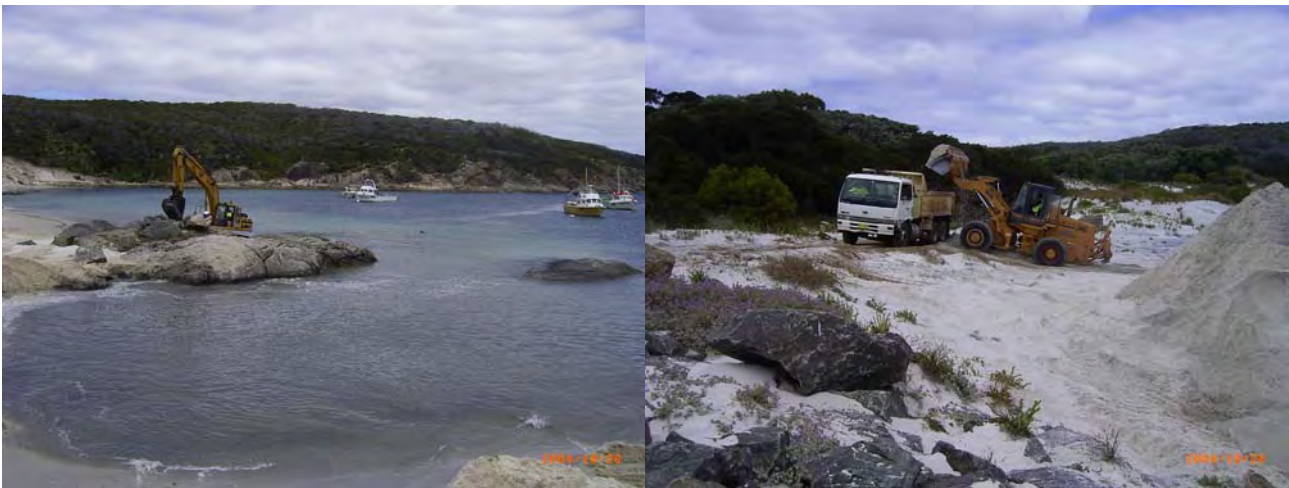
**Figure 13: Two photographs from the 26<sup>th</sup> October 2004 showing the excavation of sand from the boat ramps at the eastern end of the beach. Maintenance similar to this has been conducted at least once a year for several years to ensure the boat ramp can be used at peak holiday periods over summer.**

This option is essentially a ‘do nothing’ approach. Maintenance of the boat ramps would continue approximately once a year to ensure the ramps can be used over the peak summer holiday period. The cost would continue to be shared 50 / 50 between DPI and the Shire of Jerramungup. It is likely however, that erosion of the western end of the beach and siltation of the boat ramps will continue.

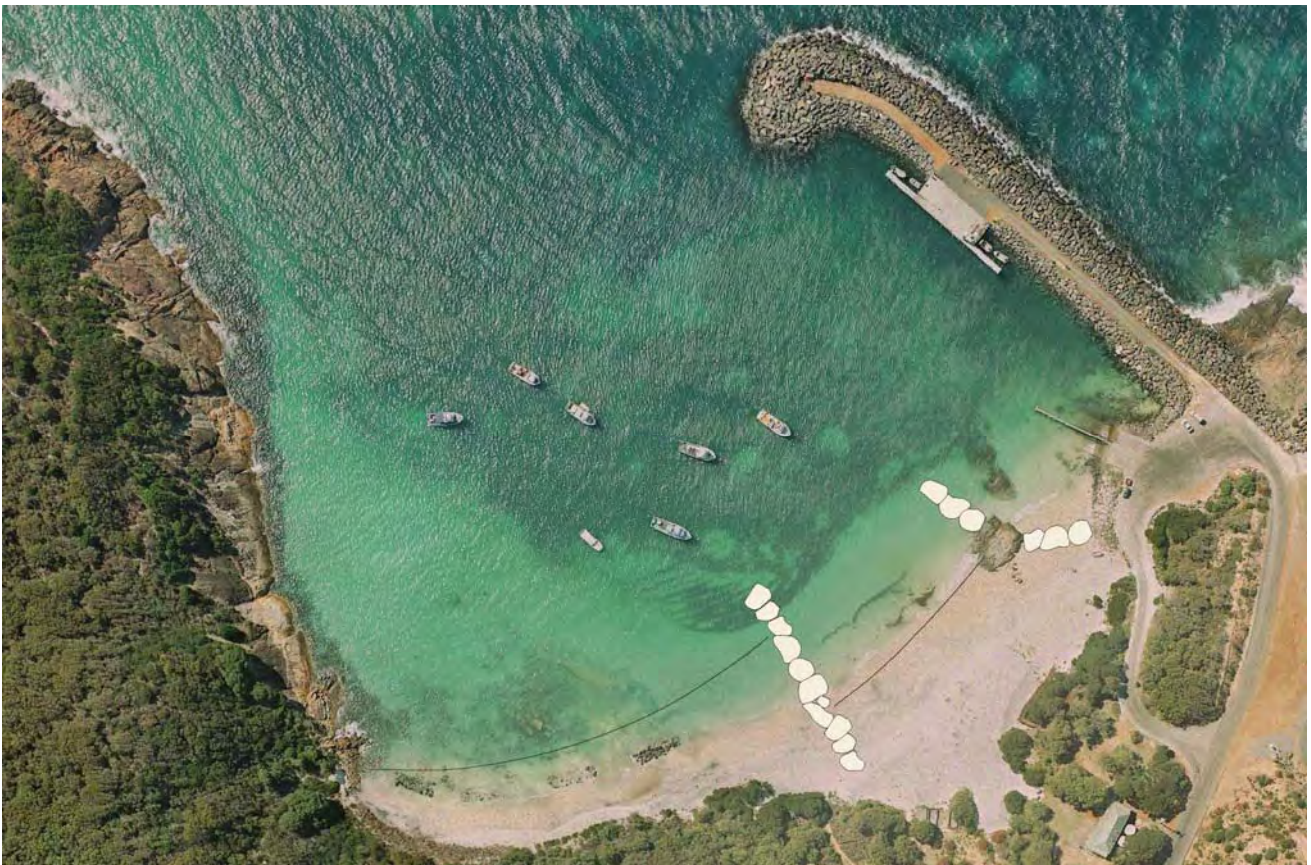
**Figure 15: Rubble mound cut-off groyne to be constructed near boat ramp in combination with a geotextile bag mid-beach groyne to compartmentalise Fishery Beach to ensure stability.**

DPI's preferred option to stabilise Fishery Beach is to construct two groynes on the beach as depicted in Figure 15. A small impermeable 'cut-off' groyne at the eastern end of the beach should minimise sediment being transported both behind and in front of the large rock in the near-shore environment. Hence the amount sand available to deposit on the boat ramps is likely to be minimised. The second part of this option involves the construction of a groyne approximately midway along the beach. The function of this groyne will be to effectively split the current beach into two sediment compartments. Sand nourishment of these compartments will be required to build effective buffer zones in front of the dunes. Both compartments can realign into equilibrium shorelines, which are expected to stabilise the beach.

DPI has engaged a consultant to design the two groynes and sand nourishment details required for implementation of Option 3. This option has been agreed upon in consultation with local community members and is considered to be the most appropriate solution to stabilise Fishery Beach.

The mid-beach groyne is to be designed for construction from geo-textile sand bags, whilst the cut-off groyne will be designed for construction from locally available rock. There is rock available from various locations around the Bremer Bay townsite. The design consultant will need to locate enough suitable rock from the following sources, and / or identify others;
