### ABH Compliance Assessment Report (EPBC 2008/4506)

## Augusta Boat Harbour 2014 Compliance Assessment Report (EPBC 2008/4506)

17 December 2014  
42908044 : M&C3883/R1771/0

Prepared for:  
Department of Transport

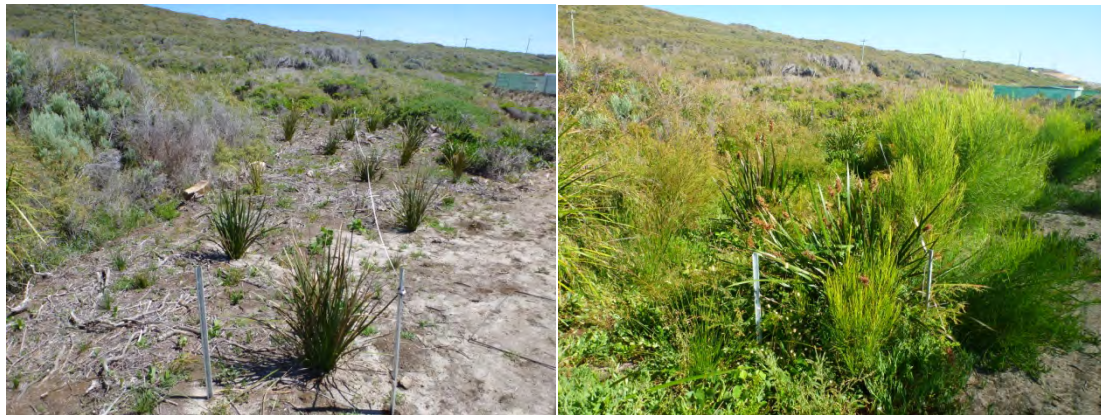
Plate 1 Transect 1, 2012 rehabilitation – comparison at 5 and 17 months old.

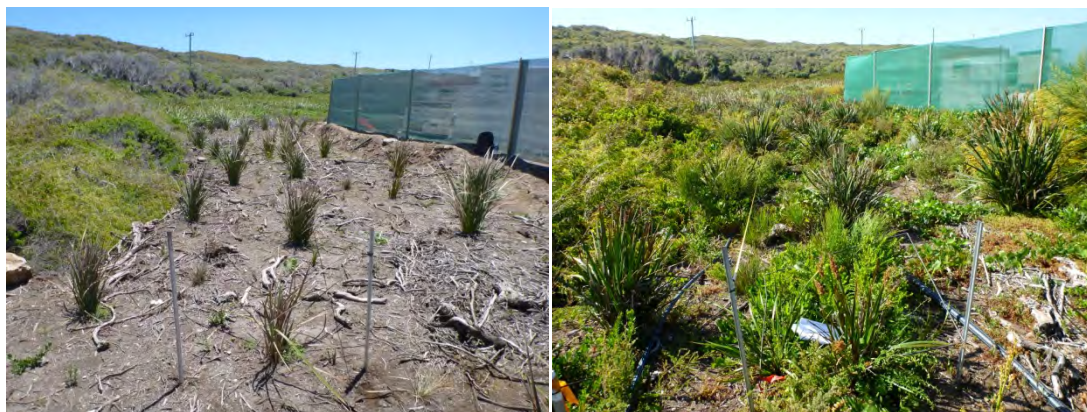
Plate 2 Transect 2, 2012 rehabilitation – comparison at 5 and 17 months old.

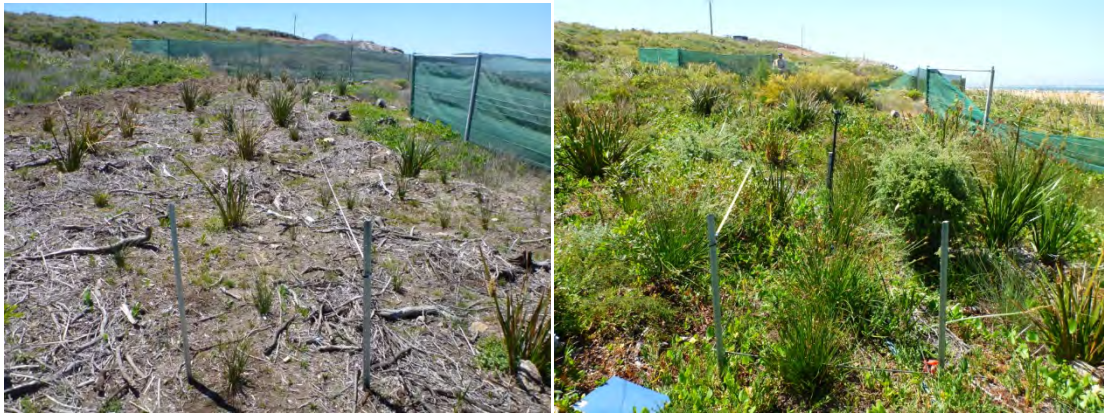
Plate 3 Transect 3, 2012 rehabilitation – comparison at 5 and 17 months old.

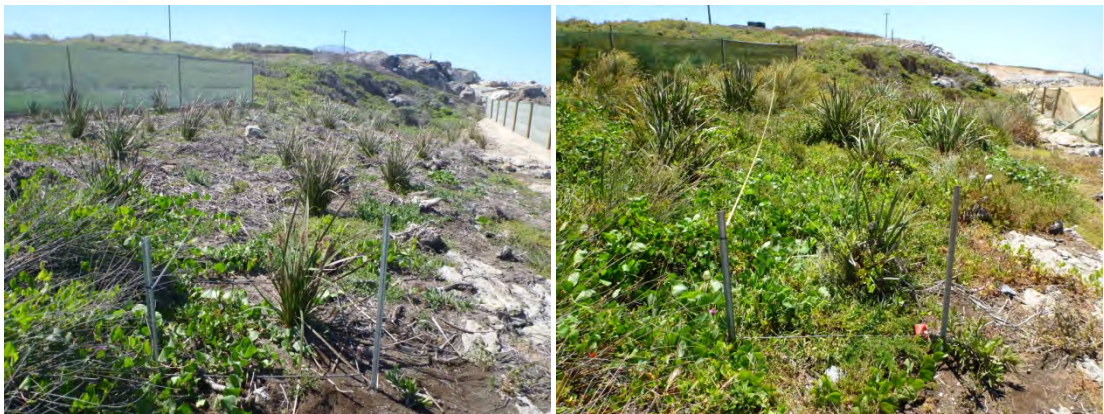
Plate 4 Transect 4, 2012 rehabilitation – comparison at 5 and 17 months old.

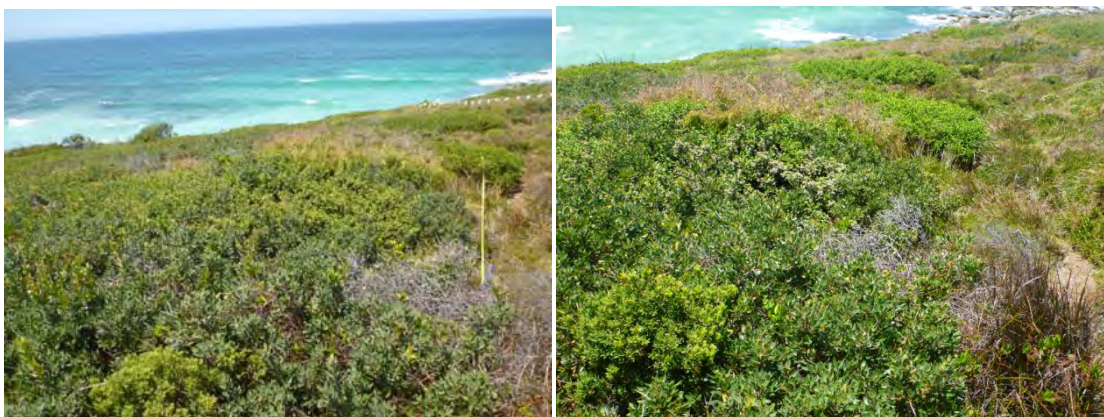
Plate 5 Transect 1, Analogue Site – comparison between November 2012 and 2013.

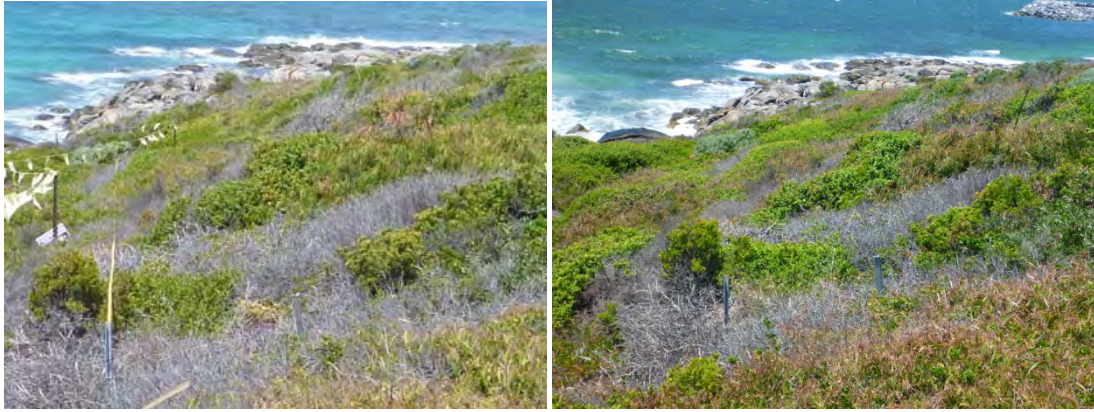
Plate 6 Transect 2, Analogue Site – comparison between November 2012 and 2013.

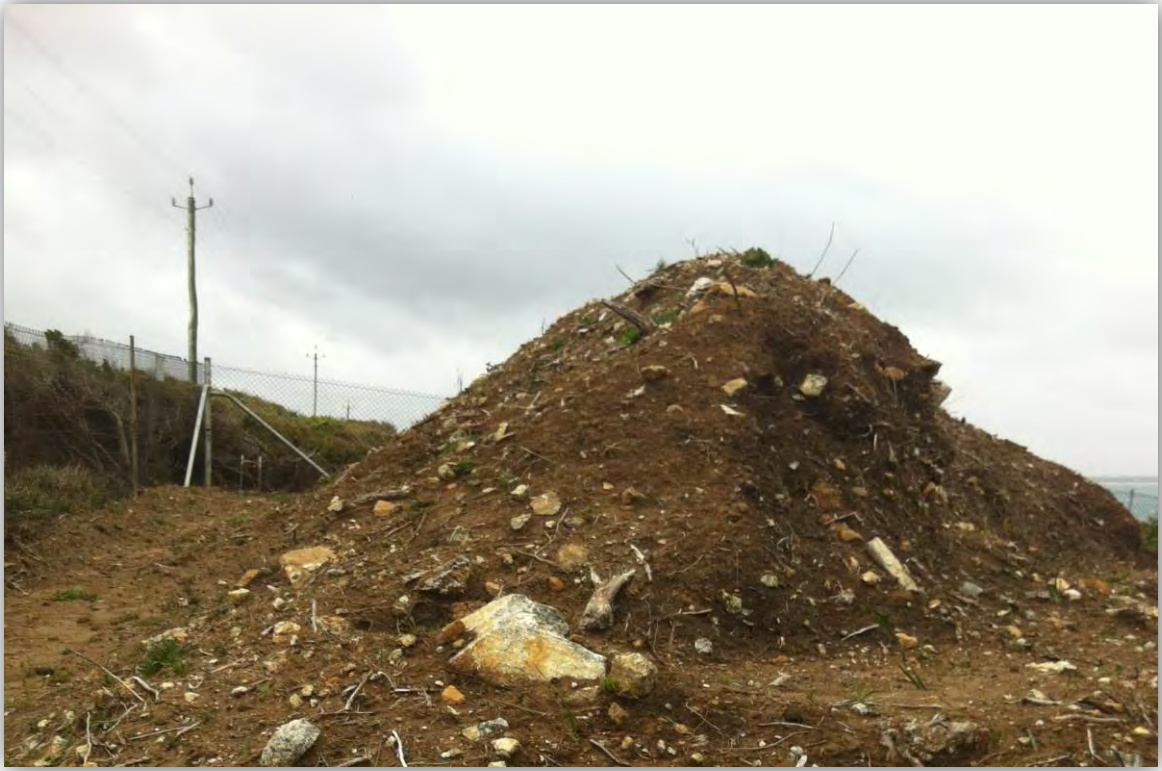
PLATE 13      Subsoil and topsoil stockpiles

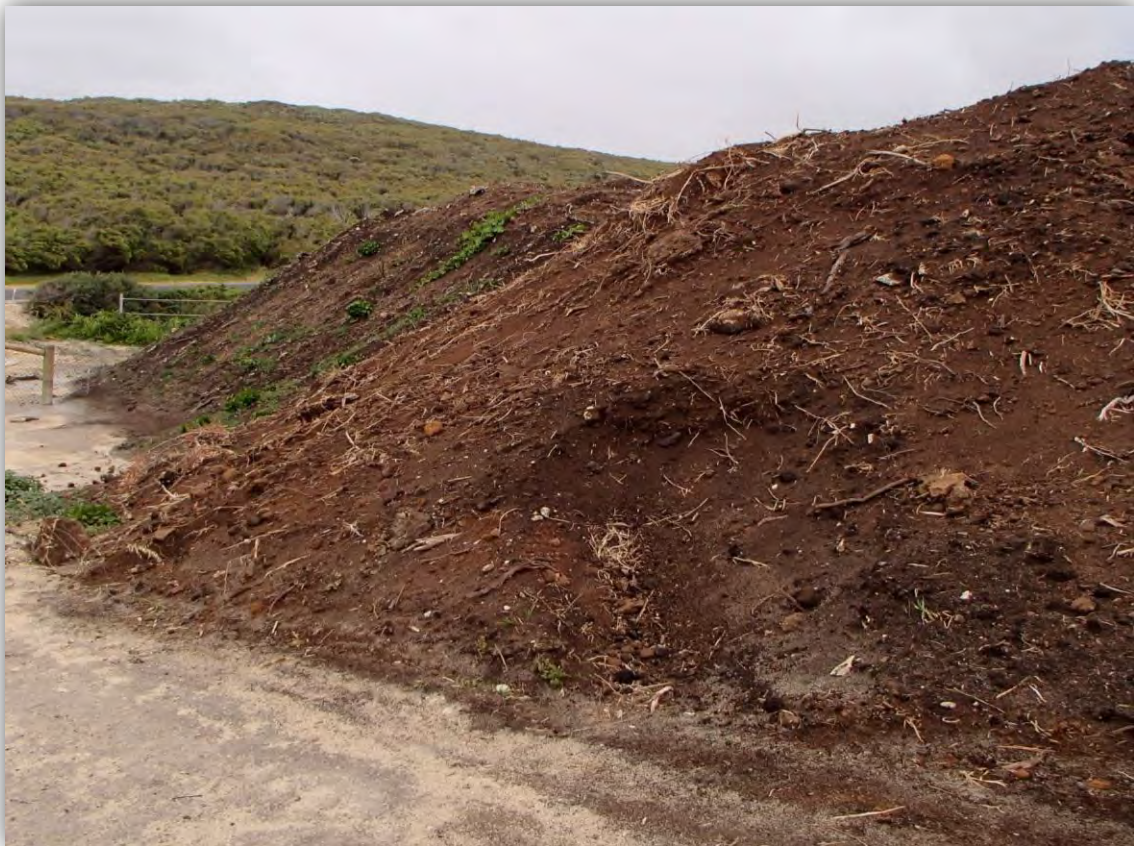
PLATE 14      Subsoil and topsoil stockpiles

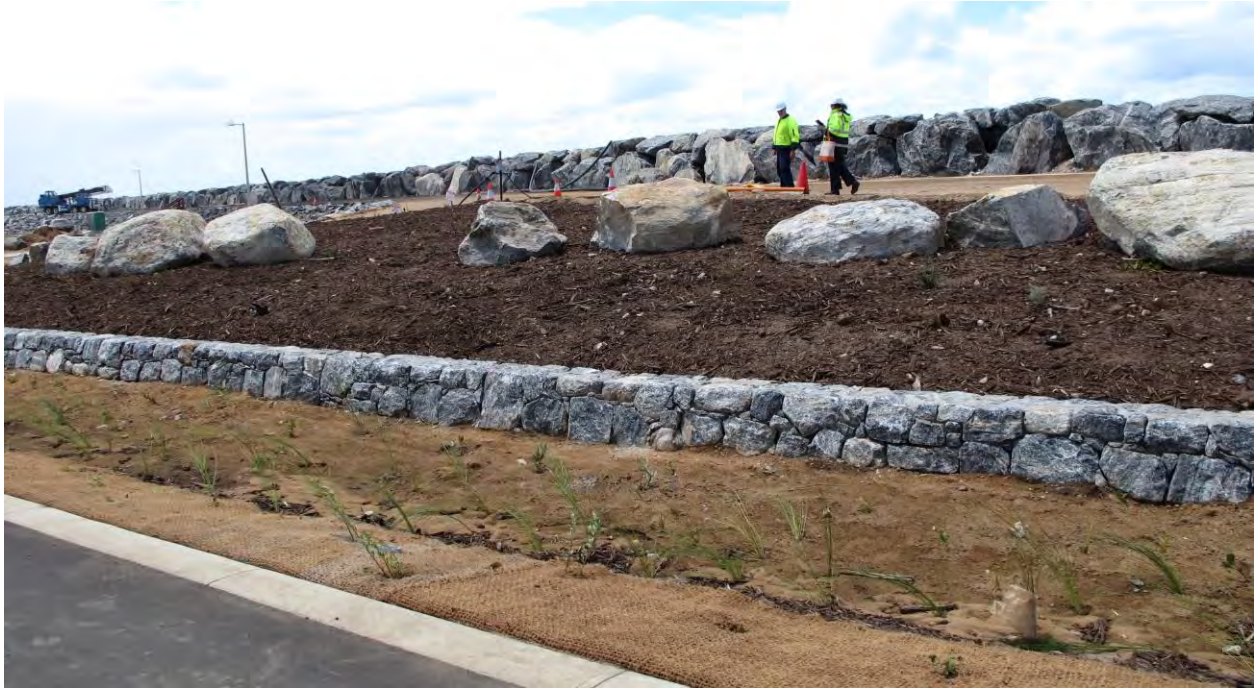
PLATE 5      Surface Water Drainage

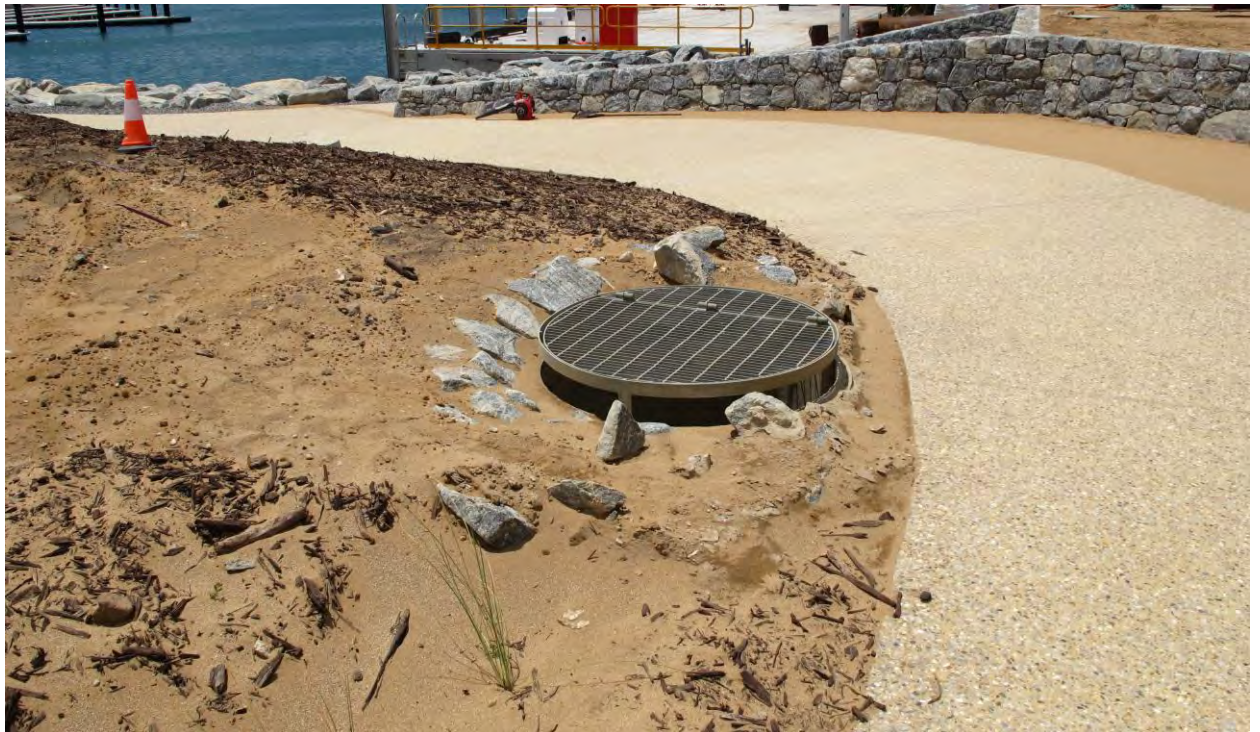
PLATE 6      Surface Water Drainage

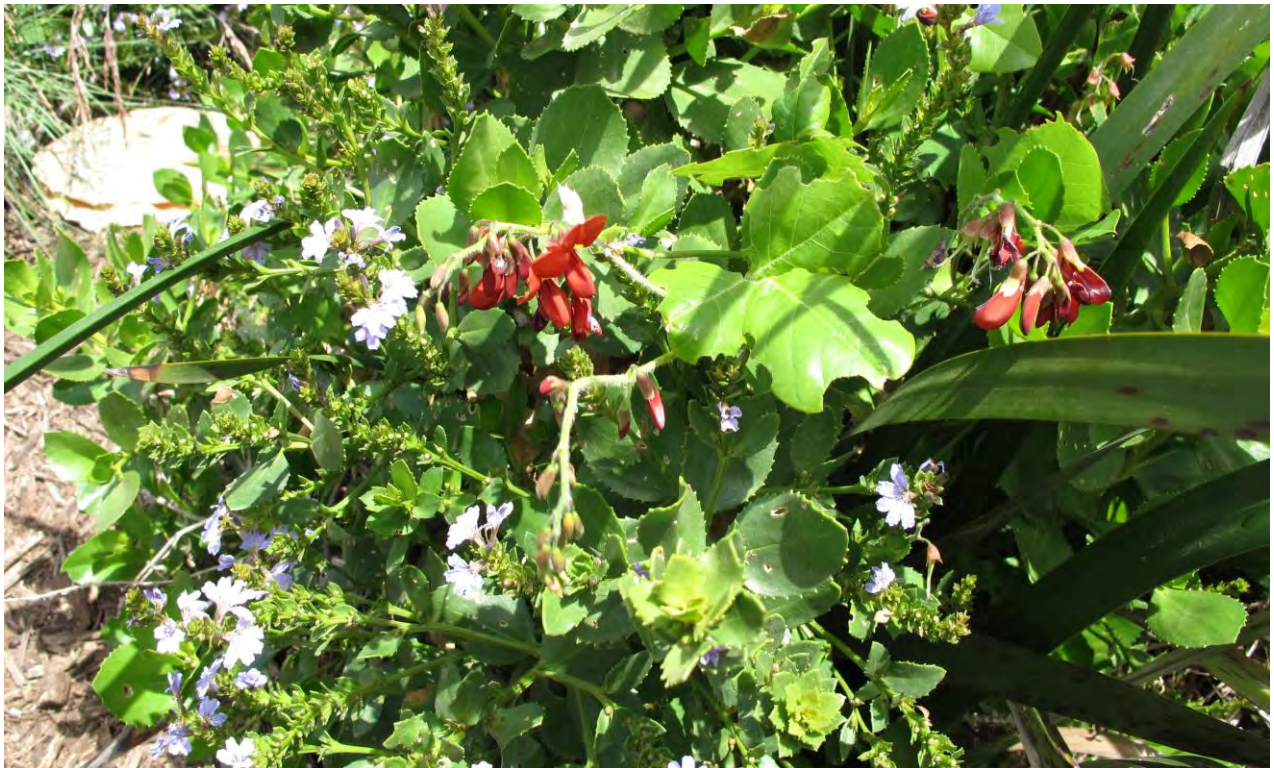
PLATE 8            Declare Rare Flora - *Kennedia lateritia*

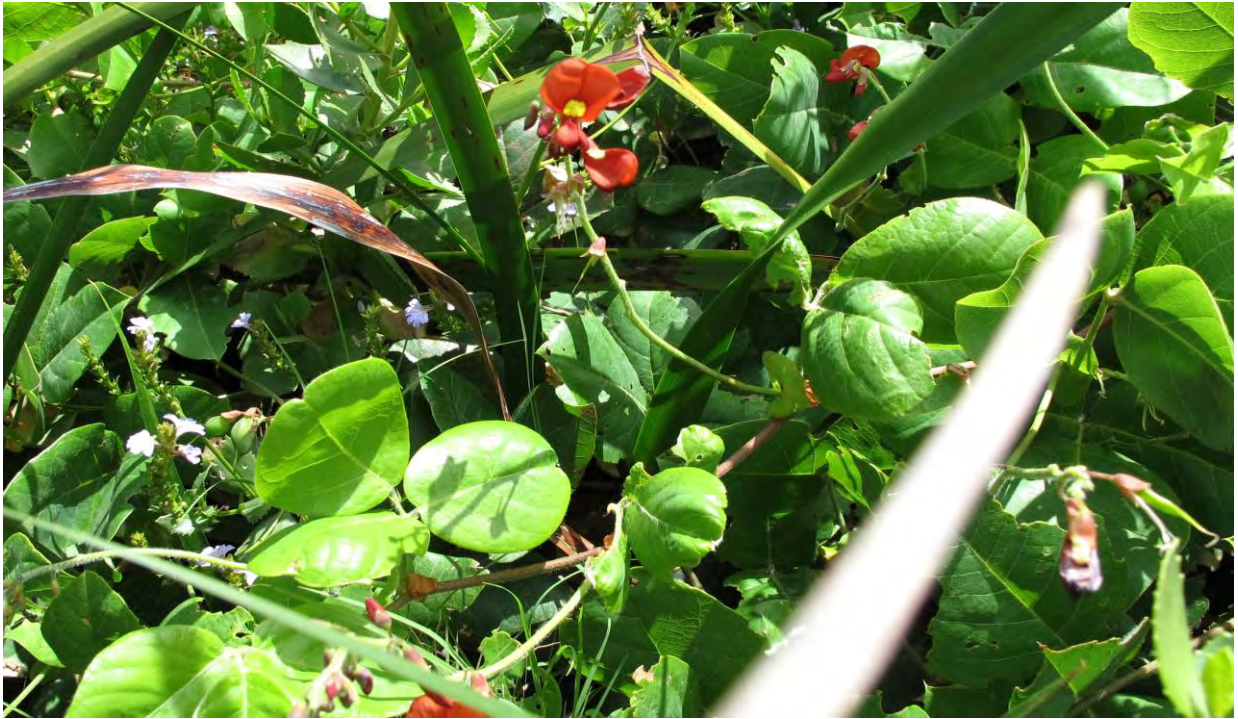
PLATE 9

Declare Rare Flora - *Kennedia lateritia*

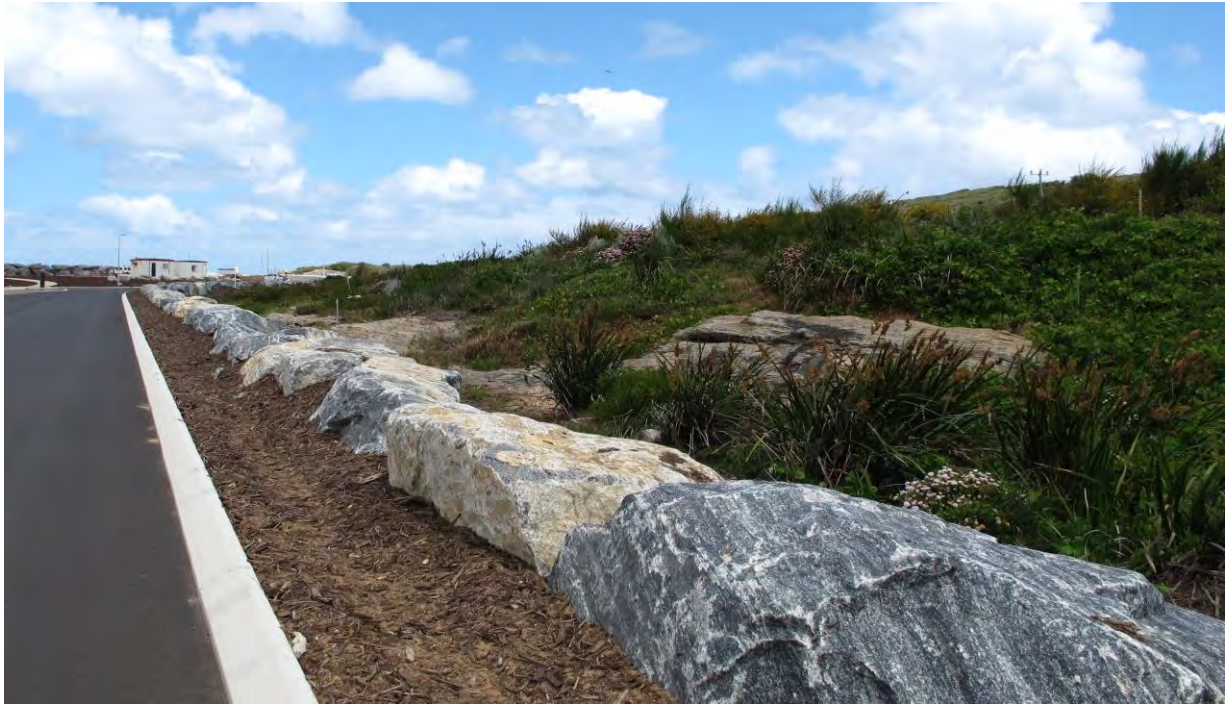
PLATE 11      Rock wall along Rehabilitaiton Block - preventing access

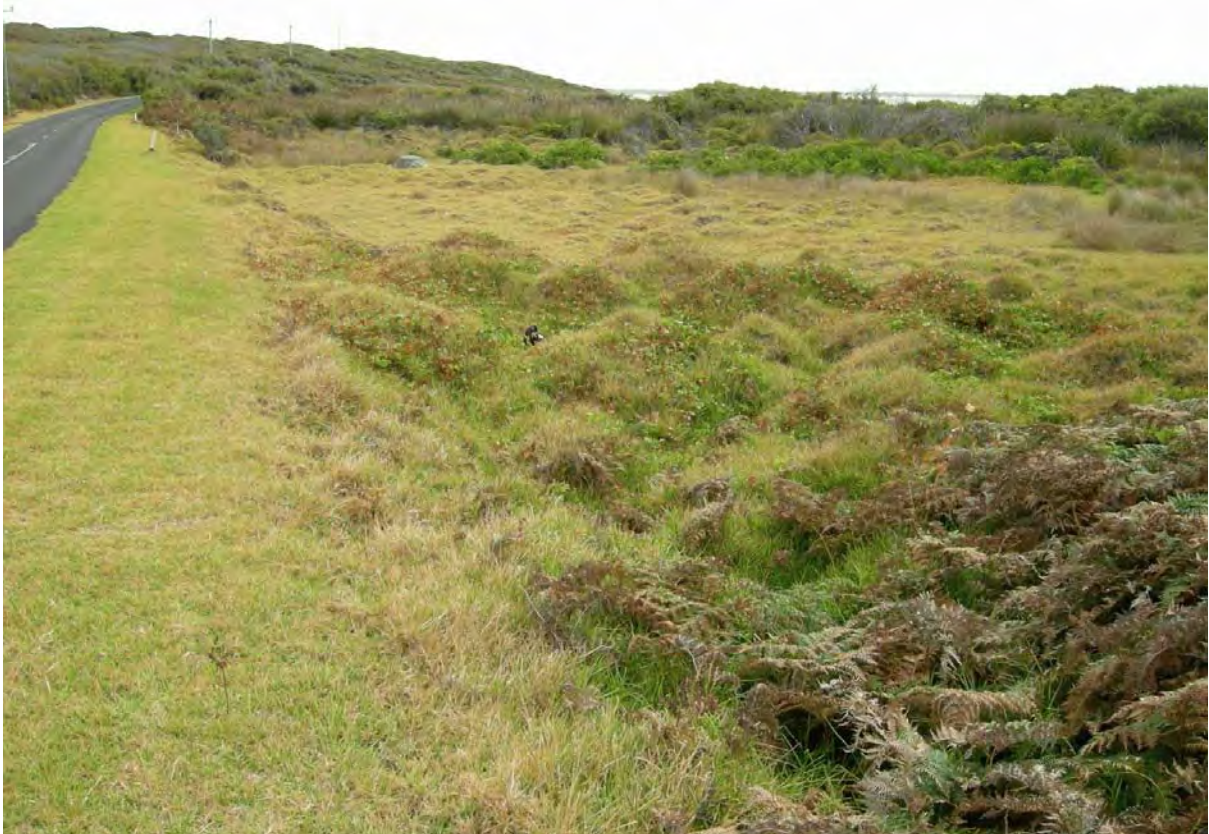
While there can be no argument that the current state of the seasonally inundated zone is an improvement on the previous cover of exotic grasses, there is an opportunity to reduce the potential impact of surface water expression on vegetation by integrating rehabilitation of adjacent areas proposed for mid 2014, i.e. access road, humus stockpile, and car park situated south of the access road. This will likely reduce the depth and duration of pooling surface water across the larger area. It should be emphasised that annual rainfall for Cape Leeuwin during 2013 totalled 982.8 mm; this was the wettest of the past 17 years (since 1996) and was the major contributing factor to seasonal inundation encroaching 1-2 m outside of the zone evidenced in recent years.

Plate 1 The seasonally inundated zone prior to rehabilitation and management by Department of Transport.

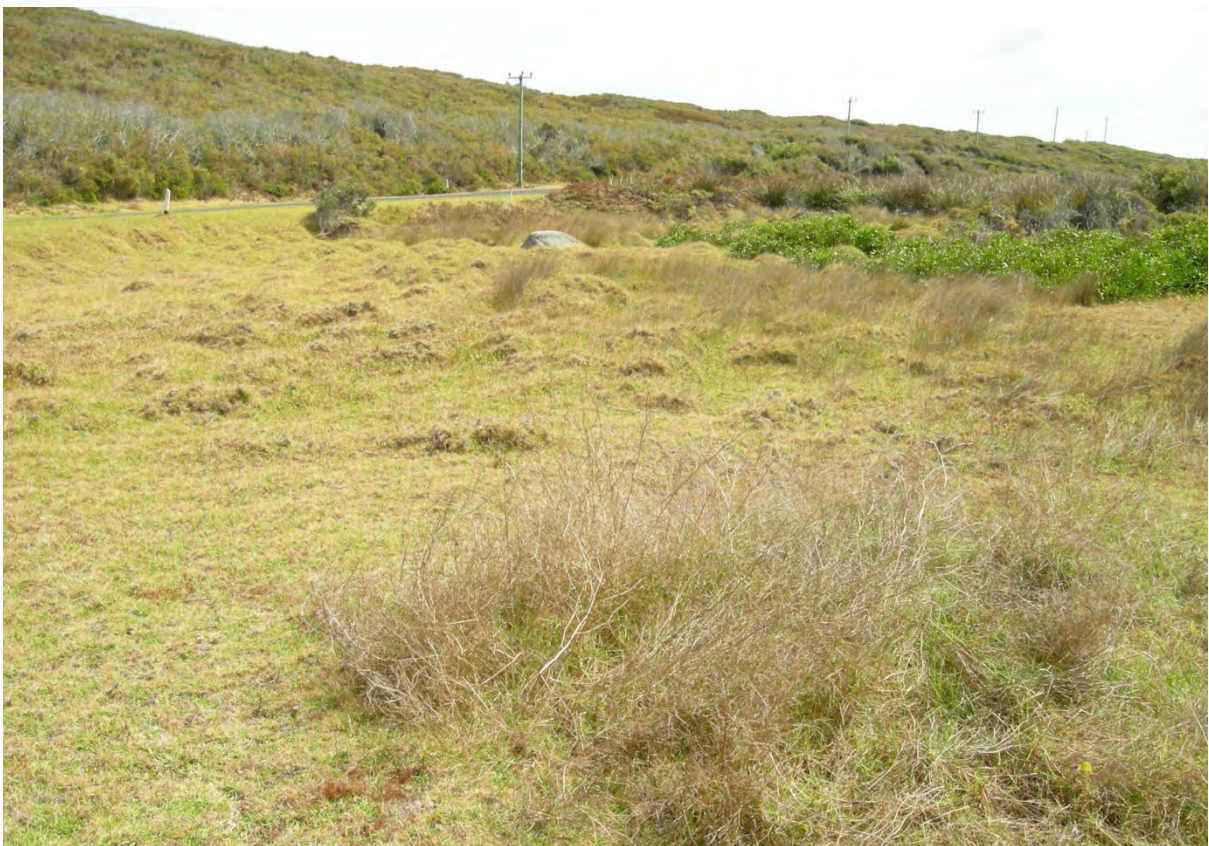
Plate 2 The seasonally inundated zone prior to rehabilitation and management by Department of Transport.

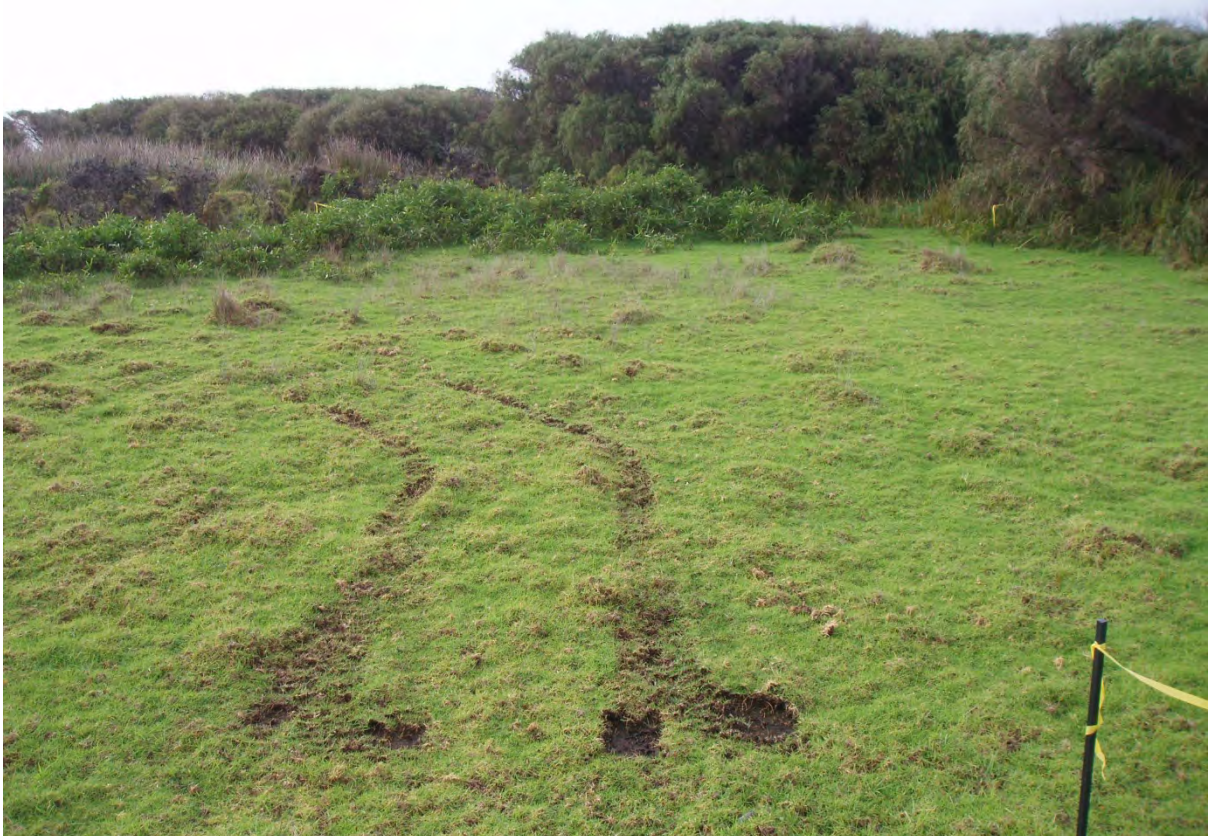
Plate 3 The seasonally inundated zone prior to rehabilitation and management by Department of Transport.
