CONDITION REPORT
SHEDS 6, 7 & 8
OUTER HARBOUR PORT, BUNBURY

WML
Consulting Engineers

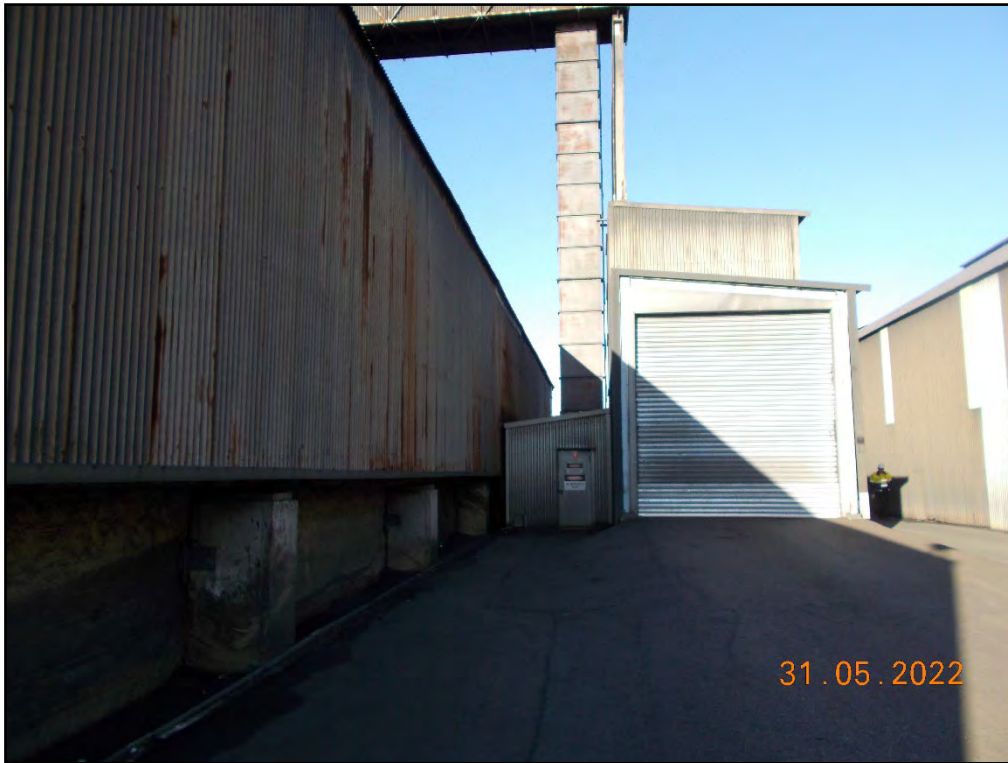
Photograph 4 Corrosion on Wall Sheeting

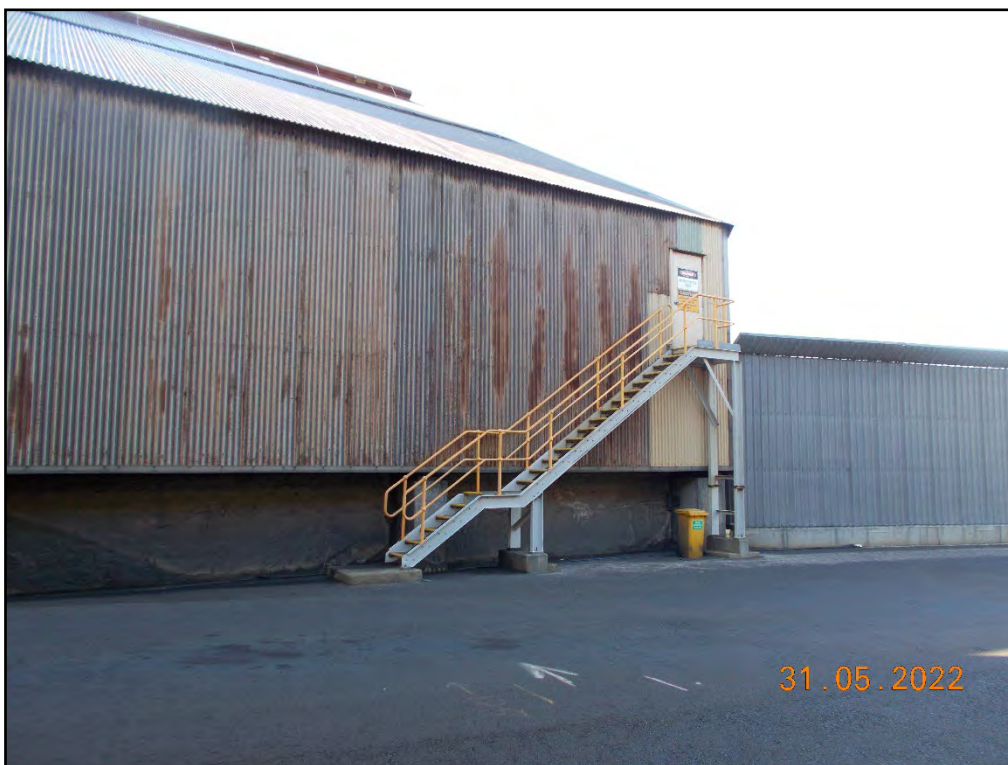
Photograph 5 Corrosion on Wall Sheeting

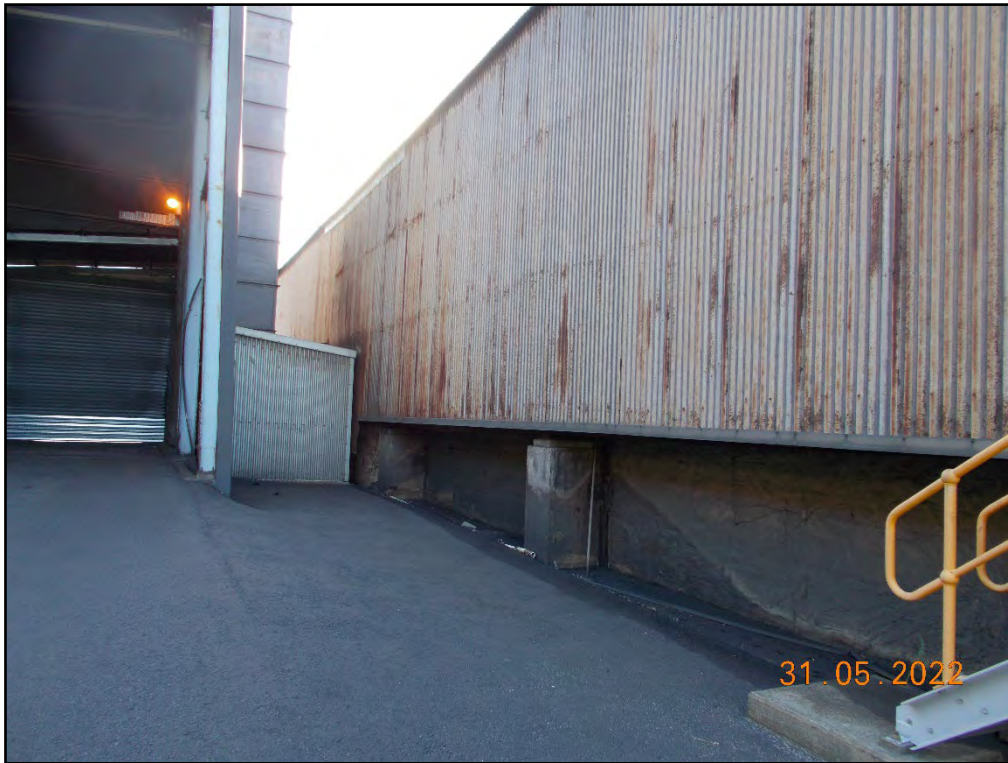
Photograph 6 Corrosion on Wall Sheeting

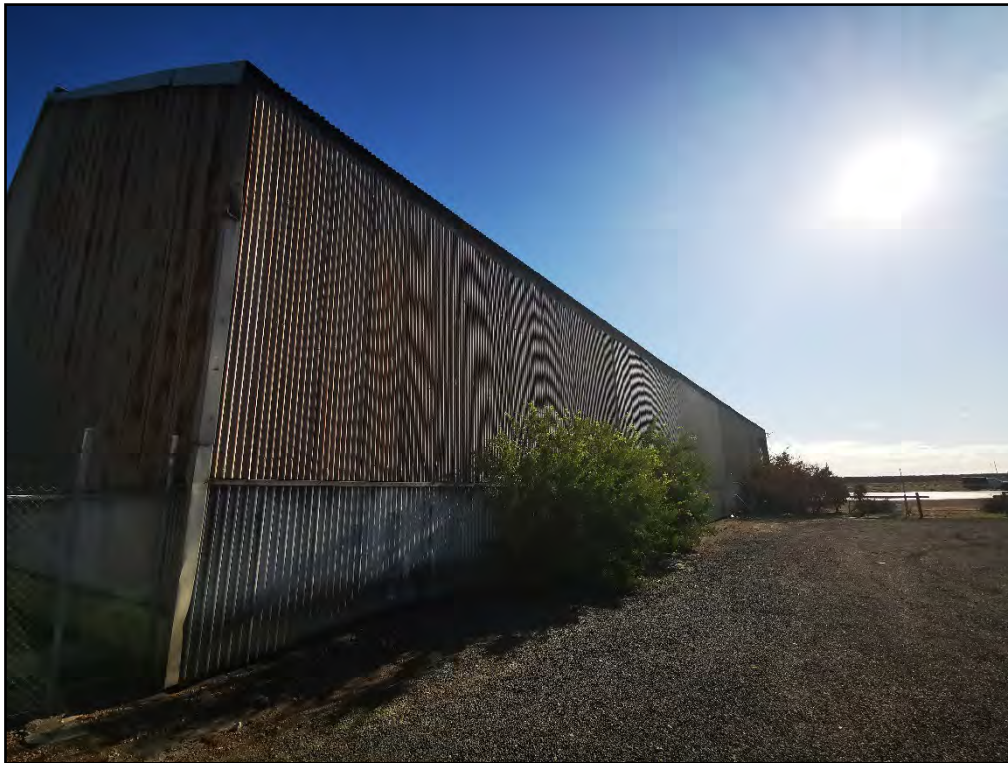
Photograph 8 Wall Sheeting East Side Minimum Damage

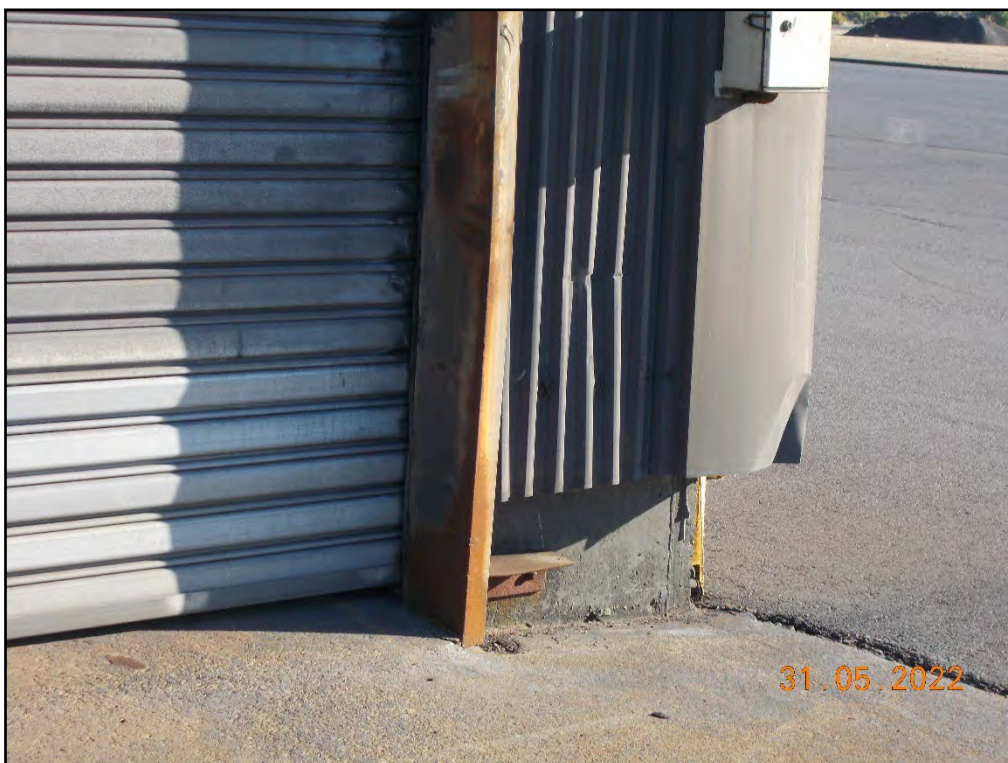
Photograph 9 Post Damage Due to Impact

The working practises need to be investigated and procedures put in place to prevent impact causing structural damage from reoccurring. Continued impact of the magnitude is high risk and may impact the structural integrity of the steel members.

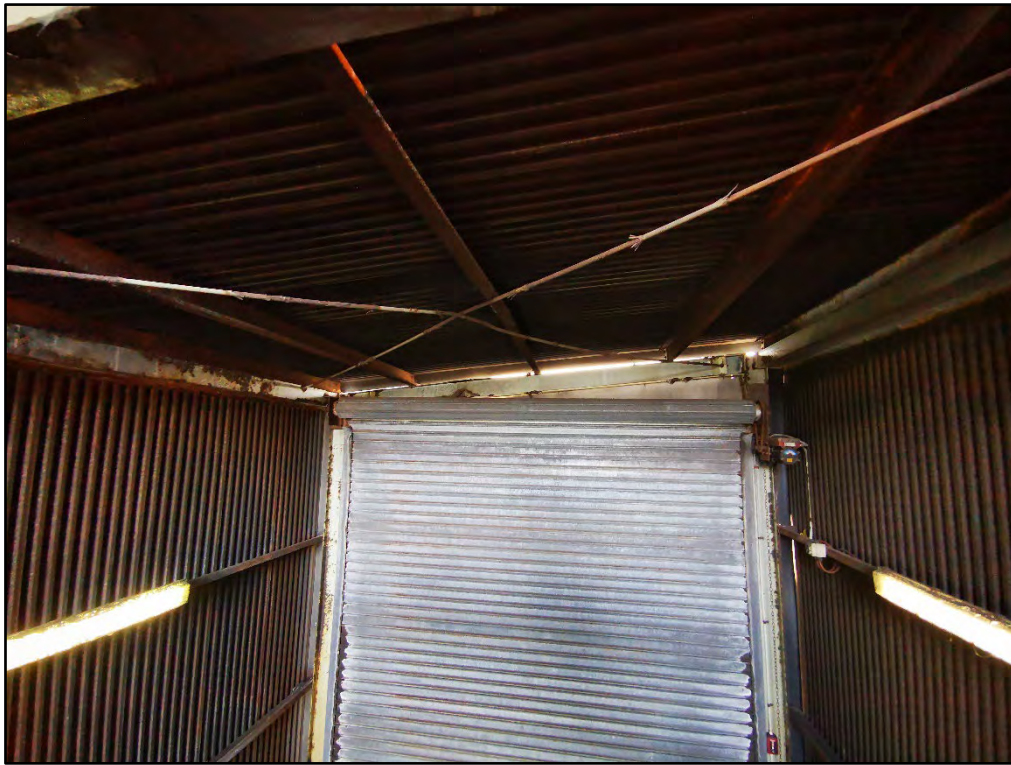
Photograph 16 Damage to Purlin and Bracing due to Impact

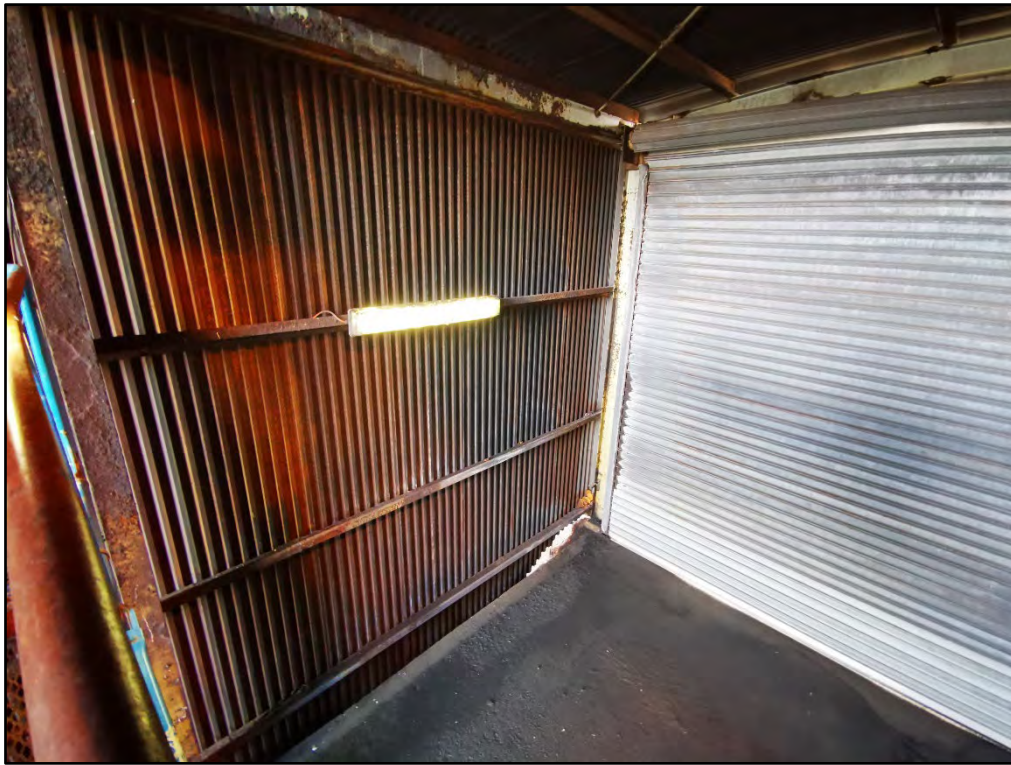
Photograph 18 Corrosion of Wall Girts and Sheeting

The unloading bays, north of shed 7 and west of shed 6, have shown signs of corrosion and weathering. Girts and purlins are heavily corroded, and, in some cases, sectional loss can be seen clearly. Girts and purlins need replacing where identified. In addition, impact damages due to vehicles were noticed at the entrance of the bays and needs immediate attention.

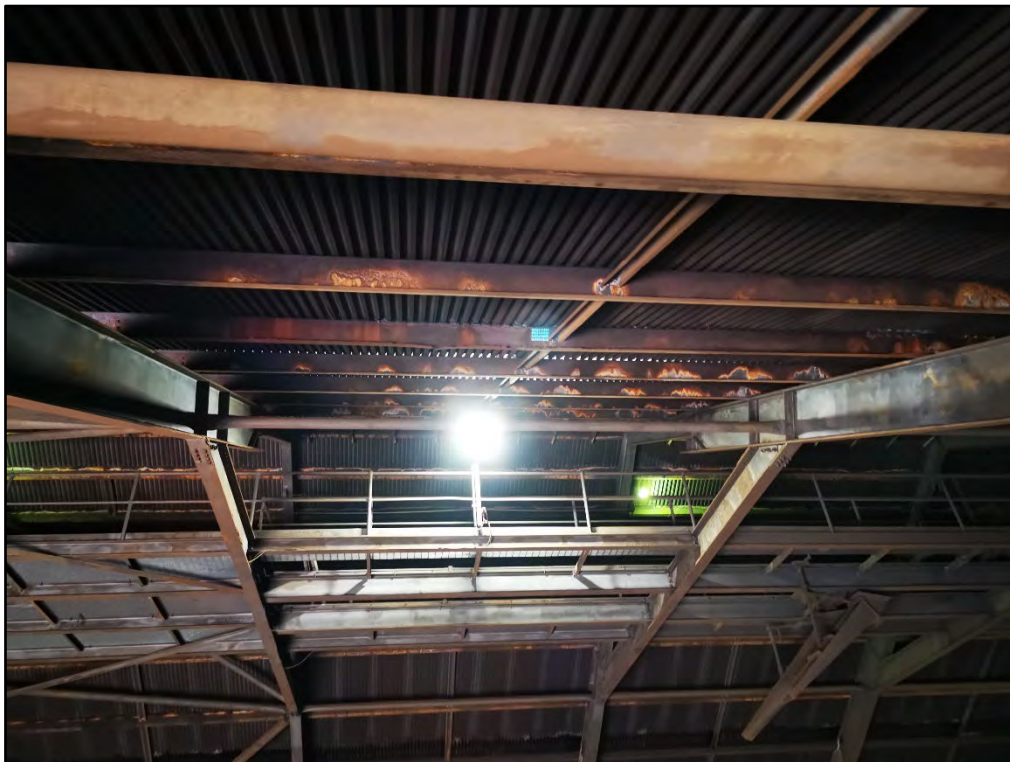
Photograph 20 Surface Corrosion of Purlins

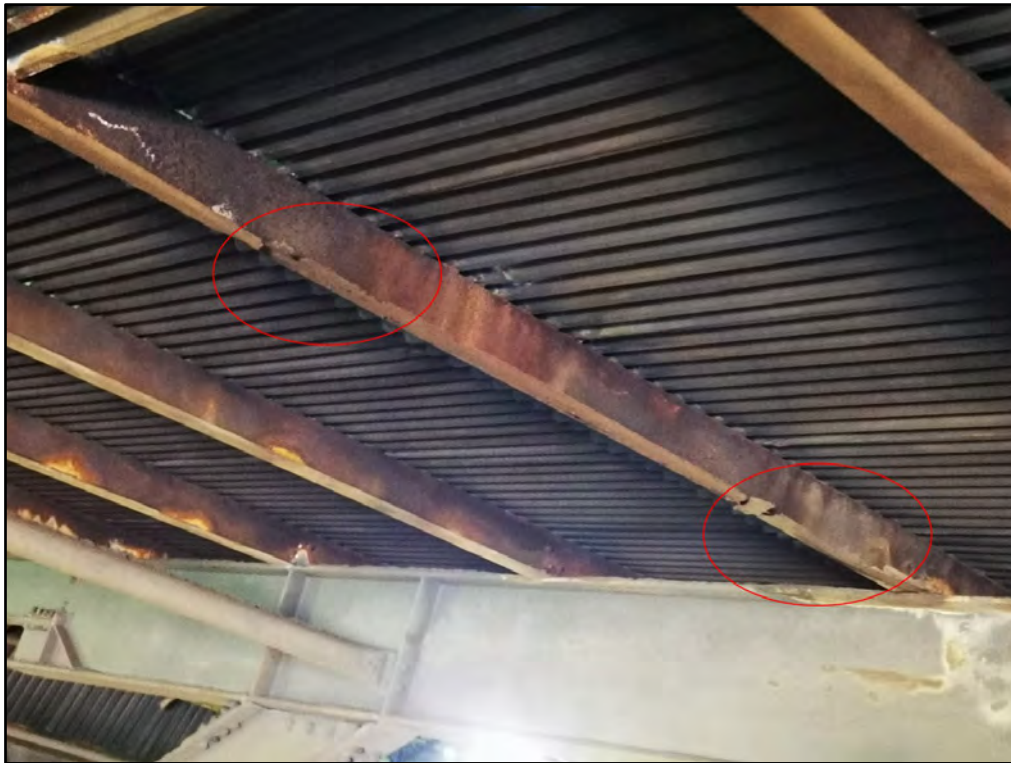
Photograph 21 Damaged Purlin and Surface Corrosion of Purlins

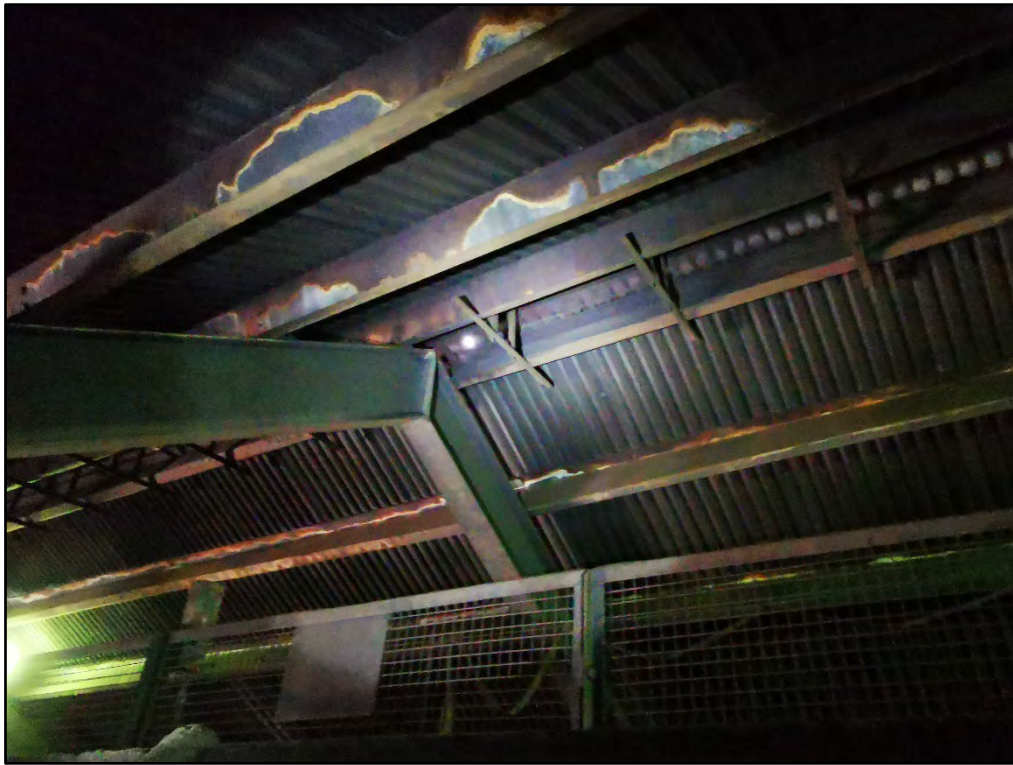
Photograph 23 Surface Corrosion of Purlins and Rafters

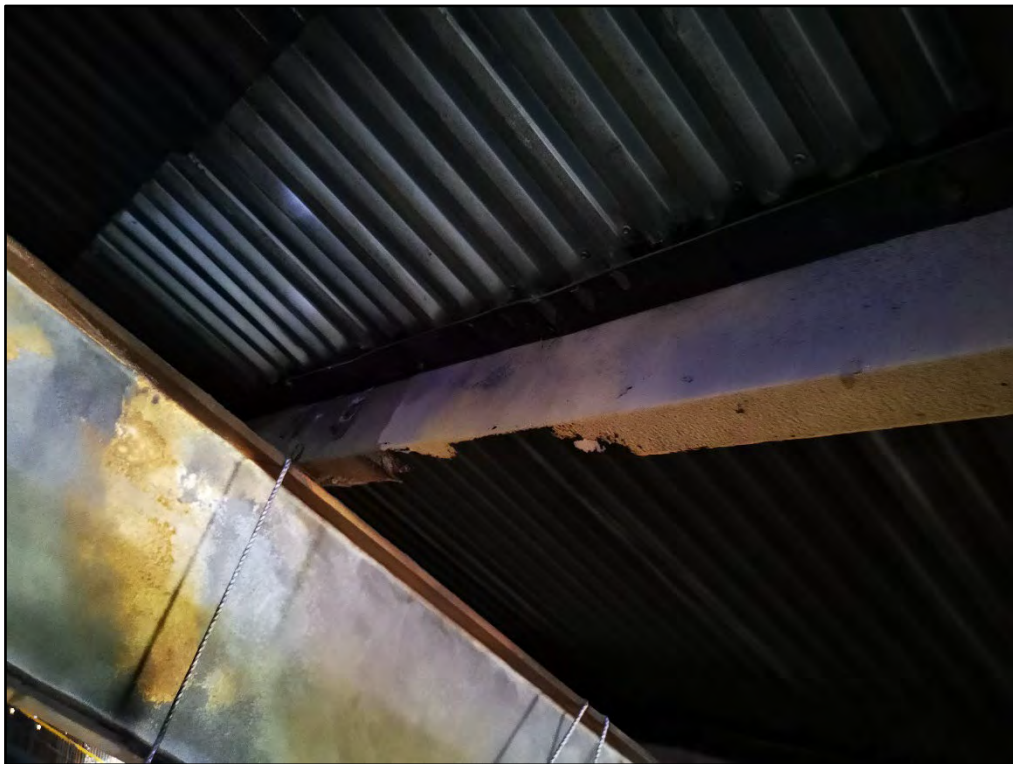
Photograph 24 Deteriorated Purlin due to Corrosion

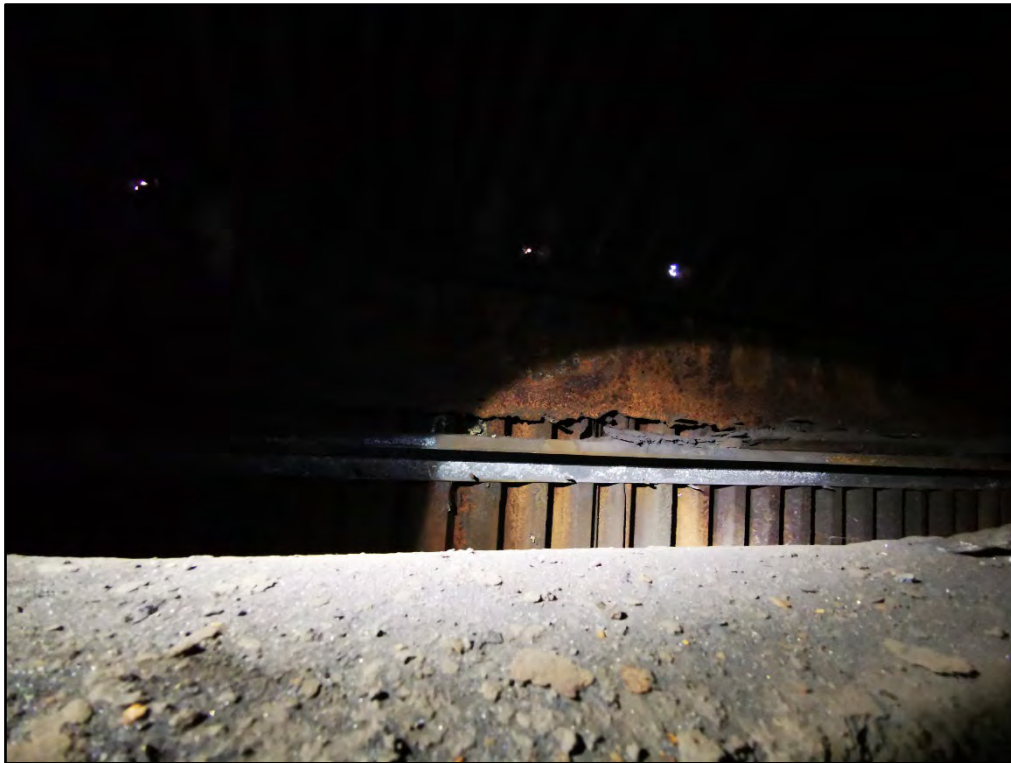
Photograph 25 Deteriorated Fascia Purlin due to Corrosion

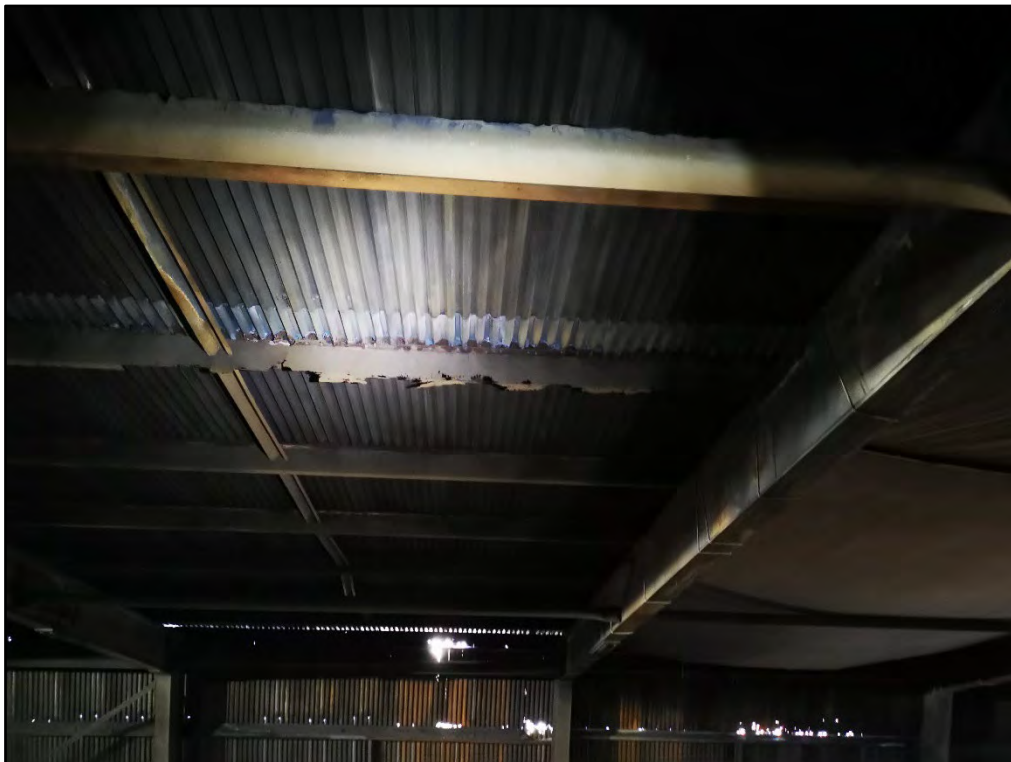
Photograph 26 Deteriorated Purlin due to Corrosion

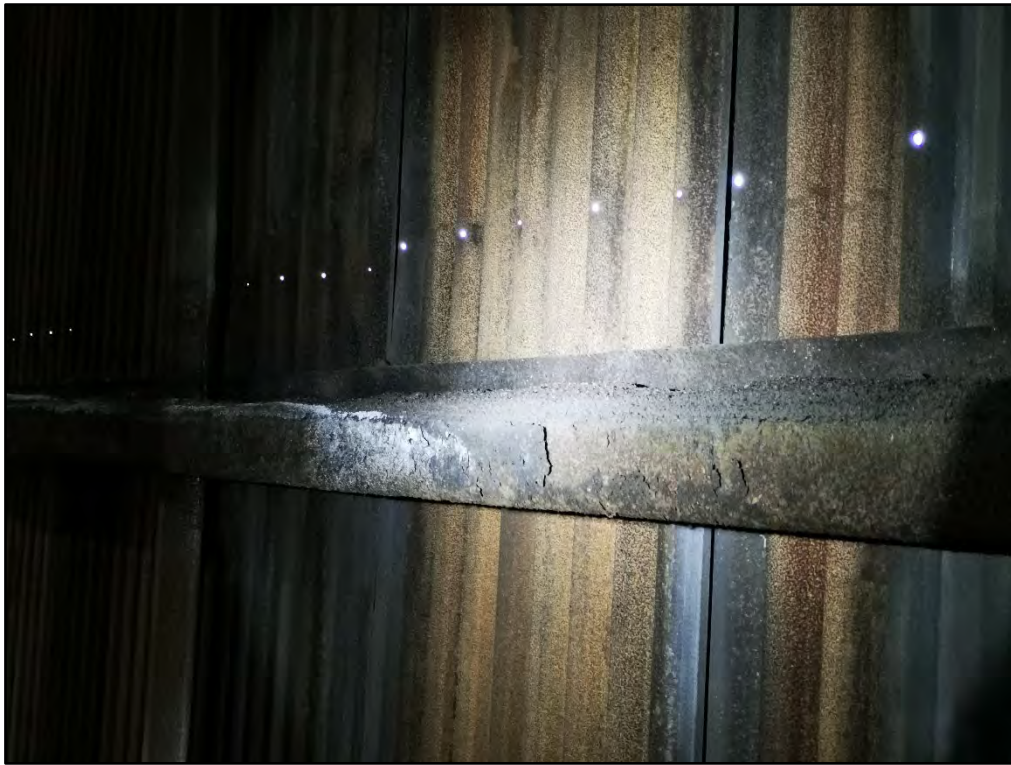
Photograph 31 Heavily Corroded Girt

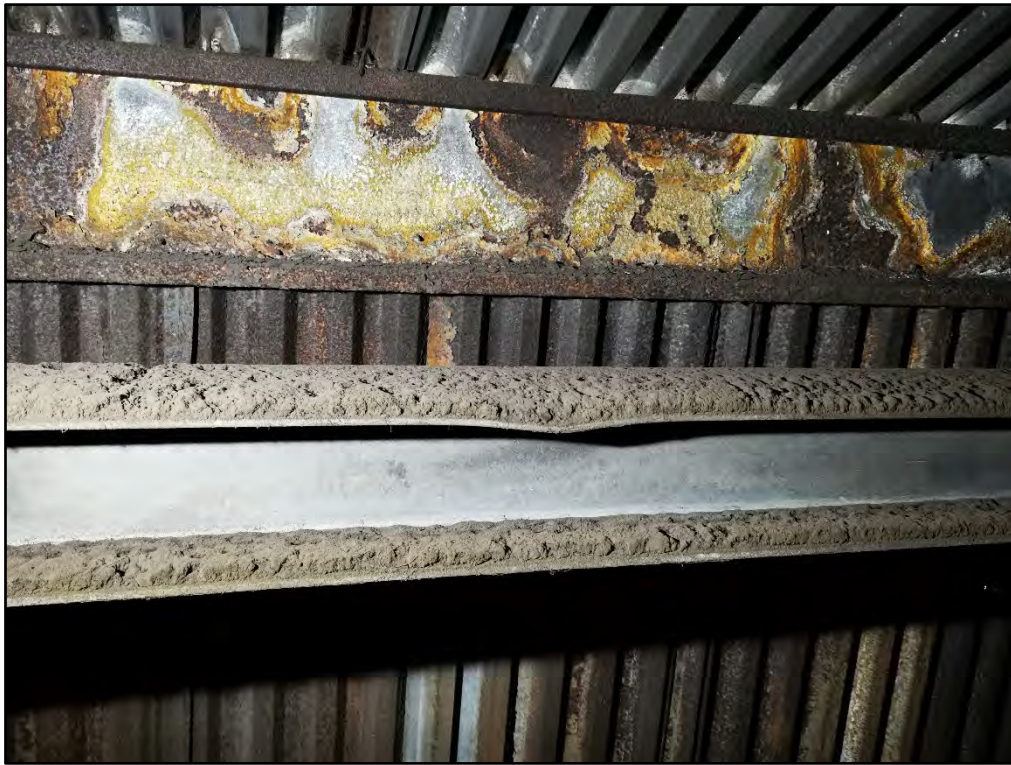
Photograph 33 Top Flange of Beam Damaged due to Impact

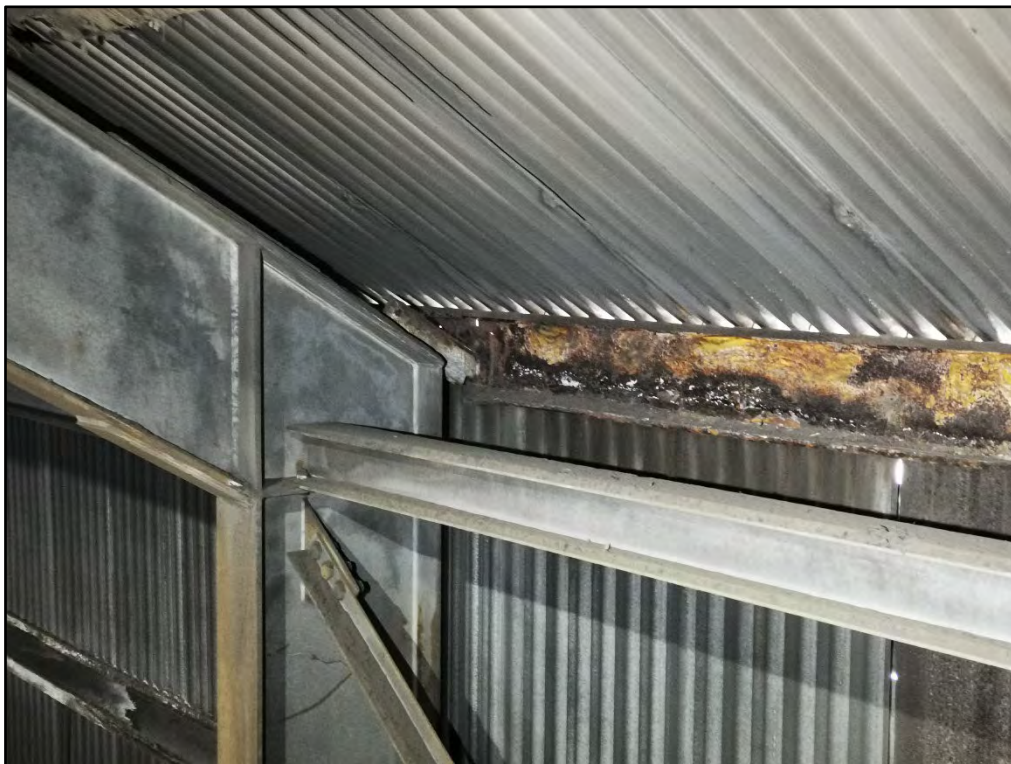
Photograph 34 Delamination of Fascia Purlin due to Corrosion

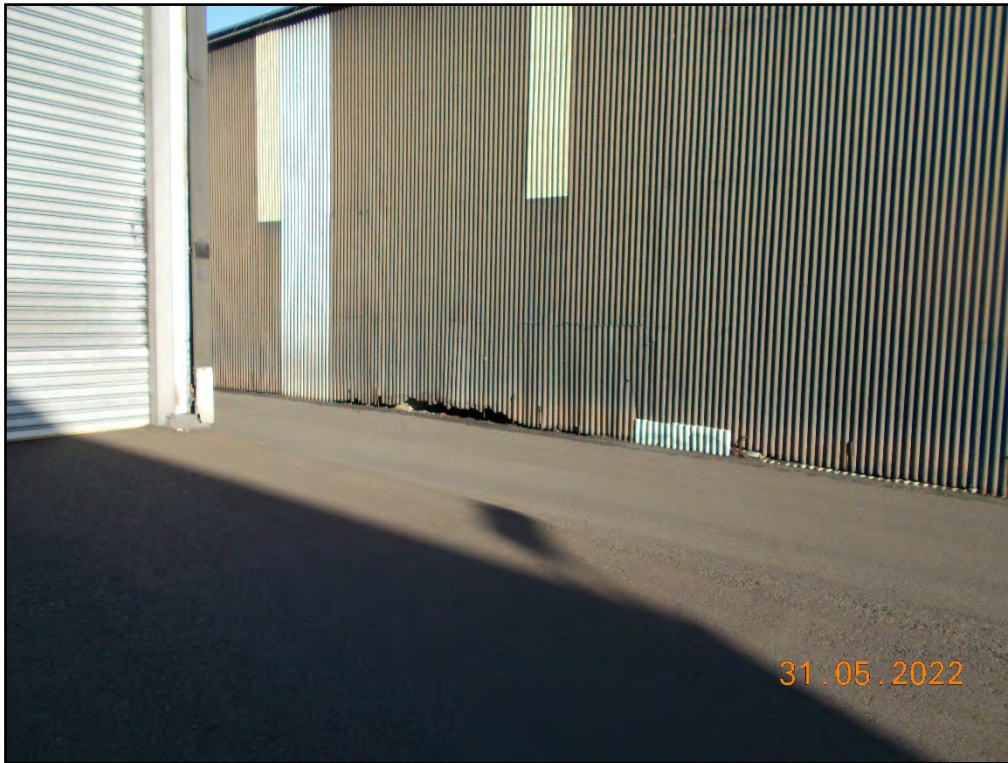
Photograph 46 Corrosion Deterioration at the Bottom of the Sheet

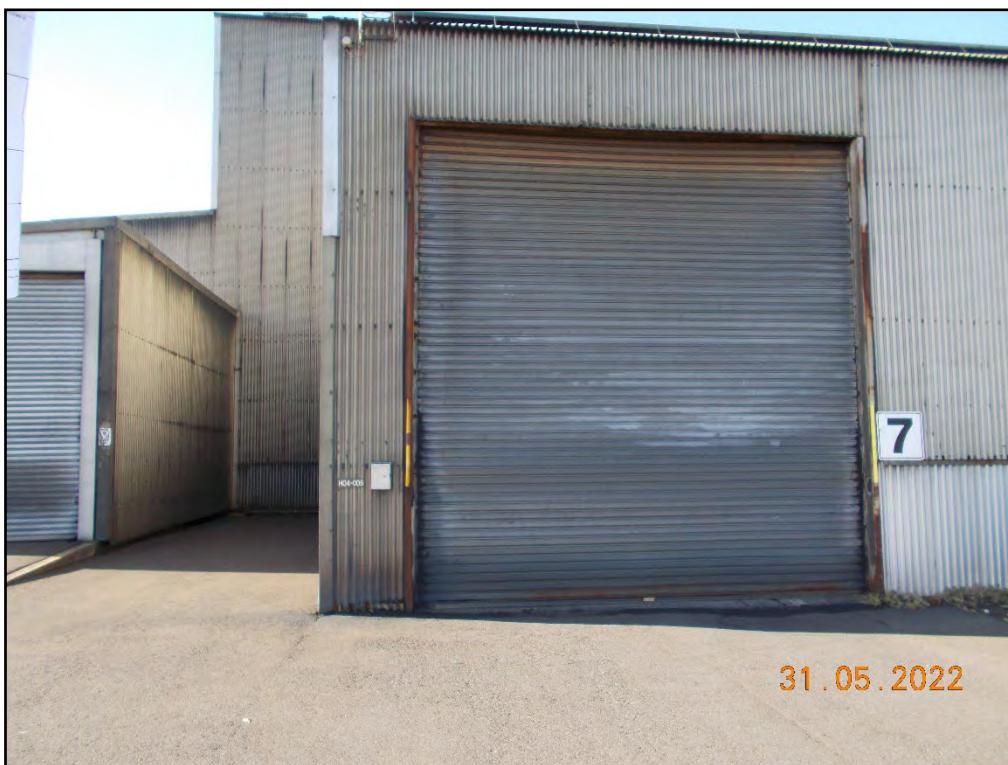
Photograph 47 Heavily Corroded Door Frame

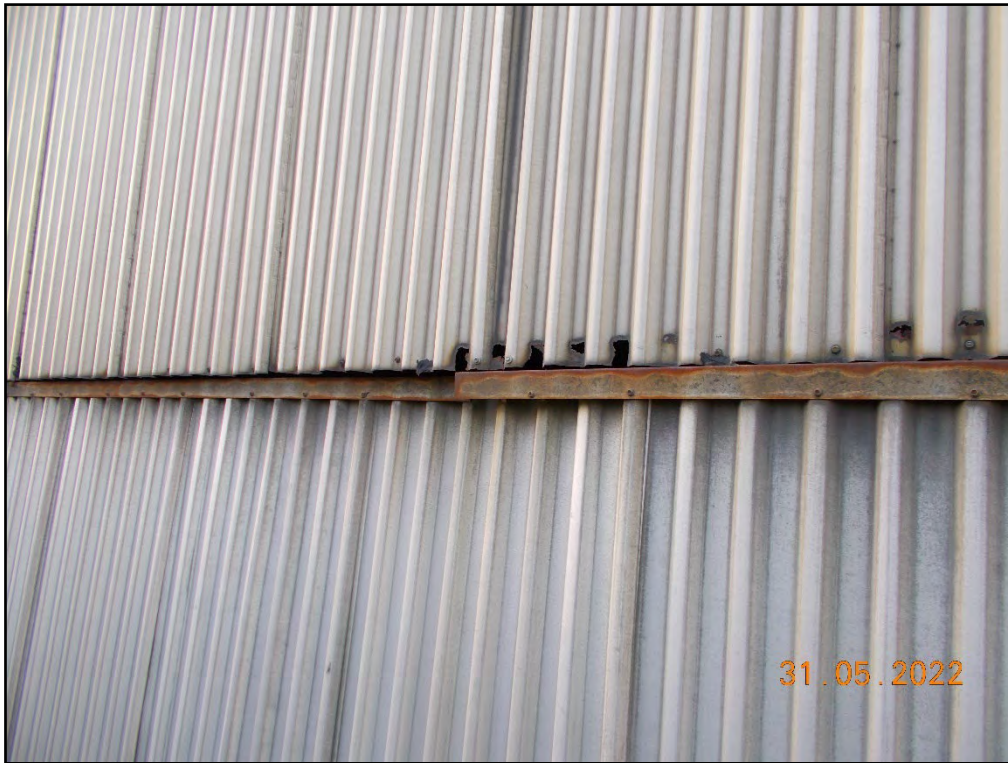
Photograph 48 Surface Corrosion of Steel Member and Wall Sheeting

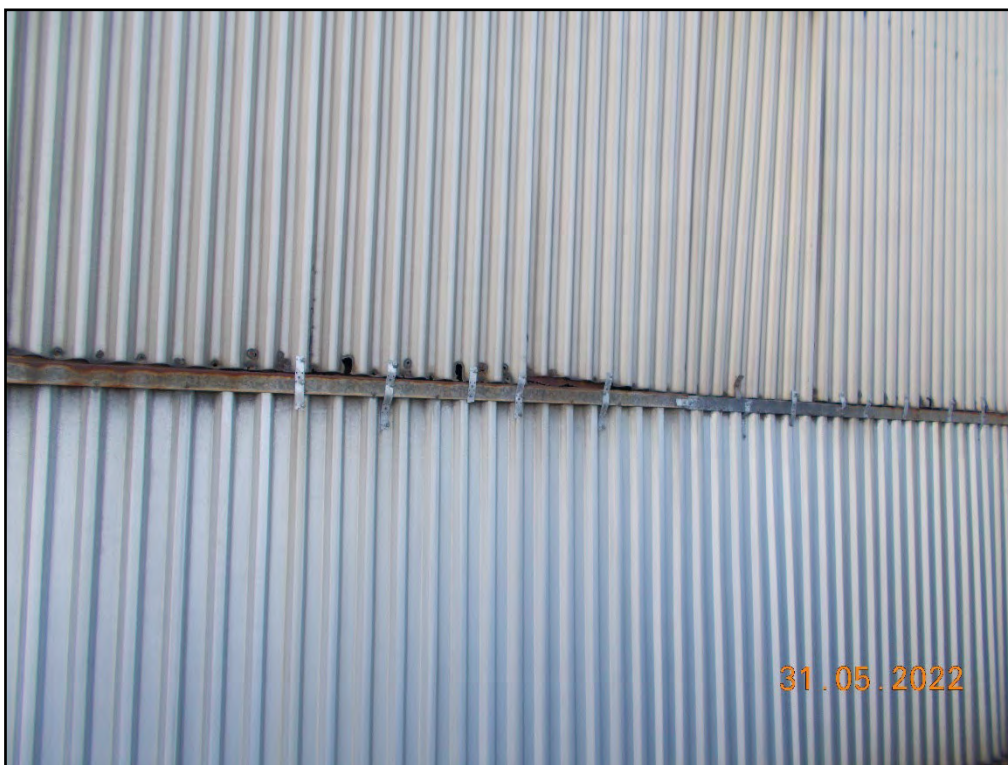
Photograph 51 Surface Corrosion of Steel Section and Wall Sheeting

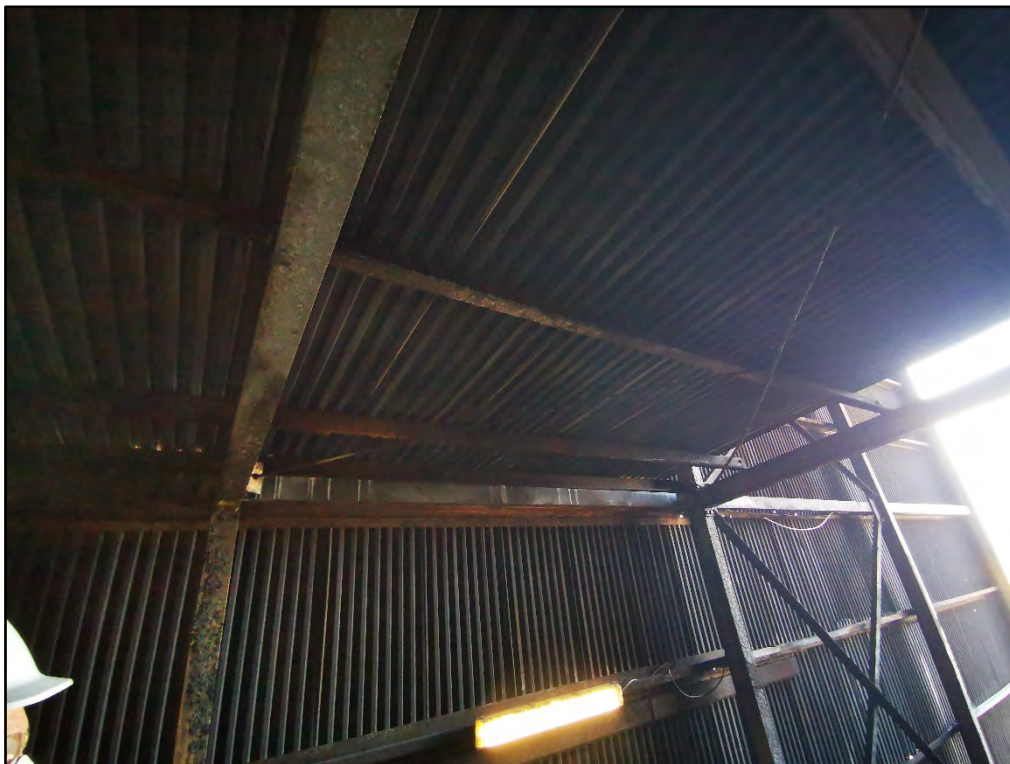
Photograph 70 Corrosion of Columns, Rafters, Purlins and Girts

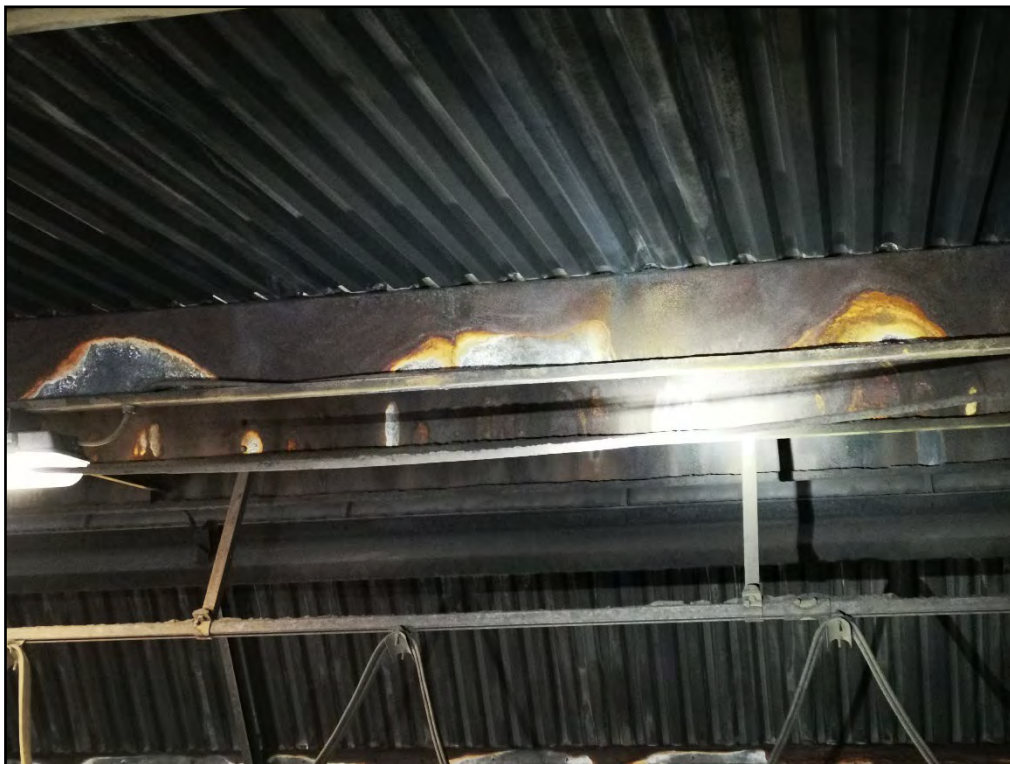
Photograph 79 Surface Corrosion of Purlin with Product Deposit

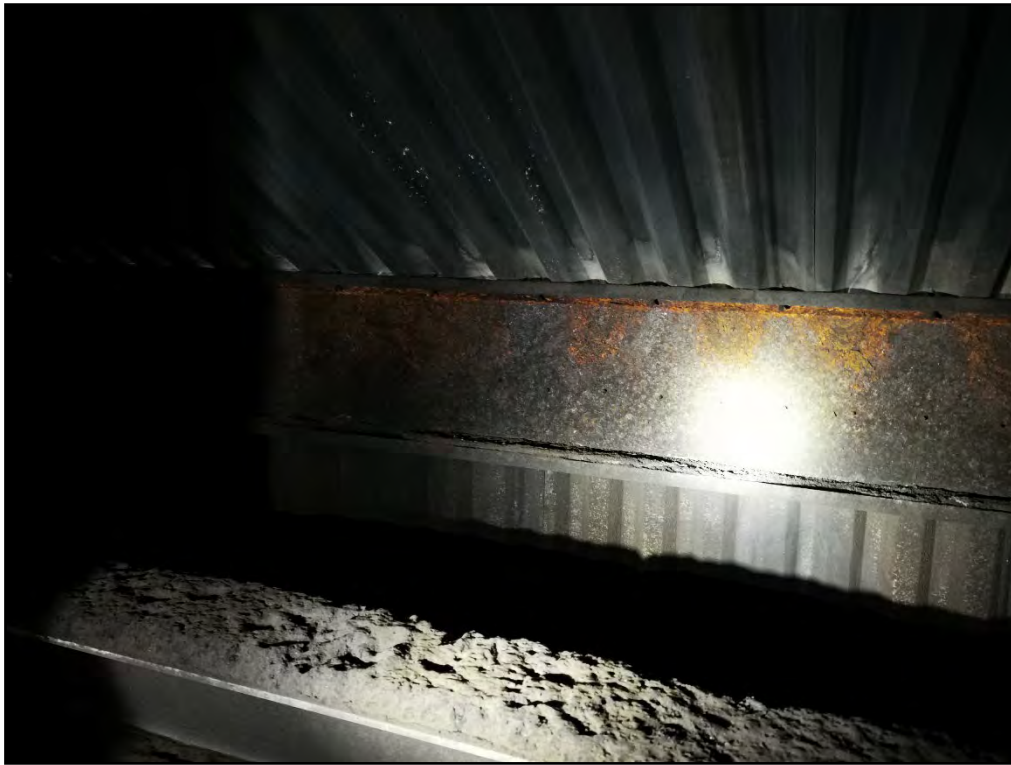
Photograph 80 Corrosion of Fascia Purlin and Product Deposit

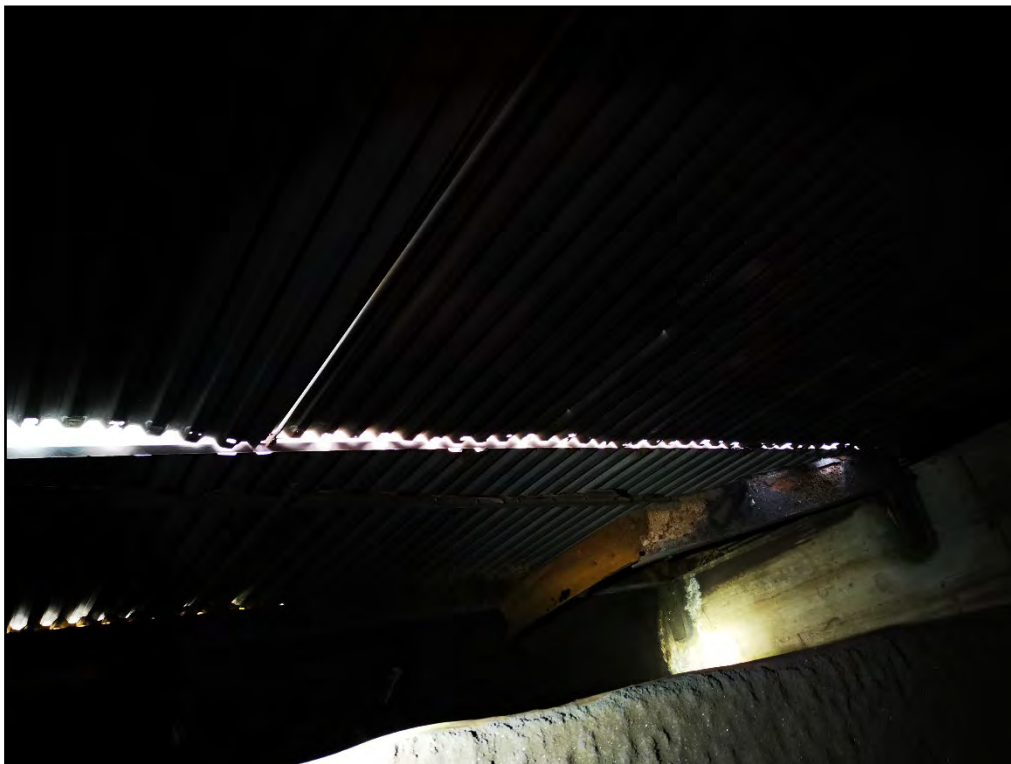
Photograph 81 Complete Failure of Wall Girt Due to Corrosion and Product Deposit

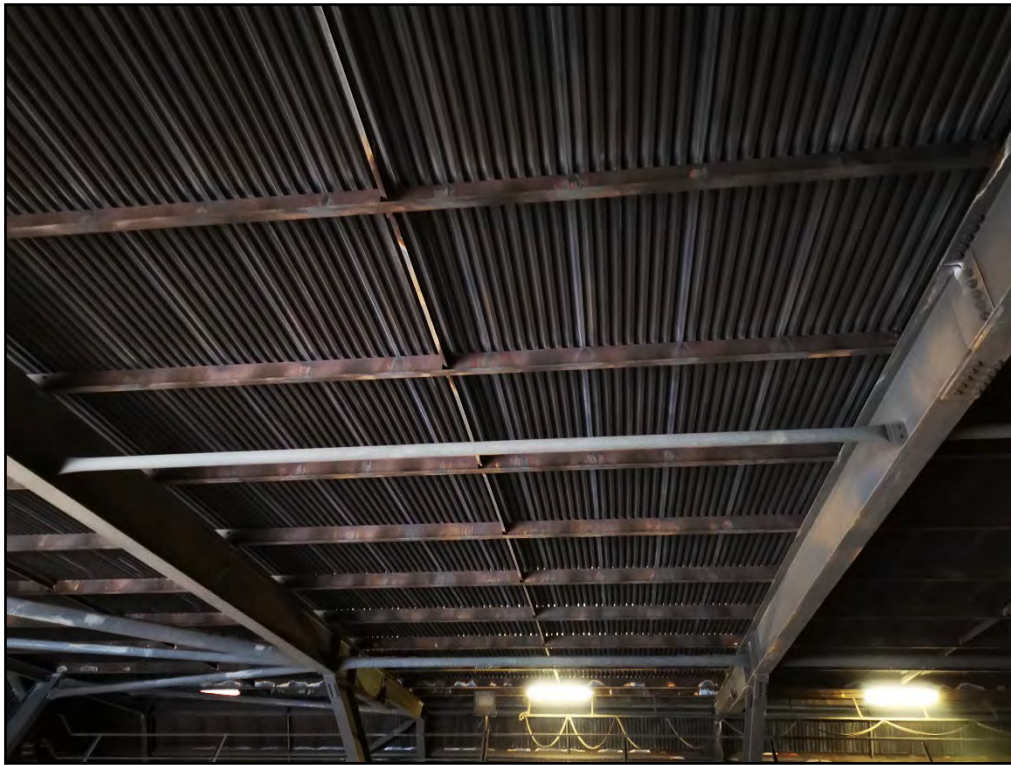
Photograph 82 Surface Corrosion of Purlins and Roof Sheeting

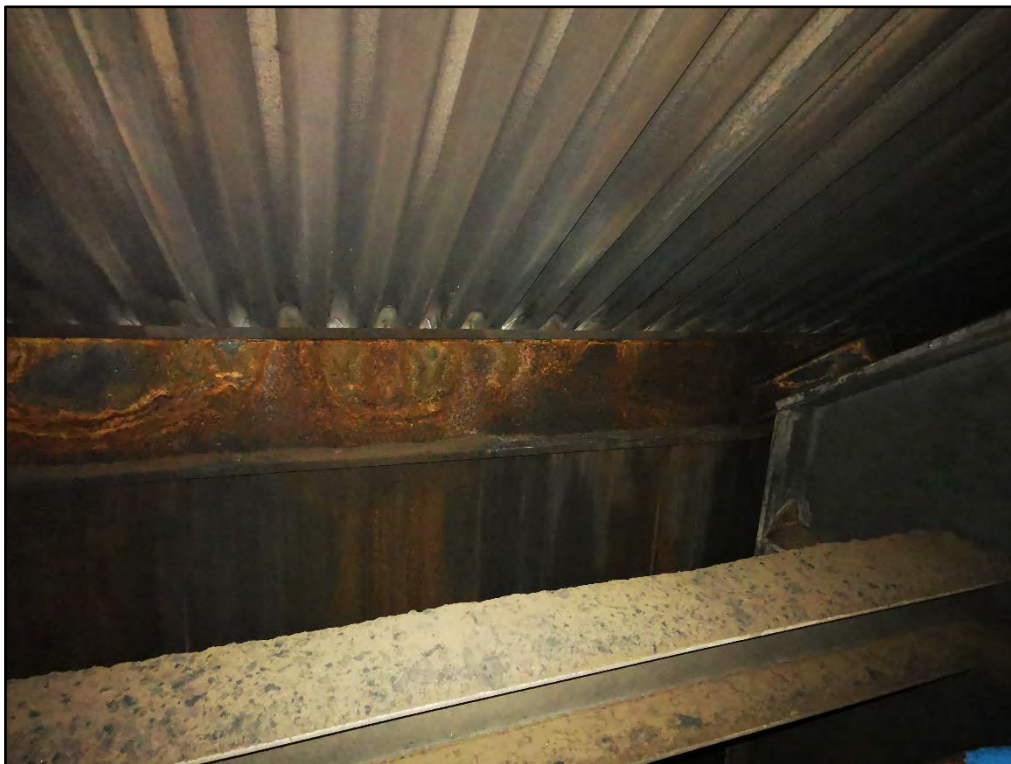
Photograph 83 Corrosion of Fascia Purlin and Product Deposit on UB Section

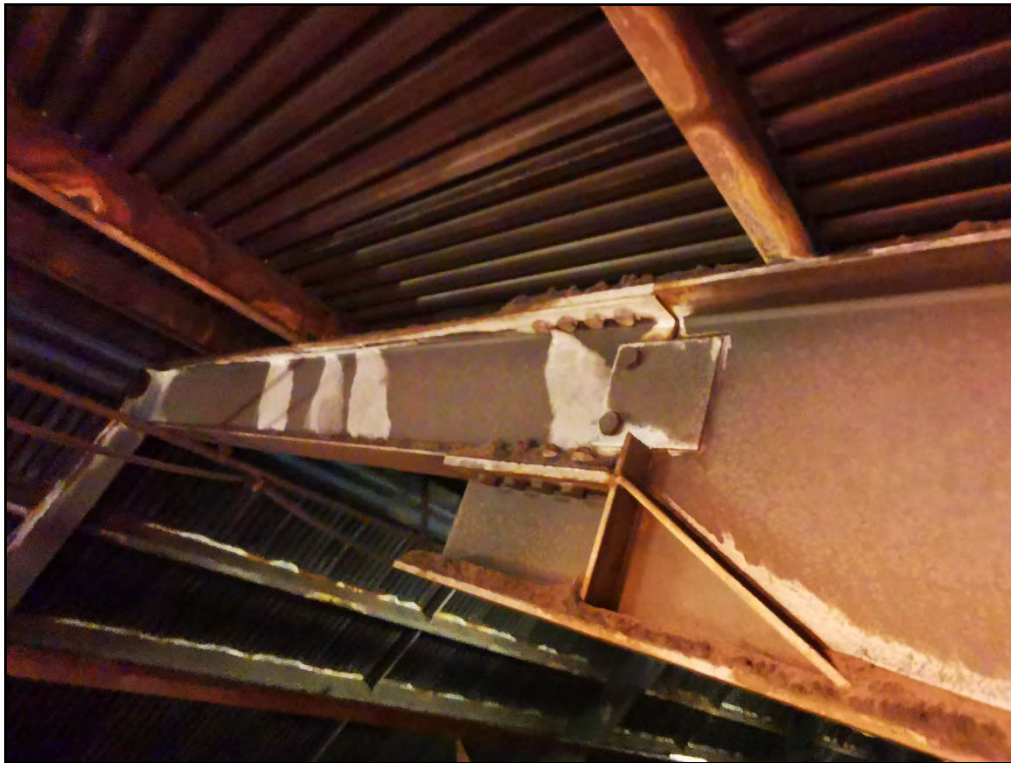
Photograph 84 Surface Corrosion of Rafter Due to Water Leakage and Product Deposit

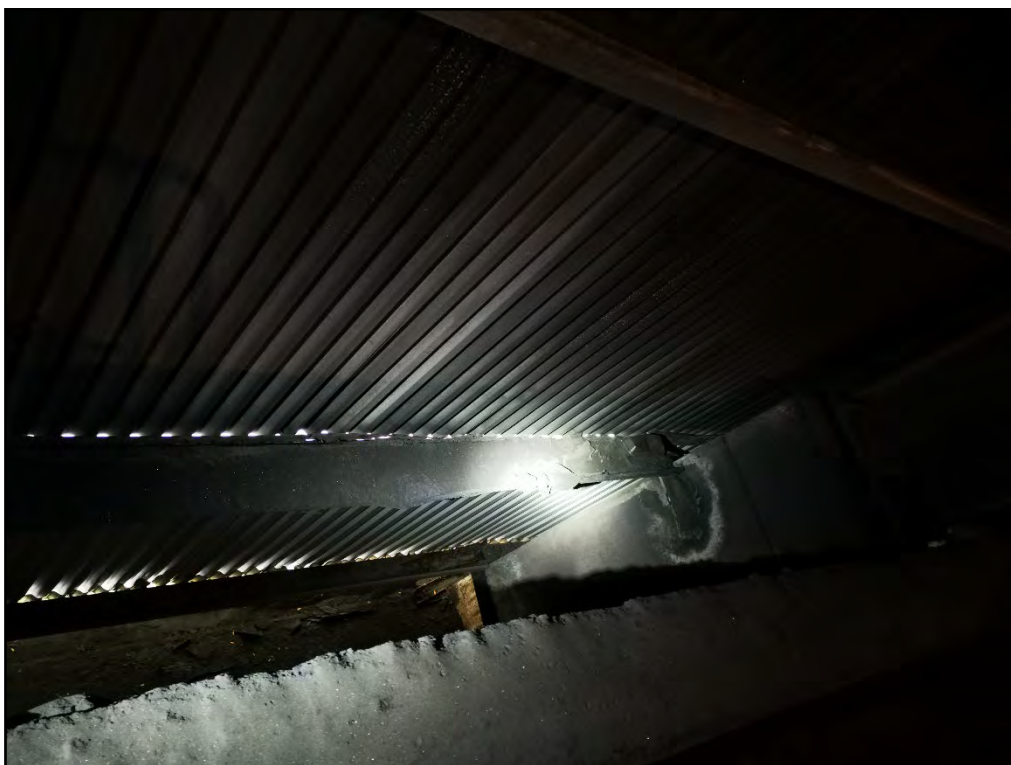
Photograph 85 Damaged Wall Girt Due to Corrosion and Product Deposit

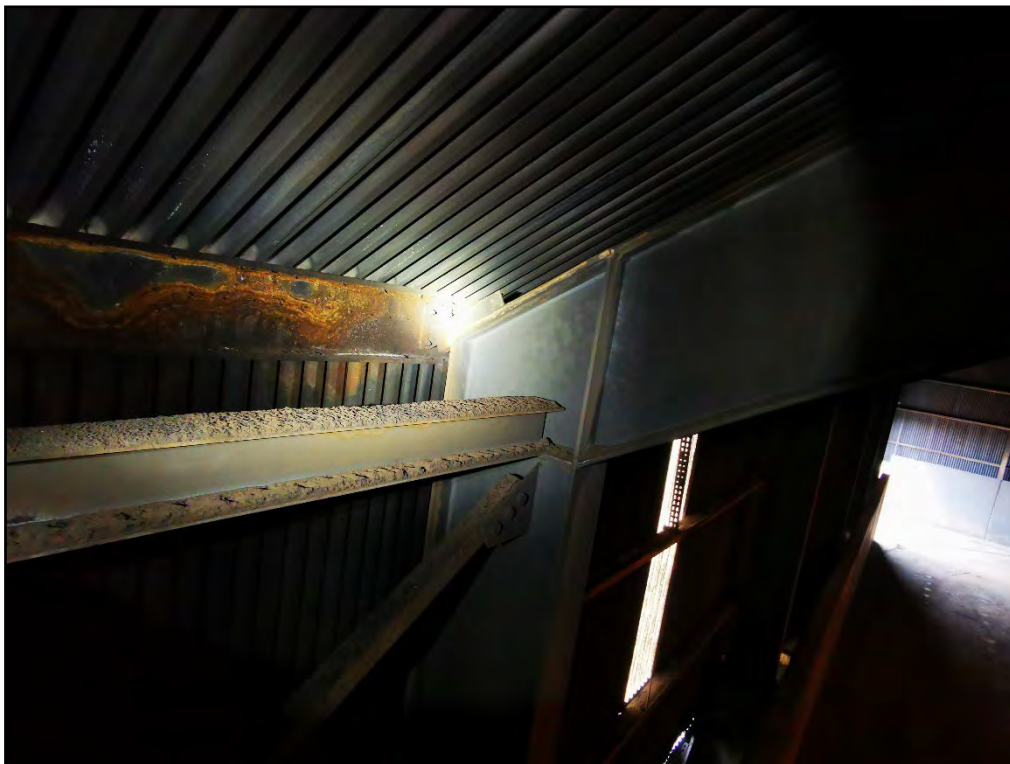
Photograph 87 Corrosion of Fascia Purlin and Product Deposit
