CONDITION REPORT
SHEDS 6, 7 & 8
OUTER HARBOUR PORT, BUNBURY

WML
Consulting Engineers

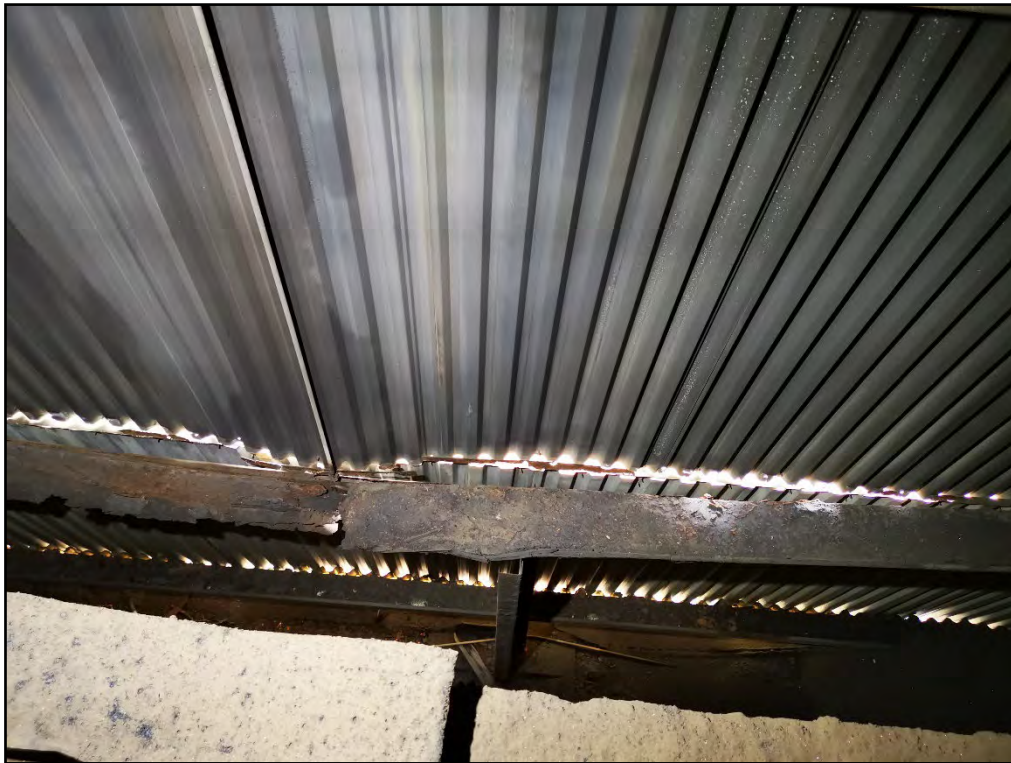
Photograph 90 Complete Failure of Wall Girt

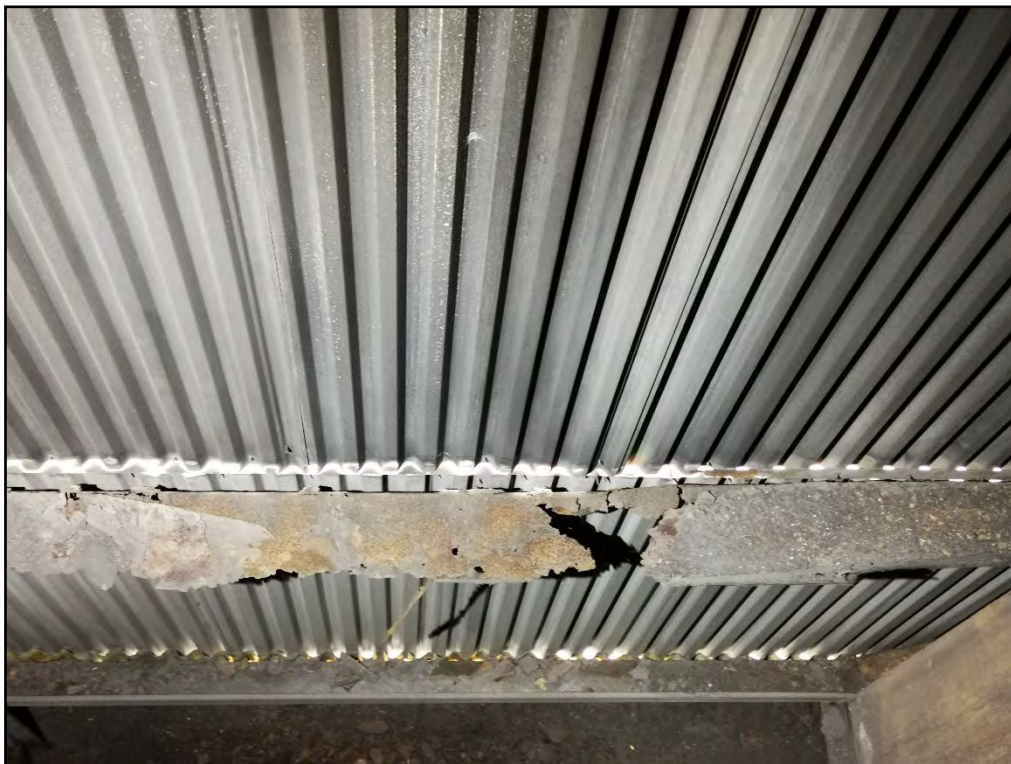
Photograph 91 Complete Failure of Wall Girt

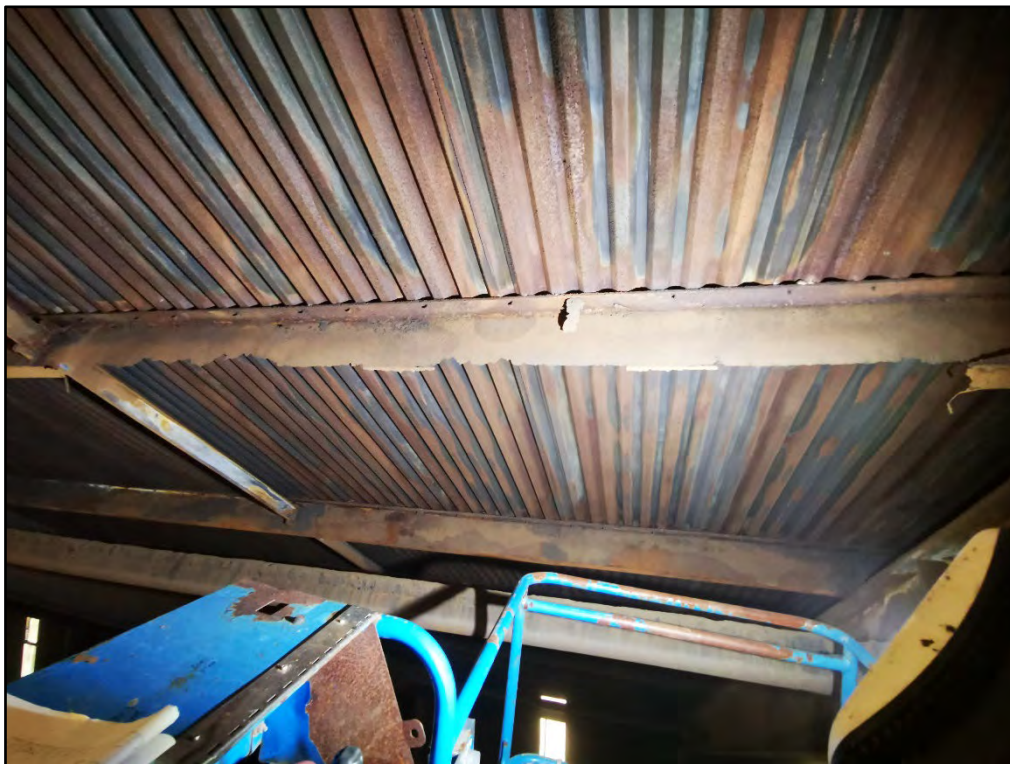
Photograph 95 Sectional Loss of Purlin Due to Corrosion and Roof Sheetting

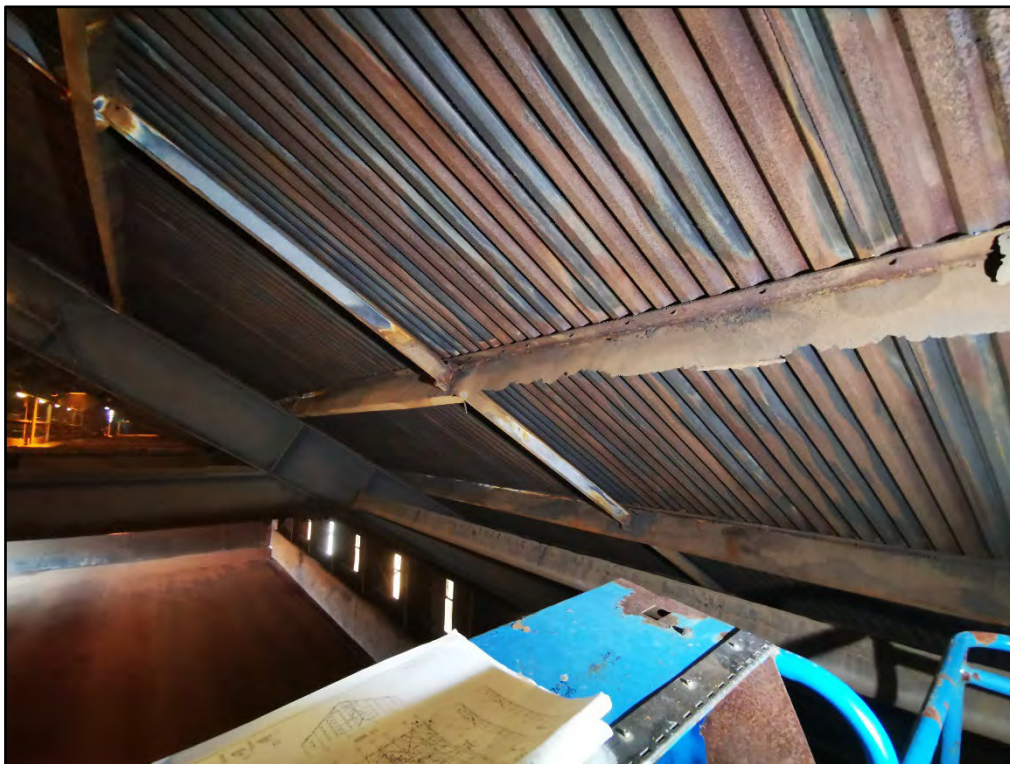
Photograph 99 Sectional Loss of Purlin

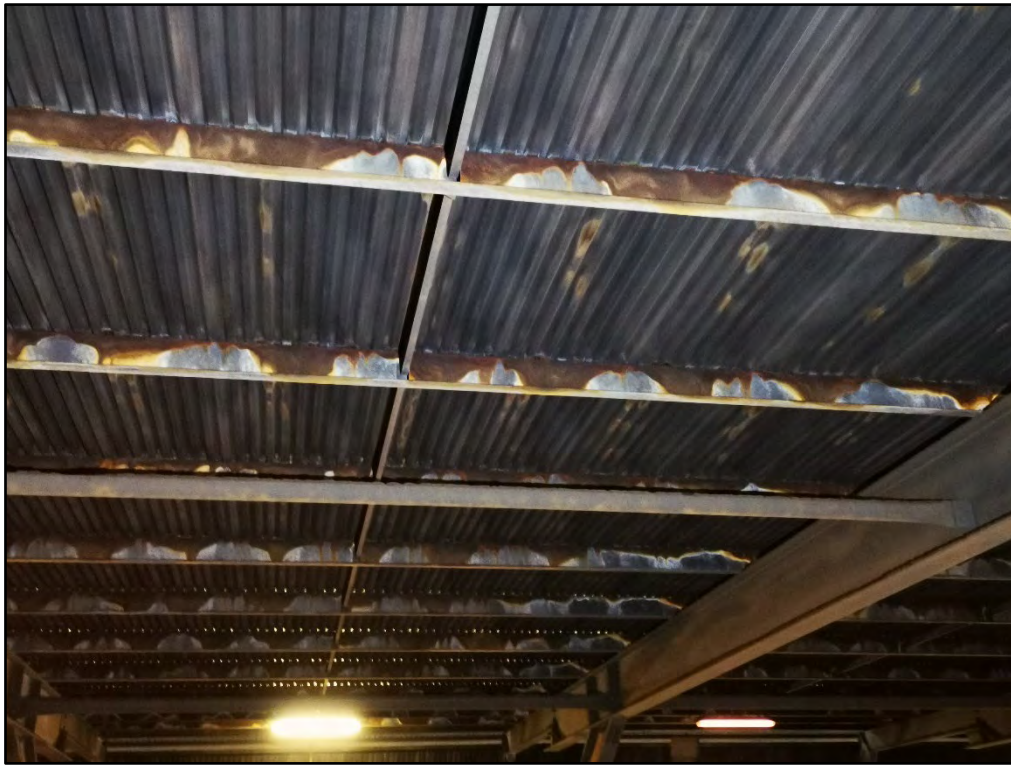
Photograph 104 Surface Corrosion of Purlins and Roof Sheeting

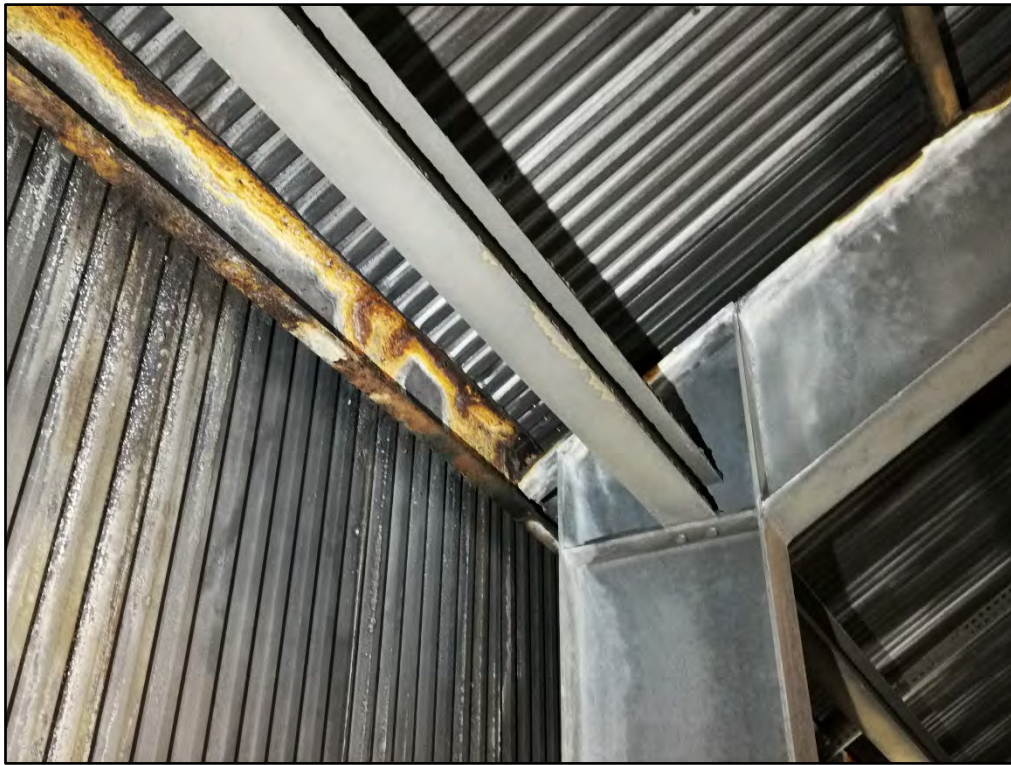
Photograph 112 Corrosion of Fascia Purlin

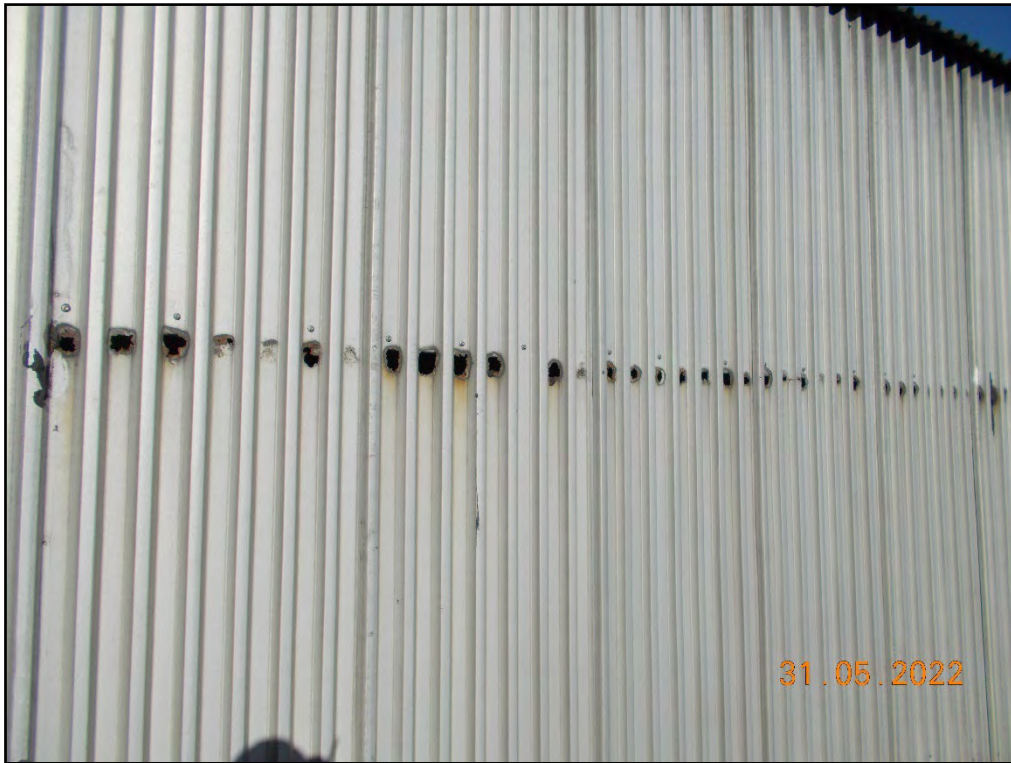
Photograph 124 Deterioration Due to Corrosion

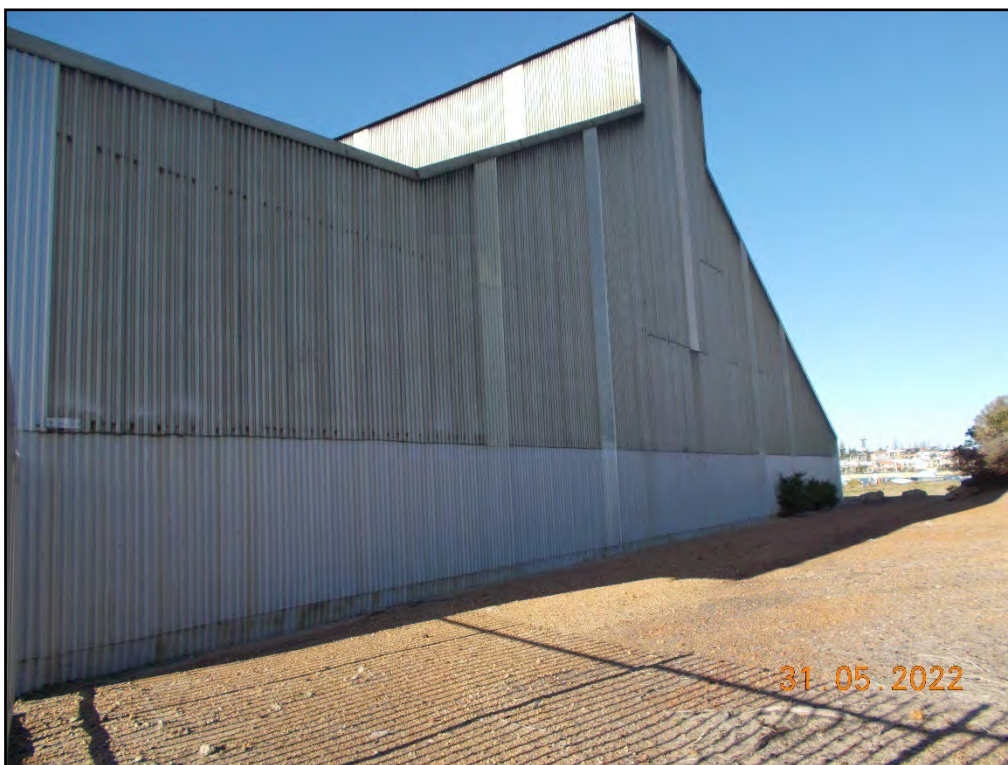
Photograph 127 Corrosion of Bolts

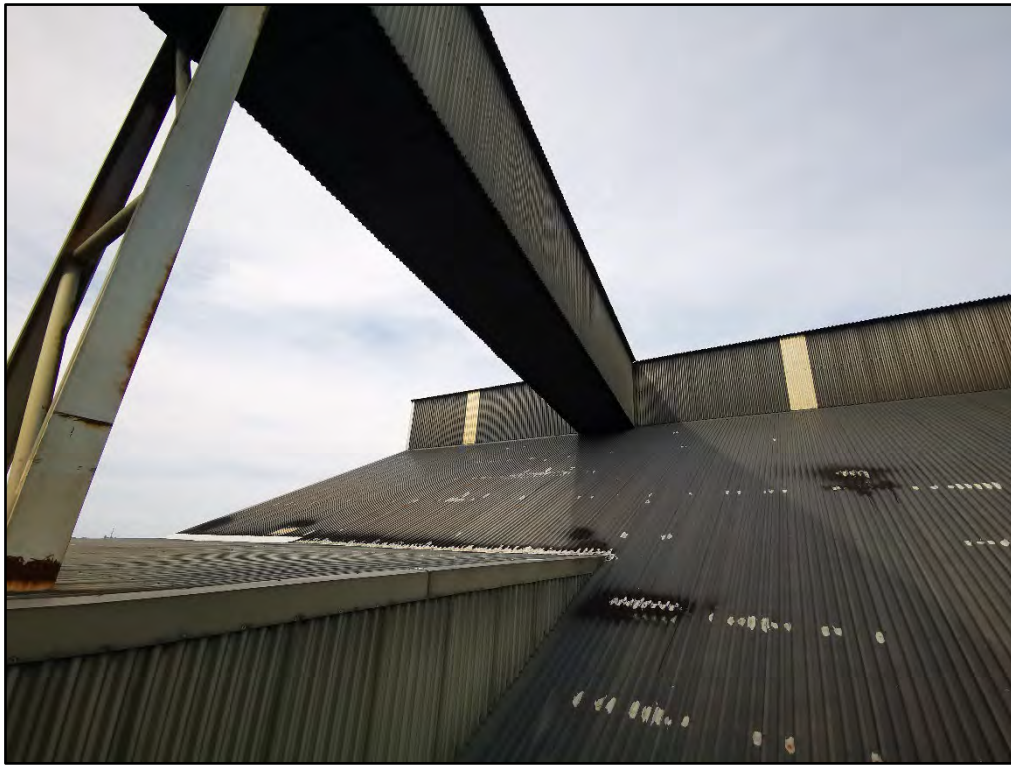
Photograph 132 Roof Sheeting and Conveyor System

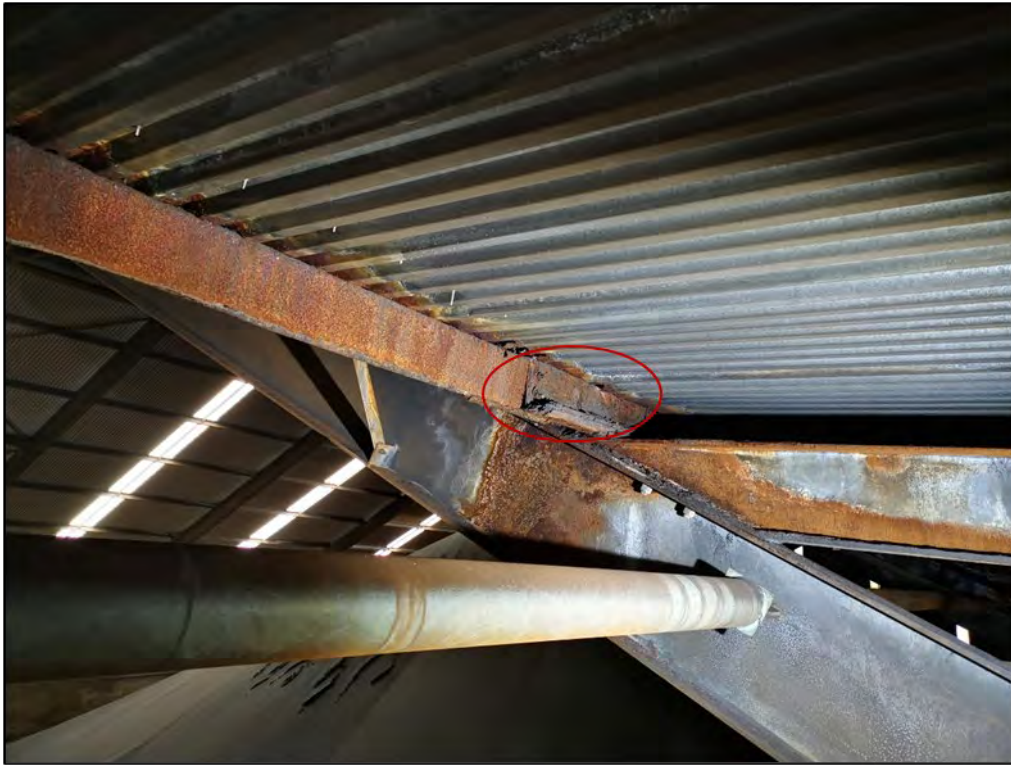
Photograph 136 Delamination of Purlin due to Corrosion

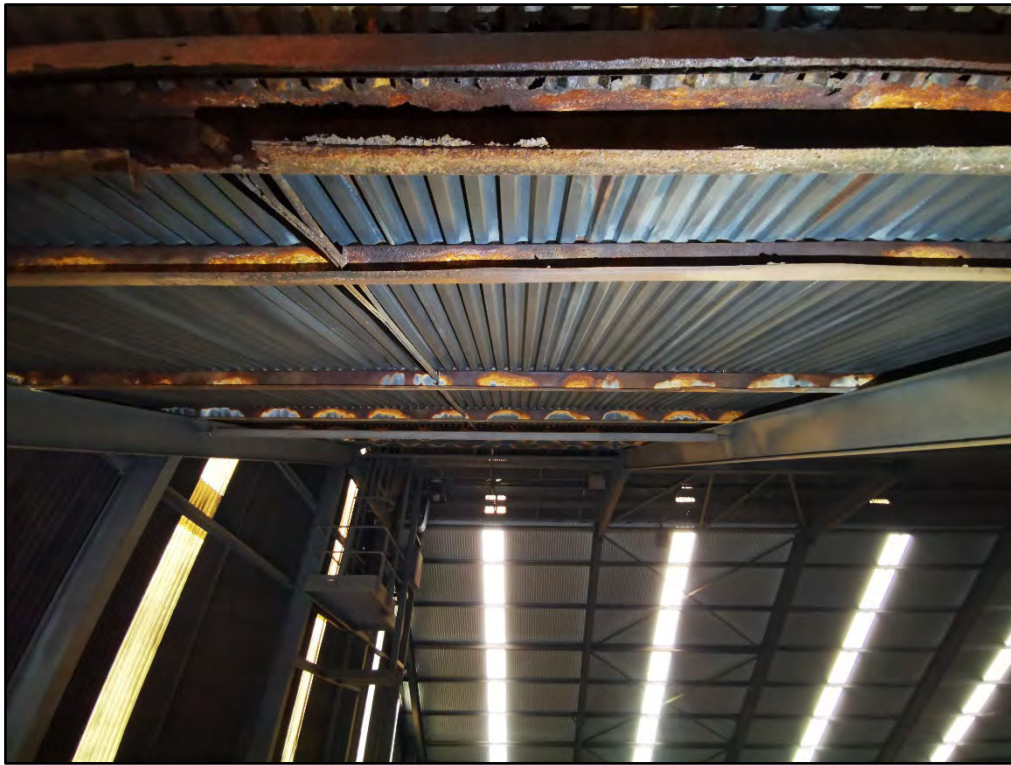
Photograph 140 Deterioration to Purlin and New Purlins and Roof Sheetting on South Side

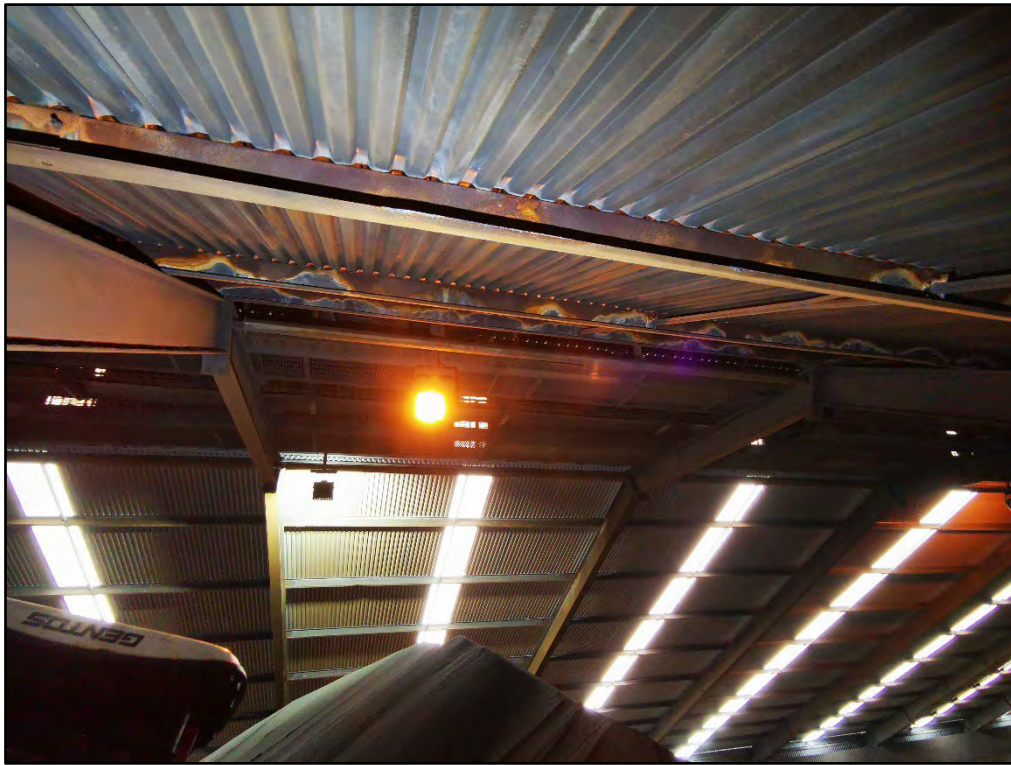
Photograph 144 Surface Corrosion of Purlins and New Purlins and Roof Sheeting in Southern Side

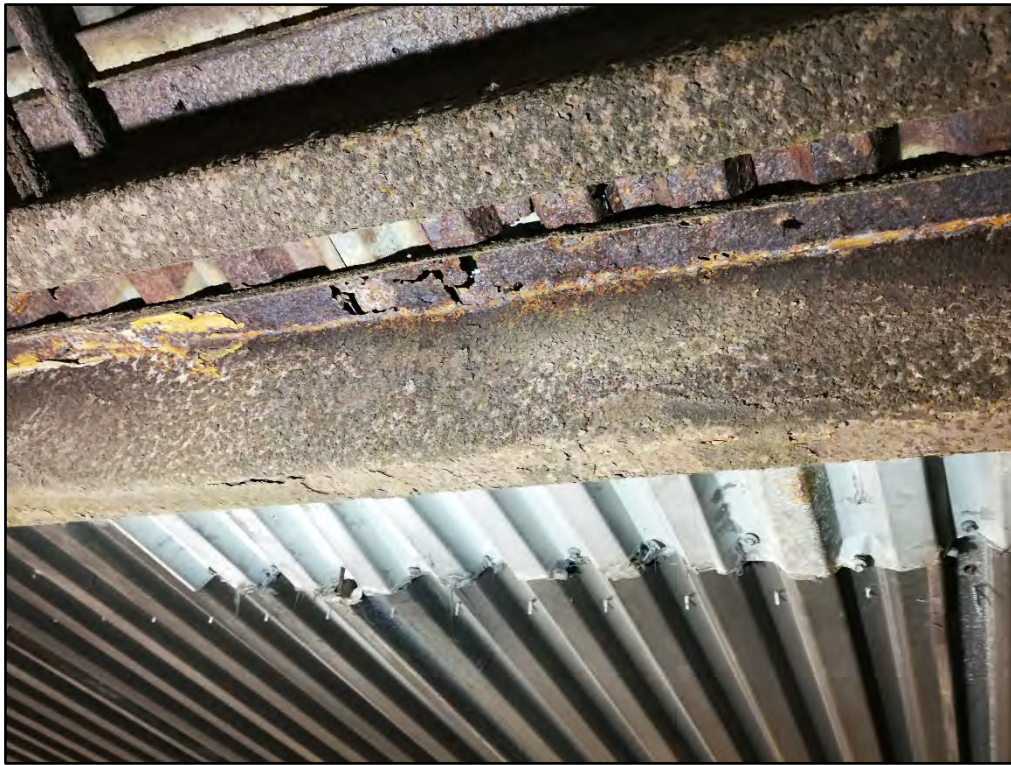
Photograph 148 Heavily Corroded Purlin

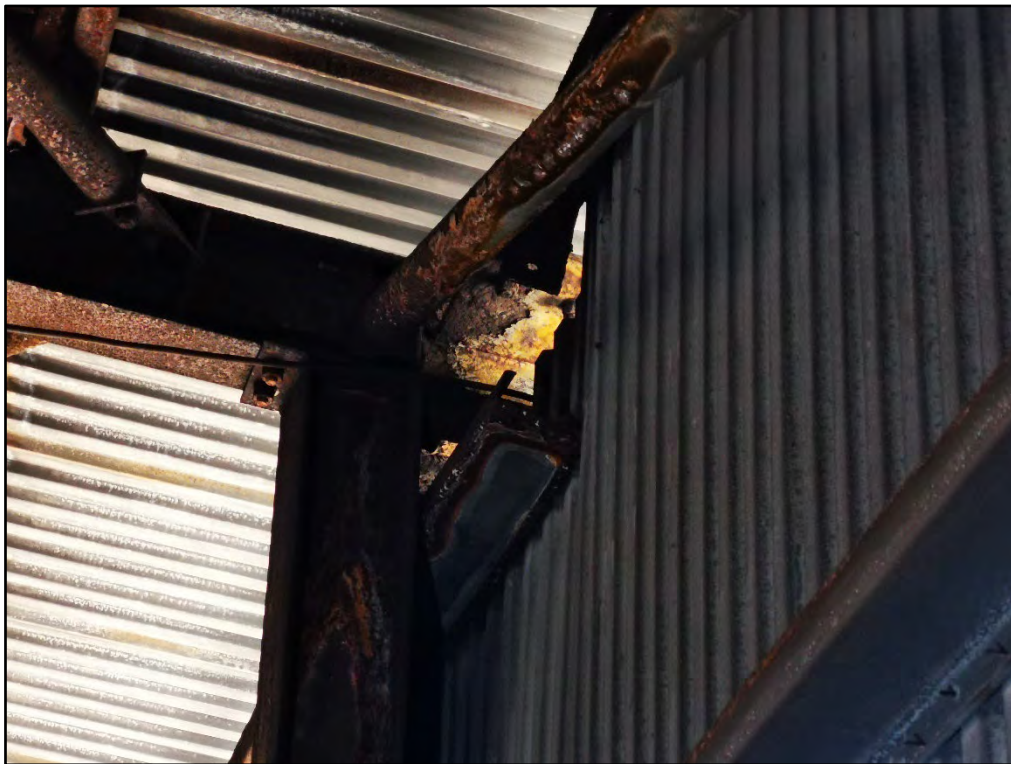
Figure 149 Heavily Corroded Steel Members

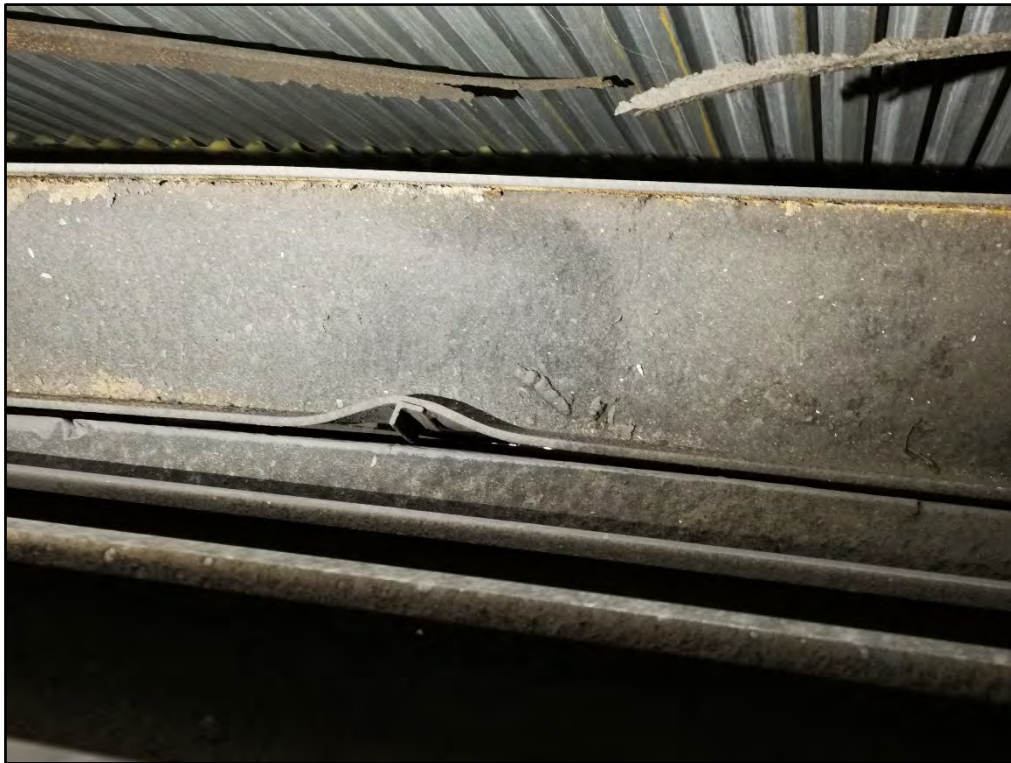
Photograph 150 Damaged PFC Section

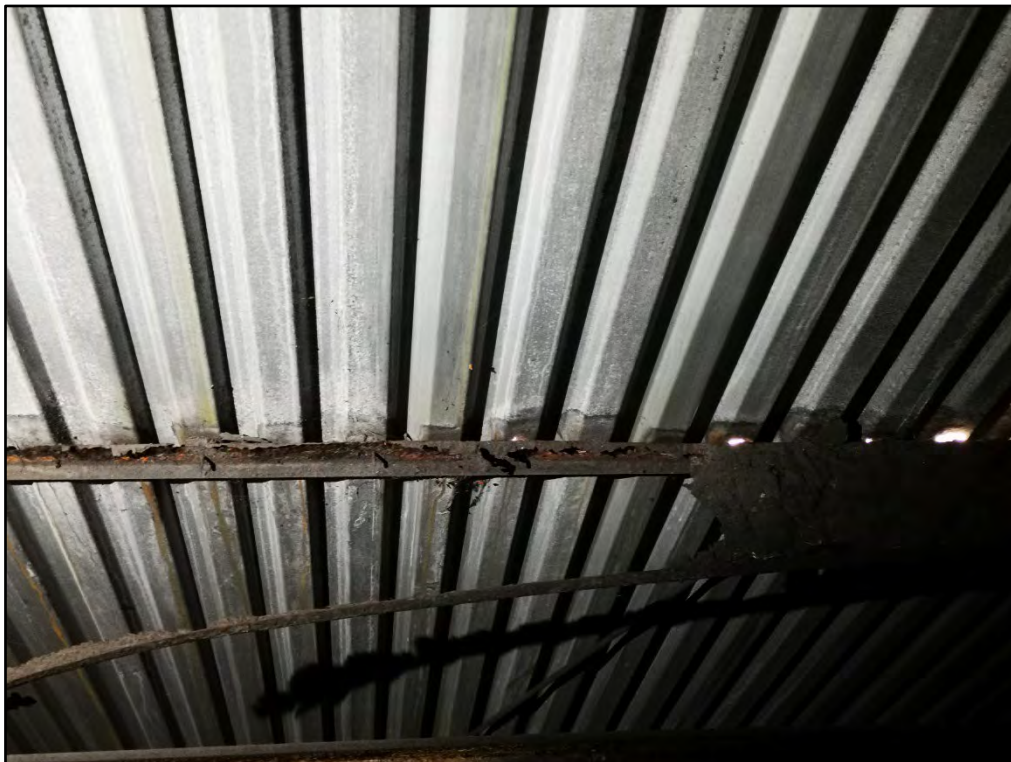
Photograph 151 Sectional Loss of Girt due to Corrosion

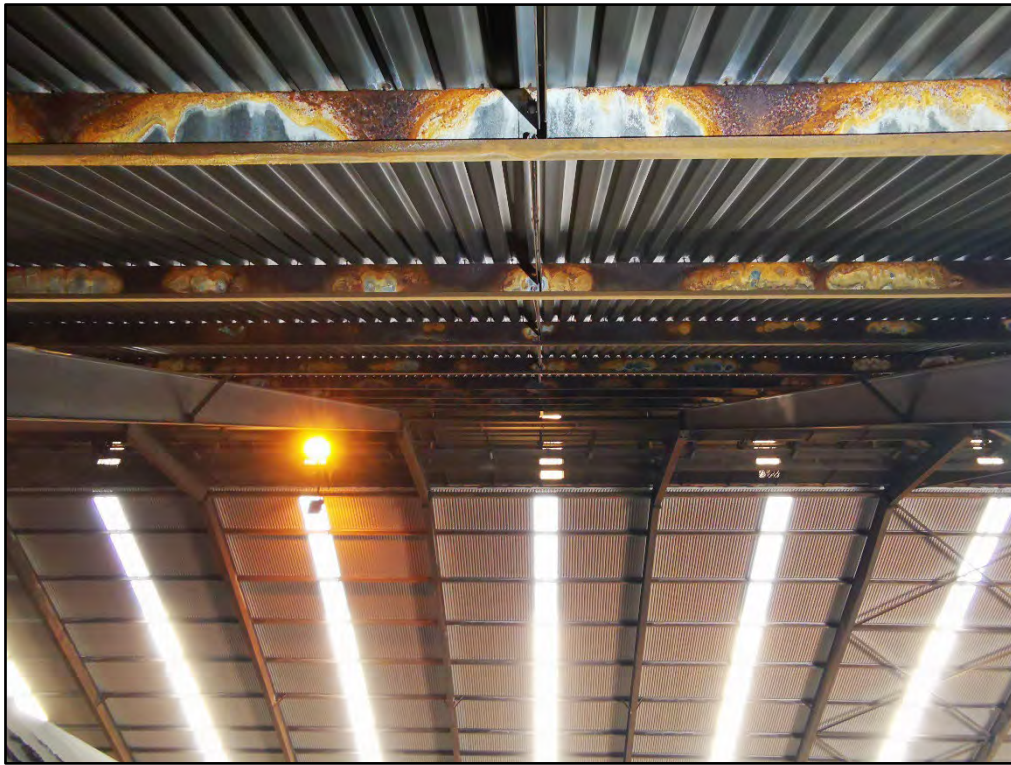
Photograph 152 Surface Corrosion of Purlins

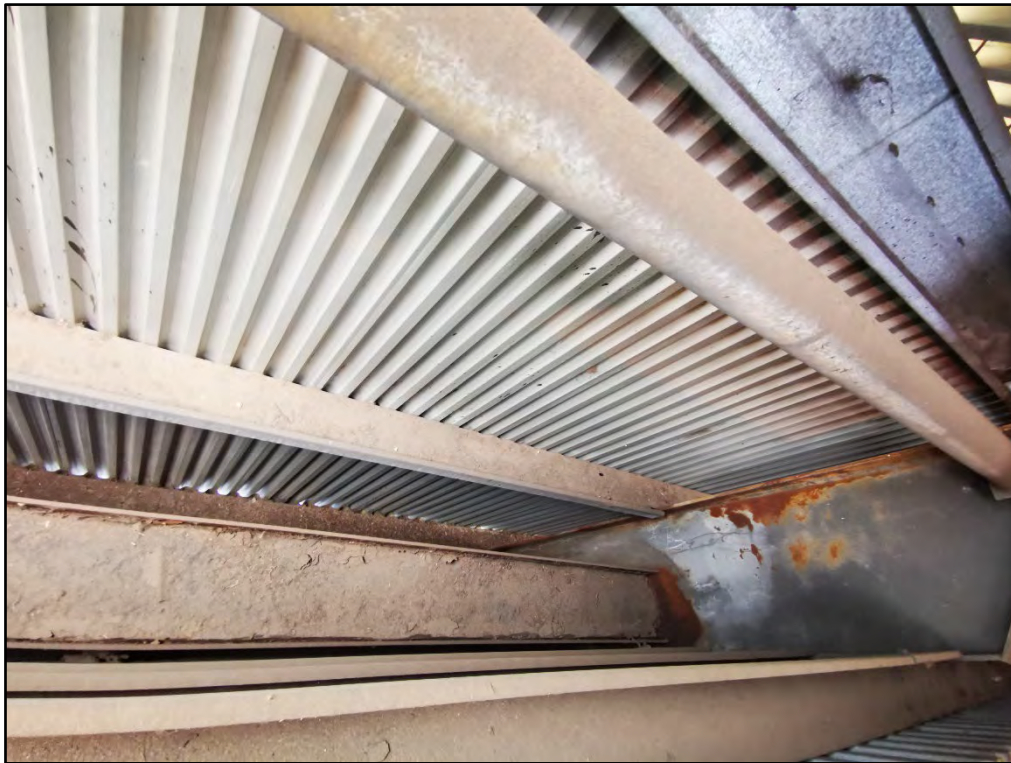
Photograph 156 Surface Corrosion of Column

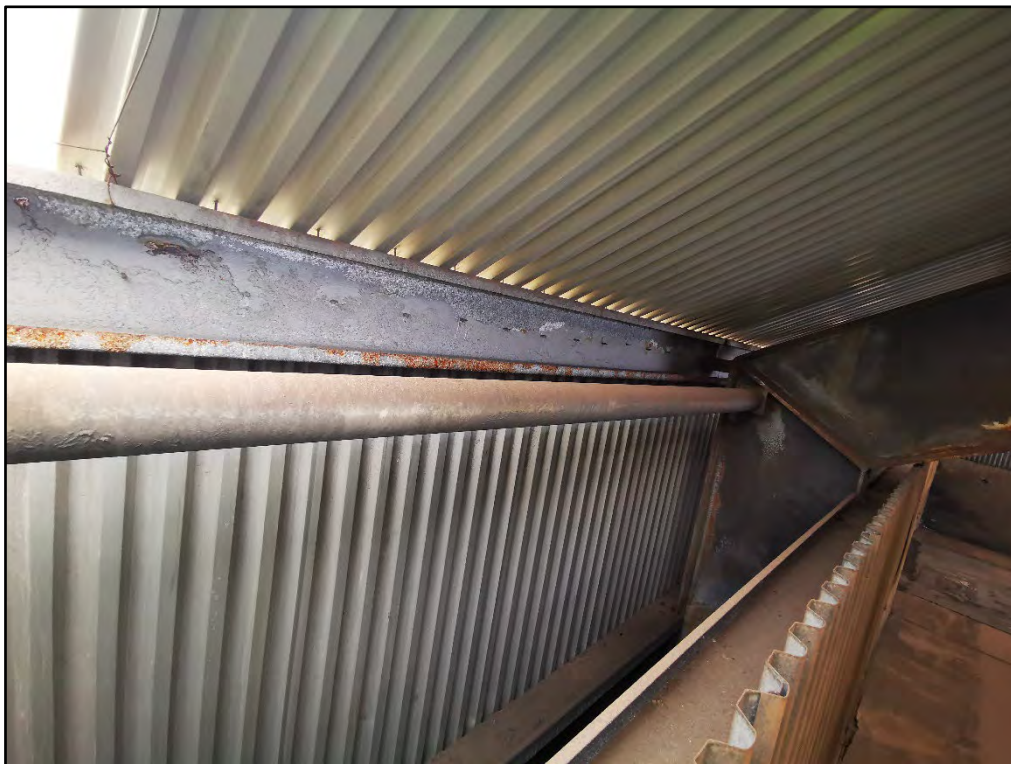
Photograph 157 Surface Corrosion of Fascia Purlin

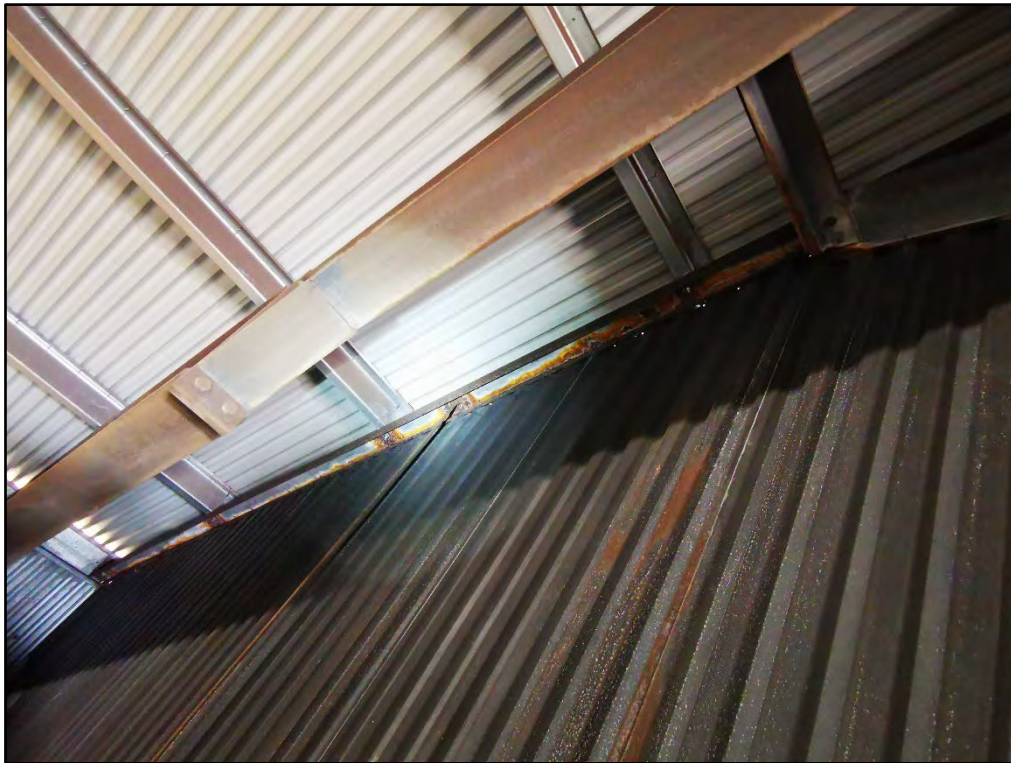
Photograph 158 Surface Corrosion of Fascia Purlin

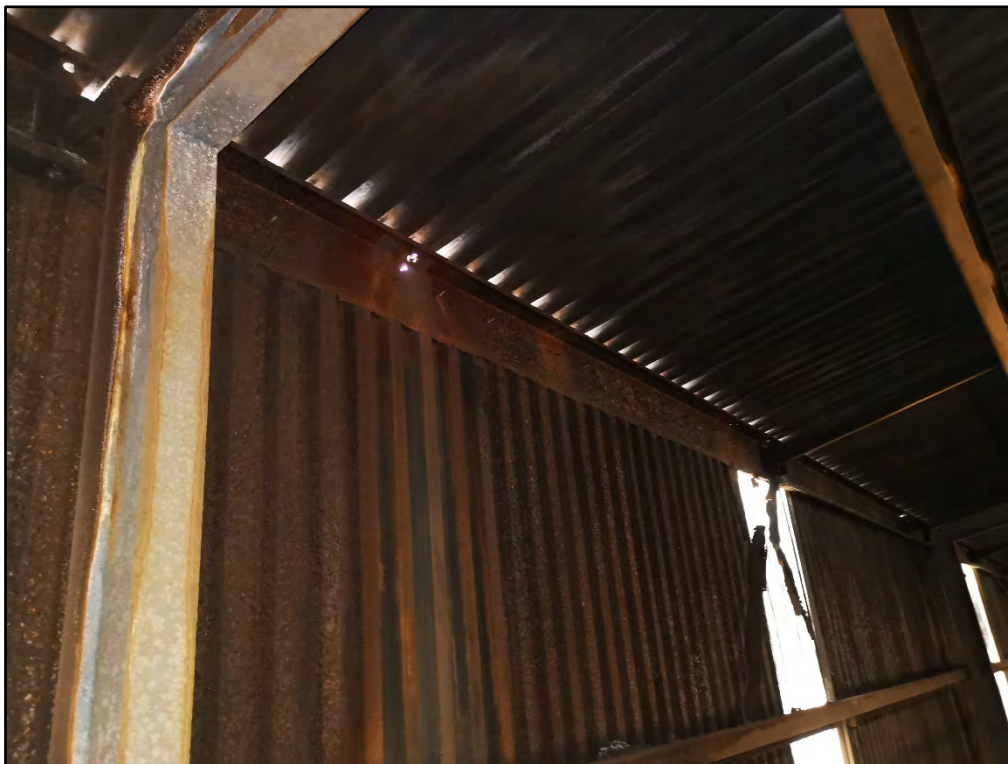
Platform 165 Deterioration to Fascia Purlin on Conveyor and Walkway
