Appendix D.35. Waikiki Beach, Rockingham

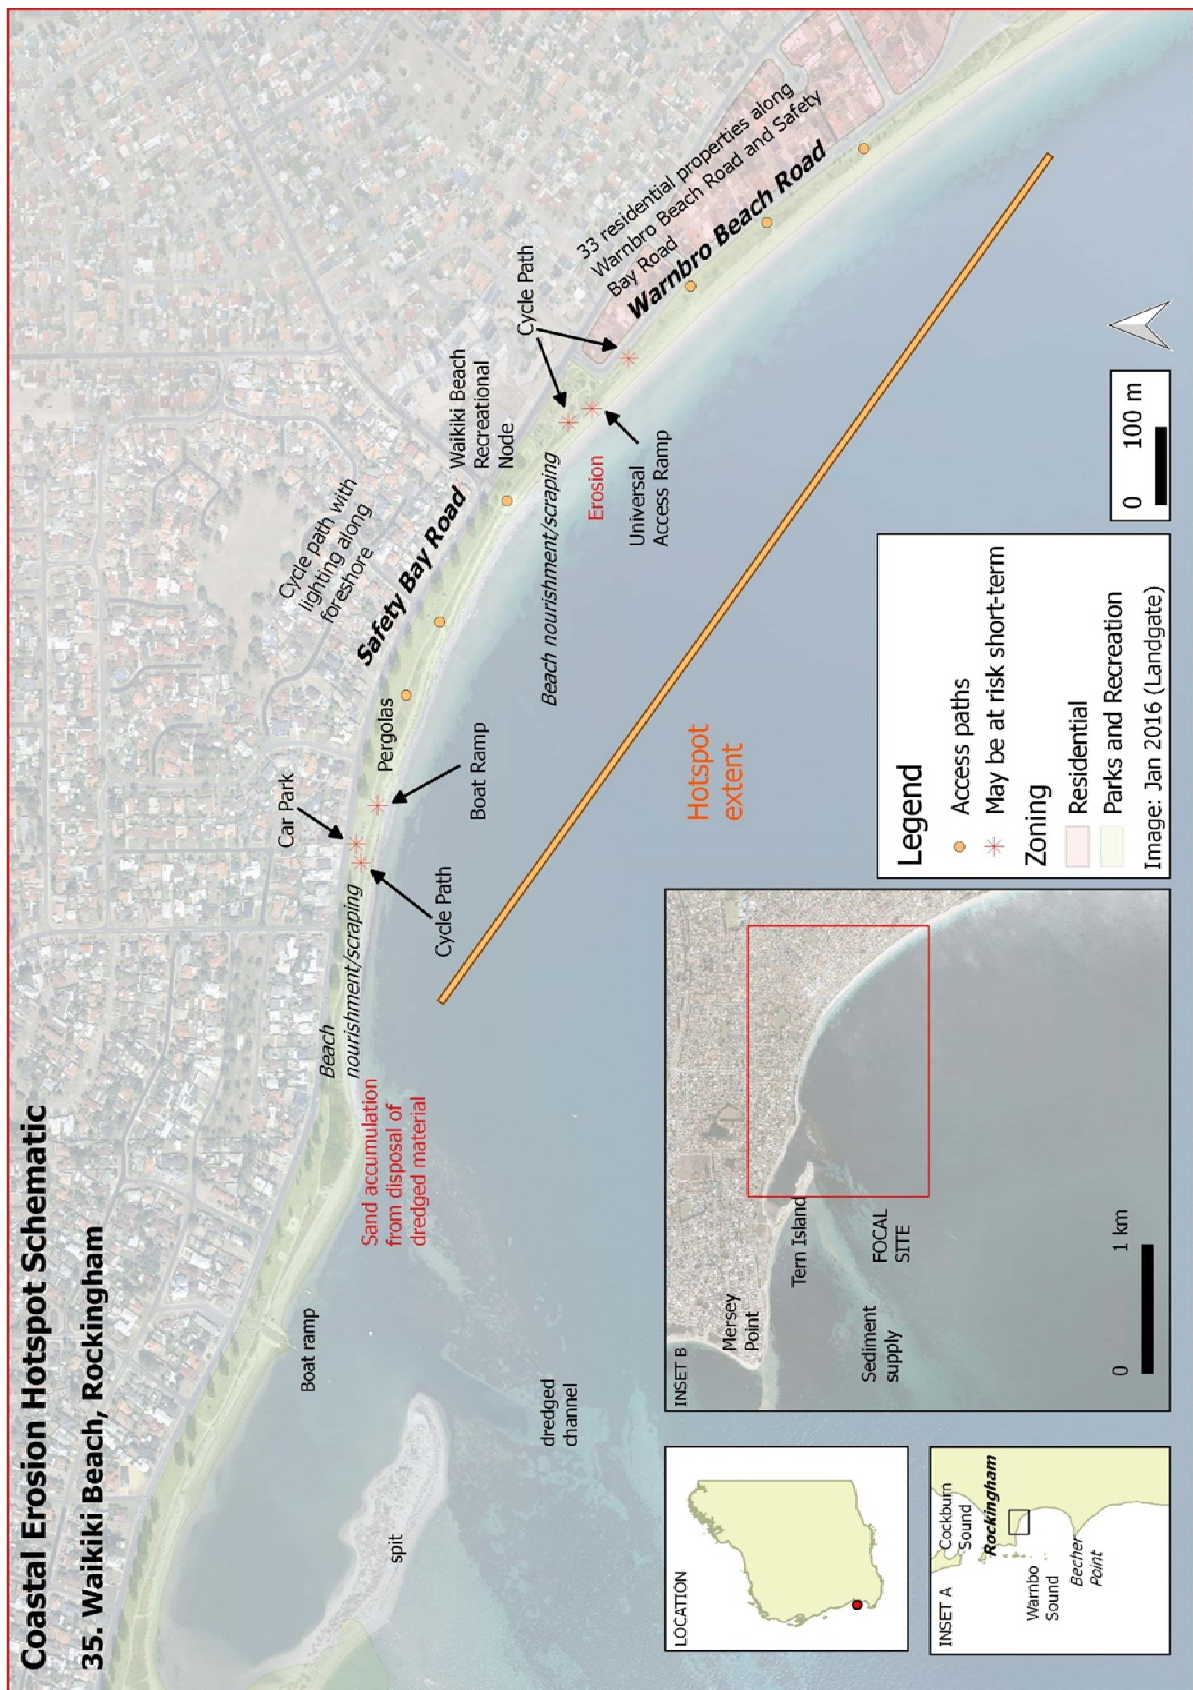
Figure D-35: Waikiki Beach, Rockingham schematic

Hotspot No.	35
Hotspot Name	Waikiki Beach, Rockingham
Local Coastal Manager	City of Rockingham
Hotspot issue	<p>The Waikiki foreshore position varies cyclically with long-term fluctuations due to the inconsistent supply of sediment onshore at Safety Bay (to the west). At present, sediment is accumulating in a sand spit and foreland, restricting the natural supply of sediment to Waikiki. In future the spit is likely to join to the foreshore and provide additional sediment to the coast. Erosion is occurring along the foreshore, with local downdrift erosion near the boat ramps and cyclic sediment loss during high storm surges. The foreshore position has been managed using beach renourishment, with sources including dredge material from the channel, as well as sediment sourced from the Point Peron sand trap. Most recently renourishment has been undertaken using sediment dredged from the channel in 2014, with material scraped from the lower part of the beach onto the foredune (beach scraping); beach scraping is ongoing in the area. Conflicting demands on the use of the area around the main boat ramp include the need for dredging to keep the boat ramp and channel clear of sediment, and the problem this causes by interfering with the sediment transport pathways.</p> <p>More than 25 publicly owned assets may be at risk of erosion damage in the area (see attached figure), five of which are at risk of damage in the short-term, including the Donald Drive car park, Donald Drive boat ramp, cycle path, the toe of beach access paths and the universal access ramp. Much of the infrastructure is focused at the Waikiki Beach recreational node. In the longer term, Warnbro Beach Road, a section of Safety Beach Road and some private properties along Warnbro Beach Road are high-value assets at risk. Recreational use is mainly swimming, walking, fishing and boat launching with the remainder of activities focused behind the beach. There are alternate options for similar activities on adjacent foreshores.</p>

Extent of erosion problem and hotspot characteristics	<p>Northern Warnbro Sound along Safety Bay Road between June Road and Viking Road</p> <p>Hotspot characteristics:</p> <ul style="list-style-type: none"> • Infrastructure close to the existing shore, or landward of progressively and rapidly eroding coast (proximity). • Typically subject to progressive or episodic erosion (instability). • Apparently limited capacity to manage future erosion using existing coastal protection measures where extension of works is likely to exacerbate erosion transfer (transfer). • Very highly valued by the community, as nominated by local government (community).
CHRMAP status and findings	<p>CHRMAP Status: Not Scheduled</p> <p>Hazard Assessment: Regional hazard assessment contained within Damara (2012)</p> <p>Management & Adaptation Options: The City is planning on extending the existing seawall to provide full protection the car parking and recreational area. Design has been completed.</p> <p>Additional Comments: Site is partly protected by an existing seawall.</p> <p>Reports:</p> <p>Damara (2012) Coastal Hazard Mapping for Economic Analysis of Climate Change Adaptation in the Peron-Naturaliste Region. Prepared by Damara WA Pty Ltd for Peron-Naturalist Partnership. Report 169-01, Rev. 0, Oct-2012</p>

Coastal dynamics studies for a level 3 assessment. Further detail in Table 4-2.	Sandbar dynamics and ongoing coastal movement data collection
Assets susceptible to erosion hazard in Imminent timeframe (0–5 years)	5 public assets susceptible to erosion hazard. Cycle path ((1) seaward of Donald Drive car park, (2) 20m cycle path E of universal access ramp, (3) 100m cycle path W of universal access ramp), universal access ramp, Donald Drive boat ramp, Donald Drive car park, toe of access paths
Assets susceptible to erosion hazard in Expected timeframe (5–25 years)	>10 public assets susceptible to erosion hazard. Possibly 25m of Warnbro Beach Rd (at the corner), cycle path and lights, Donald Drive boat ramp, Donald Drive car park, pergolas at Donald Drive ramp, nodal focus at Waikiki Beach recreation area [stairs to beach, pergola, play equipment, courts, outdoor gym equipment, car park, universal access ramp, covered area, seats, BBQs, fencing], 4 stairs access ways along Warnbro Beach Rd, numerous informal access ways along Safety Beach Rd, toe of access paths

Assets susceptible to erosion hazard in Projected timeframe (25+ years)	>12 public assets susceptible to erosion hazard. Warnbro beach road, possibly 25m of Warnbro Beach Rd (at the corner), sections of Safety Beach Rd, cycle path and lights, Donald Drive boat ramp, Donald Drive car park, pergolas at Donald Drive ramp, nodal focus at Waikiki Beach recreation area [stairs to beach, pergola, play equipment, courts, outdoor gym equipment, car park, universal access ramp, covered area, seats, BBQs, fencing], 4 stairs access ways along Warnbro Beach Rd, numerous informal access ways along Safety Beach Rd, toe of beach paths Private property: 32 on Warnbro Beach Rd and 1 on Safety Bay Rd
Existing management	Avoid (N), Retreat (N), Accommodate (N), Protect (Y - Minor renourishment using beach & boating channel sources)
Management options for Imminent timeframe (0–5 years)	Anticipated behaviour: Storm erosion will continue to result in loss of renourishment and scarping Avoid (N), Retreat (N), Accommodate (N) Protect (Y -Increase renourishment rates using external sources. Emergency renourishment if assets at risk May-August) Preparation of planning frameworks for retreat in next level of management and identify funding mechanisms.

Works to avoid to achieve long-term plans	<p>Coastal protection works without substantial associated renourishment; Infill development along Warnbro Beach Road.</p> <p>The existing situation has fixed infrastructure close to the majority of the shore. Any hard protection works will transfer erosion protection further alongshore. Consequently, soft works such as an artificial dune or beach renourishment are appropriate. Due to the site and length of Warnbro Sound beach, soft works will have a short life, with rapid redistribution alongshore. Viking Road park area represents the first alongshore location where erosion stress may be transferred to.</p>
--	---

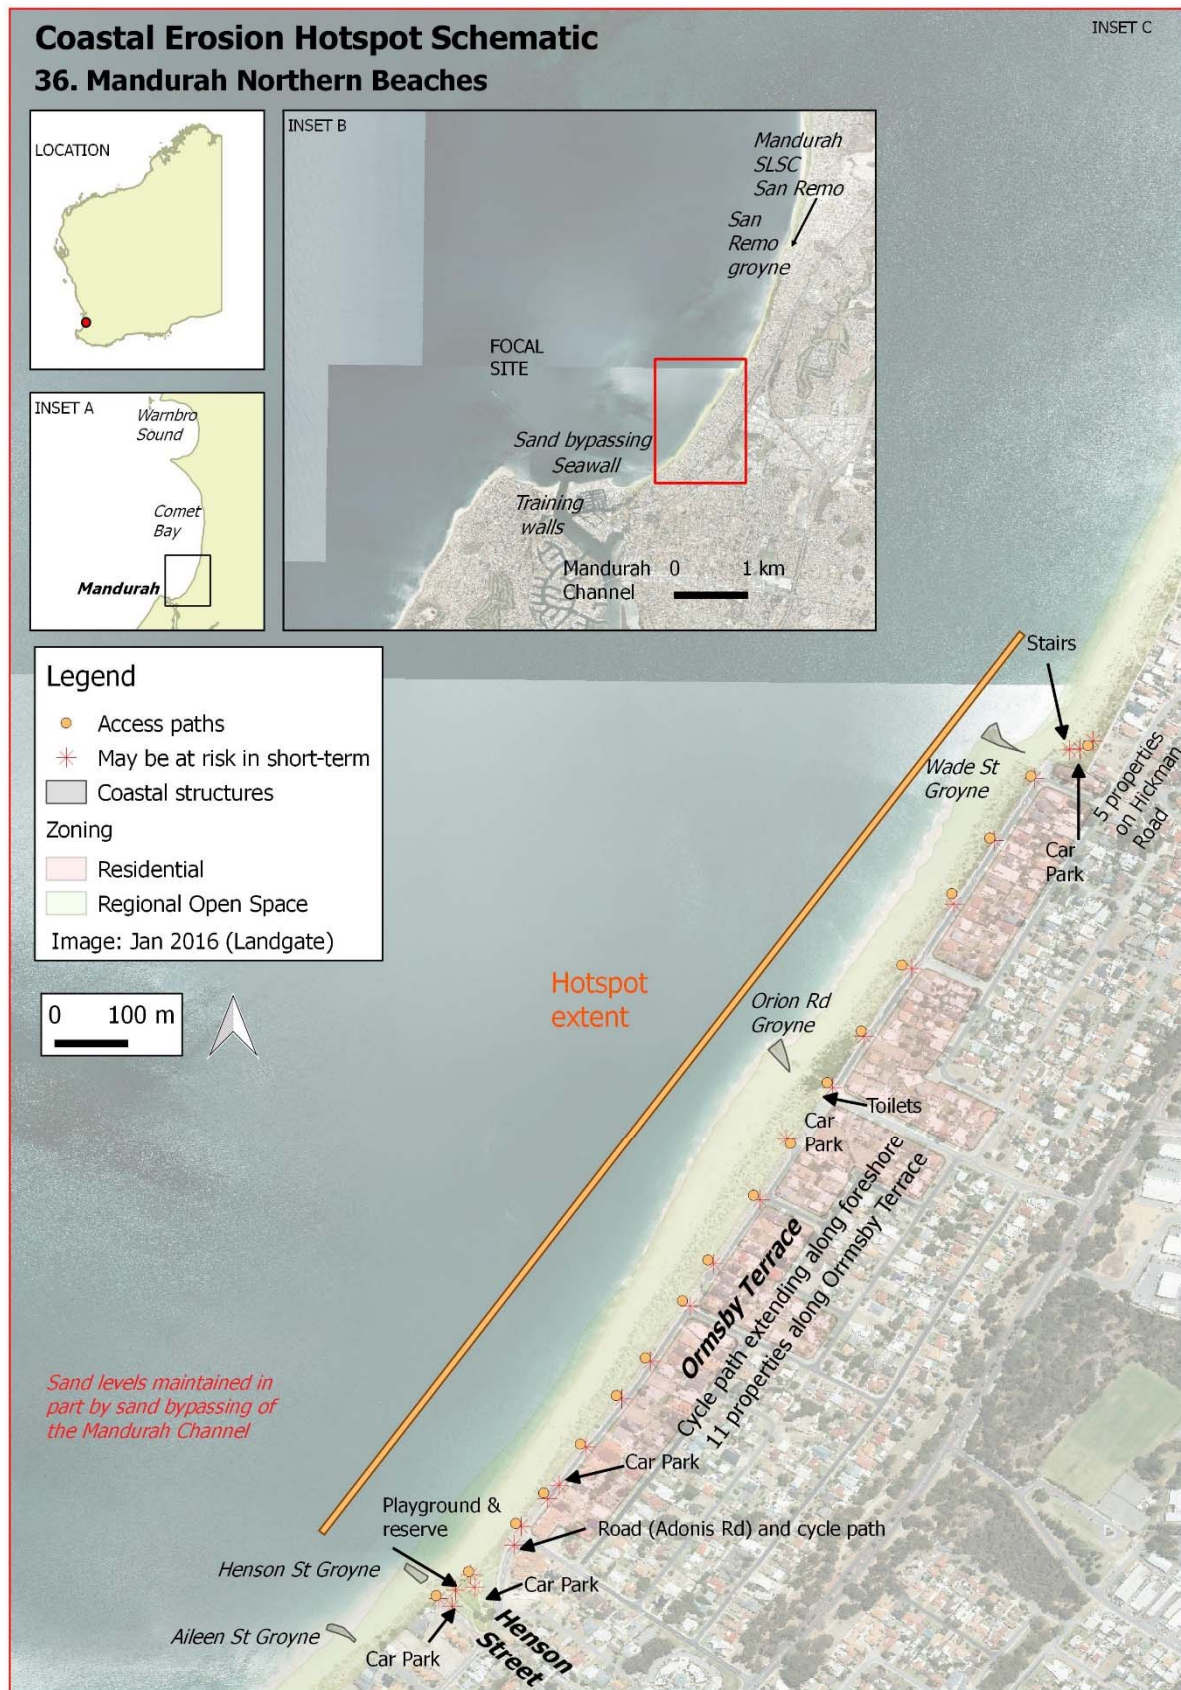
Figure D-36: Mandurah Northern Beaches schematic

Hotspot No.	36
Hotspot Name	Mandurah Northern Beaches
Local Coastal Manager	City of Mandurah
Hotspot issue	<p>Mandurah Northern Beaches have had an ongoing erosion problem since development was undertaken on the foredune and foredune sand was used to fill swampy land behind those dunes to enable the levelling of the area and improve suitability for development. Downdrift erosion to the north has been caused by training walls at the Mandurah channel and marina seawalls limiting sediment availability. Erosion mitigation works have included sand bypassing of the Mandurah channel and construction of a series of groynes, including a recent extension of the trapping lengths. Downdrift erosion occurs on the northern side of the groynes where recreational assets are focussed. The foreshore is reliant on the sand bypassing, with the rate of bypassing not always matching the sediment demand required to stabilise the coast. The City of Mandurah is looking to implement, among other studies, a coastal data collection campaign along the Northern Beaches.</p> <p>More than 15 publicly owned assets may be at risk of erosion damage in the area (see attached figure), eight of which are at risk of damage in the short-term, including Adonis Place, three car parks (Henson Street, Ormsby Terrace and Wade Street), staircase and beach access points, the reserve and cycle path. In the longer term, Ormsby Terrace, its associated infrastructure and private properties to landward (including on Ormsby Tce and Hickman Road) are high-value assets at risk. The main recreational uses are walking, swimming, fishing and cycling. The community pressure to protect these recreational uses is anticipated to increase as damage occurs to assets near Wade Street and Henson Street.</p>

Assets susceptible to erosion hazard in Imminent timeframe (0–5 years)	8 public assets susceptible to erosion hazard. 15m of Adonis Road, 5m of cycle path on Adonis Rd, stairs to beach from Wade St car park, Henson St carpark (N), Ormsby Terrace southern carpark (cul de sac), Wade St car park, reserve at Henson St with playground, non-rigid access locations
Assets susceptible to erosion hazard in Expected timeframe (5–25 years)	11 public assets susceptible to erosion hazard. 30m of Adonis Road, possibly up to 200m of Ormsby Terrace (S), Possibly up to 200m of Ormsby Terrace from Orion St to Wade St, cycle path along ~400m of foreshore, stairs to beach from Wade St car park, access track seaward of houses N of Wade St, Henson St carpark (N), Ormsby Terrace southern carpark (cul de sac), Wade St car park, reserve at Henson St with playground, many non-rigid access locations. Private property: 8 (5 on Ormsby St, 3 N of Wade St along Hickman Rd)

Assets susceptible to erosion hazard in Projected timeframe (25+ years)	15 public assets susceptible to erosion hazard. 60m of Adonis Road, possibly up to 200m of Ormsby Terrace (S), Ormsby Terrace centre section with 2 cul de sacs, possibly up to 200m of Ormsby Terrace from Orion St to Wade St, Ormsby Terrace from Orion St to Wade St, cycle path along most of foreshore, stairs to beach from Wade St car park, access track seaward of houses N of Wade St, Henson St carpark (x2), Ormsby Terrace southern carpark (cul de sac), Wade St car park, Orion Street car park, reserve at Henson St with playground, toilet block at Orion St, many non-rigid access locations. Private property: 16 (11 on Ormsby St, 5 N of Wade St along Hickman Rd)
Existing management	Avoid (N), Retreat (N), Accommodate (Y - Annual bypassing undertaken at Mandurah Channel entrance), Protect (Y - Small groynes used to slow alongshore transport rates)

Works to avoid to achieve long-term plans	<p>No additional armoured facilities north of groynes (e.g. Mandurah SLSC north of San Remo groyne) as these effectively use the sand buffer necessary for the beach segments to withstand seasonal downdrift erosion; No infill development to the north; No additional sand retention works west of Henson Street.</p>

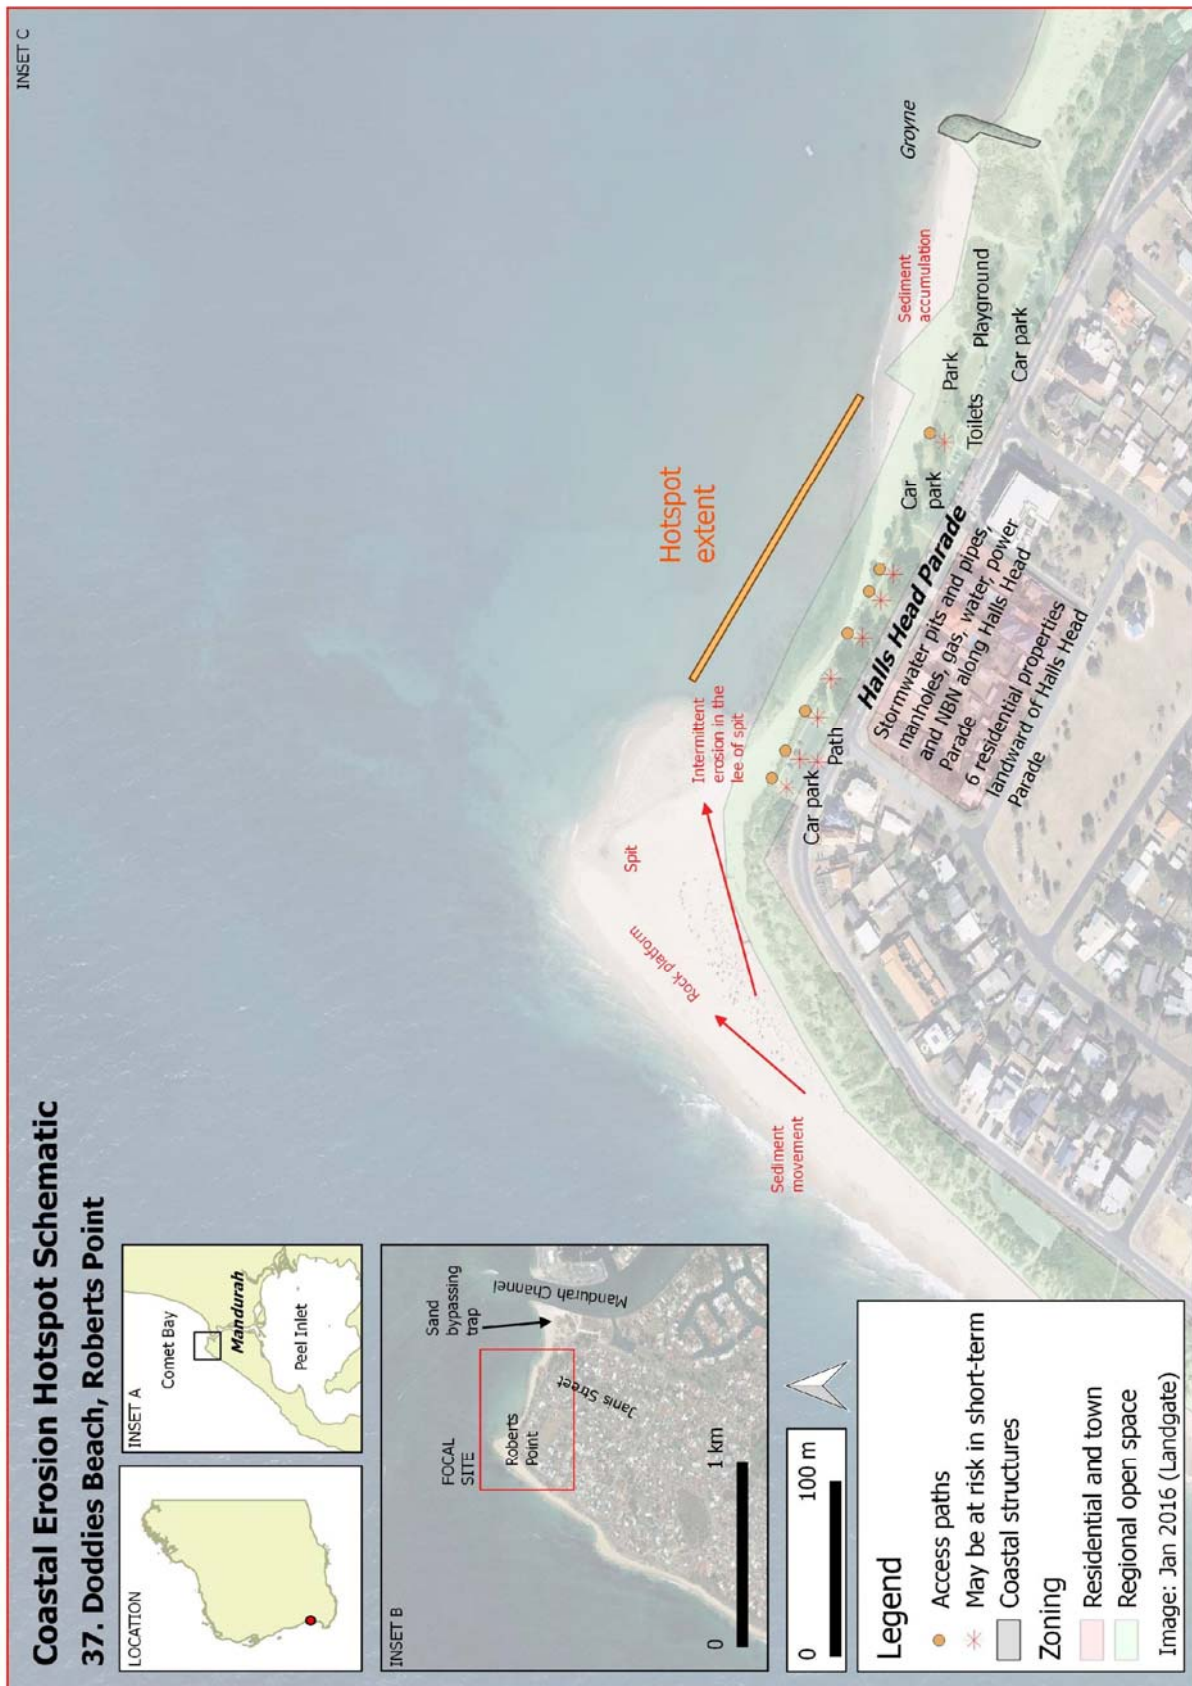
Figure D-37: Doddies Beach, Roberts Point schematic

Coastal dynamics studies for a level 3 assessment. Further detail in Table 4-2.	Ongoing coastal movement data collection, and possibly geotechnical
Assets susceptible to erosion hazard in Imminent timeframe (0–5 years)	3 public assets susceptible to erosion hazard. 7 pedestrian access tracks, 190m of footpaths, Halls Head Parade carpark west.
Assets susceptible to erosion hazard in Expected timeframe (5–25 years)	6 public assets susceptible to erosion hazard. 7 pedestrian access tracks, grassed park area, Halls Head Parade carpark east, 300m of footpaths, 80m of Halls Head Parade, Halls Head Parade carpark west.

Assets susceptible to erosion hazard in Projected timeframe (25+ years)	<p>15 public assets susceptible to erosion hazard. 7 pedestrian access tracks, grassed park area, shaded playground, Halls Head Parade carpark east, toilet block, 310m of footpaths, 230m of Halls Head Parade, Halls Head Parade carpark west.</p> <p>Services: Storm water pits with connecting pipe to W of Halls Head Parade, 80PVC1.5MP 70kPa gas pipeline along Halls Head Parade, 100AC water main along Halls Head Parade, 6 non-trafficable manholes, LV buried cable along Halls Head Parade, LV overhead cable along Halls Head Parade, in-service NBN cable along Halls Head Parade.</p> <p>Private Property: 6 private properties on Halls Head Parade, including 2 vacant lots</p>
Existing management	<p>Avoid (N), Retreat (N), Accommodate (N), Protect (Y - groyne off Janis St installed 1988 to east of site. Bypassing of sediment around Dawesville cut may regulate sediment supply)</p>

Approximation of cost for Expected timeframe (5–25 years) options (L/M/H)	<p>Retreat - M Prepare plans - 50k</p>
Trigger for next level management, monitoring and alternate management option (Expected timeframe 5–25 years)	<p>Trigger for next level management: Buffer width to road <10m OR sand drift on to road more than 1x per year. Monitoring: Buffer width measurement; post-storm monitoring Alternate option: Protect - armouring (revetment) along Halls Head Parade (not recommended).</p>
Management and adaptation options for Projected timeframe (25+ years).	<p>Anticipated behaviour: Sustained erosion may cause loss of foreshore reserve at western end (subject to underlying rock), affecting roadway.</p> <p>Avoid (N), Retreat (Y - plan to cul-de-sac north west corner of Halls Head Parade. Retreat 6 private properties along Halls Head Parade), Accommodate (N), Protect (N)</p>
Works to avoid to achieve long-term plans	<p>Fixed infrastructure (toilet blocks etc.) Services on northern side of road.</p>

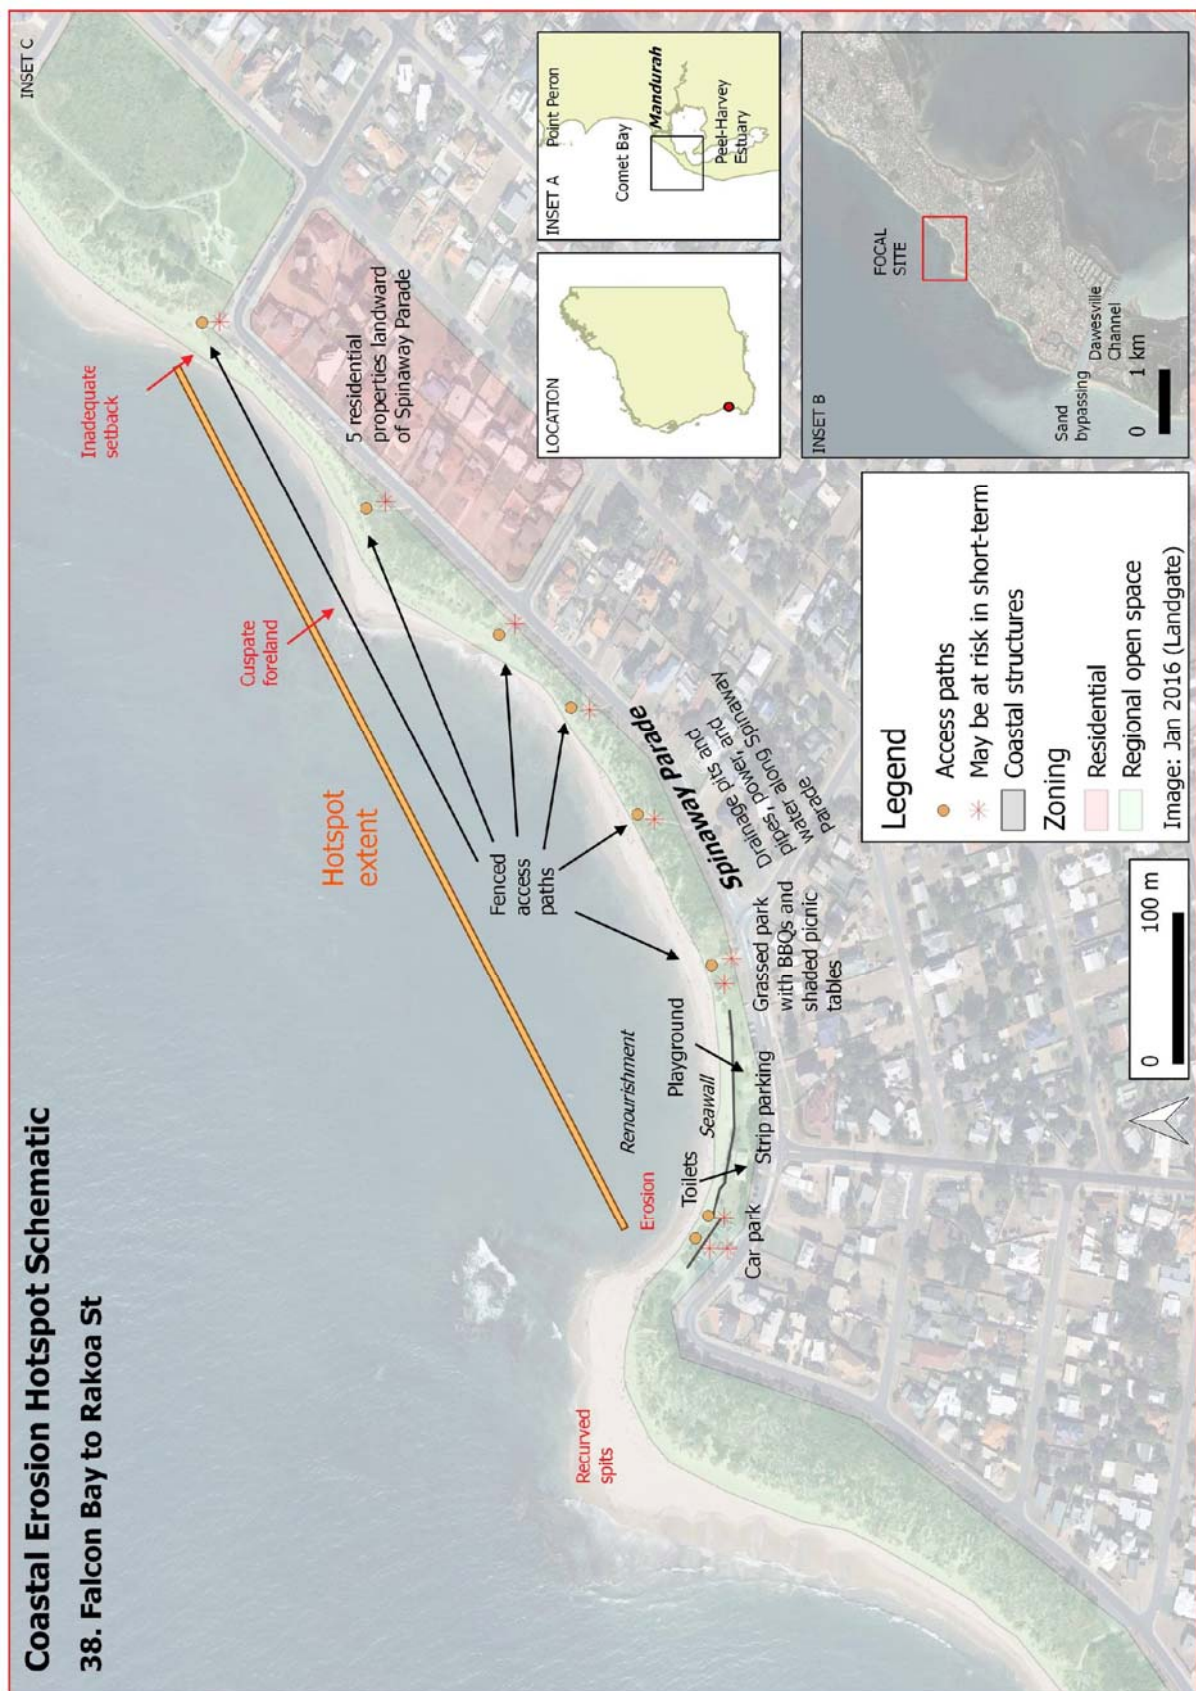
Figure D-38: Falcon Bay to Rakoa St schematic

Extent of erosion problem and hotspot characteristics	<p>Foreshore along Spinaway Parade between the sand boat ramp at the point and Rakoa Street.</p> <p>Hotspot characteristics:</p> <ul style="list-style-type: none"> • Infrastructure close to the existing shore, or landward of progressively and rapidly eroding coast (proximity). • Typically subject to progressive or episodic erosion (instability). • Very highly valued by the community, as nominated by local government (community).
CHRMAP status and findings	<p>CHRMAP Status: Pre-CHRMAP Adaptation Plan CZM (2009b)</p> <p>Hazard Assessment: CZM (2009a) Coastal compartment rated as highly vulnerable to erosion.</p> <p>Management & Adaptation Options: CZM (2009b) -CZM (2009b) - Study area Mandurah coastline, split in to coastal compartments. No timeframes specified. Recommendations (Gretel Drive to Falcon Point) specific focal points should be toilet block, car park. Model predicted shoreline change at Falcon Bay and determine mitigation actions required.</p> <p>Reports</p> <p>Additional Comments: Management of beaches interconnected with Dawesville sand bypassing. City of Mandurah has advertising (Jan-2017) tenders for the design and construction of a seawall.</p> <p>Reports:</p> <p>CZM (2009a) Mandurah Coastal Zone Climate Change Risk Assessment and Adaptation Plan: Phase I Strategic Risk Assessment. Report prepared for the City of Mandurah by Coastal Zone Management. May-2009</p> <p>CZM (2009b) Mandurah Coastal Zone Climate Change Risk Assessment and Adaptation Plan: Phase I Strategic Adaptation Report prepared for the City of Mandurah by Coastal Zone Management. Jun-2009</p>

Coastal dynamics studies for a level 3 assessment. Further detail in Table 4-2.	Ongoing coastal movement data collection, and possibly geotechnical
Assets susceptible to erosion hazard in Imminent timeframe (0–5 years)	8 public assets susceptible to erosion hazard. Spinaway Parade carpark, grassed park area, 6 fenced access tracks.
Assets susceptible to erosion hazard in Expected timeframe (5–25 years)	13 public assets susceptible to erosion hazard. Spinaway Parade carpark, grassed park area, BBQs, shaded picnic tables, toilet block, playground, 80m of Spinaway Parade, 6 fenced access tracks.

Assets susceptible to erosion hazard in Projected timeframe (25+ years)	18 public assets susceptible to erosion hazard. Spinaway Parade carpark, strip parking, grassed park area, BBQs, shaded picnic tables, toilet block, playground, 600m of Spinaway Parade, and 150m of Spinaway Parade, 6 fenced access tracks. Services: Drainage pits and connecting pipes along Spinaway Parade, LV overhead cable along Spinaway Parade, 100AC water main along Spinaway Parade Private Property: 5 on Spinaway Parade
Existing management	Existing behaviour: A sheet pile wall has been tendered for design and construct to protect toilet block. Beach boat launching ramp removed a number of years ago. Avoid (N), Retreat (N), Accommodate (Y - dune planting and stabilisation), Protect (Y - Renourishment, limestone walling possibly installed in 1960s)
Management options for Imminent timeframe (0–5 years)	Anticipated behaviour: Storm erosion may affect dune mobility near Rakoa St & beach amenity near BBQs. Avoid (N), Retreat (N), Accommodate (Y - Manage access paths. Runoff management), Protect (Y - planned upgrade to walling with expectation of future retreat (i.e. short to medium-term), Review Dawesville bypassing arrangement) Preparation of planning frameworks for retreat in next level of management and identify funding mechanisms.

Works to avoid to achieve long-term plans	Do not support subdivision. Avoid permanent development seaward of current development (e.g. in greenfield foreshore reserve) - temporary/relocatable development as per SPP2.6 is acceptable.
--	---

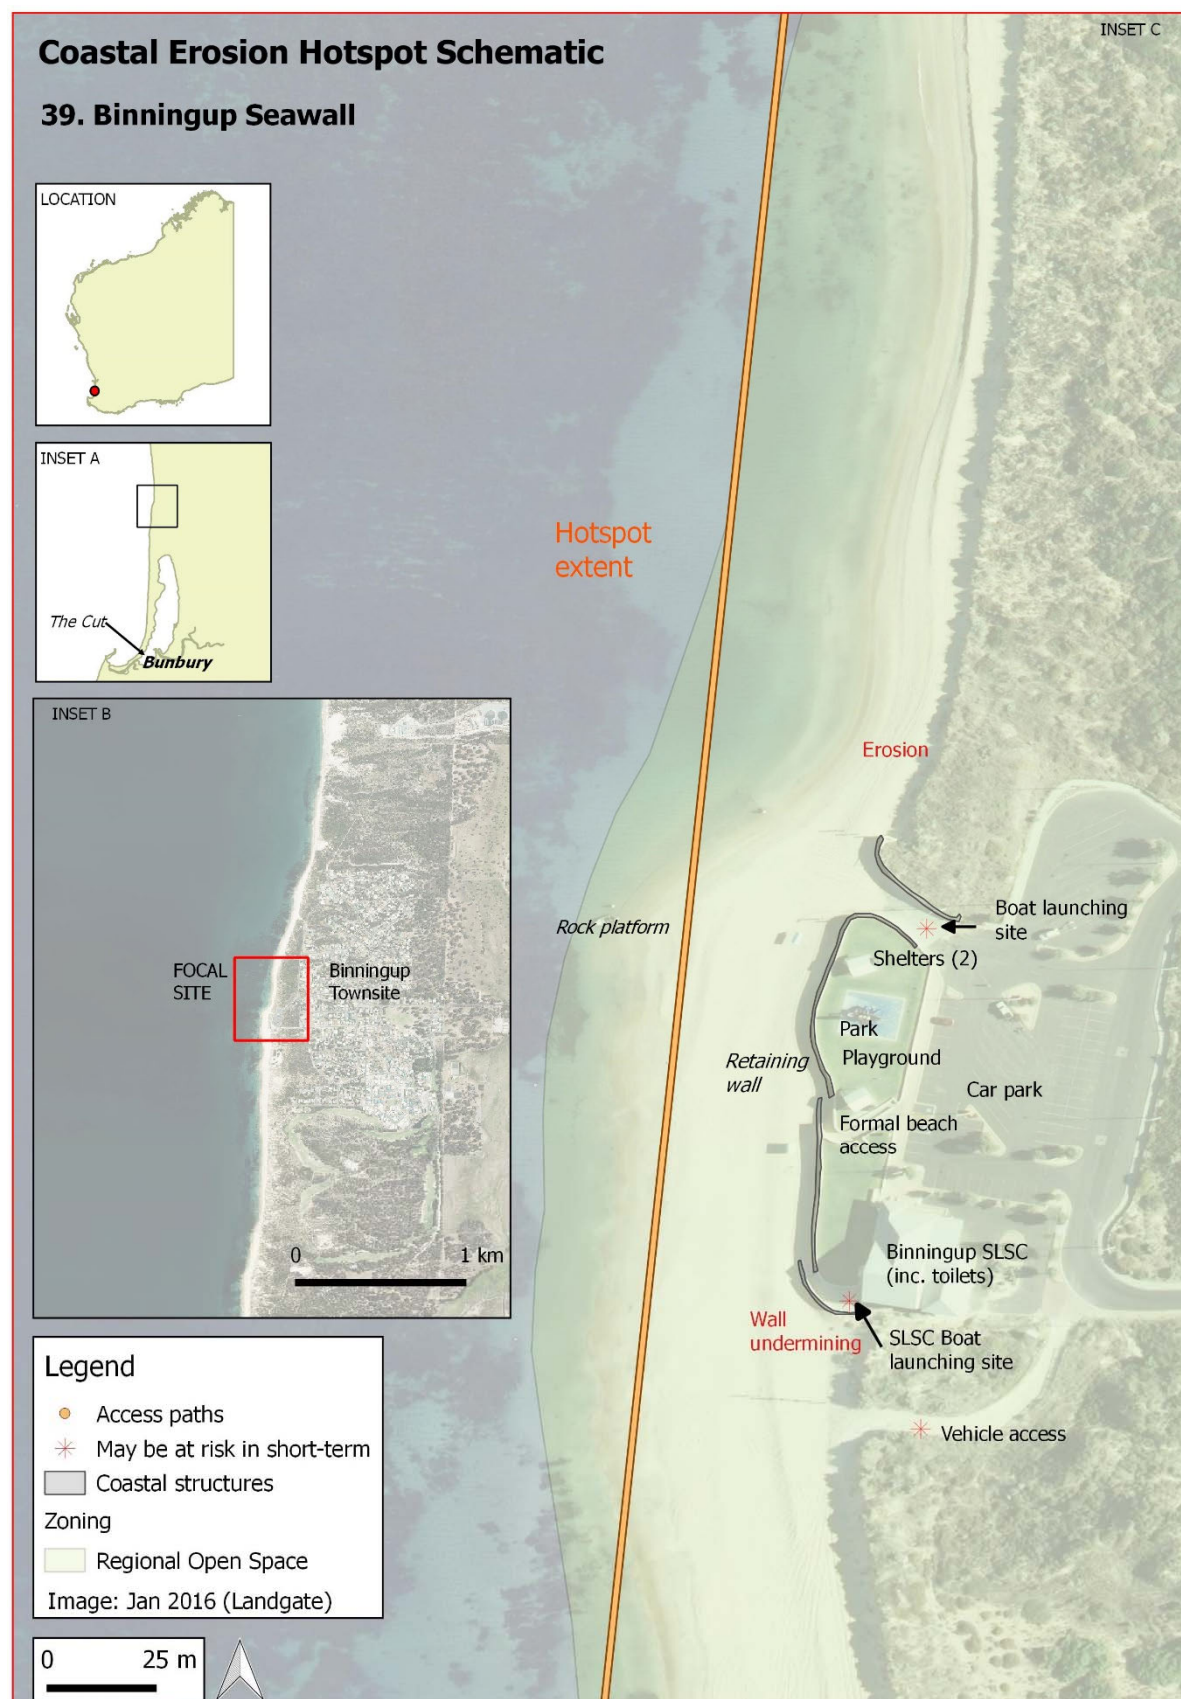
Figure D-39: Binningup Seawall schematic

Hotspot No.	39
Hotspot Name	Binningup Seawall
Local Coastal Manager	Shire of Harvey
Hotspot issue	<p>The Binningup site was developed to improve the delivery of 4WD vehicles with trailerable vessels to the beach with all season access for the surf lifesaving club. The seawall was initially constructed in 2007 and extended in 2011, replacing the foredune with recreational facilities; it should be noted that the non-typical seawall may not possess the ability to withstand wave energy. The development is located on or seaward of the vegetation line with a seawall that is not tolerable to shoreline change and is impacted by the seasonal and year to year variations in beach width and dune position which may be up to 25m in an individual storm (e.g. storm damage of wall in 2013). Beach access from the ramps is limited when the beach narrows. The damage observed at the seawall suggests the marine conditions have not been appropriately assessed and taken into account in the design. Erosion will impact on the amenity and integrity of the facility, with frequent damage and eventual retreat so the wall will have increased downdrift erosion.</p> <p>Seven publicly owned assets may be at risk of erosion damage in the area (see attached figure), with three assets at risk of damage in the short-term, including two boat launching areas and beach access points, including crushed limestone vehicle access to the south. In the moderate-term, the Binningup SLSC, which is partly protected, is a high-value asset at risk.</p>

Coastal dynamics studies for a level 3 assessment. Further detail in Table 4-2.	Geotechnical and ongoing coastal movement data collection
Assets susceptible to erosion hazard in Imminent timeframe (0–5 years)	3 public assets susceptible to erosion hazard. Boat launching x 2, fixed beach access, crushed limestone vehicle access to S
Assets susceptible to erosion hazard in Expected timeframe (5–25 years)	6 public assets susceptible to erosion hazard. Boat launching x 2, fixed beach access, crushed limestone vehicle access to S, *Binningup SLSC (part protected includes toilet block), park, *playground
Assets susceptible to erosion hazard in Projected timeframe (25+ years)	7 public assets susceptible to erosion hazard. Boat launching x 2, fixed beach access, crushed limestone vehicle access to S, car park, *Binningup SLSC (part protected includes toilet block), park, *playground

Management and adaptation options for Projected timeframe (25+ years).	Avoid (N), Retreat (Y - Remove facility and construct new facility to landward), Accommodate (Y - Reduce coastal footprint of facility. Extend beach access points landward), Protect (N)
Works to avoid to achieve long-term plans	Permanent development to the north. Ideally, avoid protecting present facility further as this will reduce beach access which is the primary function of the facility

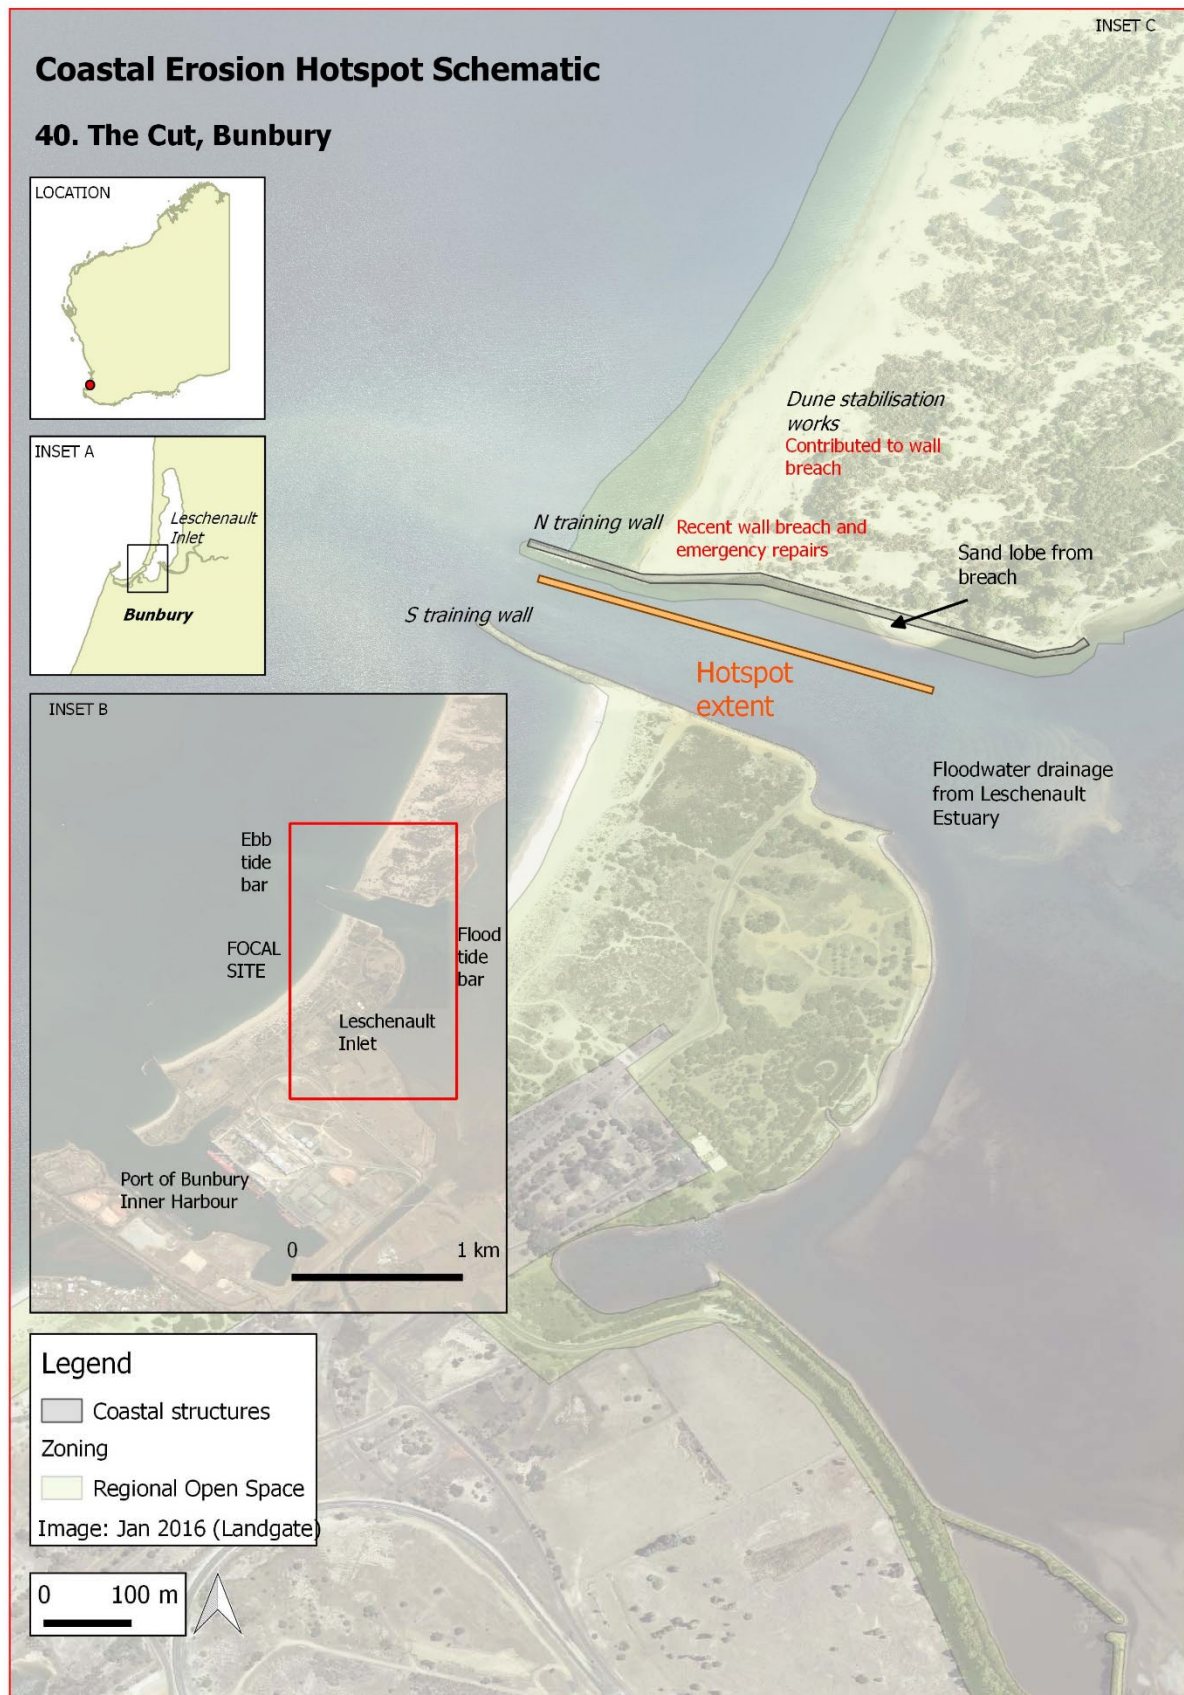
Figure D-40: The Cut, Bunbury schematic

Extent of erosion problem and hotspot characteristics	<p>Along the northern training wall</p> <p>Hotspot characteristics:</p> <ul style="list-style-type: none"> • Apparent costs of likely forms of erosion mitigation are high. • Very highly valued by the community, as nominated by local government (community).
CHRMAP status and findings	<p>CHRMAP Status: Complete</p> <p>Hazard Assessment: Damara (2016)</p> <p>Management & Adaptation Options: Damara (2016) - Study area Shire coastline, with focus on individual townsites. Recommend adaption strategy (training walls) design review of the training wall immediately (0-5 years) and by 2026 and onwards undertake continued modifications to training wall as shoreline retreats.</p> <p>Additional Comments: There is no clearly defined organisation with management responsibility for the training walls.</p> <p>Reports:</p> <p>Damara (2016) Shire of Harvey Coastal Hazard Risk Management and Adaptation Plan. Prepared by Damara WA and Land Insights for Shire of Harvey. Report 246-00-09, Rev. 0, Sep-2016.</p>

Coastal dynamics studies for a level 3 assessment. Further detail in Table 4-2.	Sandbar dynamics and possibly littoral transport
Assets susceptible to erosion hazard in Imminent timeframe (0–5 years)	1 public asset susceptible to erosion hazard, the maintenance of the channel for flood mitigation
Assets susceptible to erosion hazard in Expected timeframe (5–25 years)	1 public asset susceptible to erosion hazard, the maintenance of the channel for flood mitigation
Assets susceptible to erosion hazard in Projected timeframe (25+ years)	1 public asset susceptible to erosion hazard, the maintenance of the channel for flood mitigation

Approximation of cost for Expected timeframe (5–25 years) options (L/M/H)	Accommodate - H
Trigger for next level management, monitoring and alternate management option (Expected timeframe 5–25 years)	Trigger for next level management: Existing length of training walls does not serve a purpose for entrance stability, and deepening is contributing to structural damage Monitoring: Beach width observations Alternate option: N/A
Management and adaptation options for Projected timeframe (25+ years).	Avoid (N), Retreat (N), Accommodate (Y - Progressively reduce seaward length of training walls), Protect (N)
Works to avoid to achieve long-term plans	Extension of the training walls and deepening via dredging

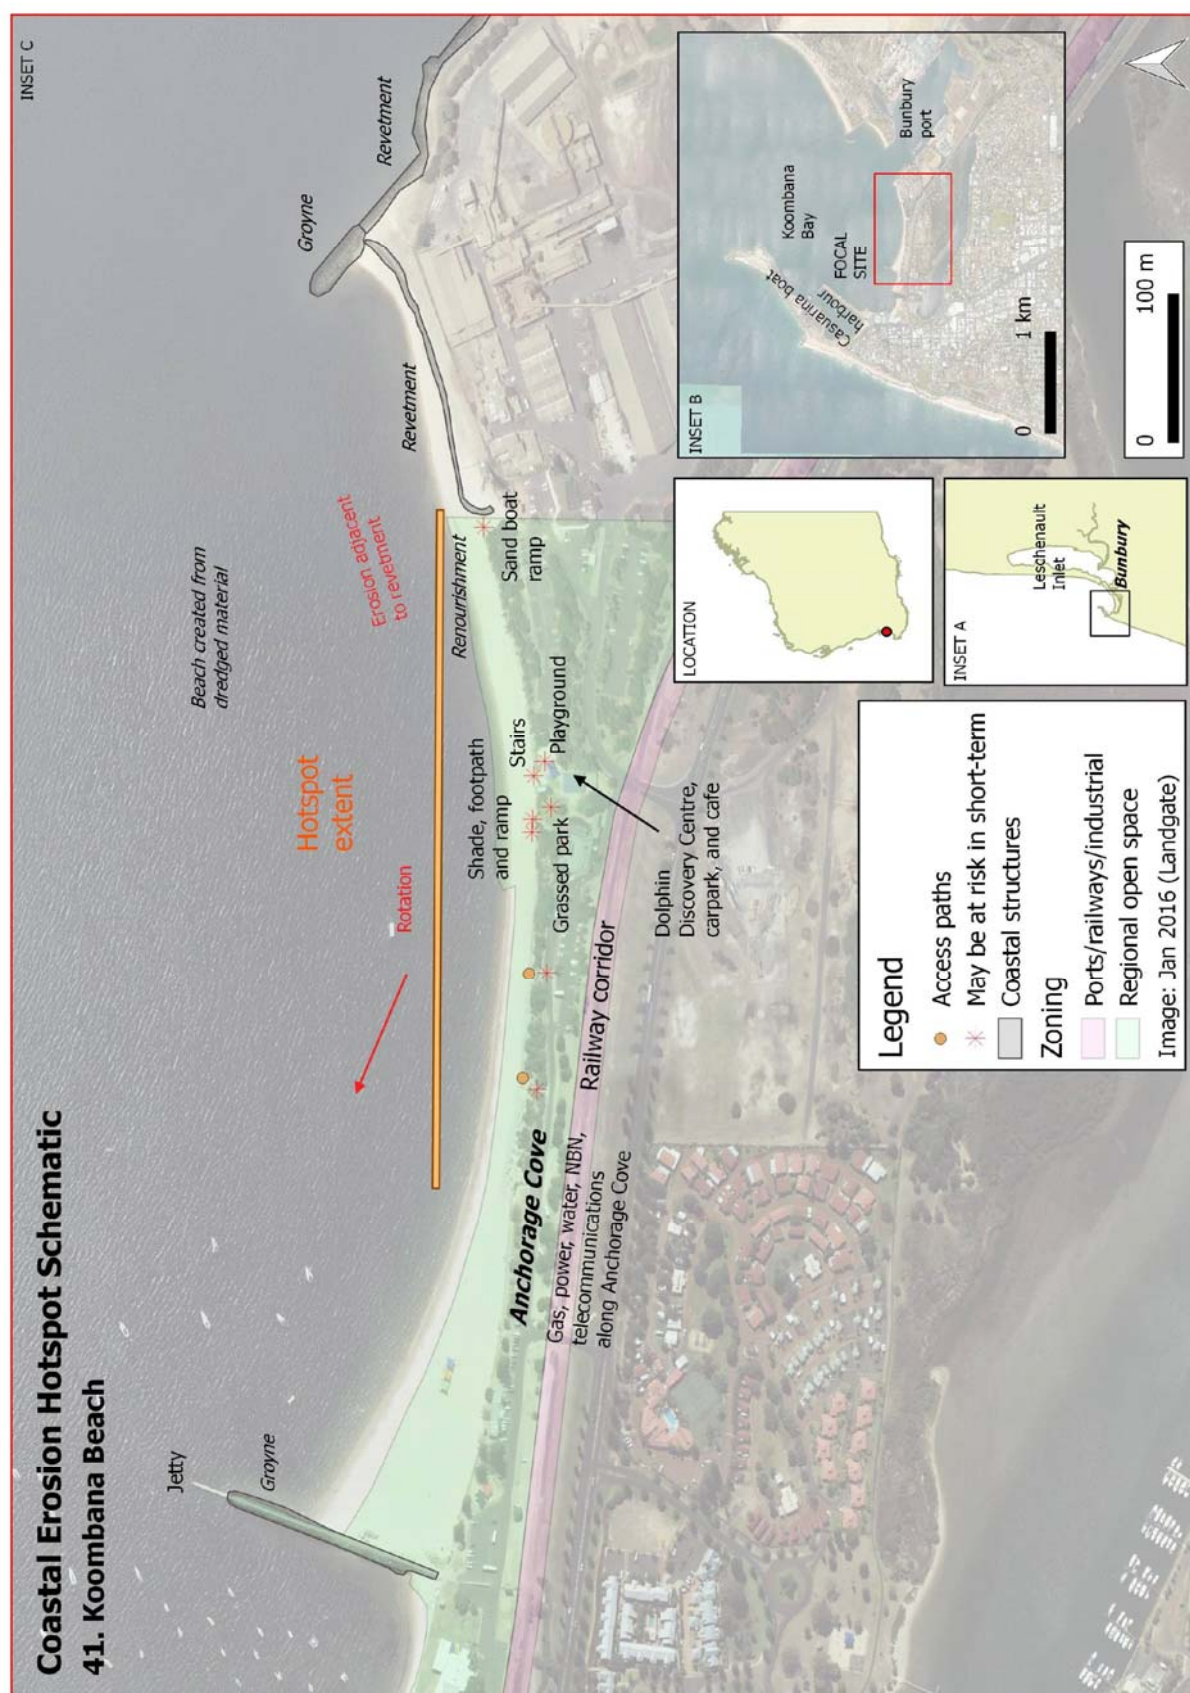
Figure D-41: Koombana Beach schematic

Coastal dynamics studies for a level 3 assessment. Further detail in Table 4-2.	Renourishment source, including characterisation of sediments in harbour sand traps, and ongoing coastal movement data collection
Assets susceptible to erosion hazard in Imminent timeframe (0–5 years)	9 public assets susceptible to erosion hazard. 2 fenced access paths, gazebo, footpath and ramp to beach, grassed area, playground, stairs access, sand boat ramp.
Assets susceptible to erosion hazard in Expected timeframe (5–25 years)	17 public assets susceptible to erosion hazard. 2 fenced access paths, , Dolphin Discovery Centre carpark, gazebo, footpath and ramp to beach, grassed area, playground, stairs access, sand boat ramp, 210m of Anchorage Cove (road), Dolphin Discovery Centre building and Dolphin Discovery Centre café. Services: 100PVCMP 70kPa gas pipeline along Anchorage Cove, LV buried cable along Anchorage Cove, 4 power poles along Anchorage Cove, 40PVC water pipe between Anchorage Cove and Koombana Drive, in-service NBN cable along Anchorage Cove, fibre optic telecommunications cable running to Dolphin Discovery Centre. Leasehold: Dolphin Discovery Centre and Dolphin Discovery Centre cafe.

Assets susceptible to erosion hazard in Projected timeframe (25+ years)	19 public assets susceptible to erosion hazard. 2 fenced access paths, Dolphin Discovery Centre carpark, gazebo, footpath and ramp to beach, grassed area, playground, stairs access, sand boat ramp, 210m of Anchorage Cove (road), 10m of railway corridor, Dolphin Discovery Centre building and Dolphin Discovery Centre café. Services: 100PVCMP 70kPa gas pipeline along Anchorage Cove, LV buried cable along Anchorage Cove, 4 power poles along Anchorage Cove, 40PVC water pipe between Anchorage Cove and Koombana Drive, in-service NBN cable along Anchorage Cove, fibre optic telecommunications cable running to Dolphin Discovery Centre. Leasehold: Dolphin Discovery Centre and Dolphin Discovery Centre café.
Existing management	Existing behaviour: Beach created from dredge spoil from inner harbour works and widened from large dredge campaigns. Avoid (N), Retreat (N), Accommodate (N), Protect (Y - Revetment constructed immediately to the east, Renourishment, most recently 2017)

Management and adaptation options for Expected timeframe (5–25 years)	Anticipated behaviour: Moderate erosion will cause loss of minimal remaining dune buffer. Avoid (N), Retreat (Y - Modify eastern car park), Accommodate (N), Protect (Y - ongoing renourishment to maintain beach, consider short groynes to extend the life of the renourishment) Preparation of planning frameworks for retreat in next level of management and identify funding mechanisms.
Approximation of cost for Expected timeframe (5–25 years) options (L/M/H)	Retreat - L Protect - M Prepare plans - 50k
Trigger for next level management, monitoring and alternate management option (Expected timeframe 5–25 years)	Trigger for next level management: Buried seawall exposed for more than 6 months of the year. Monitoring: Photographic monitoring Alternate option: N/A
Management and adaptation options for Projected timeframe (25+ years).	Anticipated behaviour: Sustained erosion that exceeds the renourishment rate will cause any 'buried' revetment to become exposed, lowering the beach & losing the main beach amenity. Only consider one of the retreat or protect options. Avoid (N), Retreat (Y - retreat towards the west as there is insufficient space to retain a functional beach in front of beach-use facilities [do not protect]), Accommodate (N), Protect (Y - massive renourishment [do not retreat] with contribution by lessee)

Works to avoid to achieve long-term plans	Works that will result in a permanent loss of the beach because the sandy beach is an essential component of the Dolphin Discovery Centre
