Appendix D.35. Waikiki Beach, Rockingham

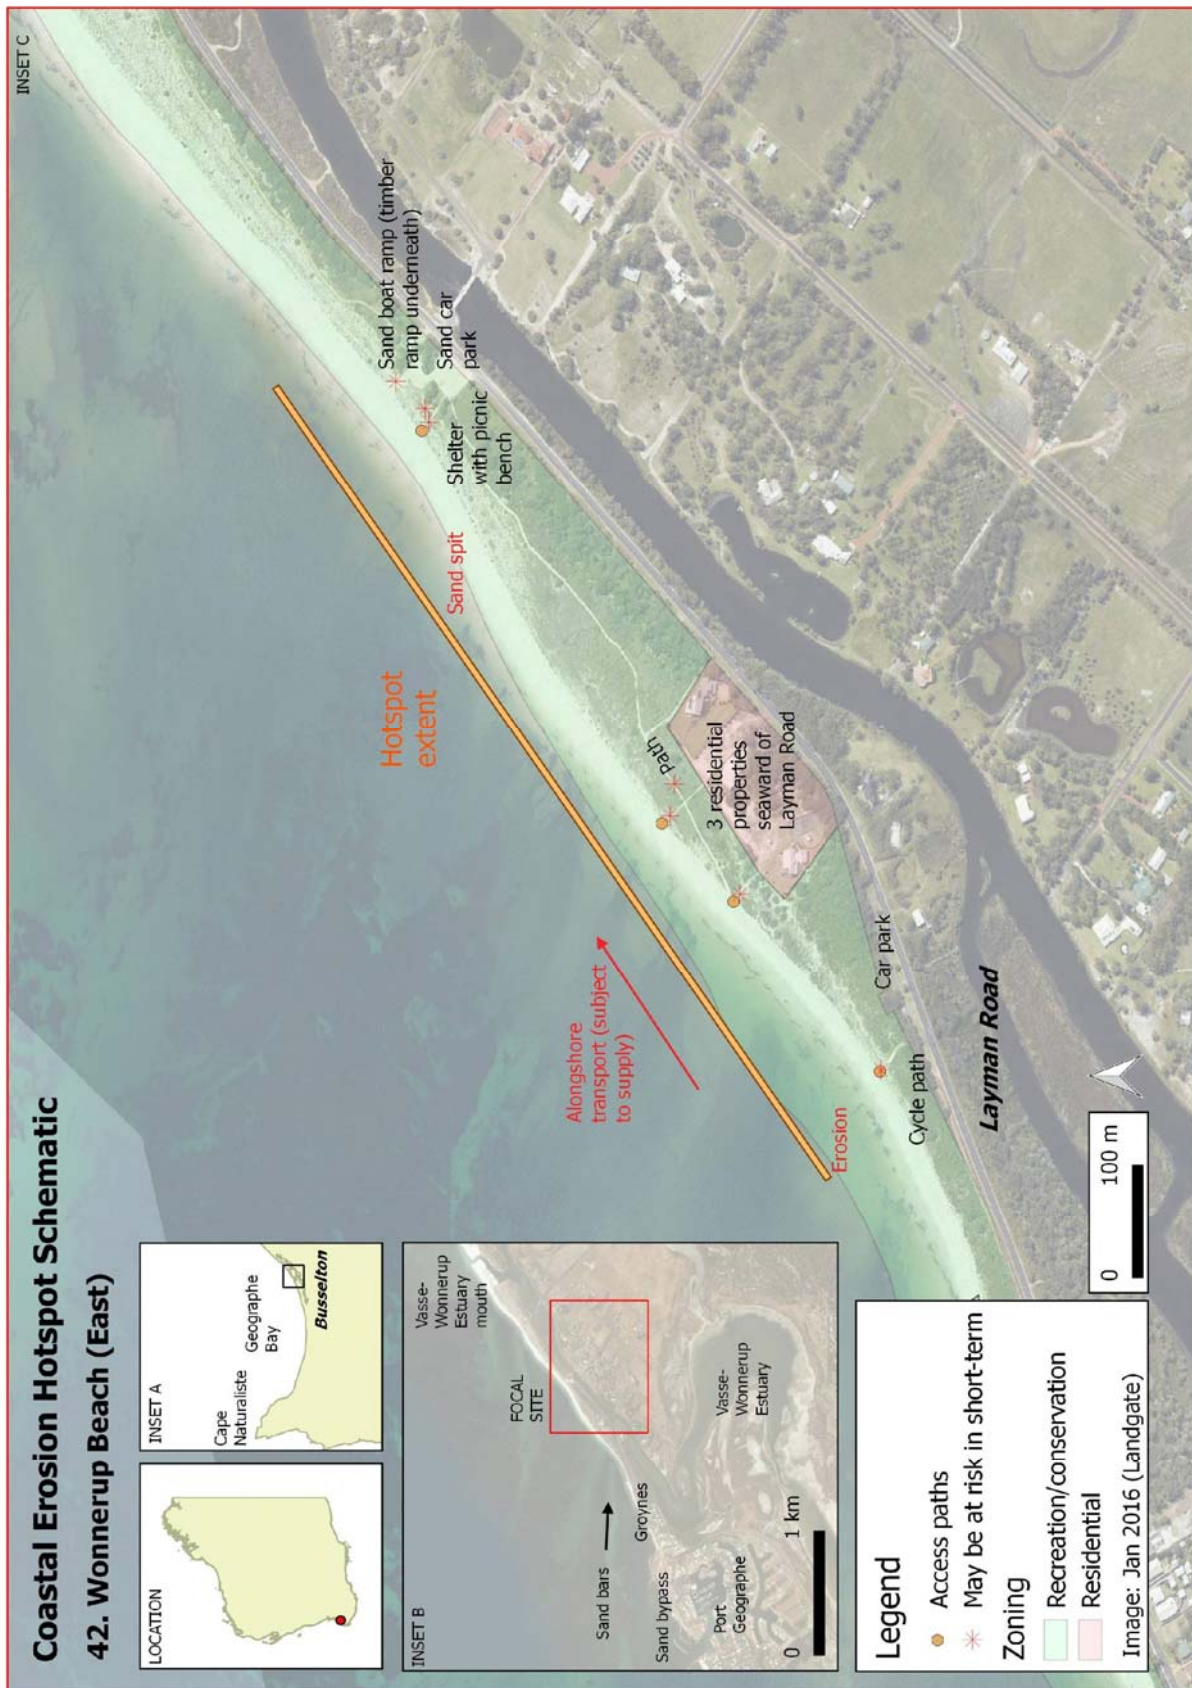
Figure D-42: Wonnerup Beach (East) schematic

Coastal dynamics studies for a level 3 assessment. Further detail in Table 4-2.	Ongoing coastal movement data collection
Assets susceptible to erosion hazard in Imminent timeframe (0–5 years)	4 public assets susceptible to erosion hazard. 4 informal access tracks, one sand boat ramp (with timber ramp underneath), informal sand paths, beach shelter over picnic bench

Assets susceptible to erosion hazard in Expected timeframe (5–25 years)	6 public assets susceptible to erosion hazard. 3 informal access tracks, one sand boat ramp (with timber ramp underneath), informal sand paths, sand parking area, beach shelter over picnic bench, cycle path (at western extent). Private Property: 3 on Layman Road.
Assets susceptible to erosion hazard in Projected timeframe (25+ years)	8 public assets susceptible to erosion hazard. 4 informal access tracks, one sand boat ramp (with timber ramp underneath), informal sand paths, sand parking area, beach shelter over picnic bench, Baudin Reserve beach carpark, Layman Road (at the western extent), cycle path (at the western extent). Private Property: 3 on Layman Road.
Existing management	Avoid (Y - existing buffer to the three houses and boat ramp), Retreat (N), Accommodate (N - note it is partially reliant on sand bypassing across Port Geographe), Protect (N)

Works to avoid to achieve long-term plans	Sub-division of properties and further development on the private properties. Additional investment in coastal infrastructure in area of likely hazard.

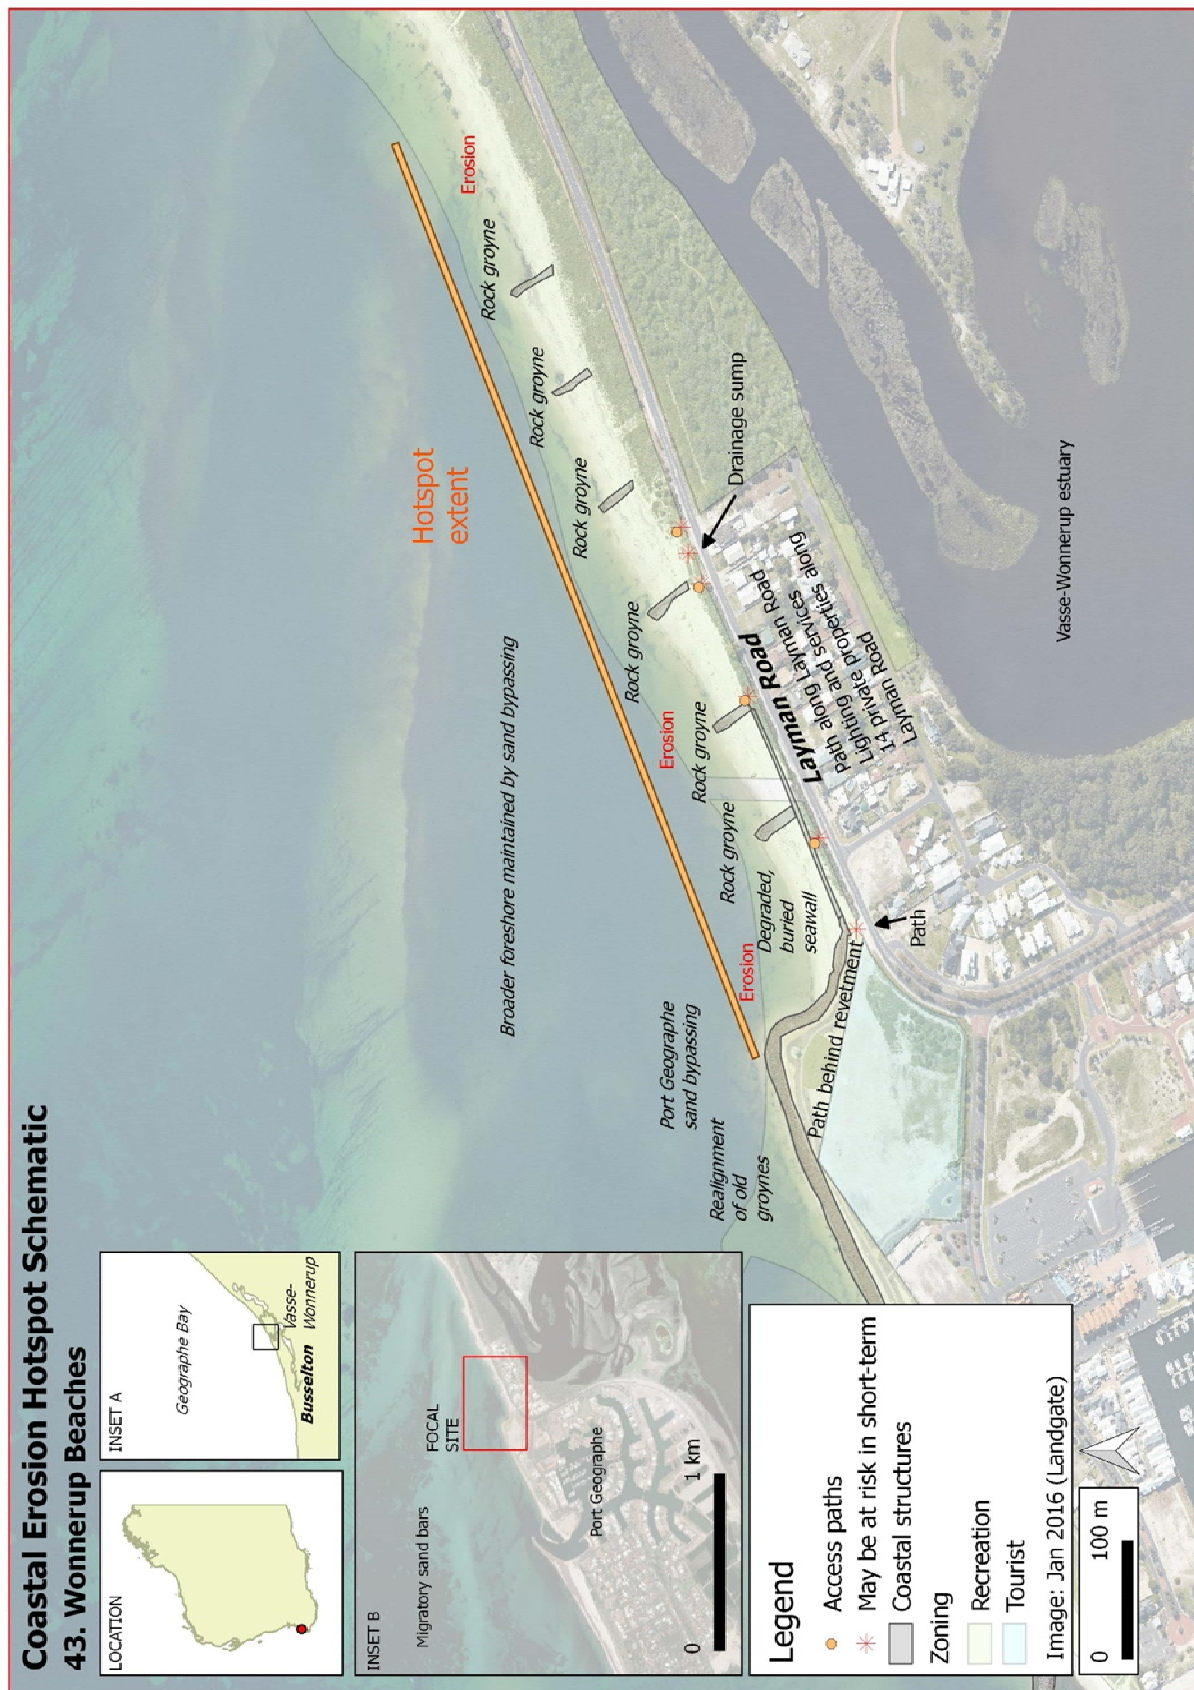
Figure D-43: Wonnerup Beaches schematic

Hotspot No.	43
Hotspot Name	Wonnerup Beaches
Local Coastal Manager	City of Busselton
Hotspot issue	<p>Wonnerup is part of the broader Geographe Bay shore with rhythmic supply of sediment to the shore, with erosion exacerbated by the interruption of sediment transport by the Port Geographe Marina structures. The foreshore has had a revetment, six groynes, reconfiguration of the Port Geographe structures, bypassing and renourishment undertaken to address the erosion issues. Monitoring is undertaken at the site.</p> <p>Five publicly owned assets may be at risk of erosion damage in the area (see attached figure), with two assets at risk of damage in the short-term, including a path and beach access points. In the longer term, Layman Road and the associated lighting and services (gas, water, phone, power), and 14 private properties (including 4 vacant lots) along Layman Road are high-value assets at risk. The foreshore is used for walking, swimming, dog walking and fishing. There are community groups and residents with a vested interest in the management of Wonnerup.</p>

Extent of erosion problem and hotspot characteristics	<p>From NE end of Spinnaker Blvd revetment to 135m NE of 6th groyne in field.</p> <p>Hotspot characteristics:</p> <ul style="list-style-type: none"> • Infrastructure close to the existing shore, or landward of progressively and rapidly eroding coast (proximity). • Typically subject to progressive or episodic erosion (instability). • Very highly valued by the community, as nominated by local government (community).
CHRMAP status and findings	<p>CHRMAP Status: Not Scheduled</p> <p>Hazard Assessment: Damara (2011) - Identified as at risk by 2110 under low climate change scenario.</p> <p>Management & Adaptation Options: Nil</p> <p>Additional Comments: Existing coastal protection structures in place at this site. Management of the beach is interconnected to the sand bypassing at Port Geographe.</p> <p>Reports:</p> <p>Shore Coastal (2013) Busselton Coastal Management Program (2014-2018). Prepared for the City of Busselton by Shore Coastal. Report SCR1211, Apr-2013</p> <p>Damara (2011) Coastal Erosion Assessment of Climate Change Impacts. Prepared for the Shire of Busselton. Report 96-00-01, Aug-2011</p> <p>Damara (2012) Coastal Hazard Mapping for Economic Analysis of Climate Change Adaptation in the Peron-Naturaliste Region. Prepared by Damara WA Pty Ltd for Peron-Naturalist Partnership. Report 169-01, Rev. 0, Oct-2012</p>

Coastal dynamics studies for a level 3 assessment. Further detail in Table 4-2.	Ongoing coastal movement data collection
Assets susceptible to erosion hazard in Imminent timeframe (0–5 years)	2 public assets susceptible to erosion hazard. Path, access paths (4).
Assets susceptible to erosion hazard in Expected timeframe (5–25 years)	<p>5 public assets susceptible to erosion hazard. Layman Road, *path (behind rock revetment), path, access paths (4).</p> <p>Services: Gas, water, power, telecommunications.</p>
Assets susceptible to erosion hazard in Projected timeframe (25+ years)	<p>5 public assets susceptible to erosion hazard. Layman Road and services, *path (behind rock revetment), path, access paths (4).</p> <p>Services: Gas, water, power, telecommunications.</p> <p>Private property: 14 on Layman Road including 4 vacant lots.</p>
Existing management	<p>Avoid (N),</p> <p>Retreat (N),</p> <p>Accommodate (Y - Sand bypassing, harbour entrance modification),</p> <p>Protect (Y - Drown-drift groyne field, 'back-up' seawall)</p>

Management options for Imminent timeframe (0–5 years)	Anticipated behaviour: Beach use is considered susceptible to acute hazard Avoid (N), Retreat (Y - Relocate drainage sump to avoid sand movement), Accommodate (Y - Continue sand bypassing as required), Protect (Y - Maintain groyne field and back-up sea wall)
Approximation of cost for Imminent timeframe (0–5 years) options (L/M/H)	Retreat - L Accommodate - M Protect - L
Trigger for next level management, monitoring and alternate management option (Imminent timeframe 0–5 years)	Trigger for next level management: East Wonnerup properties subject to acute erosion or active sand drift Monitoring: Beach width. Existing Geographe Bay coastal monitoring program, assessing acute and progressive erosion. Alternate option: N/A
Management and adaptation options for Expected timeframe (5–25 years)	Anticipated behaviour: Imbalance of sand on downdrift side of Port Geographe is possible. Avoid (N), Retreat (N), Accommodate (Y - Continue sand bypassing as required and increase sand supply where possible), Protect (Y - Allow East Wonnerup properties to build 'back-up' seawall (private property), Extension of existing structures is a possible but expensive option, valid only for the short-term (10-20 years)) Preparation of planning frameworks for retreat in next level of management and identify funding mechanisms.

Works to avoid to achieve long-term plans	Additional investment in coastal infrastructure Continued imbalance of sand on the downdrift side of Port Geographe is possible. This can be managed by increasing the sand supply (treated through entrance reconfiguration), extending the groyne field up to the end of Layman Road or increasing the tolerance to erosion phases (e.g. 'back-up' seawall).

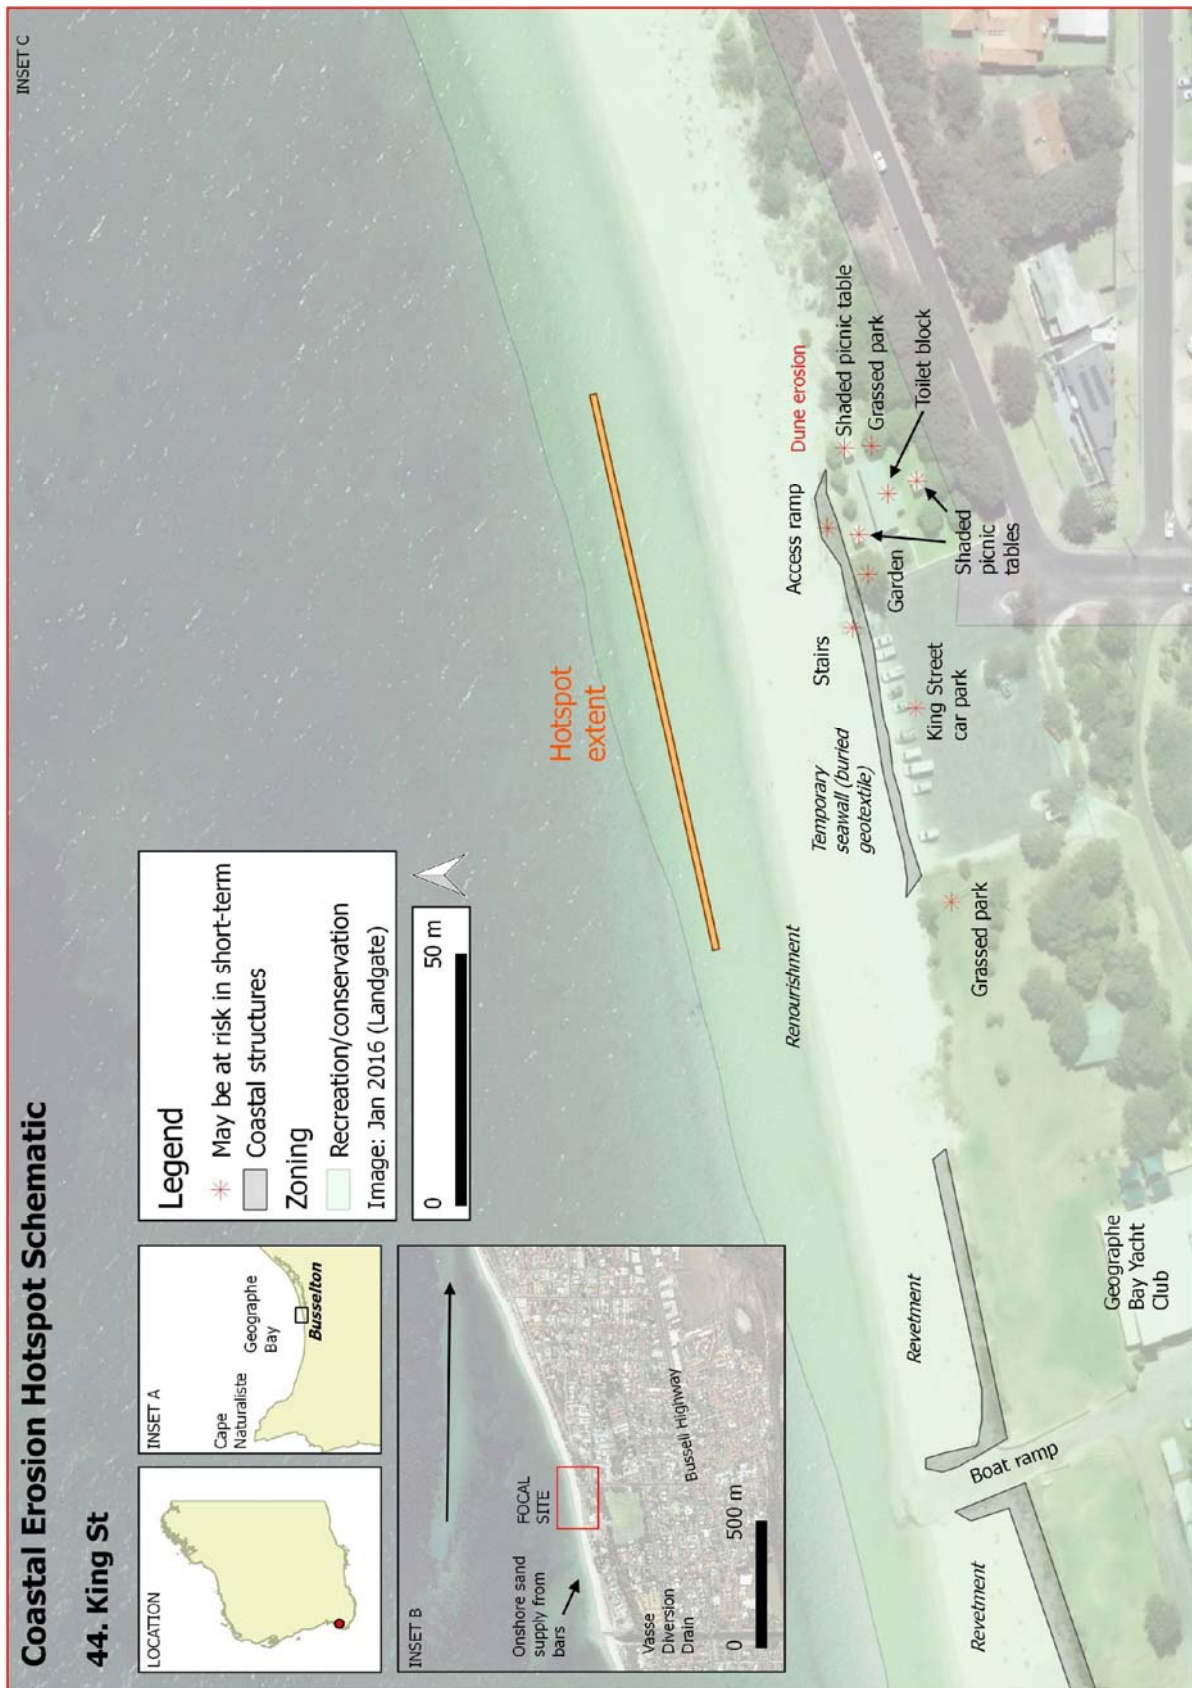
Figure D-44: King St schematic

Coastal dynamics studies for a level 3 assessment. Further detail in Table 4-2.	Ongoing coastal movement data collection
Assets susceptible to erosion hazard in Imminent timeframe (0–5 years)	10 public assets susceptible to erosion hazard. 2 grassed park areas, King Street carpark, garden, toilet block, access ramp, access stairs, 3 shaded picnic tables
Assets susceptible to erosion hazard in Expected timeframe (5–25 years)	10 public assets susceptible to erosion hazard. 2 grassed park areas, King Street carpark, garden, toilet block, access ramp, access stairs, 3 shaded picnic tables
Assets susceptible to erosion hazard in Projected timeframe (25+ years)	10 public assets susceptible to erosion hazard. 2 grassed park areas, King Street carpark, garden, toilet block, access ramp, access stairs, 3 shaded picnic tables

Management and adaptation options for Projected timeframe (25+ years).	Anticipated behaviour: Sustained erosion reducing useable area. Avoid (N), Retreat (Y - managed retreat. Note: If this becomes an area of enhanced recreation development, protect may be an alternate option.), Accommodate (N), Protect (N)
Works to avoid to achieve long-term plans	The focus should be on nodal development. Stop extending facilities to east. Any proposed works at the yacht club should consider the impact on this foreshore.

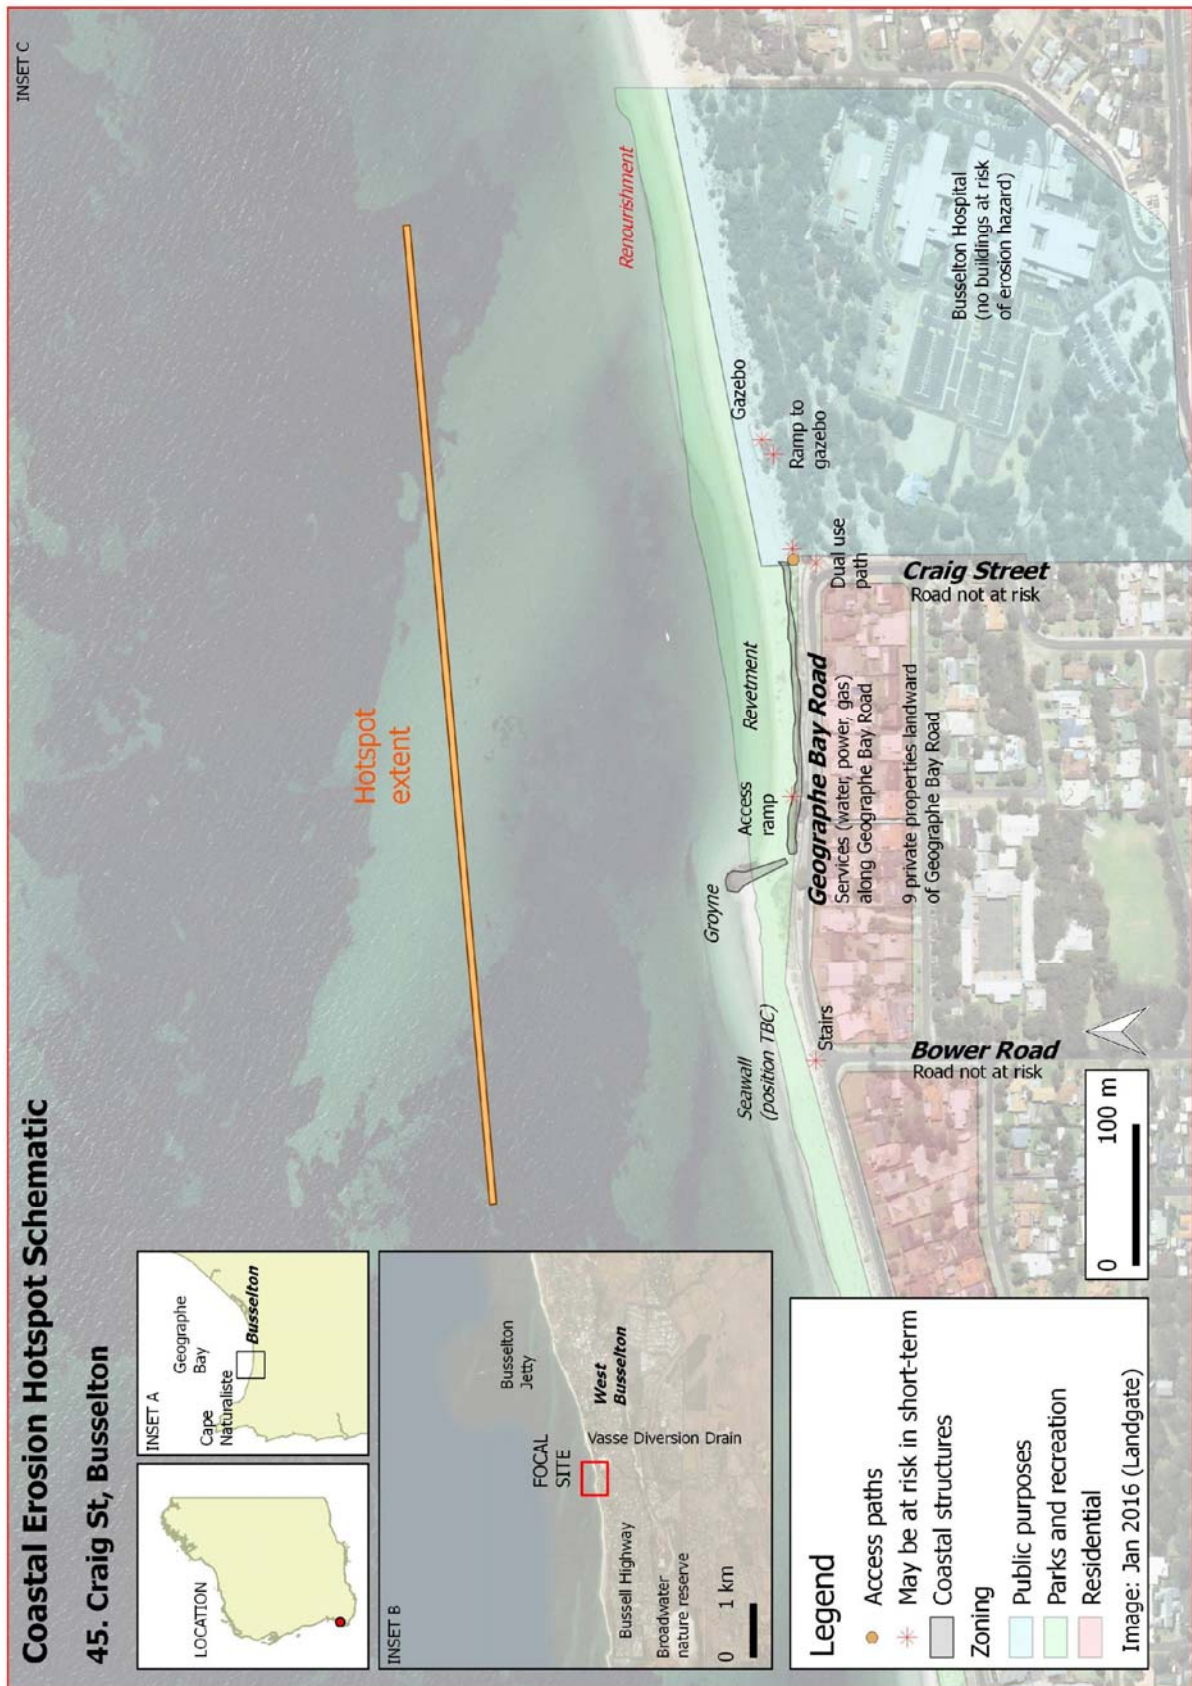
Figure D-45: Craig St, Busselton schematic

Coastal dynamics studies for a level 3 assessment. Further detail in Table 4-2.	Ongoing coastal movement data collection
Assets susceptible to erosion hazard in Imminent timeframe (0–5 years)	6 public assets susceptible to erosion hazard. Access ramp. A formal access path with ramp, a small section of path at eastern extent of rock revetment, an informal access track, a gazebo/lookout, and ramp/path leading to gazebo.
Assets susceptible to erosion hazard in Expected timeframe (5–25 years)	6 public assets susceptible to erosion hazard. Access ramp. A formal access path with ramp, a small section of path at eastern extent of rock revetment, an informal access track, a gazebo/lookout, and ramp/path leading to gazebo.
Assets susceptible to erosion hazard in Projected timeframe (25+ years)	10 public assets susceptible to erosion hazard. Access ramp, a formal access path with ramp, a path (some sitting behind rock revetment) an informal access track, a gazebo/lookout, and ramp/path leading to gazebo, Geographe Bay Rd (partially behind rock revetment).

Management and adaptation options for Expected timeframe (5–25 years)	Avoid (N), Retreat (Y - relocation of DUP if required), Accommodate (N), Protect (Y - Construct new short groyne to east, with nourishment; large-scale nourishment and extend/relocate groyne)
Approximation of cost for Expected timeframe (5–25 years) options (L/M/H)	Retreat - L (if required) Protect - H
Trigger for next level management, monitoring and alternate management option (Expected timeframe 5–25 years)	Trigger for next level management: Short groyne outflanked (i.e. need longer structure) Monitoring: Photographic monitoring. Existing Geographe Bay coastal monitoring program, assessing acute and progressive erosion. Alternate option: N/A
Management and adaptation options for Projected timeframe (25+ years).	Avoid (N), Retreat (N), Accommodate (N), Protect (Y - Seawalls and groynes)
Works to avoid to achieve long-term plans	Redevelopment or increased development on the hospital site further seaward

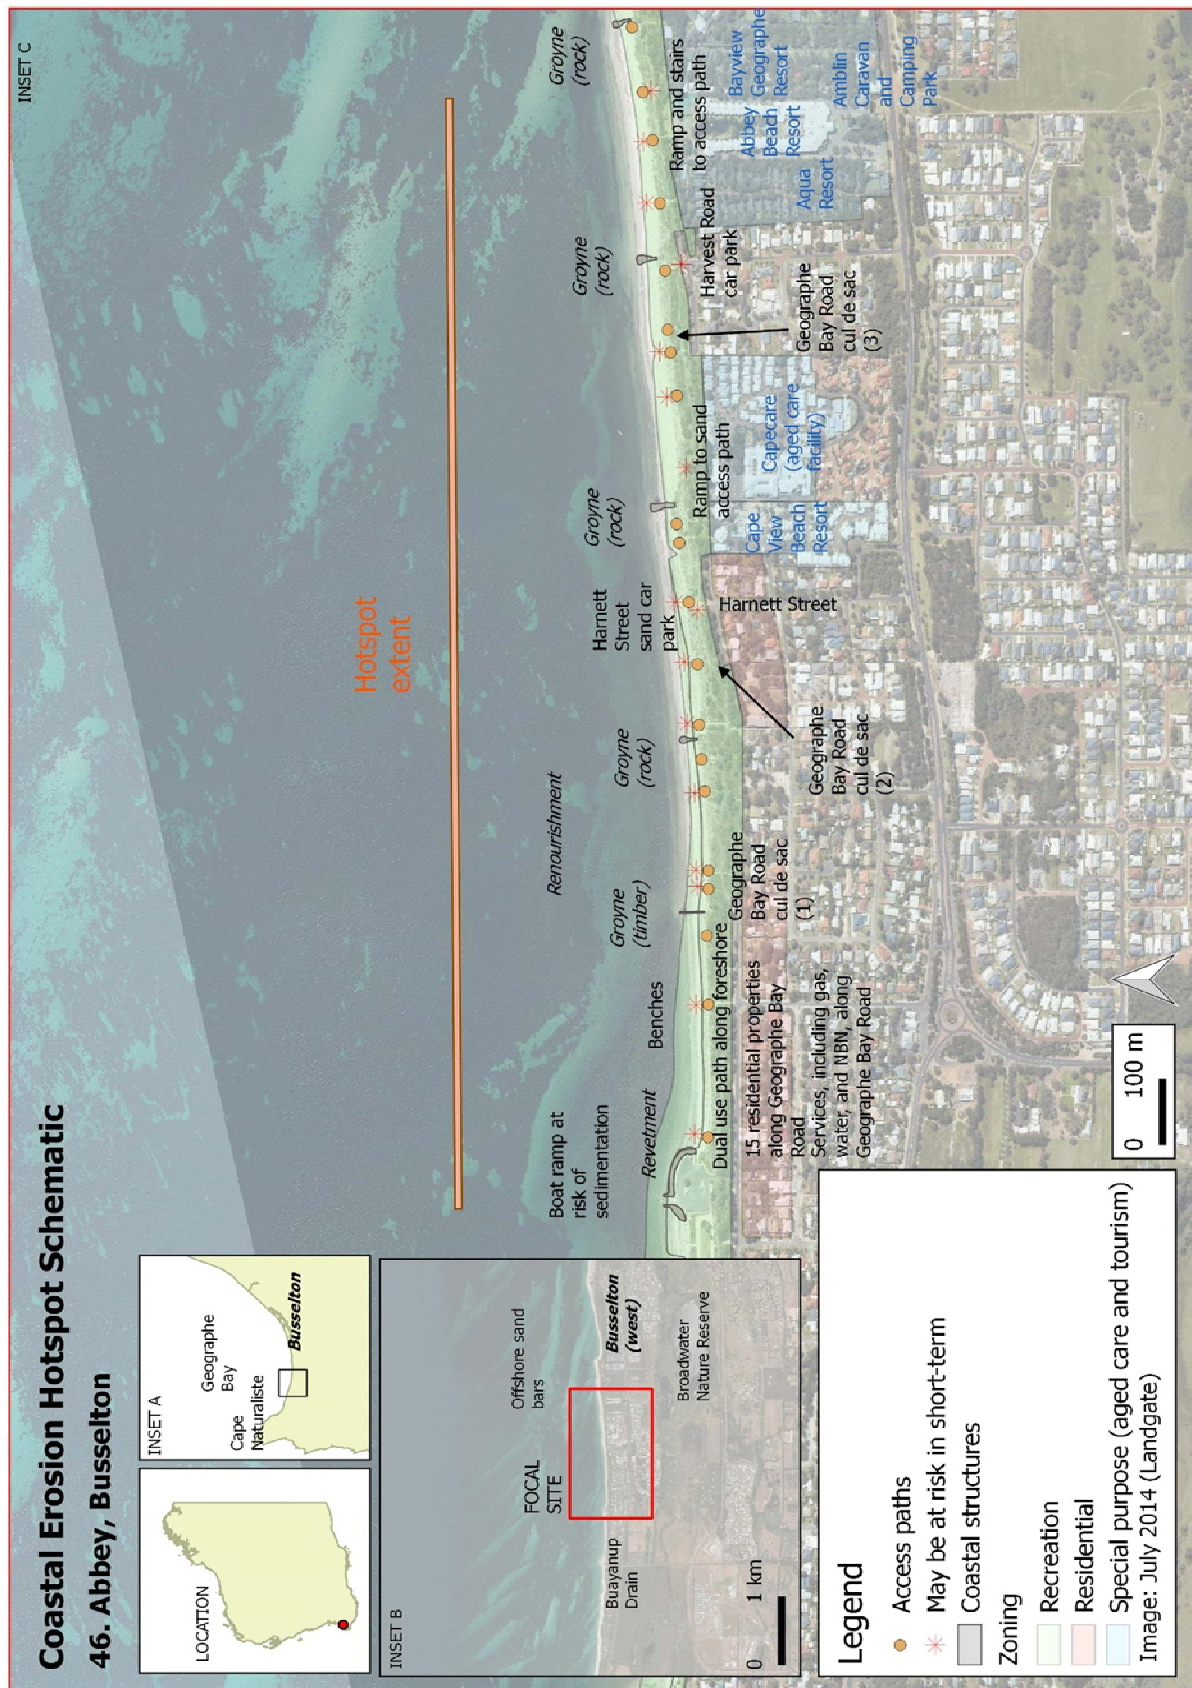
Figure D-46: Abbey, Busselton schematic

Coastal dynamics studies for a level 3 assessment. Further detail in Table 4-2.	Ongoing coastal movement data collection
Assets susceptible to erosion hazard in Imminent timeframe (0–5 years)	9 public assets susceptible to erosion hazard. Toes of multiple access paths, 2 benches at beach access point, boat ramp at risk of sedimentation, ramp to sand access path, sand car park at Harnett Street, sealed path and stairs to sand access path, Harvest Road sealed car park (seaward of DUP), short sealed path and stairs to sand access path.

Assets susceptible to erosion hazard in Expected timeframe (5–25 years)	17 public assets susceptible to erosion hazard. Toes of multiple access paths, 2 benches at beach access point, boat ramp at risk of sedimentation, ramp to sand access path, sand car park at Harnett Street, sealed path and stairs to sand access path, Harvest Road sealed car park (seaward of DUP), short sealed path and stairs to sand access path, *3 cul de sacs (reliant on groynes), *DUP along foreshore (reliant on groynes). Services: Gas, water, power and NBN along Geographe Bay Road
Assets susceptible to erosion hazard in Projected timeframe (25+ years)	17 public assets susceptible to erosion hazard. Toes of multiple access paths, 2 benches at beach access point, boat ramp at risk of sedimentation, ramp to sand access path, sand car park at Harnett Street, sealed path and stairs to sand access path, Harvest Road sealed car park (seaward of DUP), short sealed path and stairs to sand access path, *3 cul de sacs (reliant on groynes), *DUP along foreshore (reliant on groynes). Services: Gas, water, power and NBN along Geographe Bay Road Private Property: 15 residential properties on Geographe Bay Road and Harnett Street, 5 resorts (4 on Bussell Highway, 1 on Little Collins St), and 1 aged care facility on Ray Avenue.

Management and adaptation options for Projected timeframe (25+ years).	Avoid (N), Retreat (Y - relocated DUP), Accommodate (N), Protect (Y - Seawalls and groynes)
Works to avoid to achieve long-term plans	Development within the foreshore reserve should only include temporary recreational facilities (as per SPP2.6).

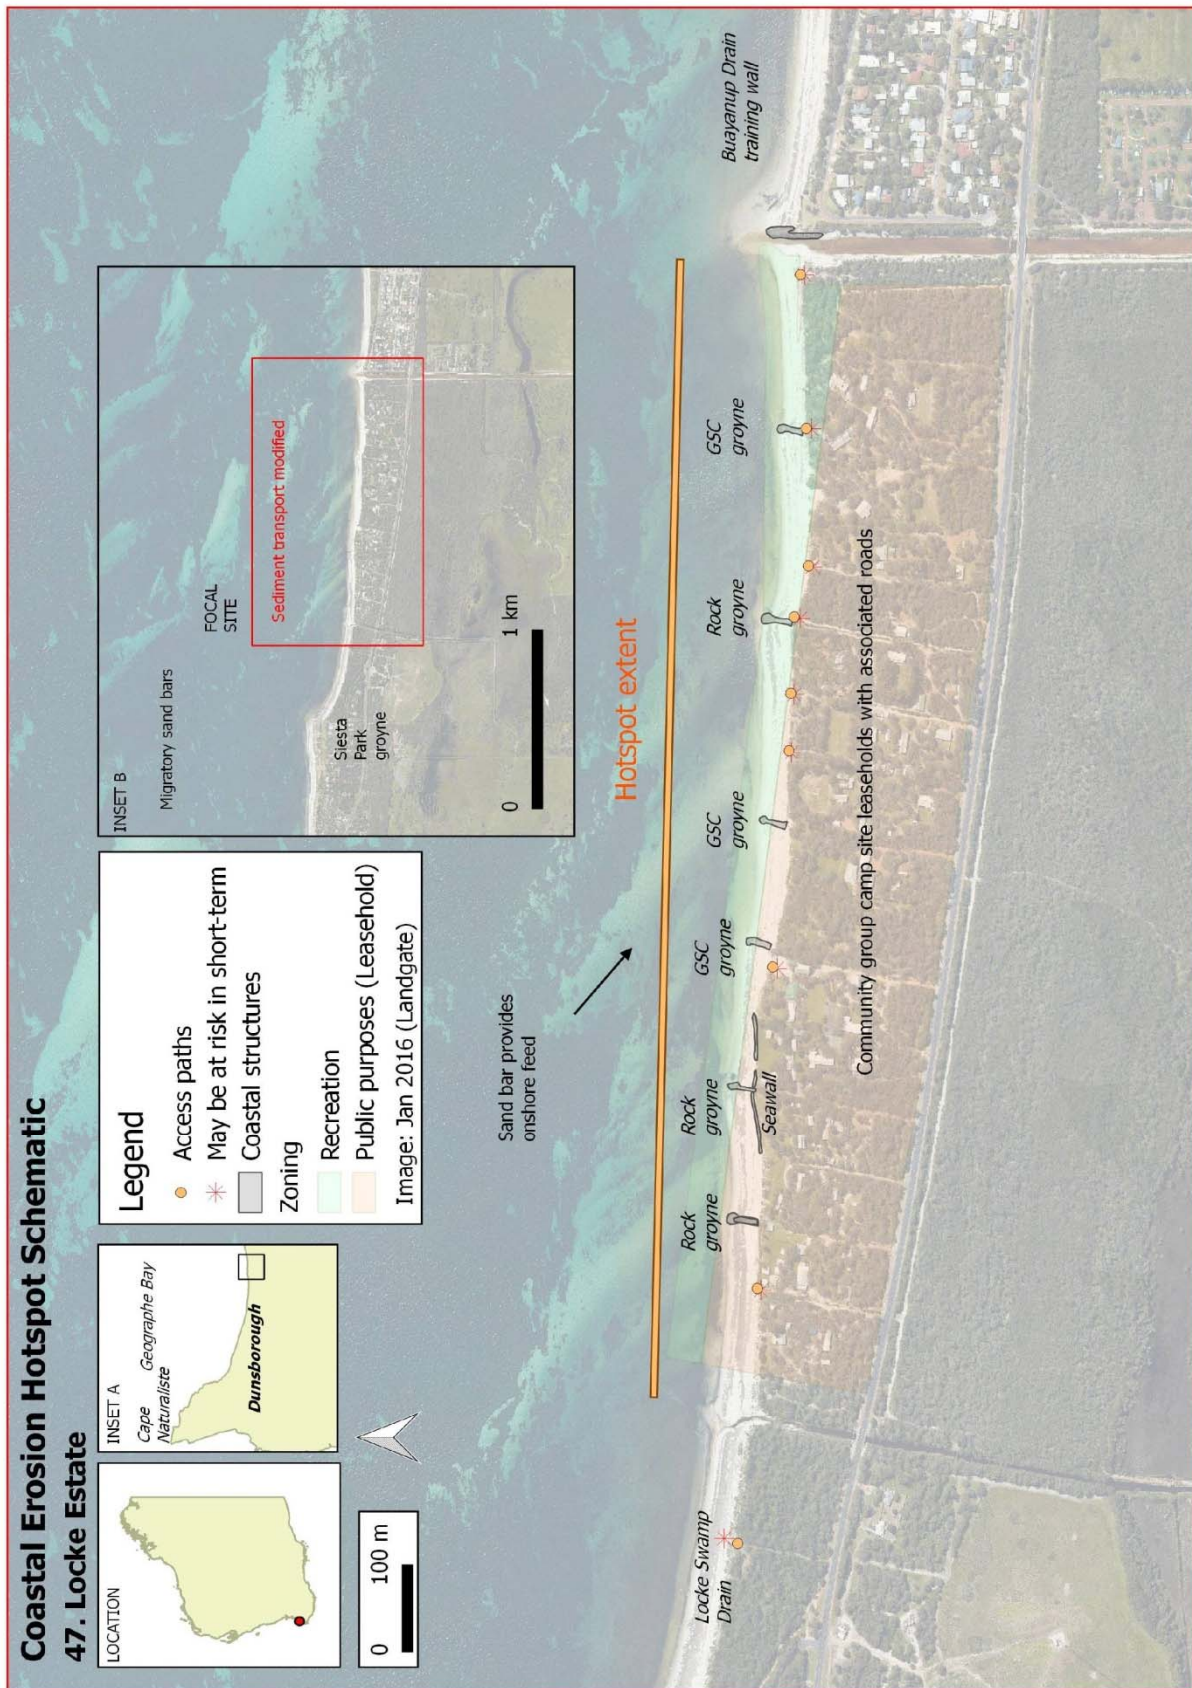
Figure D-47: Locke Estate schematic

Extent of erosion problem and hotspot characteristics	<p>From Locke Swamp Drain to Buayanup Drain</p> <p>Hotspot characteristics:</p> <ul style="list-style-type: none"> • Infrastructure close to the existing shore, or landward of progressively and rapidly eroding coast (proximity). • Typically subject to progressive or episodic erosion (instability). • Very highly valued by the community, as nominated by local government (community).
CHRMAP status and findings	<p>CHRMAP Status: Not Scheduled</p> <p>Hazard Assessment: Damara (2011) - Risk of erosion identified as dependent on integrity of existing groyne structures.</p> <p>Management & Adaptation Options: The City has recently undertaken the replacement of existing groynes and associated sand nourishment.</p> <p>Additional Comments: Nil</p> <p>Reports:</p> <p>Shore Coastal (2013) Busselton Coastal Management Program (2014-2018). Prepared for the City of Busselton by Shore Coastal. Report SCR1211, Apr-2013</p> <p>Damara (2011) Coastal Erosion Assessment of Climate Change Impacts. Prepared for the Shire of Busselton. Report 96-00-01, Aug-2011</p> <p>Damara (2012) Coastal Hazard Mapping for Economic Analysis of Climate Change Adaptation in the Peron-Naturaliste Region. Prepared by Damara WA Pty Ltd for Peron-Naturalist Partnership. Report 169-01, Rev. 0, Oct-2012</p>

Coastal dynamics studies for a level 3 assessment. Further detail in Table 4-2.	Ongoing coastal movement data collection
Assets susceptible to erosion hazard in Imminent timeframe (0–5 years)	1 public asset susceptible to erosion hazard. Access paths (8)
Assets susceptible to erosion hazard in Expected timeframe (5–25 years)	<p>12 public assets susceptible to erosion hazard. Access paths (8), 11 local roads within leasehold camps.</p> <p>Leasehold: 10 community group camp sites</p>
Assets susceptible to erosion hazard in Projected timeframe (25+ years)	<p>12 public assets susceptible to erosion hazard. Access paths (8), 11 local roads within leasehold camps.</p> <p>Leasehold: 10 community group camp sites</p>

Existing management	6 groynes recently rebuilt. The current management arrangement requires lessees to progressively remove threatened or dilapidated buildings within a coastal setback zone. Additionally, lessees are required, within a capped limit, to contribute annually towards the cost of coastal protection works. Avoid (N), Retreat (Y - Retreat and relocation of selected buildings and facilities has been undertaken), Accommodate (N), Protect (Y - Refurbishment and replacement of several of the previous stabilisation works has been undertaken)
Management options for Imminent timeframe (0–5 years)	Avoid (N), Retreat (N), Accommodate (N), Protect (Y - Continued refurbishment and replacement of previous active stabilisation works may be undertaken. Some sand renourishment is appropriate to support installation of new stabilisation structures) Preparation of planning frameworks for retreat in next level of management and identify funding mechanisms.

Works to avoid to achieve long-term plans	Extension of Siesta Park groyne.

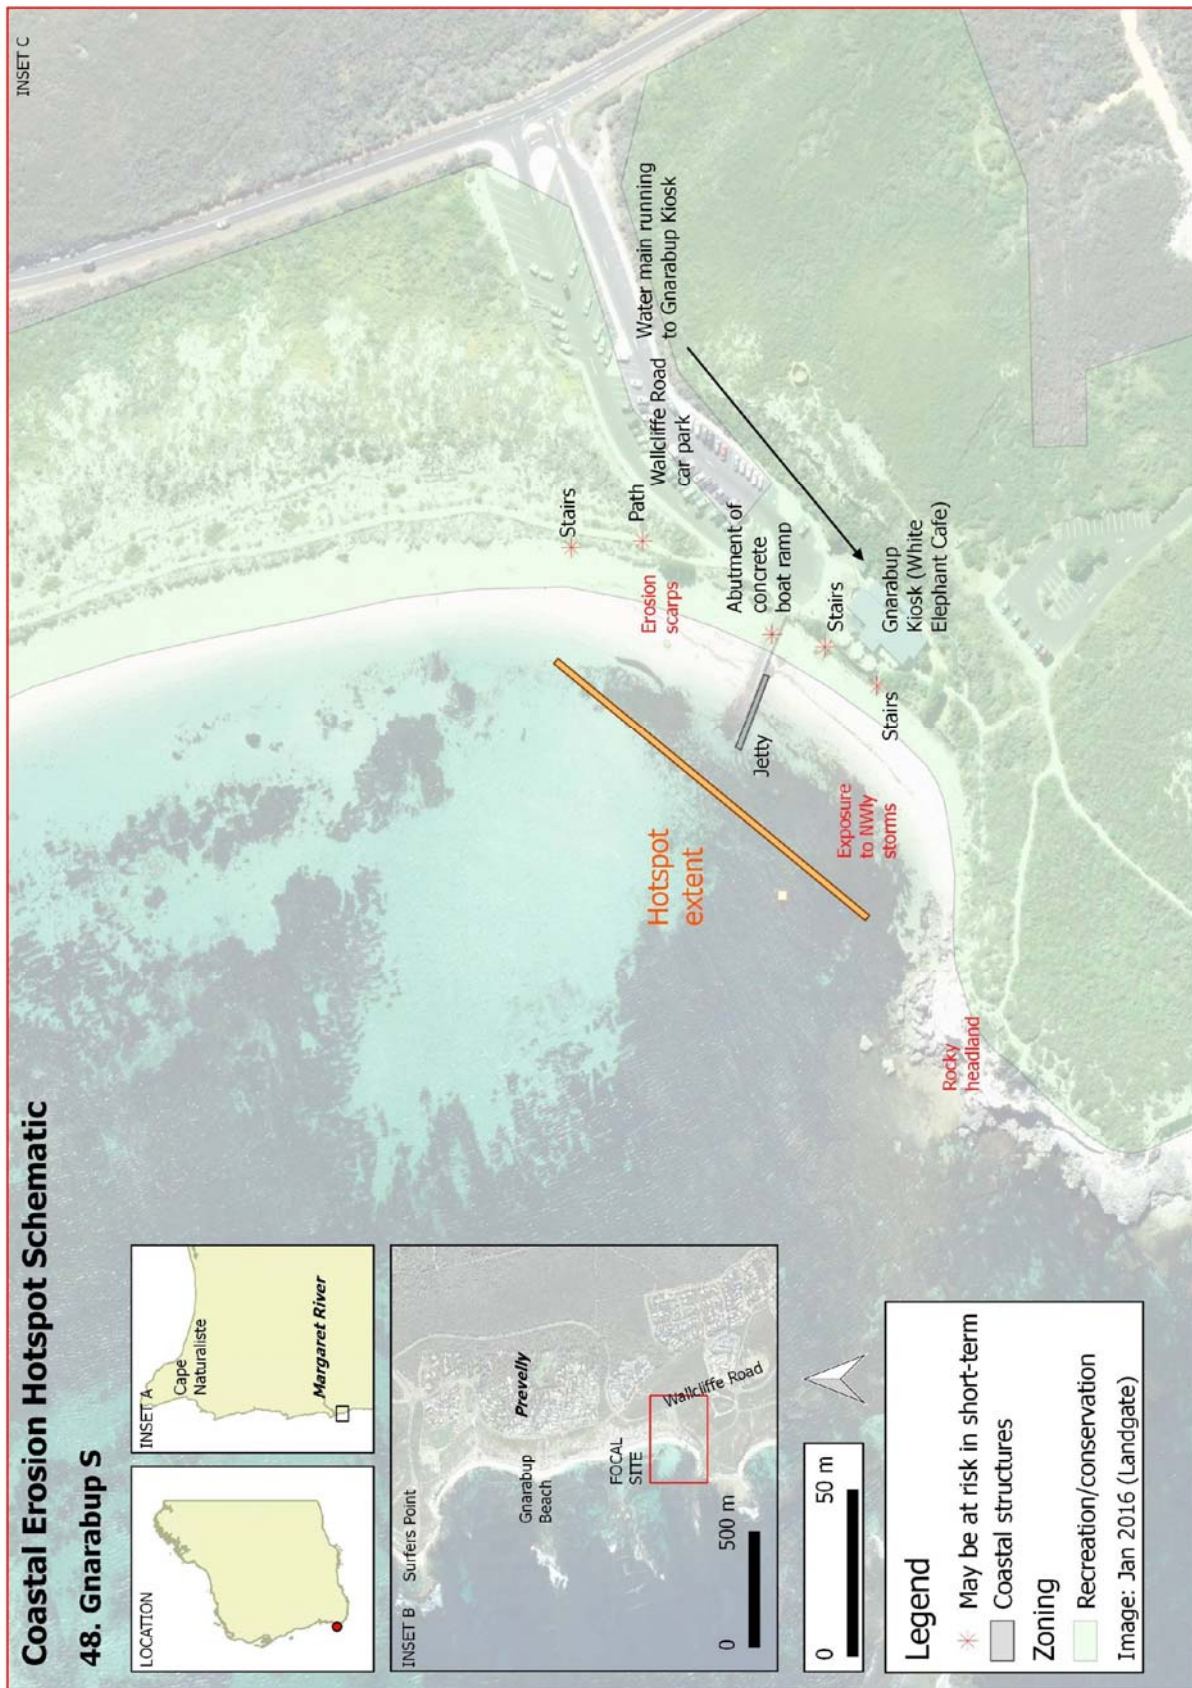
Figure D-48: Gnarabup S schematic

Extent of erosion problem and hotspot characteristics	<p>Southern Gnarabup from rocky headland to the third staircase to the north.</p> <p>Hotspot characteristics:</p> <ul style="list-style-type: none"> • Infrastructure close to the existing shore, or landward of progressively and rapidly eroding coast (proximity). • Typically subject to progressive or episodic erosion (instability). • Very highly valued by the community, as nominated by local government (community).
CHRM status and findings	<p>CHRM status: Completed 2015</p> <p>Hazard Assessment: Shore Coastal (2015) - Immediate risk of erosion identified (existing buffer <S1)</p> <p>Management & Adaptation Options: Shore Coastal (2015) - Study area Shire coastline, with focus on Townsites. Recommended immediate adaptation strategy (Gnarabup Beach) managed retreat, progressive removal of beach access stairs, car park etc. as coast erodes.</p> <p>Additional Comments: Cafe deck was recently reconstructed as a piled structure founded on rock to accommodate a degree of erosion.</p> <p>Reports:</p> <p>Shore Coastal (2015) Coastal Hazard Risk Management and Adaptation Plan. Prepared for Shire of Augusta Margaret. Report SCR1507, Nov-2015</p> <p>CMPAP funded</p>

Coastal dynamics studies for a level 3 assessment. Further detail in Table 4-2.	Geotechnical and ongoing coastal movement data collection
Assets susceptible to erosion hazard in Imminent timeframe (0–5 years)	5 public assets susceptible to erosion hazard. 3 stairs/ramp access locations, abutment of concrete boat ramp, 150m of footpath.
Assets susceptible to erosion hazard in Expected timeframe (5–25 years)	<p>8 public assets susceptible to erosion hazard. 3 stairs/ramp accesses, abutment of concrete boat ramp, boat launching car park, 150m of footpath.</p> <p>Leasehold: The White Elephant Café.</p>
Assets susceptible to erosion hazard in Projected timeframe (25+ years)	<p>9 public assets susceptible to erosion hazard. 10m of footpath, 3 stairs/ramp access, abutment of concrete boat ramp, boat launching car park, 150m of footpath.</p> <p>Services: Critical water main running to Private Gnarabup Kiosk PS.</p> <p>Leasehold: The White Elephant Café.</p>

Existing management	Avoid (N), Retreat (N), Accommodate (Y - some dune stabilisation and planting. Decking at White Elephant is stumped without replacement walling), Protect (Y - concrete wall at boat ramp)
Management options for Imminent timeframe (0–5 years)	Avoid (N), Retreat (Y - Manage beach access (relocate north), realign coastal path), Accommodate (N), Protect (N) Review lease agreements with White Elephant Cafe to clarify responsibilities for coastal erosion mitigation
Approximation of cost for Imminent timeframe (0–5 years) options (L/M/H)	Retreat - L Review Lease Agreement - 50k
Trigger for next level management, monitoring and alternate management option (Imminent timeframe 0–5 years)	Trigger for next level management: Boat ramp damage / loss of functionality. Monitoring: Photographic monitoring Alternate option: N/A
Management and adaptation options for Expected timeframe (5–25 years)	Avoid (N), Retreat (N), Accommodate (Y - continue to adapt boat ramp), Protect (N) Preparation of planning frameworks for retreat in next level of management and identify funding mechanisms.

Approximation of cost for Expected timeframe (5–25 years) options (L/M/H)	Accommodate - M Prepare plans - 50k
Trigger for next level management, monitoring and alternate management option (Expected timeframe 5–25 years)	Trigger for next level management: Beach depth within 0.5m of café foundation capacity for more than one month. Monitoring: Photographic monitoring Alternate option: Retreat - remove boat ramp. Construct new access point.
Management and adaptation options for Projected timeframe (25+ years).	Avoid (N), Retreat (Y - relocate café and reduce carpark (managed retreat)), Accommodate (N), Protect (N)
Works to avoid to achieve long-term plans	Additional leasehold development without clauses within lease that lessees are responsible for erosion mitigation or replacement construction. Avoid further development of facilities/amenities on foreshore reserve without concurrent creation of clear erosion mitigation agreements.
