Appendix D.35. Waikiki Beach, Rockingham

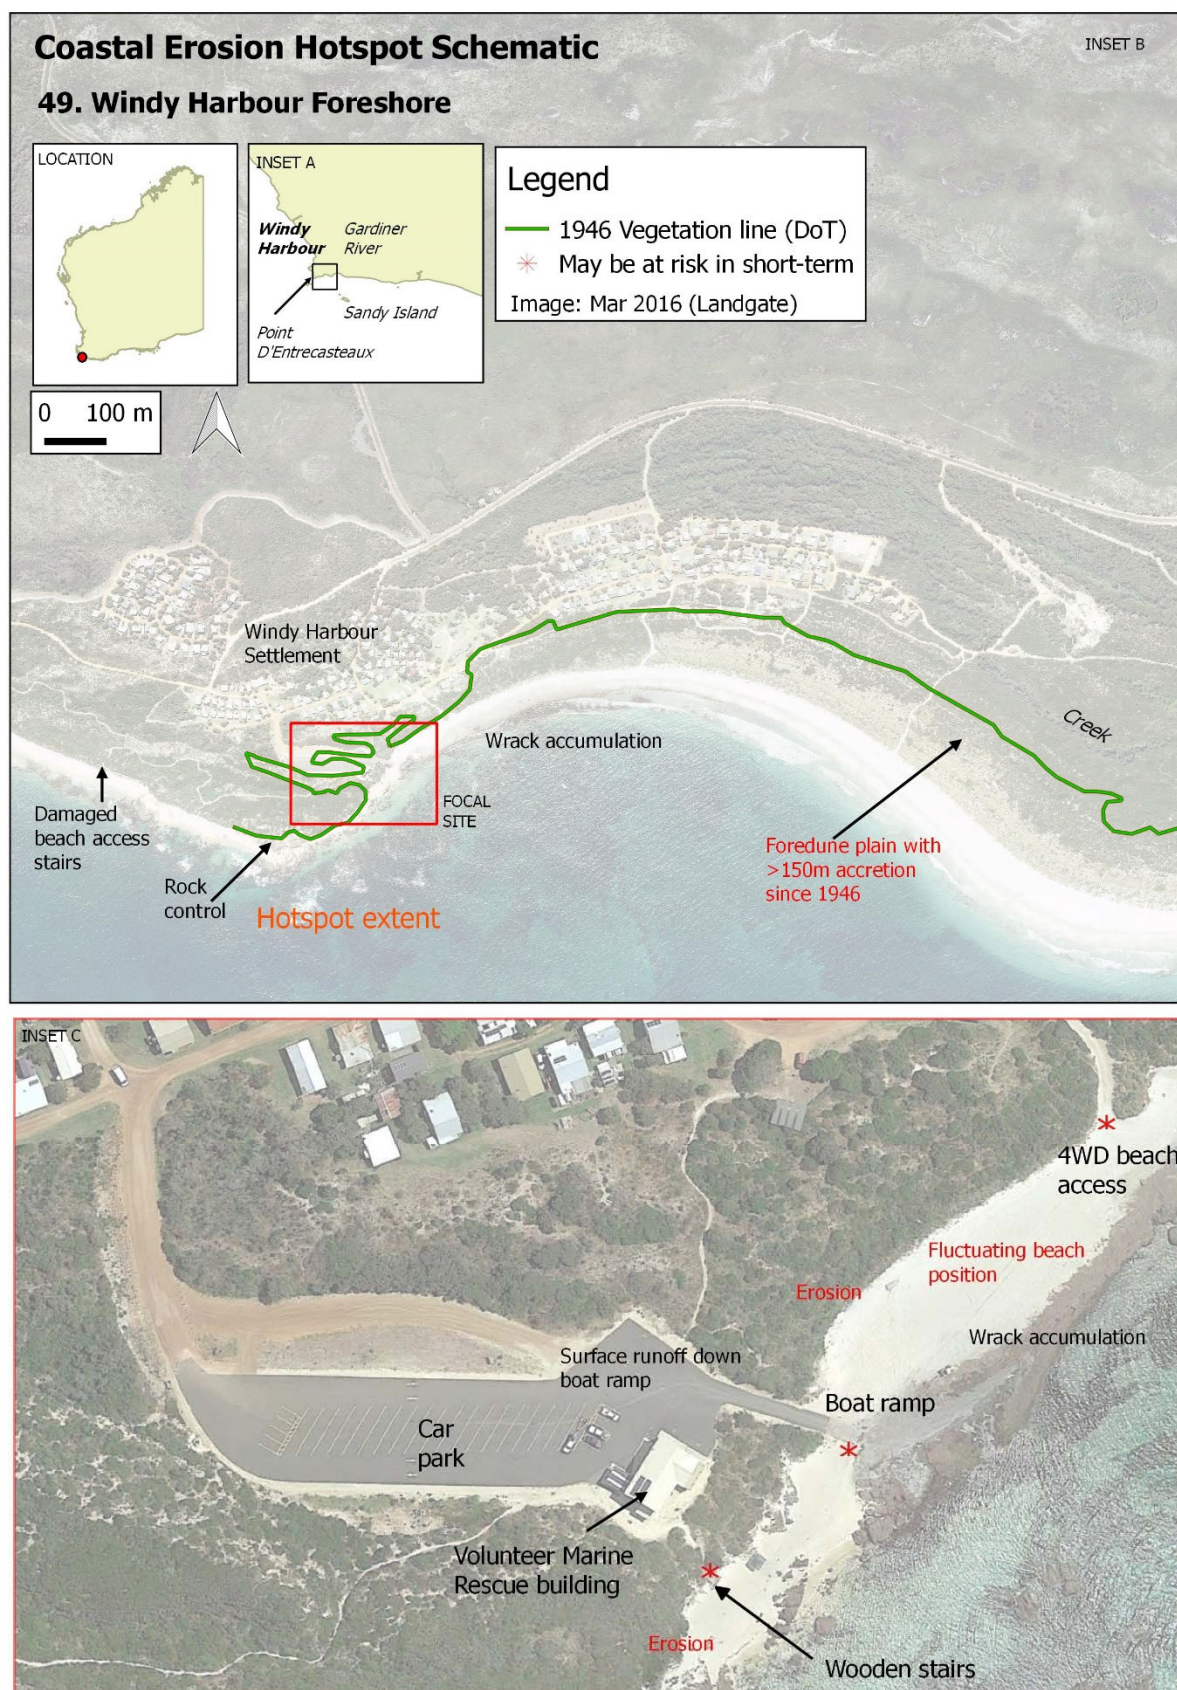
Figure D-49: Windy Harbour Foreshore schematic

Hotspot No.	49
Hotspot Name	Windy Harbour Foreshore
Local Coastal Manager	Shire of Manjimup
Hotspot issue	<p>Windy Harbour is a holiday site, popular for fishing, which is a leasehold residential area. Facilities near the boat ramp have recently been upgraded with construction of a bitumen car park, the Volunteer Marine Rescue building (leasehold) and a timber staircase to provide beach access. Issues at the site include seasonal beach erosion and seagrass wrack accumulation, which limit beach access and boat ramp use, as well as the erosion damage to the beach access stairs west of the rocky headland. Erosion and wrack accumulation occur seasonally adjacent to the rock headland, with additional year-to-year variation. Anything built in the active zone will require regular maintenance.</p> <p>Five assets may be at risk of erosion damage in the area (see attached figure), with three having short-term risk including the wooden staircase, the boat ramp and the 4WD access track to the north. Social pressure at this site relates to constraints to boat launching, driving along the beach and beach access.</p>

Extent of erosion problem and hotspot characteristics	<p>Area surrounding the headland to N of the boat ramp</p> <p>Hotspot characteristics:</p> <ul style="list-style-type: none"> • Typically subject to progressive or episodic erosion (instability). • Apparently limited capacity to manage future erosion using existing coastal protection measures where extension of works is likely to exacerbate erosion transfer (transfer). • Very highly valued by the community, as nominated by local government (community).
CHRMAP status and findings	<p>CHRMAP Status: Not Scheduled</p> <p>Hazard Assessment: Nil</p> <p>Management & Adaptation Options: Nil</p> <p>Additional Comments: Nil</p> <p>Reports:</p> <p>Thompson McRobert Edgeloe (2007) Windy Harbour Management Plan 2007 - 2017. Prepared by Thompson McRobert Edgeloe for Shire of Manjimup. Nov-2007</p>
Coastal dynamics studies for a level 3 assessment. Further detail in Table 4-2.	Ongoing coastal movement data collection

Assets susceptible to erosion hazard in Imminent timeframe (0–5 years)	<p>3 public assets susceptible to erosion hazard. Wooden stairs, boat ramp, 4wd access track</p> <p>Leasehold: Whole hotspot is leasehold.</p>
Assets susceptible to erosion hazard in Expected timeframe (5–25 years)	<p>3-5 public assets susceptible to erosion hazard. Wooden stairs, boat ramp, volunteer marine rescue building, car park, 4wd access track.</p> <p>Leasehold: Whole hotspot is leasehold.</p>
Assets susceptible to erosion hazard in Projected timeframe (25+ years)	<p>5 public assets susceptible to erosion hazard. Wooden stairs, boat ramp, volunteer marine rescue building, car park, 4wd access track.</p> <p>Leasehold: Whole hotspot is leasehold.</p>
Existing management	<p>Avoid (Y - High-value fixed infrastructure has a moderate setback buffer),</p> <p>Retreat (N),</p> <p>Accommodate (N),</p> <p>Protect (N)</p>
Management options for Imminent timeframe (0–5 years)	<p>Avoid (Y - Maintain (or increase) existing setback buffer),</p> <p>Retreat (N),</p> <p>Accommodate (Y - Increase tolerance of structures to shoreline variation (reinforce sides of ramp, deep foundation for stair supports)),</p> <p>Protect (N)</p> <p>Preparation of planning frameworks for retreat in next level of management and identify funding mechanisms.</p>

Trigger for next level management, monitoring and alternate management option (Imminent timeframe 0–5 years)	Trigger for next level management: Erosion threatens structural stability Monitoring: Structural assessment (annual) Alternate option: N/A
Management and adaptation options for Expected timeframe (5–25 years)	Avoid (N), Retreat (Y - Relocate stairs to landward if severe erosion occurs), Accommodate (Y - Repeat (anticipated to be required more than once in ~25 year timeframe) increase tolerance of structures to shoreline variation (reinforce sides of ramp, deep foundation for stair supports)), Protect (N) Preparation of planning frameworks for retreat in next level of management and identify funding mechanisms.
Approximation of cost for Expected timeframe (5–25 years) options (L/M/H)	Retreat - L Accommodate - L Prepare plans - 50k
Trigger for next level management, monitoring and alternate management option (Expected timeframe 5–25 years)	Trigger for next level management: Ramp retaining more than 1.5m height; building at less than 1:2 (V:H) from top of beach level Monitoring: Scarp/face height; Buffer width Alternate option: N/A

Management and adaptation options for Projected timeframe (25+ years).	Anticipated behaviour: Additional response to sea level rise with further rotation. Avoid (N), Retreat (Y - Rebuild beach access and ramp to landward. Under general coastal retreat, the Sea Rescue building may require relocation, depending on influence of rock), Accommodate (Y - Construction of a deep retaining foundation for the Sea Rescue building may enhance stability), Protect (N)
Works to avoid to achieve long-term plans	High expense infrastructure with low tolerance to coastal movements.

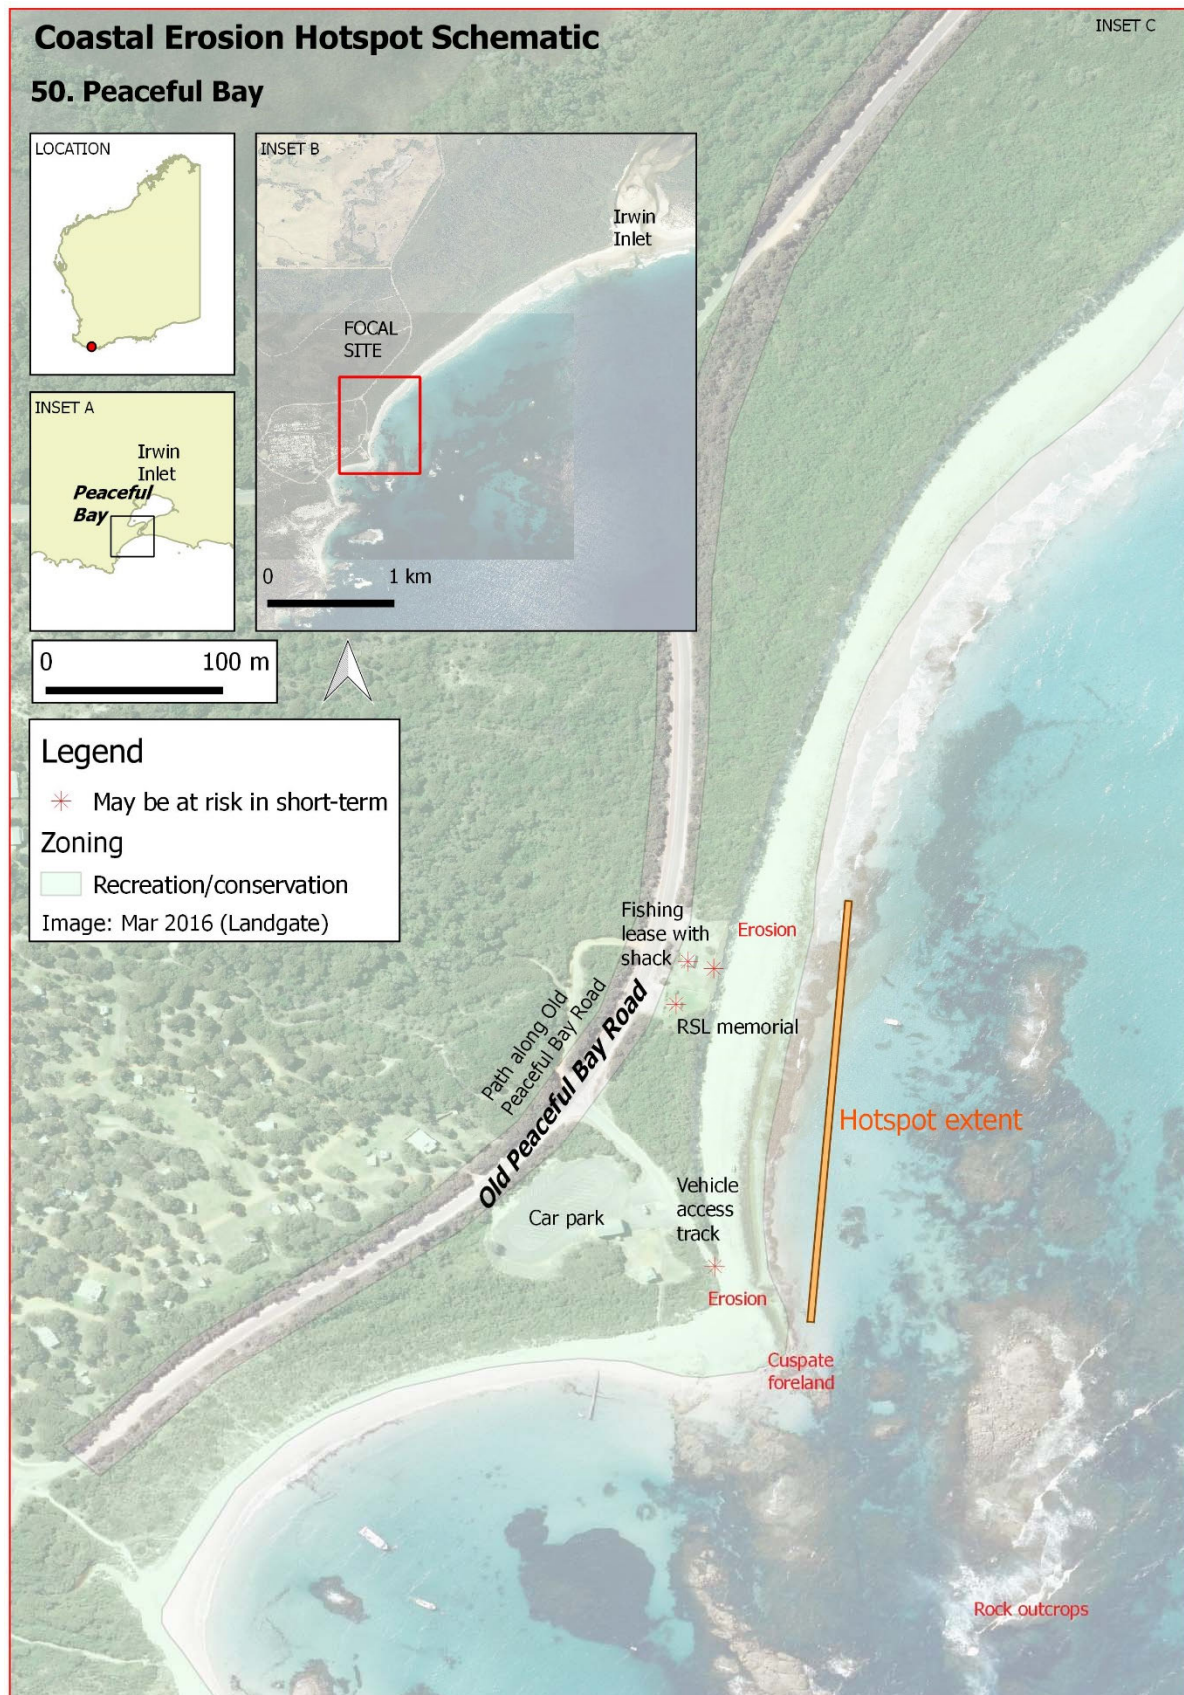
Figure D-50: Peaceful Bay schematic

Assets susceptible to erosion hazard in Imminent timeframe (0–5 years)	<p>4 public assets susceptible to erosion hazard. Vehicle access track, fishing lease area, fishing lease shack, and RSL memorial.</p> <p>Leasehold: fishing lease</p>
Assets susceptible to erosion hazard in Expected timeframe (5–25 years)	<p>4 public assets susceptible to erosion hazard. Vehicle access track, fishing lease area, fishing lease shack, and RSL memorial.</p> <p>Leasehold: fishing lease</p>
Assets susceptible to erosion hazard in Projected timeframe (25+ years)	<p>5 public assets susceptible to erosion hazard. Vehicle access track, 200m of Old Peaceful Bay Road, RSL memorial, fishing lease area, and fishing lease shack.</p> <p>Leasehold: fishing lease</p>
Existing management	<p>Avoid (Y - most of the town and road has sufficient buffer to development), Retreat (N), Accommodate (N), Protect (N)</p>

Approximation of cost for Expected timeframe (5–25 years) options (L/M/H)	Retreat - M Prepare plans - 50k
Trigger for next level management, monitoring and alternate management option (Expected timeframe 5–25 years)	Trigger for next level management: Buffer width <15m to road. Monitoring: Buffer width measurement Alternate option: N/A
Management and adaptation options for Projected timeframe (25+ years).	Avoid (N), Retreat (Y - relocate road (managed retreat)), Accommodate (N), Protect (N)
Works to avoid to achieve long-term plans	Permanent fixed boat ramp in the existing location. Protection of the road should be avoided given the large cost of this option in relation to the relocation that is suggested in the 25+ year timeframe.

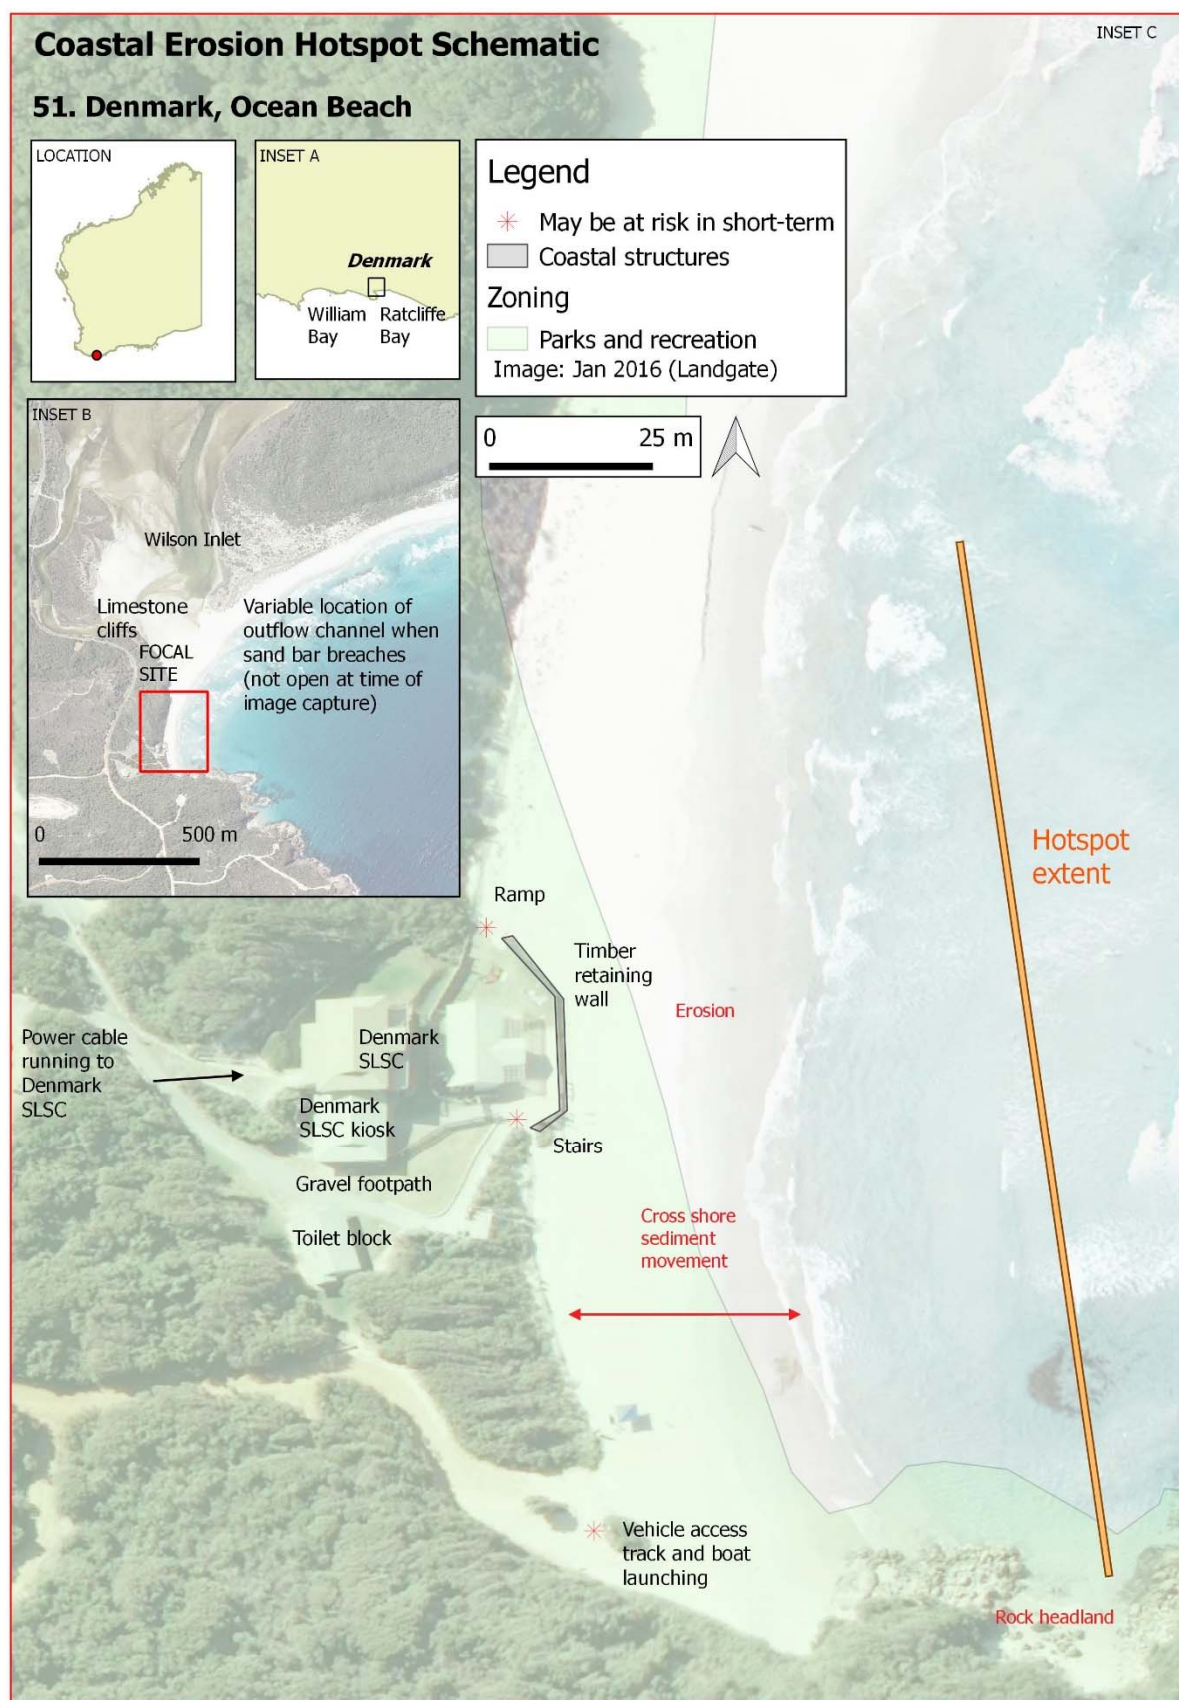
Figure D-51: Denmark, Ocean Beach schematic

Assets susceptible to erosion hazard in Imminent timeframe (0–5 years)	3 public assets susceptible to erosion hazard. Vehicle access to beach, access ramp, stairs
Assets susceptible to erosion hazard in Expected timeframe (5–25 years)	<p>6 public assets susceptible to erosion hazard. Vehicle access to beach, access ramp, stairs, Denmark SLSC building, Denmark SLSC kiosk.</p> <p>Services: LV buried cable to Denmark SLSC.</p> <p>Leasehold: Denmark SLSC, Denmark SLSC kiosk.</p>
Assets susceptible to erosion hazard in Projected timeframe (25+ years)	<p>7 public assets susceptible to erosion hazard. Vehicle access to beach, access ramp, stairs, toilet block, Denmark SLSC building, Denmark SLSC kiosk.</p> <p>Services: LV buried cable to Denmark SLSC.</p> <p>Leasehold: Denmark SLSC, Denmark SLSC kiosk.</p>

Works to avoid to achieve long-term plans	Additional buildings or fixed infrastructure immediately landward of the wall Additional investment in SLSC building
