APPENDIX A

SHED PLANS

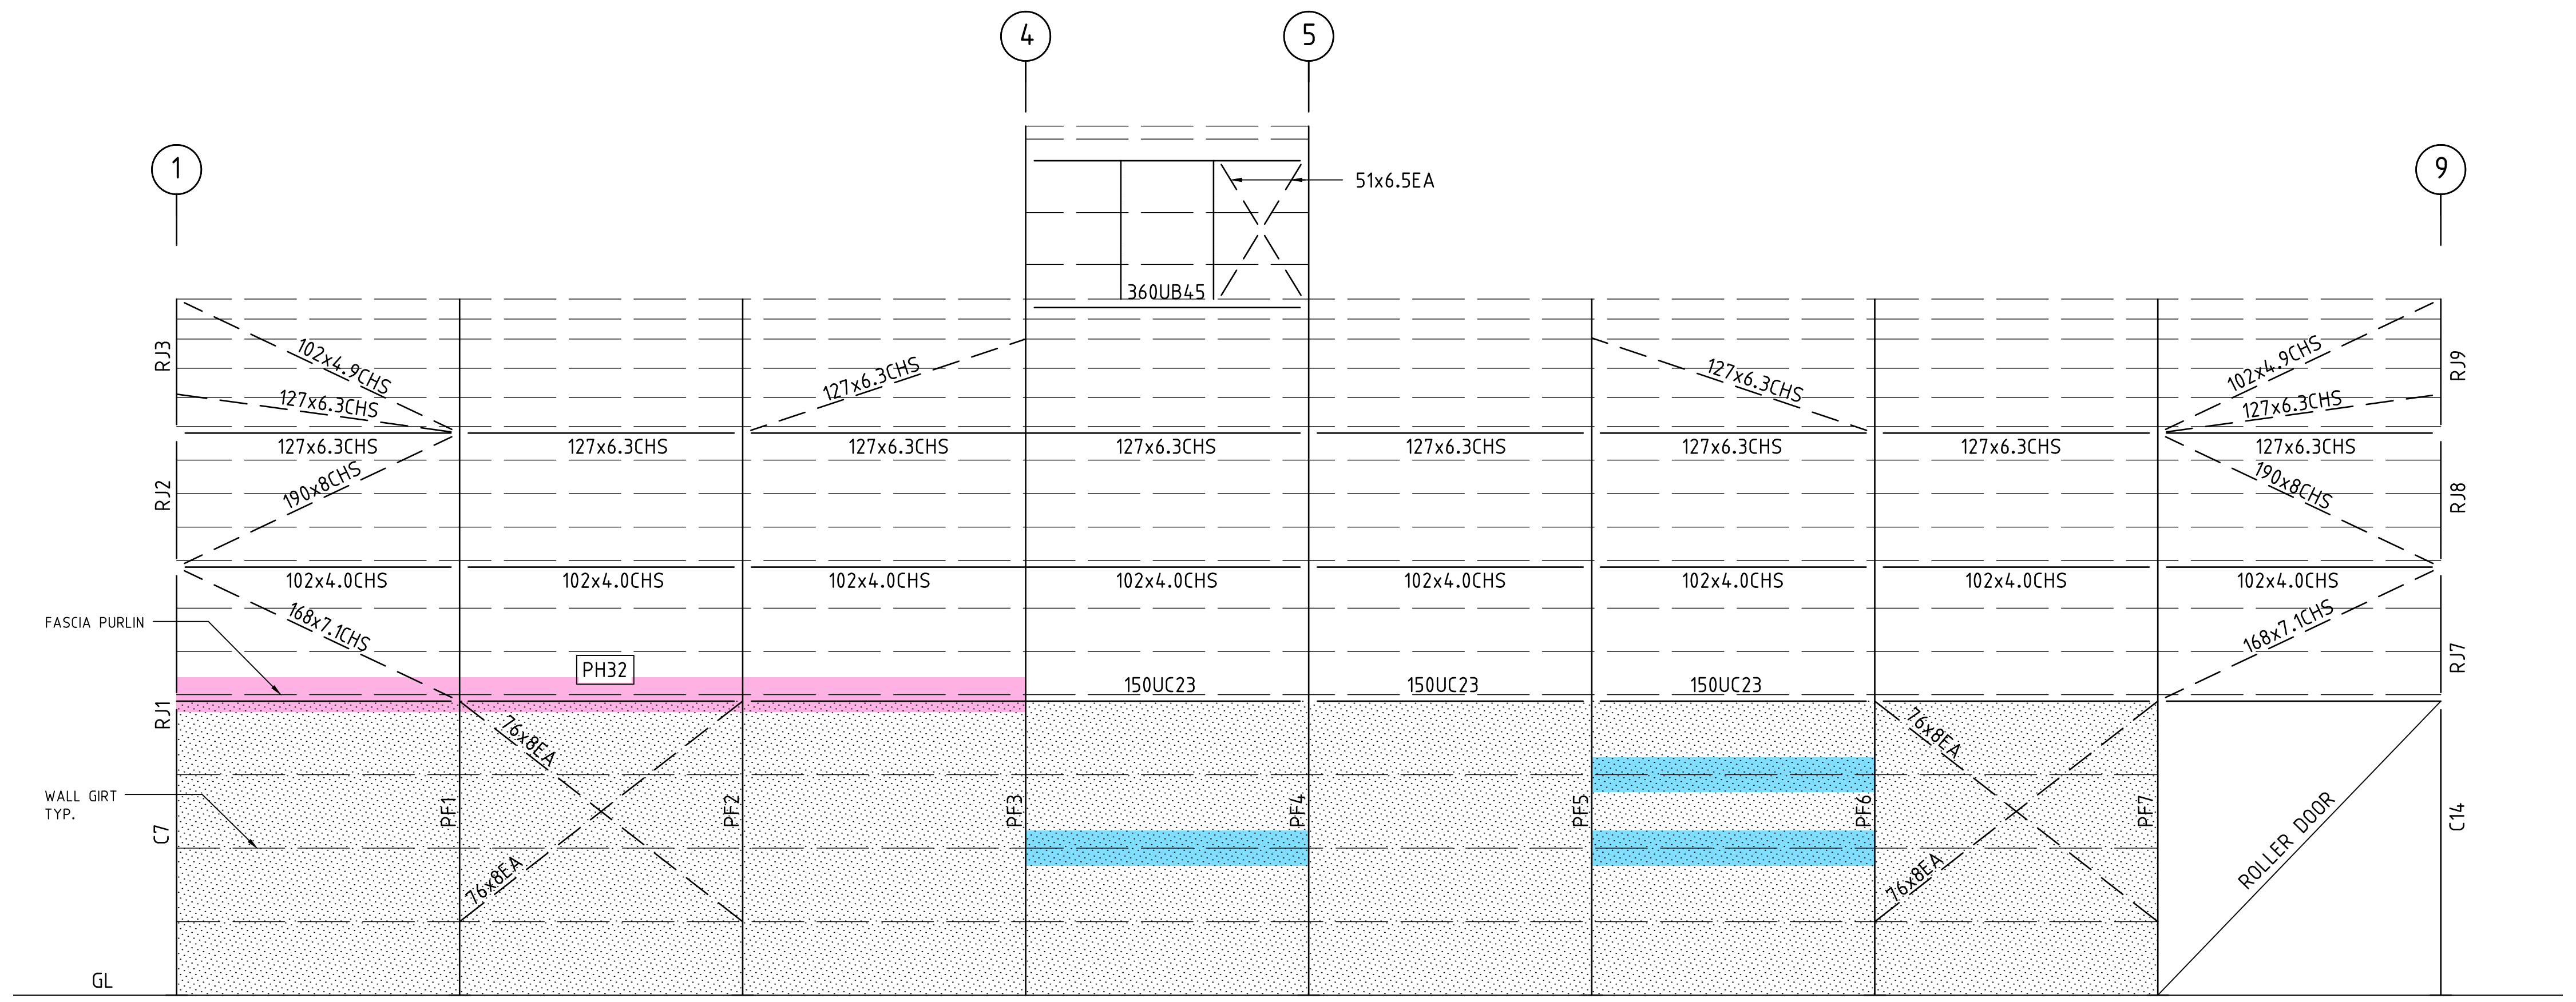
SHED No.6 - EAST ELEVATION
1:100

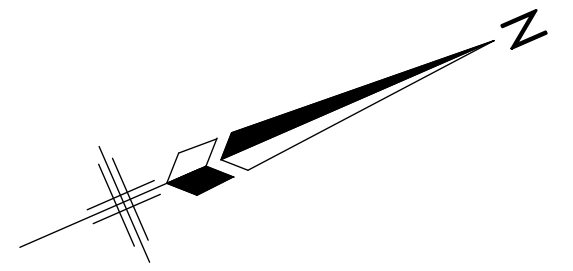
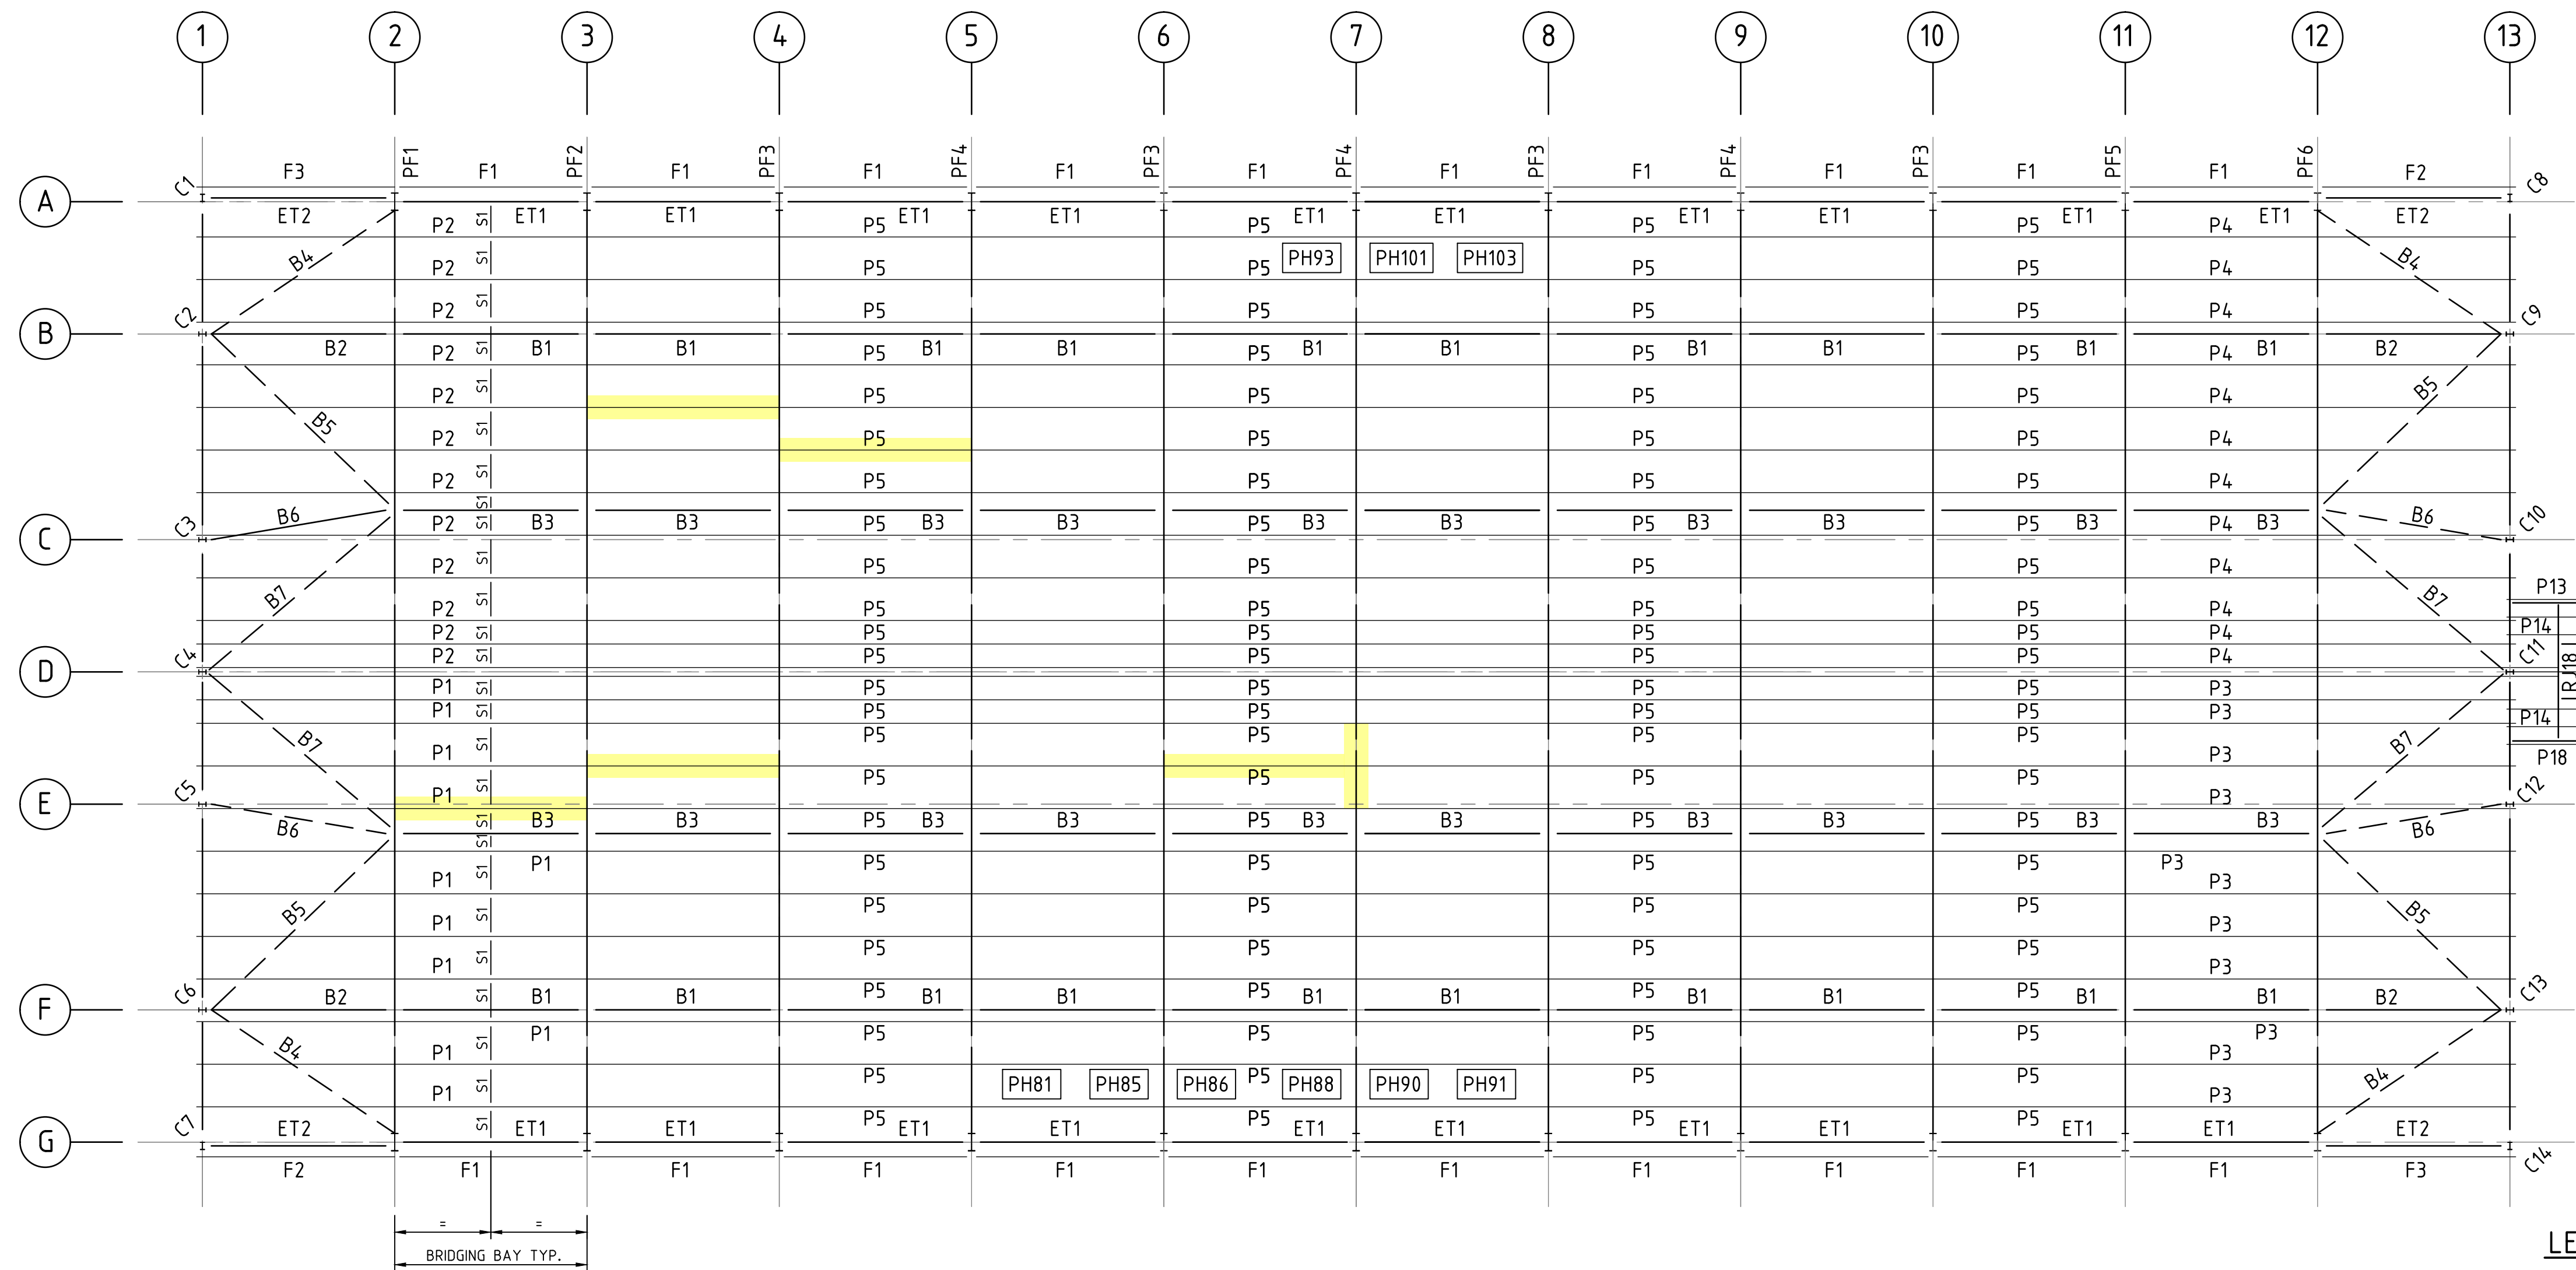
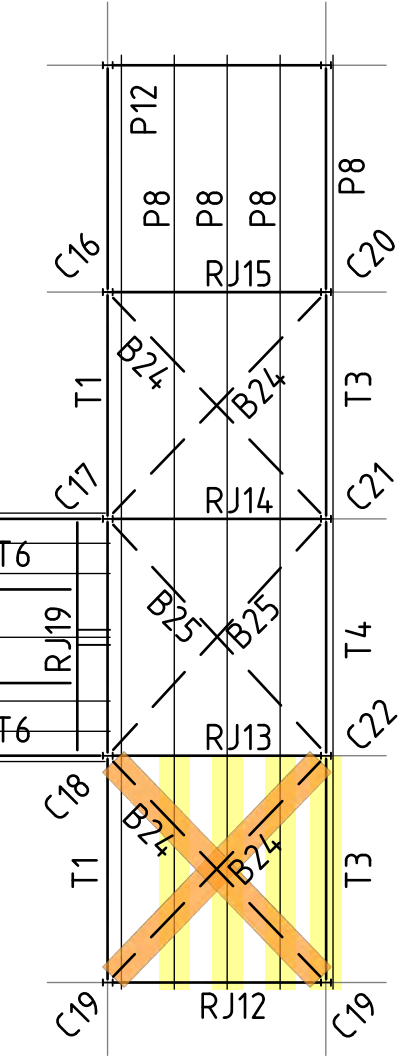
SHED No.7 - ROOF PLAN
 1:150
 NOTE:
 [PH37] - DENOTES PHOTOGRAPH NUMBER

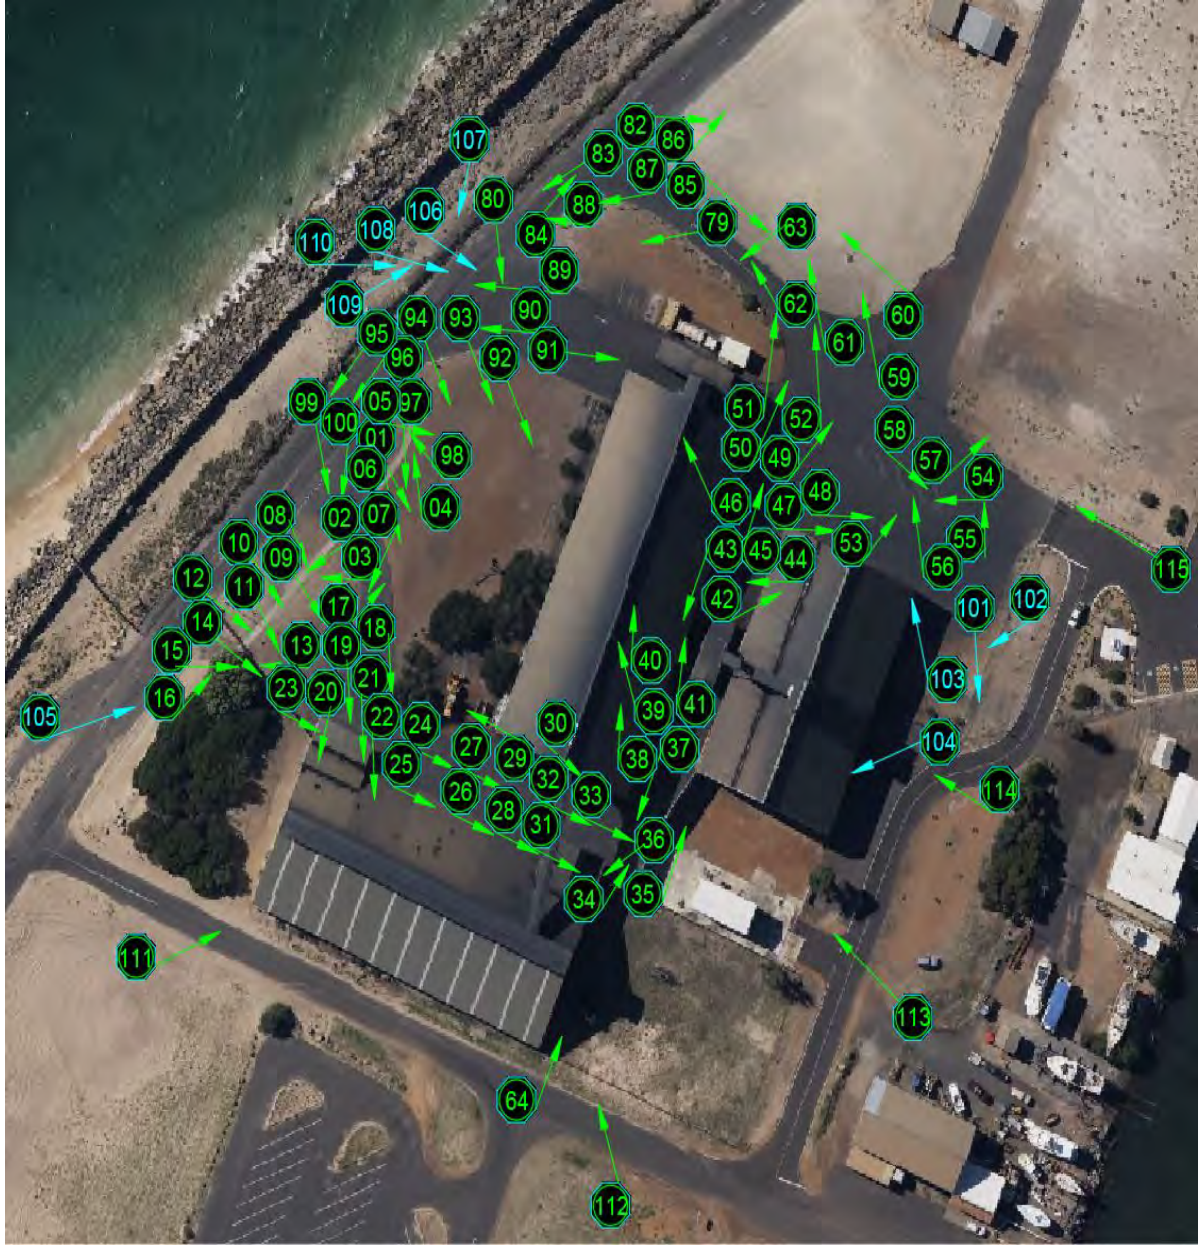
Figure 2: Photo Locations

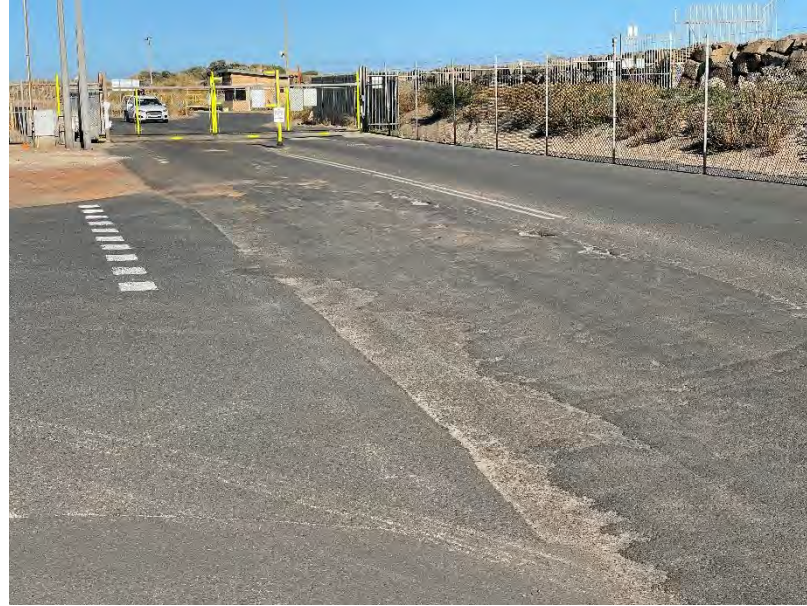
Photo 02: Outside of scope of works – full of cracks and pot-holes through the road

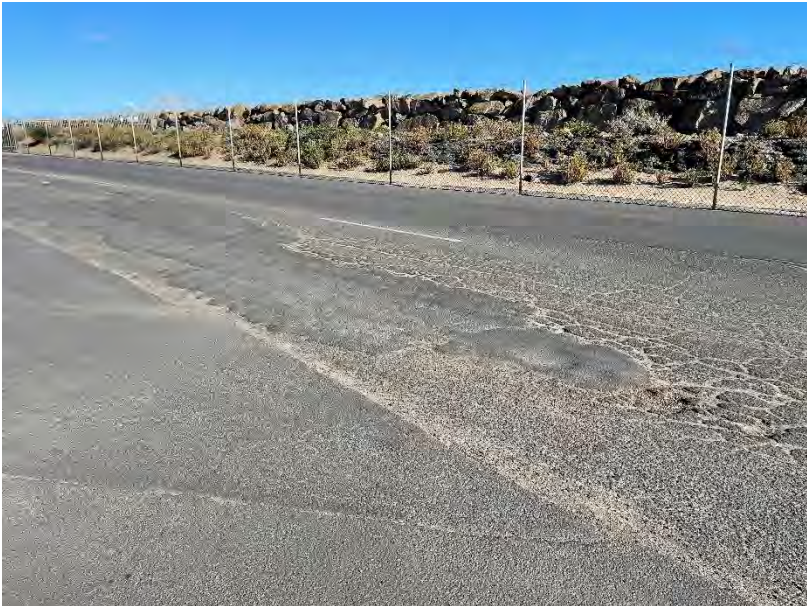
Photo 03: Outside of scope of works – full of cracks and pot-holes through the road

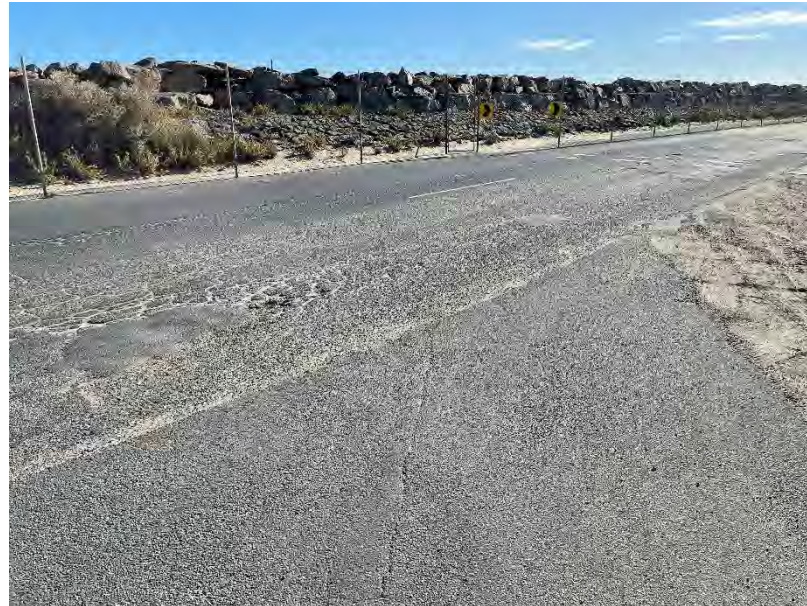
Photo 04: Outside of scope of works – full of cracks and pot-holes through the road

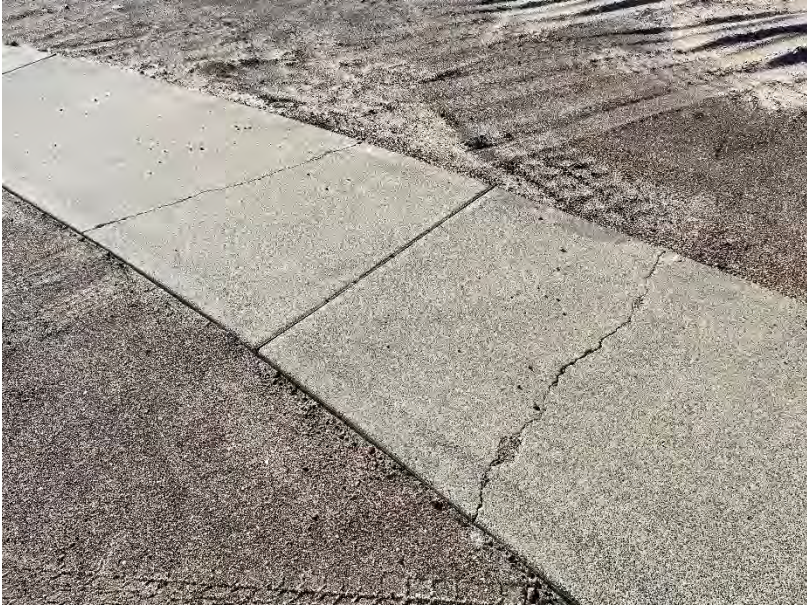
Photo 05: Cracks through the concrete path

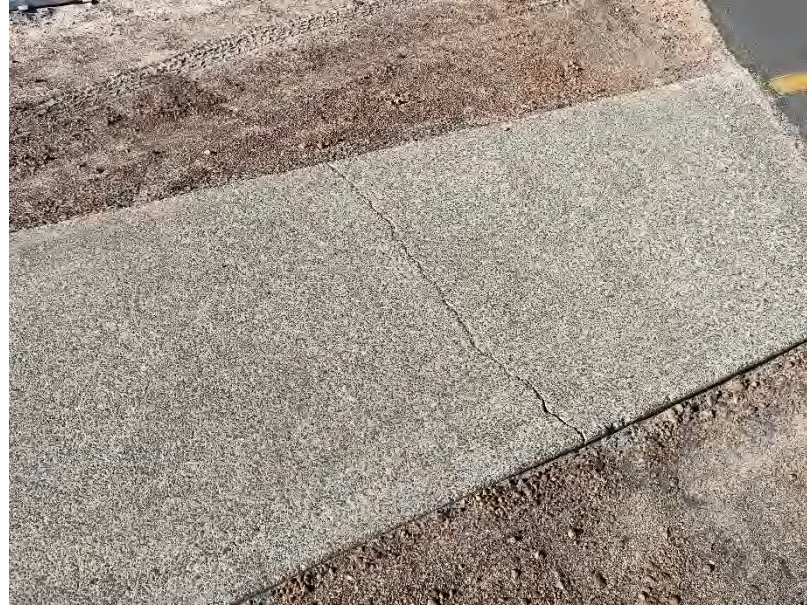
Photo 06: Cracks through the concrete path

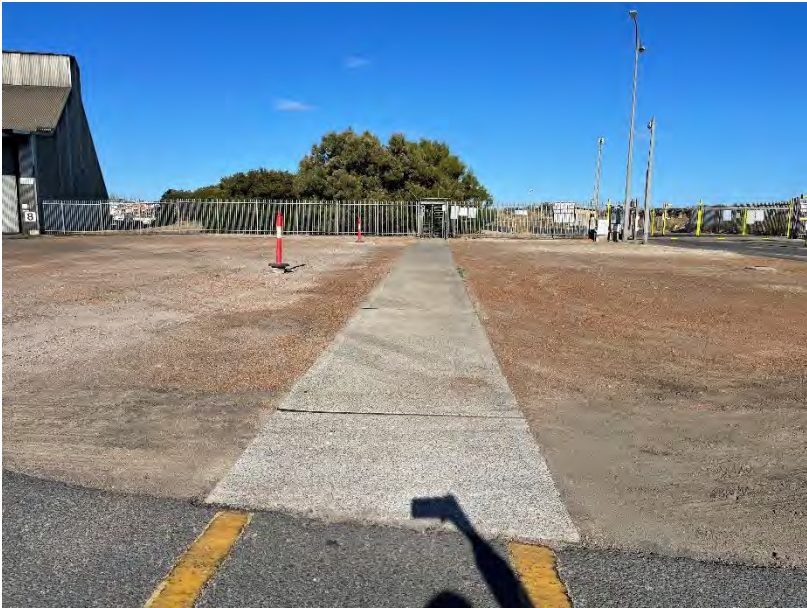
Photo 07: Cracks through the concrete path

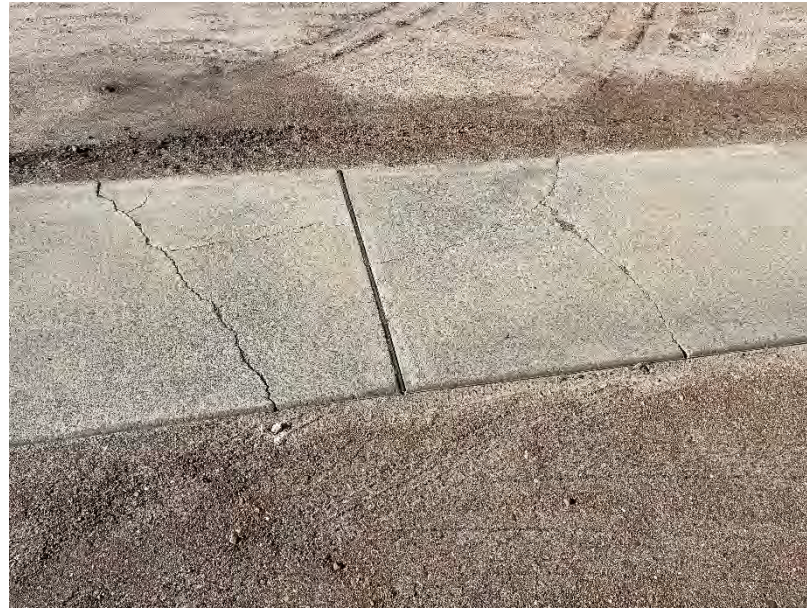
Photo 08: Cracks through the concrete path

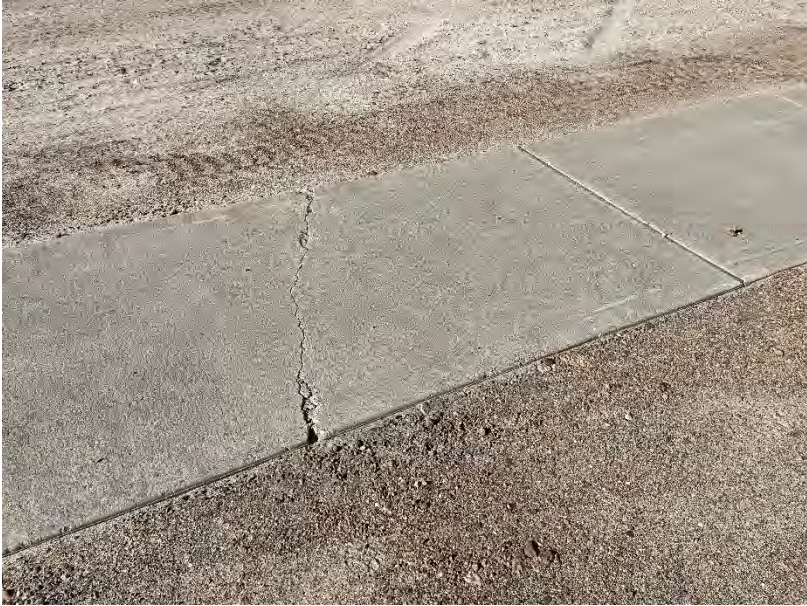
Photo 09: Cracks through the concrete path

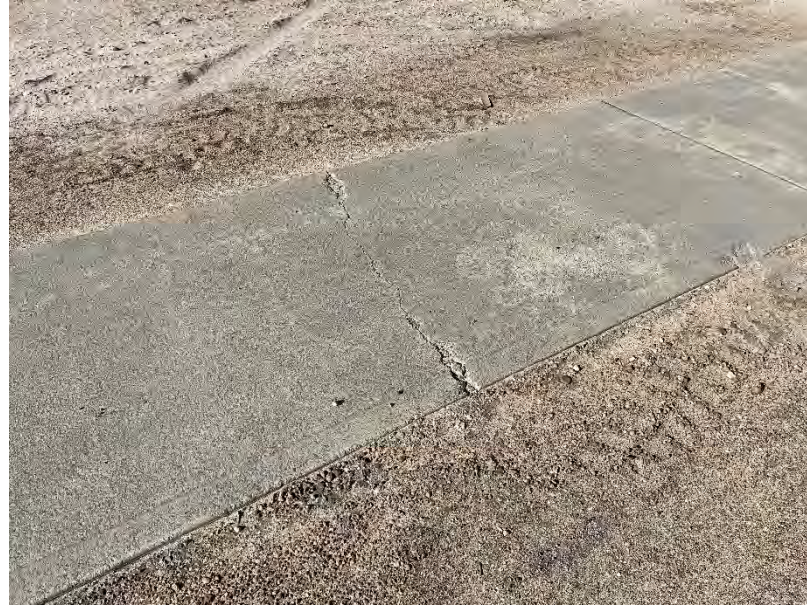
Photo 10: Cracks through the concrete path

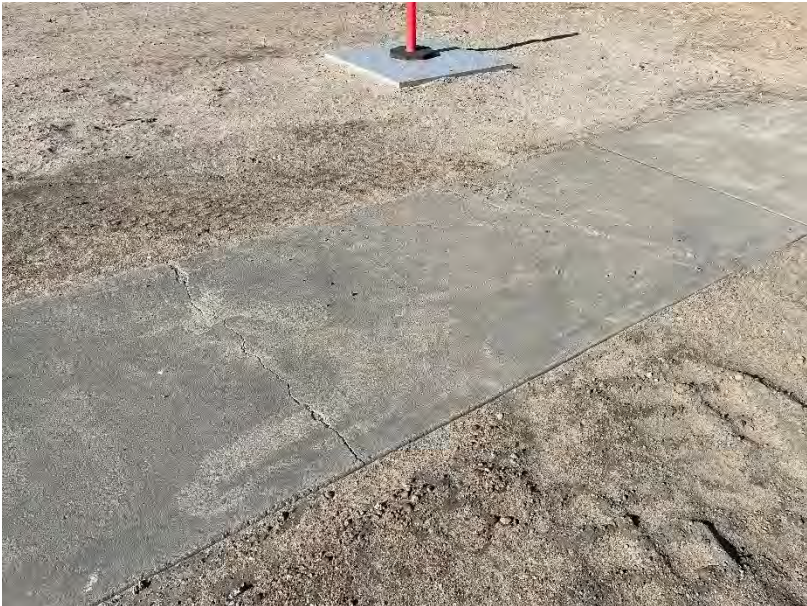
Photo 11: Cracks through the concrete path

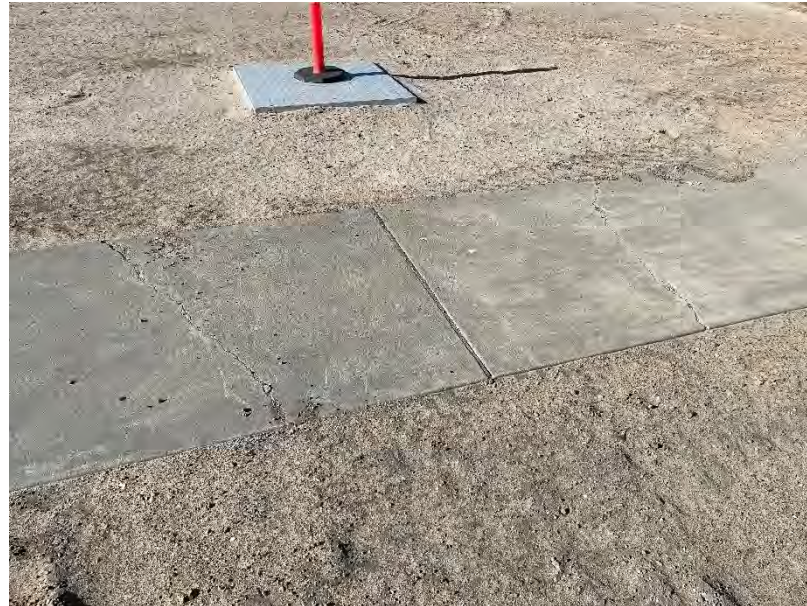
Photo 12: Cracks through the concrete path

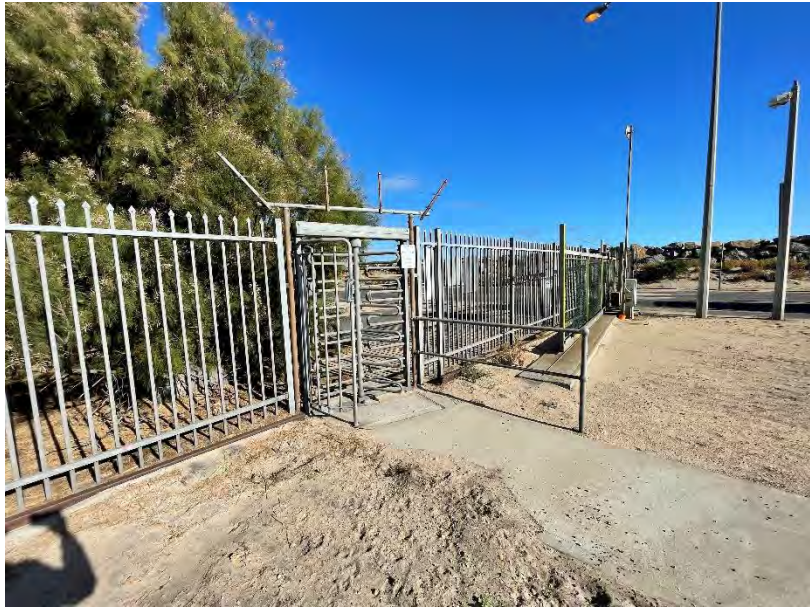
Photo 13: Pedestrian access gate to the site

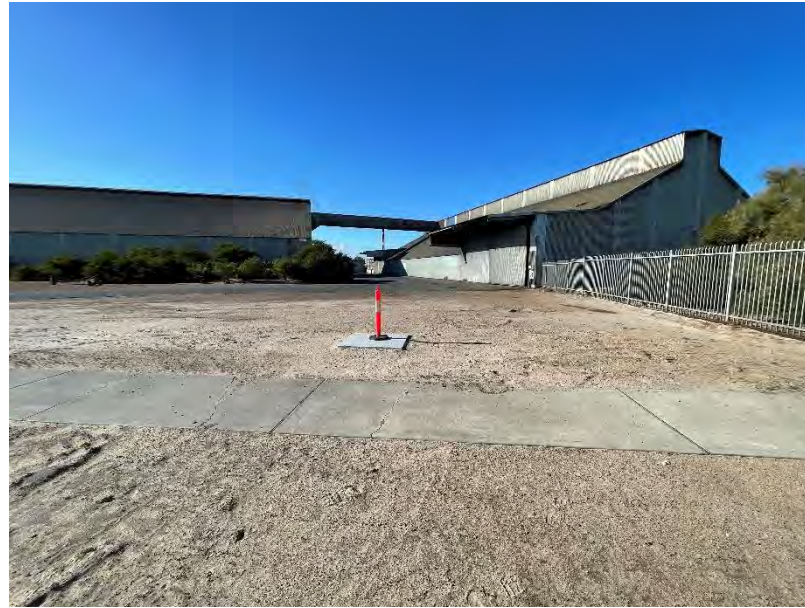
Photo 14: Cracks through the concrete path

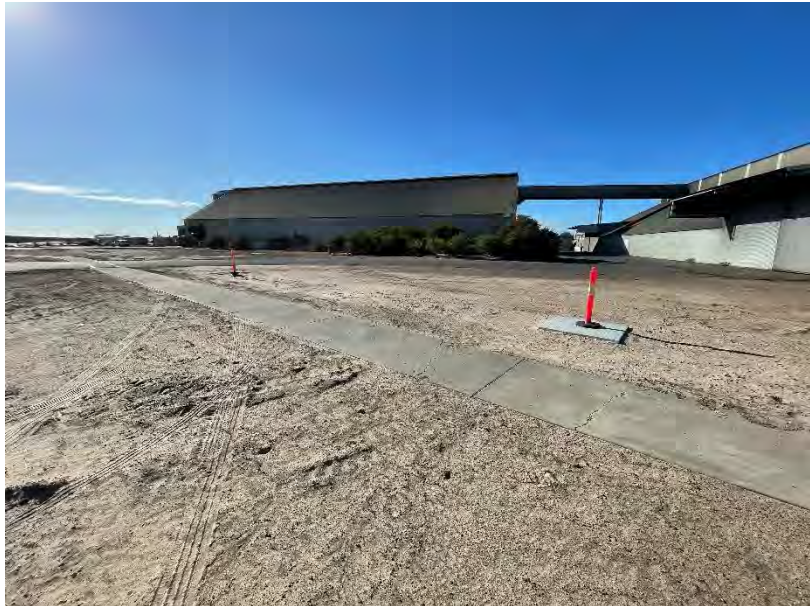
Photo 15: View to Shed 8 (right) and Shed 7 (left)

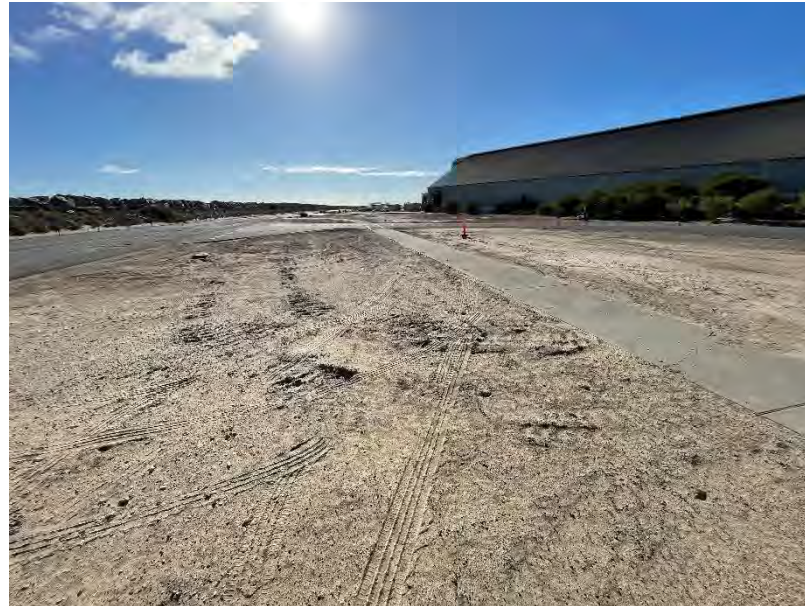
Photo 16: Cracks through the concrete path

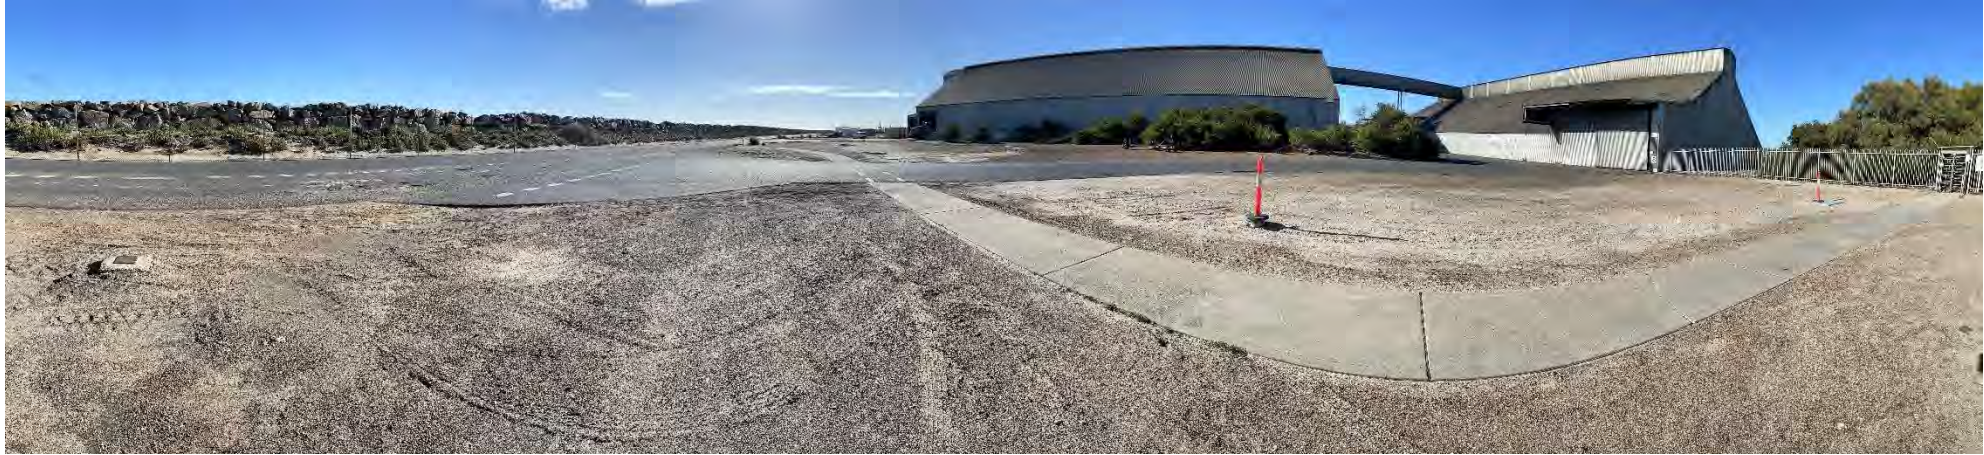
Photo 17: Shed 8 (right) Shed 7 (left)

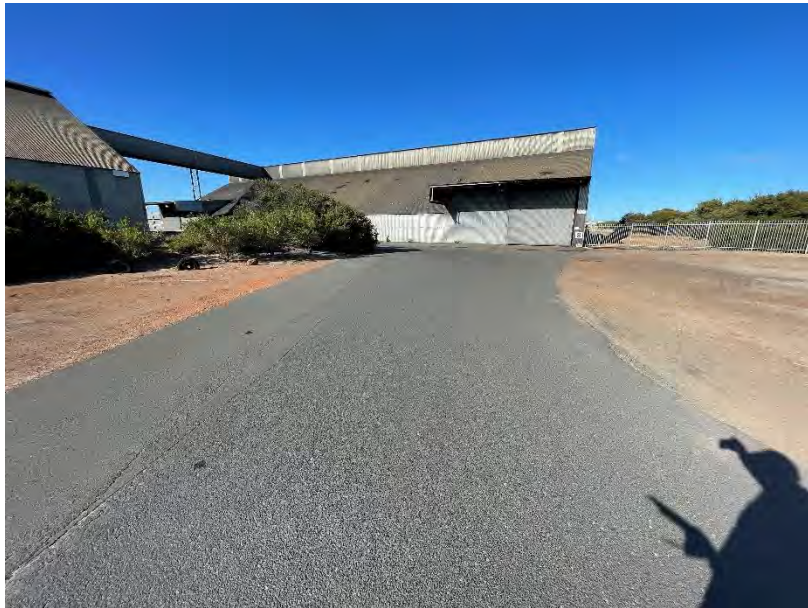
Photo 18: Road surface to Shed 8 in good condition

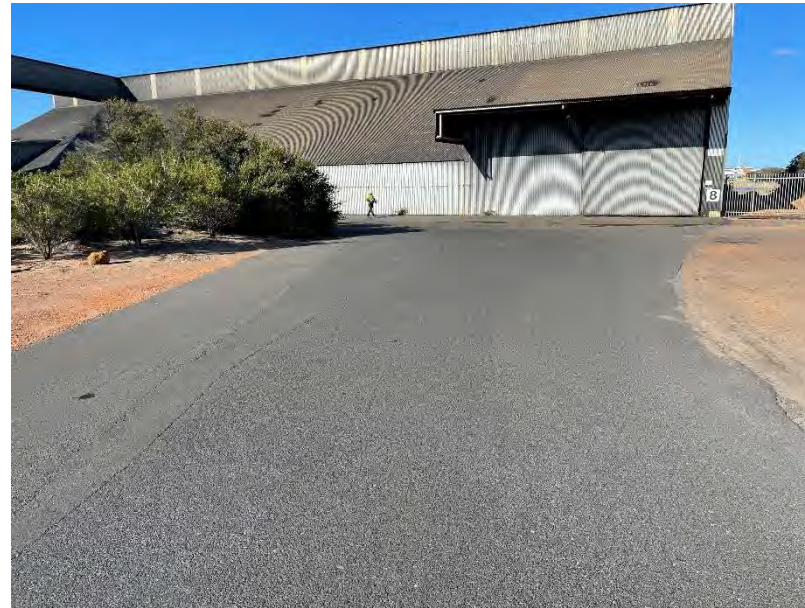
Photo 19: Road surface to Shed 8 in good condition

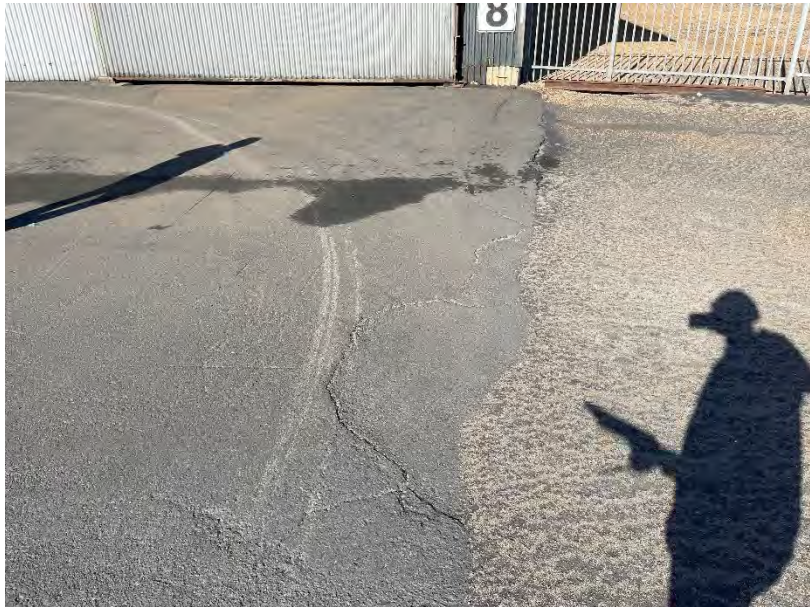
Photo 20: Damage on road edge and standing water in front of shed 8

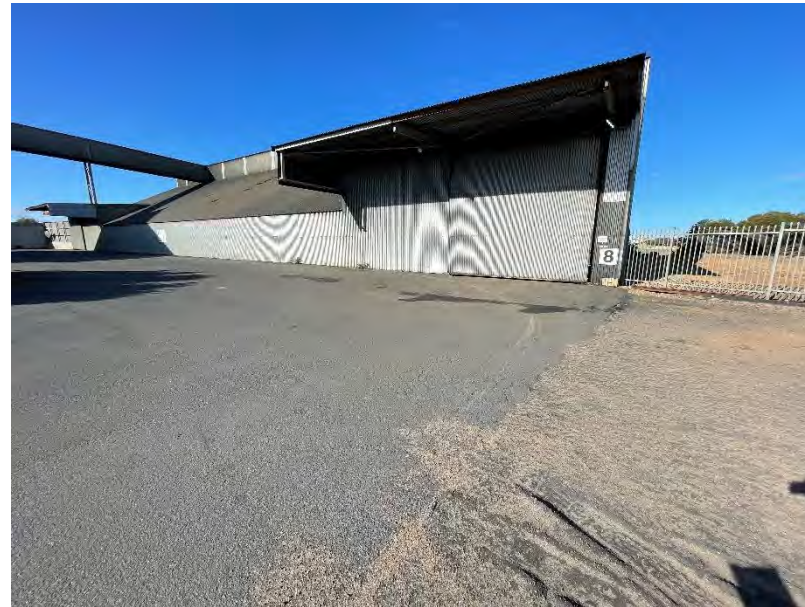
Photo 21: Damage on road edge and standing water in front of shed 8

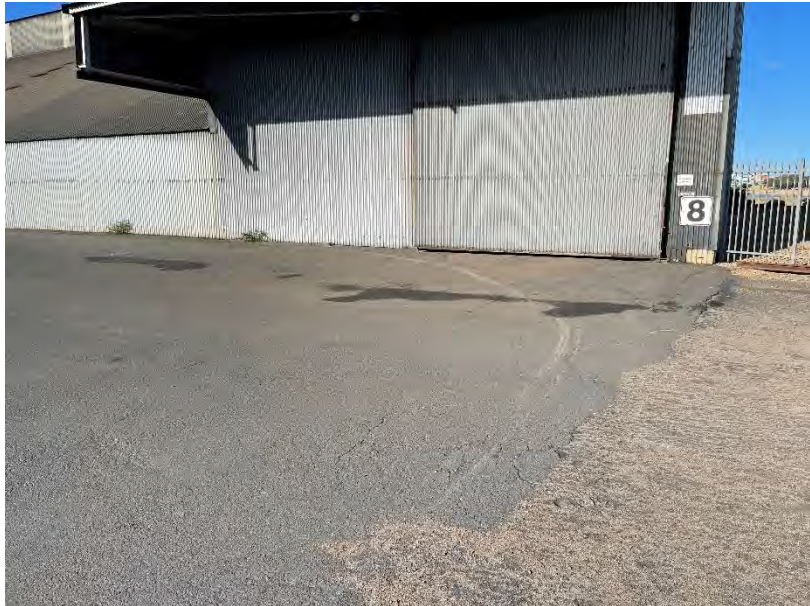
Photo 22: Damage on road edge and standing water in front of shed 8

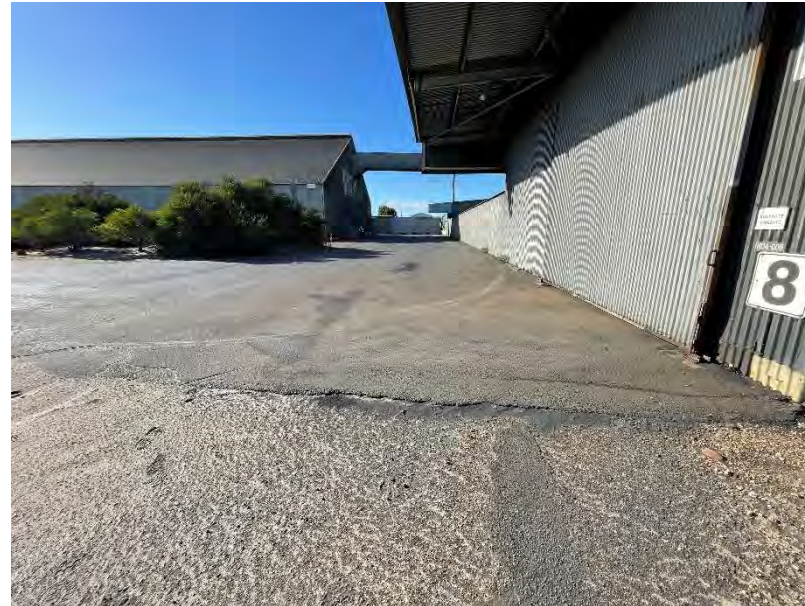
Photo 23: Require gravel top-up on road edge

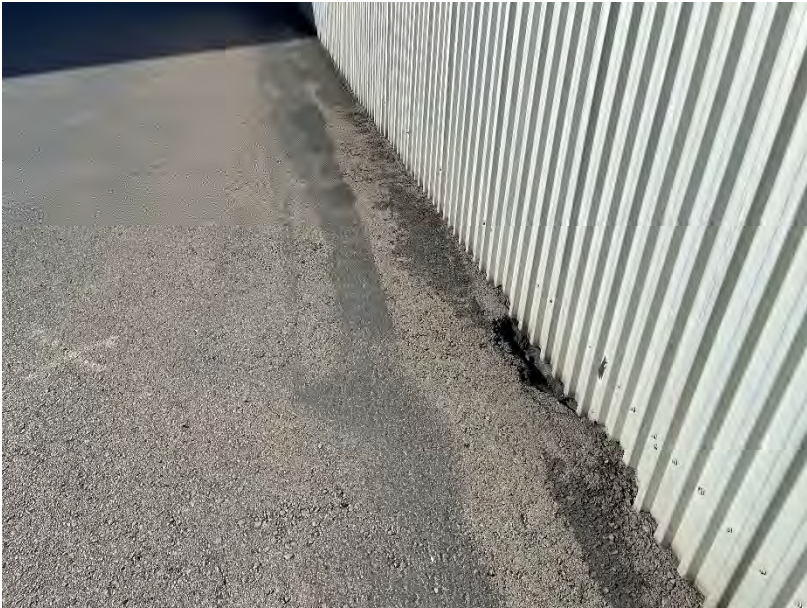
Photo 26: Damage to road edge

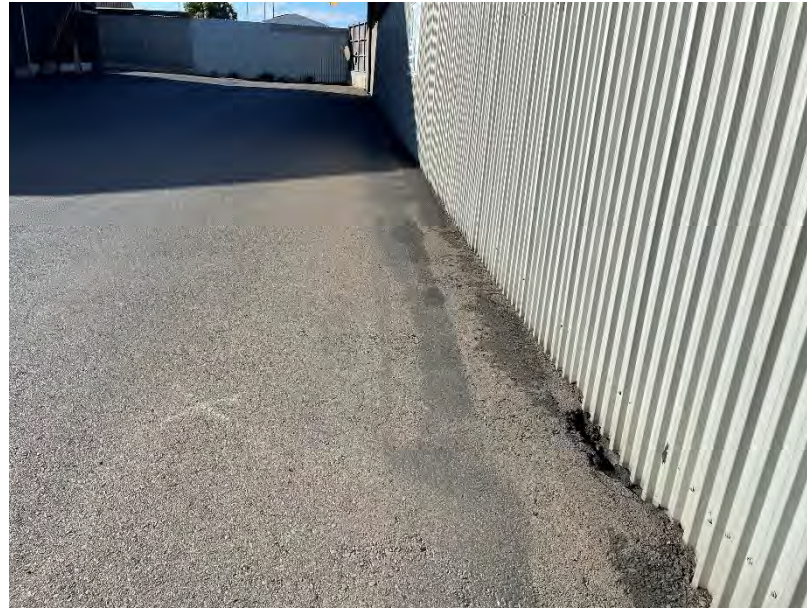
Photo 27: Damage to road edge

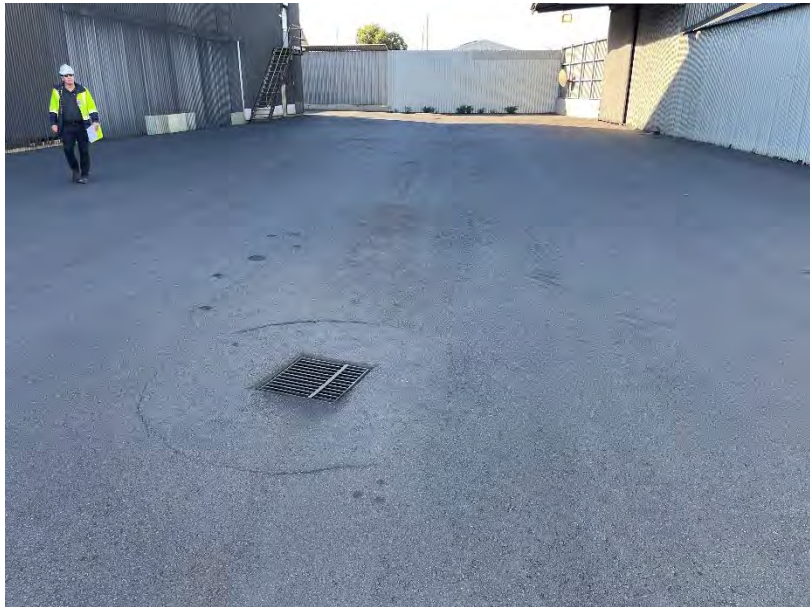
Photo 28: Settling around drainage pit

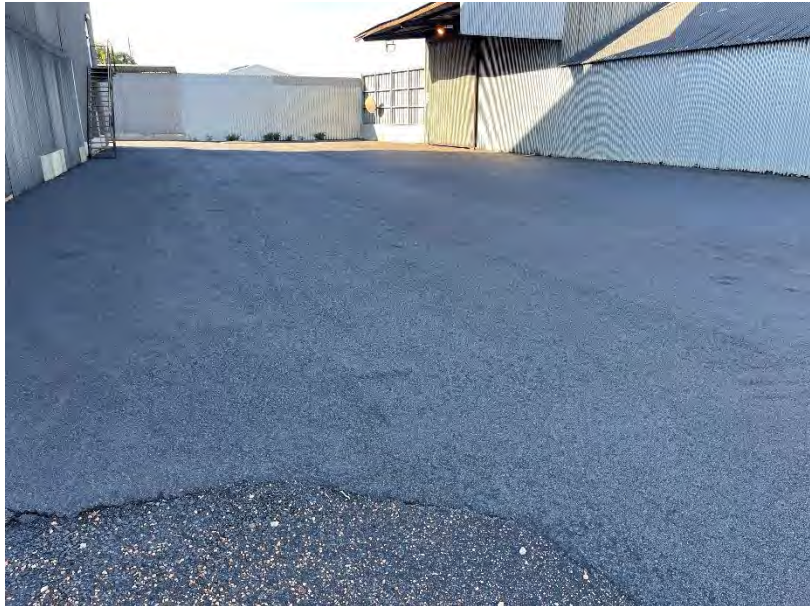
Photo 30: Road surface in good condition

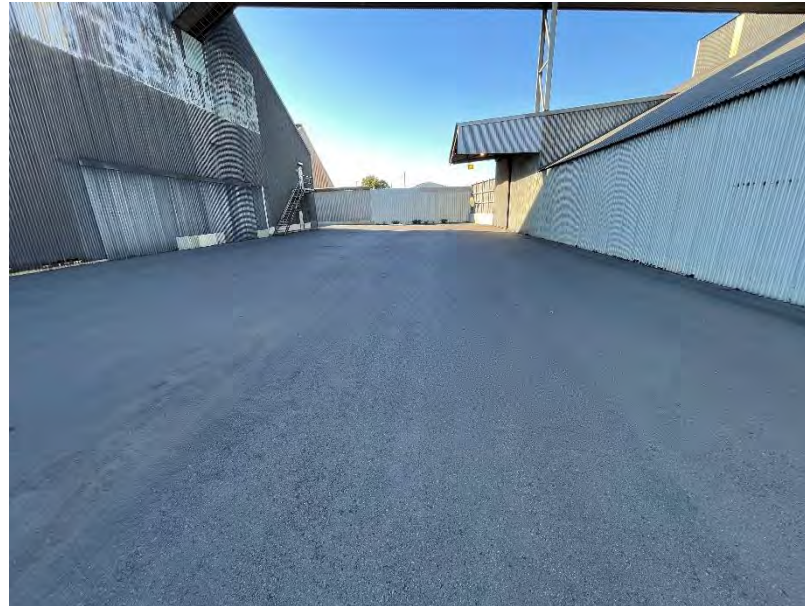
Photo 31: Road surface in good condition

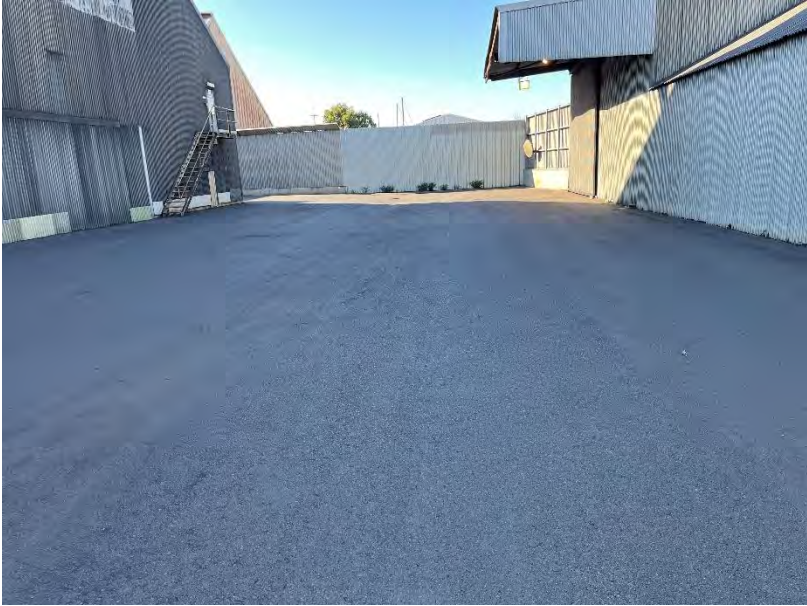
Photo 32: View to Shed 8 (right) Shed 7 (left) Shed 6 (middle)

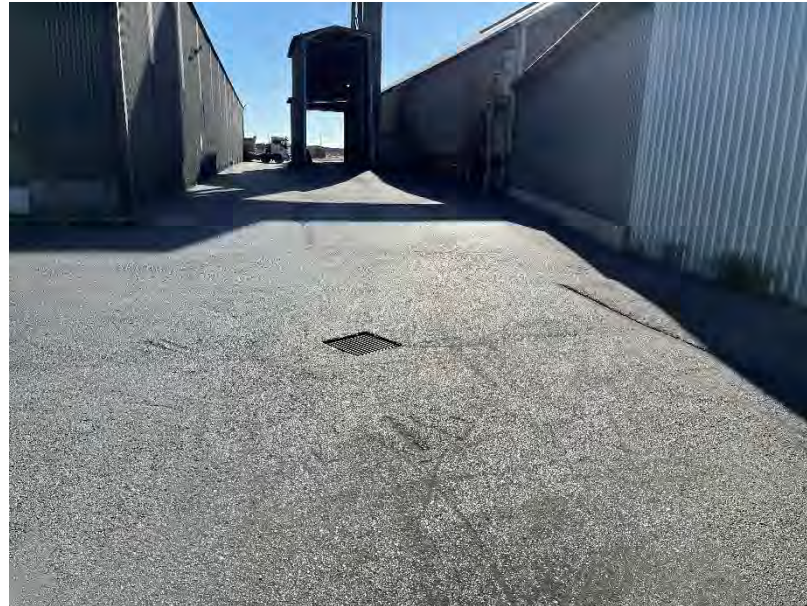
Photo 35: Surface grated inlet pit lid in good condition
