APPENDIX A

SHED PLANS

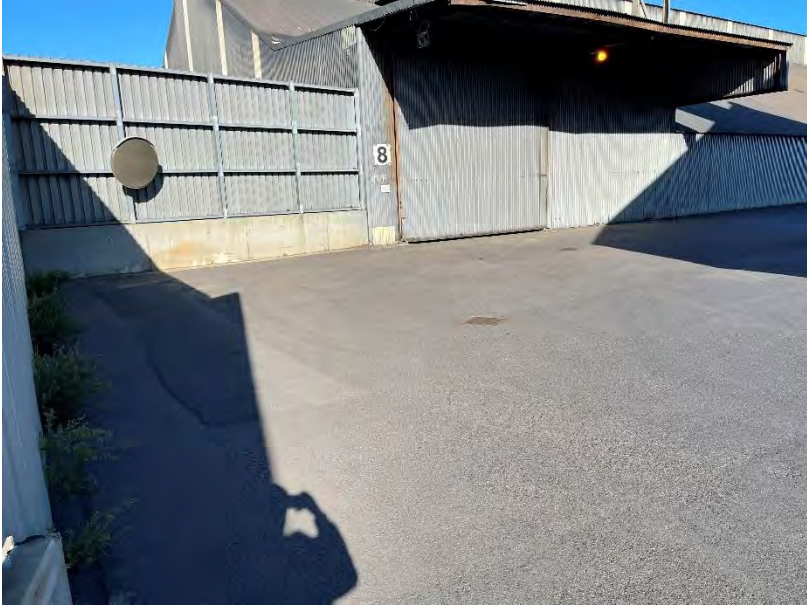
Photo 36: Require weed control, hump near road edge good condition

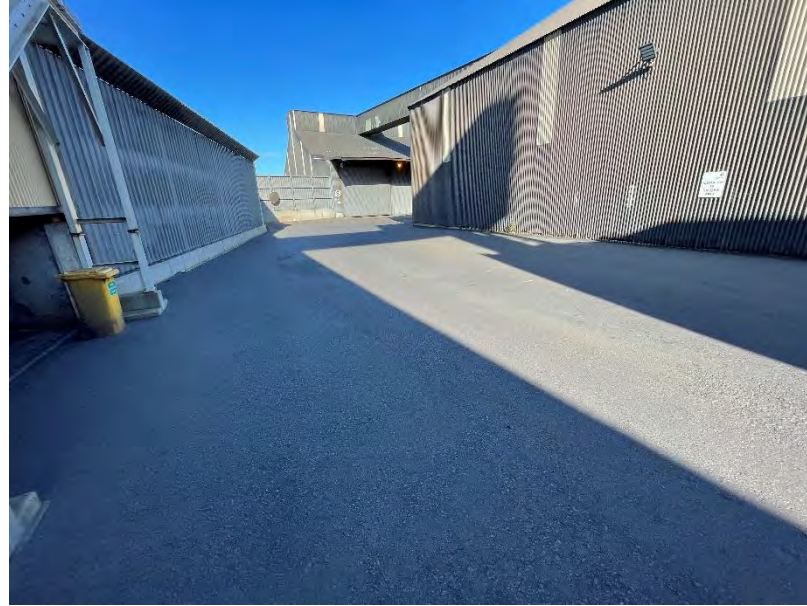
Photo 37: View to Shed 8 (middle), Shed 7 (right) Shed 6 (left)

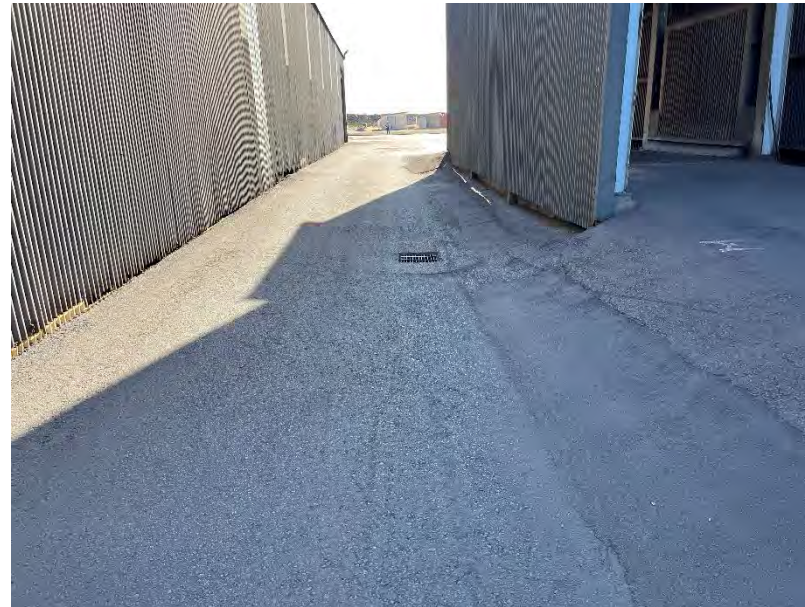
Photo 41: steep slope at Shed 6, surface grated inlet pit lid in good condition

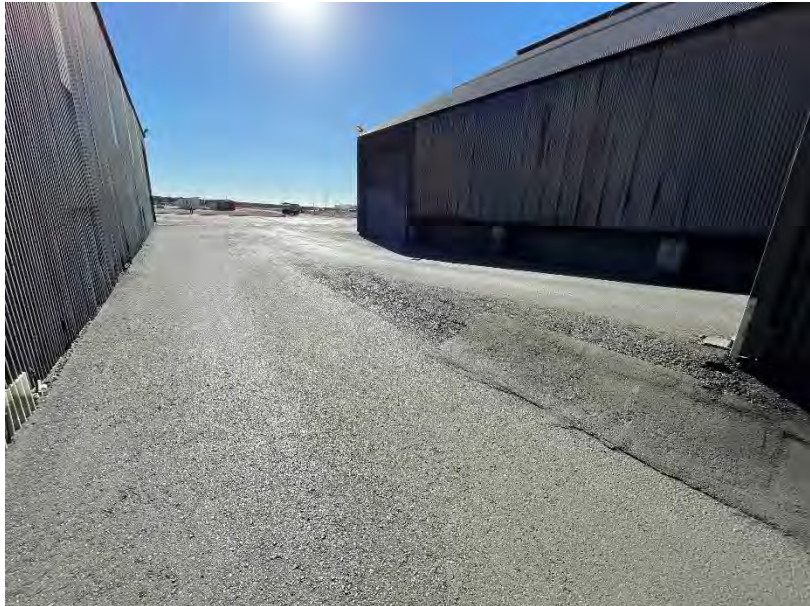
Photo 42: View to Shed 7 (left) Shed 6 (right), steep slope at Shed 6

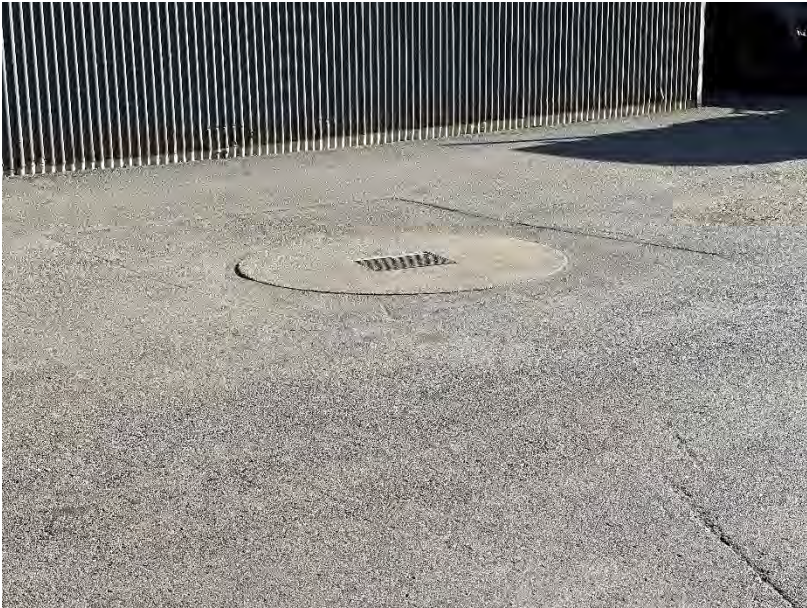
Photo 46: Surface grated inlet pit lid in good condition

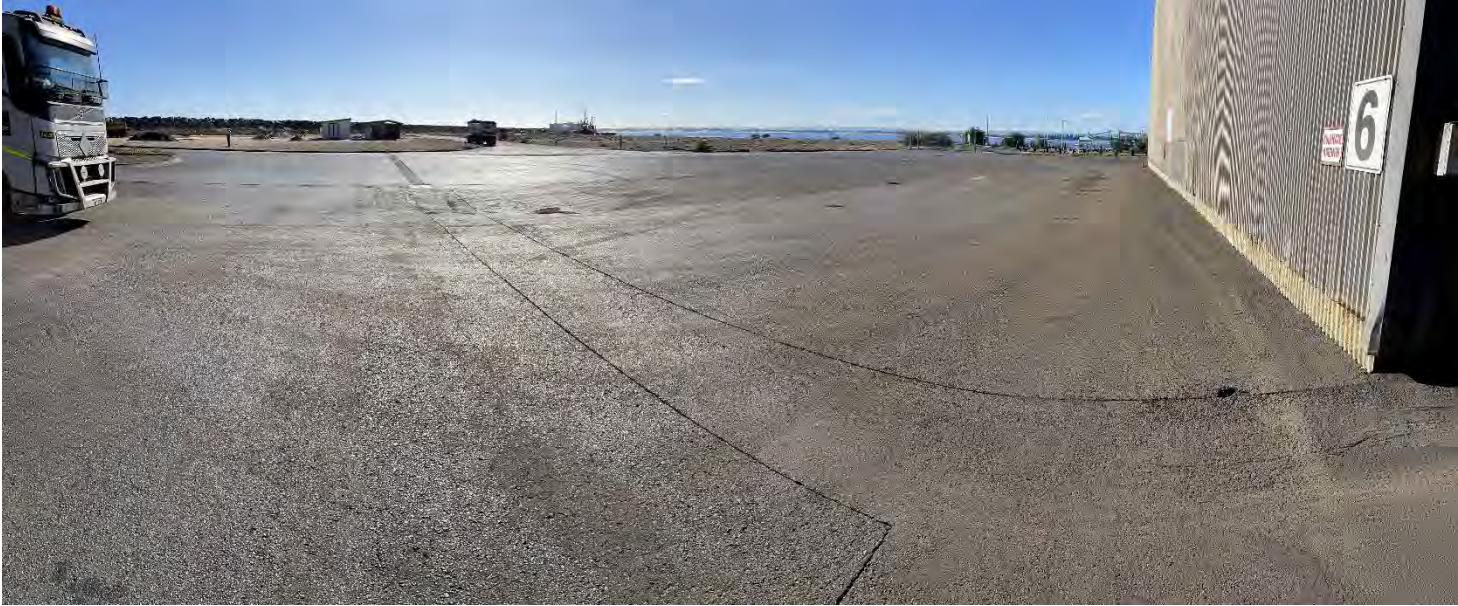
Photo 47: Road surface in good condition with some minor repair required.

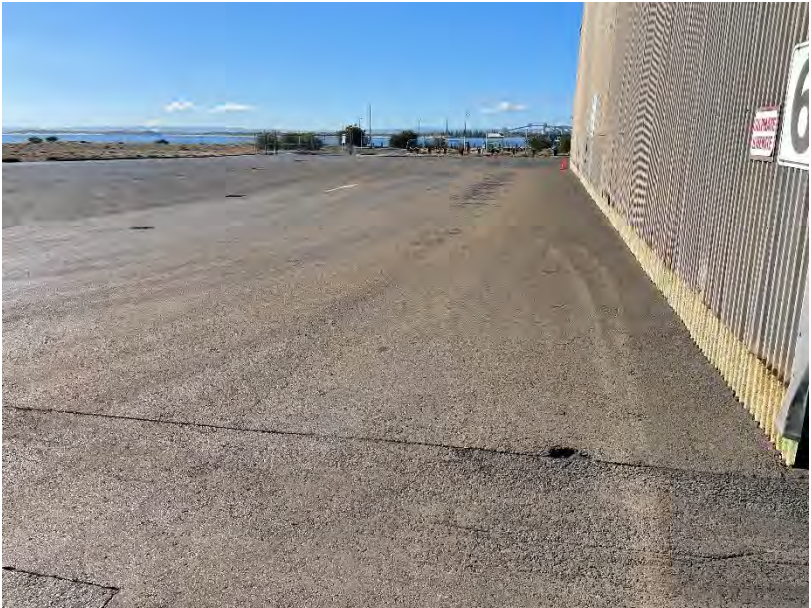
Photo 48: Small pot-hole

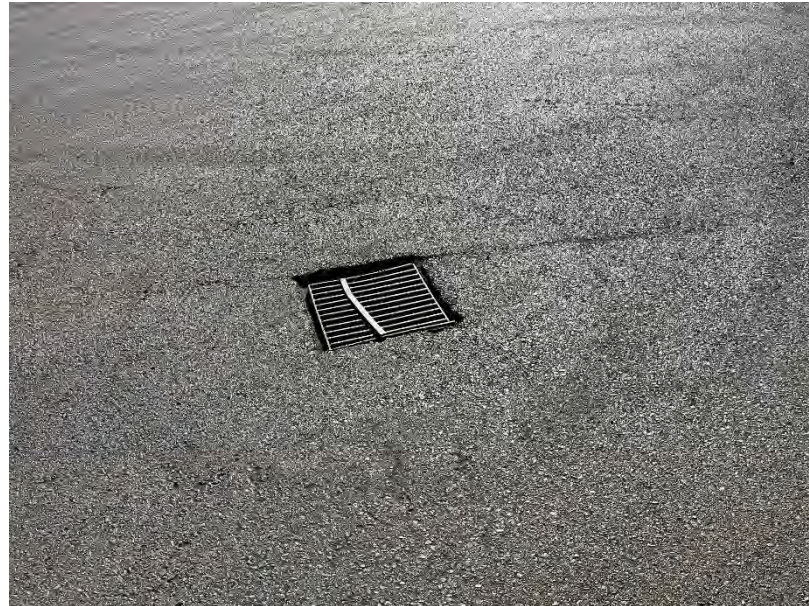
Photo 53: Damaged drainage pit

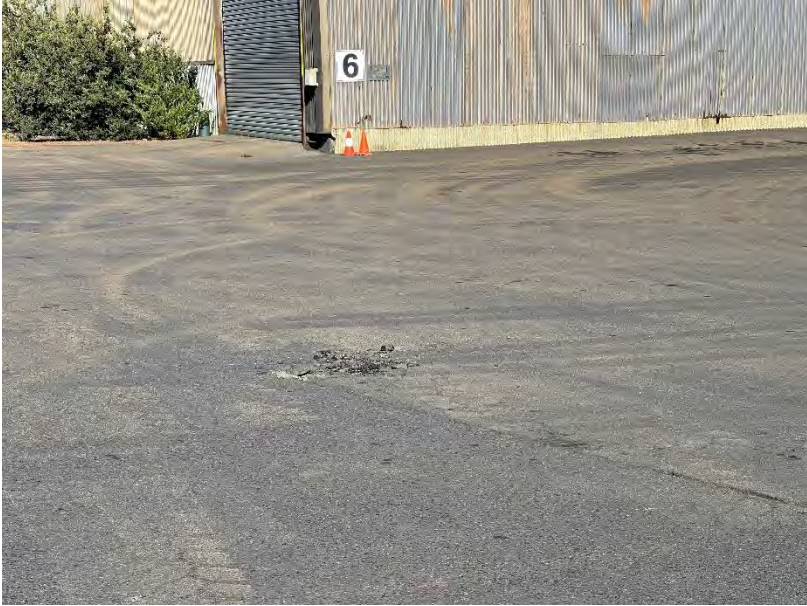
Photo 54: Damage to the road surface

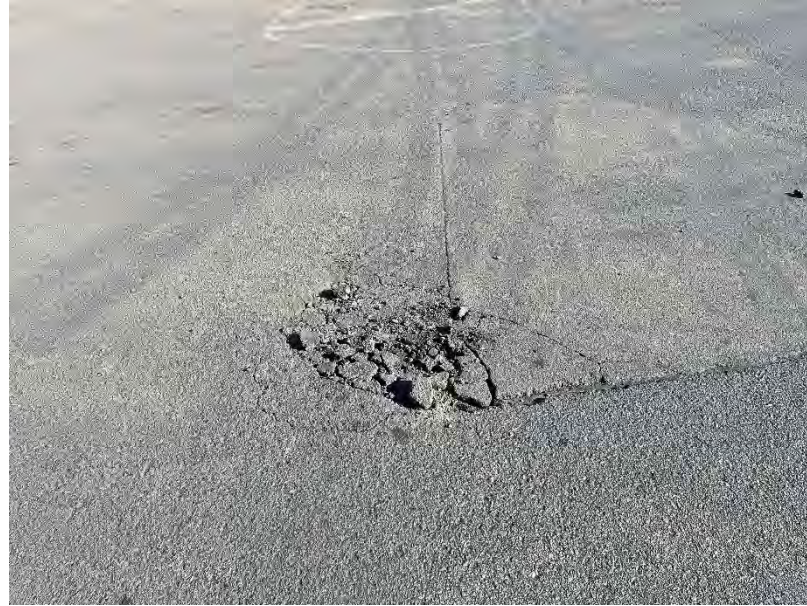
Photo 55: Damage to the road surface

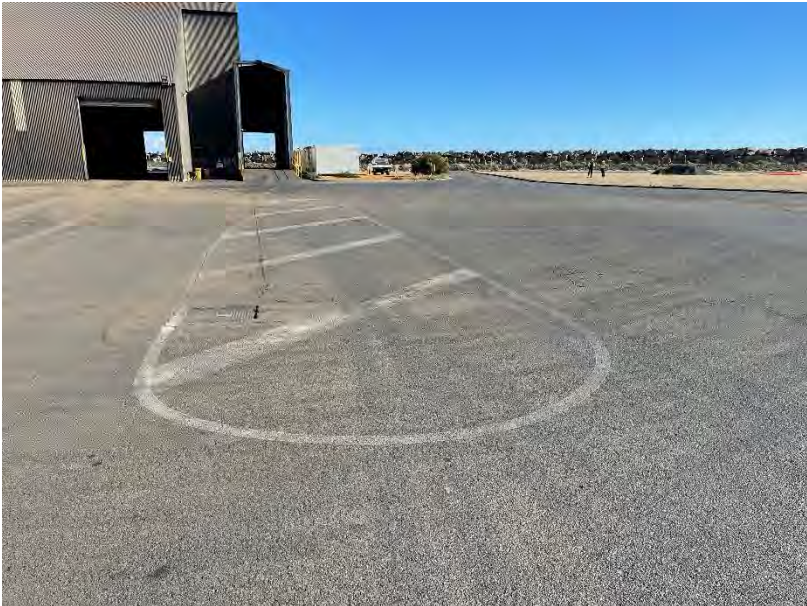
Photo 56: Reinstatement of linemarking (if required for new proposal)

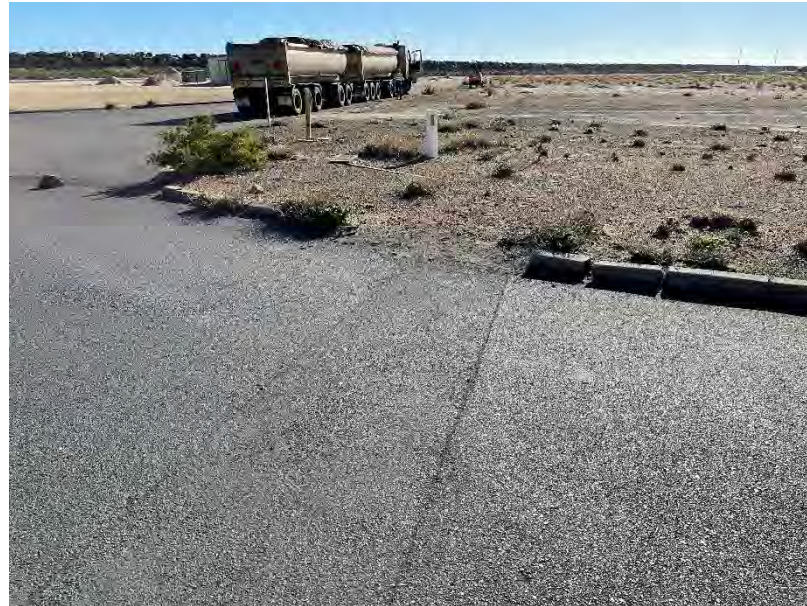
Photo 57: Missing kerb

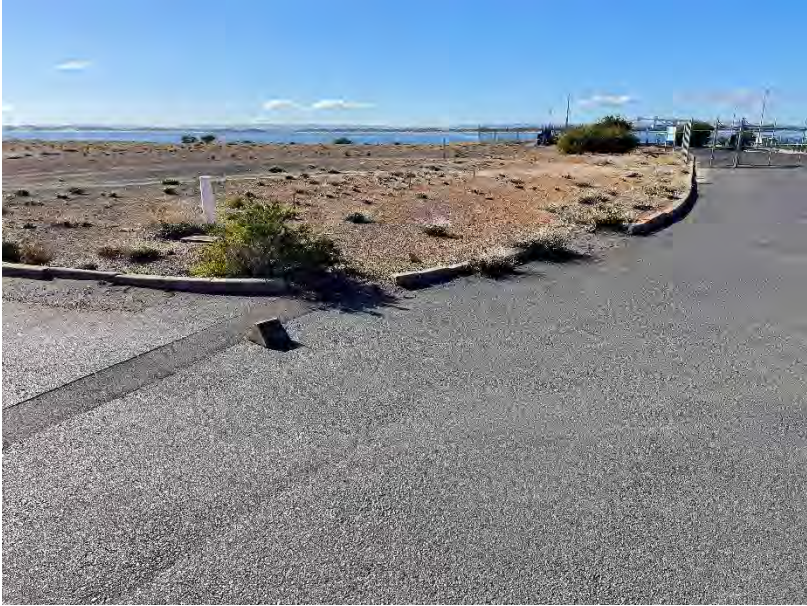
Photo 58: Missing kerb

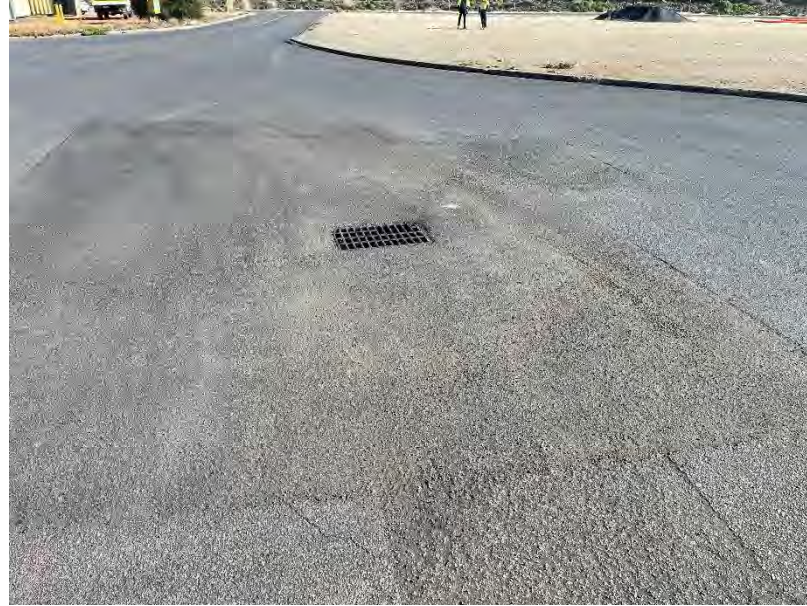
Photo 59: Surface grated inlet pit lid in good condition

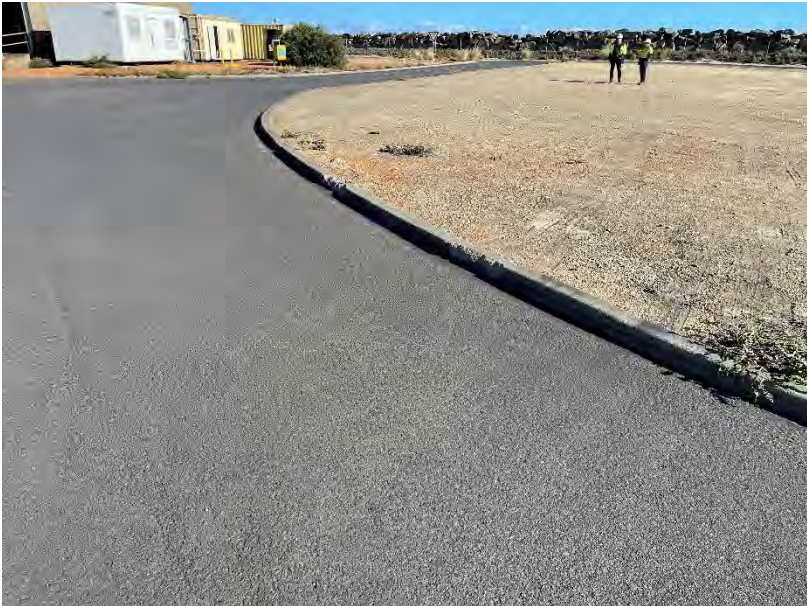
Photo 60: Damage to kerb

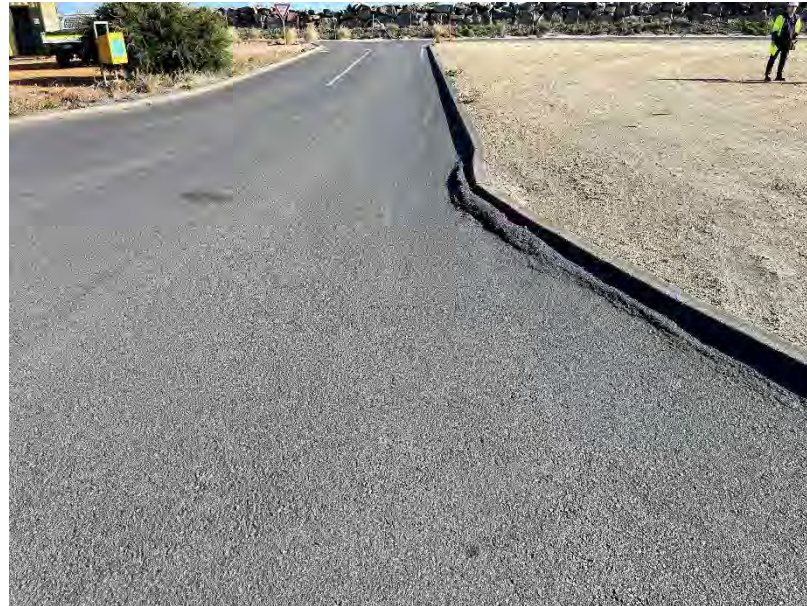
Photo 61: kerb and Road surface have moved

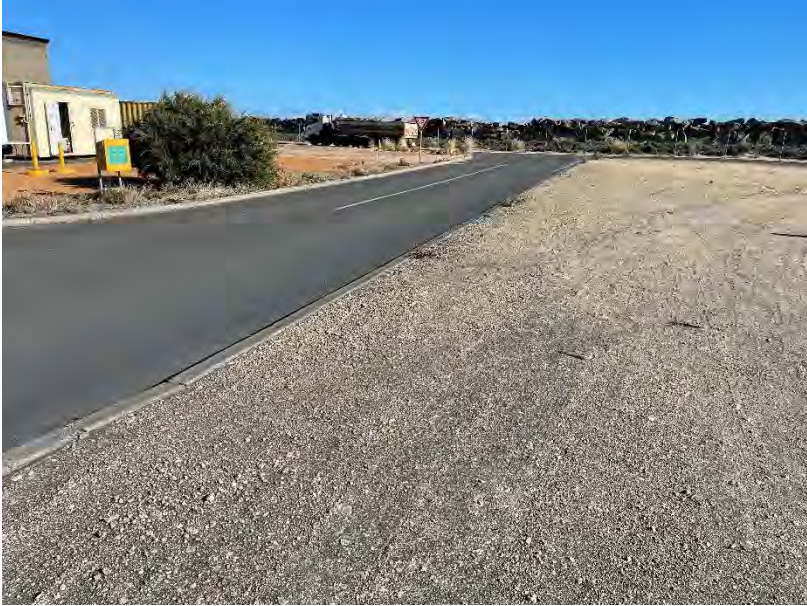
Photo 62: Road surface is in good condition.

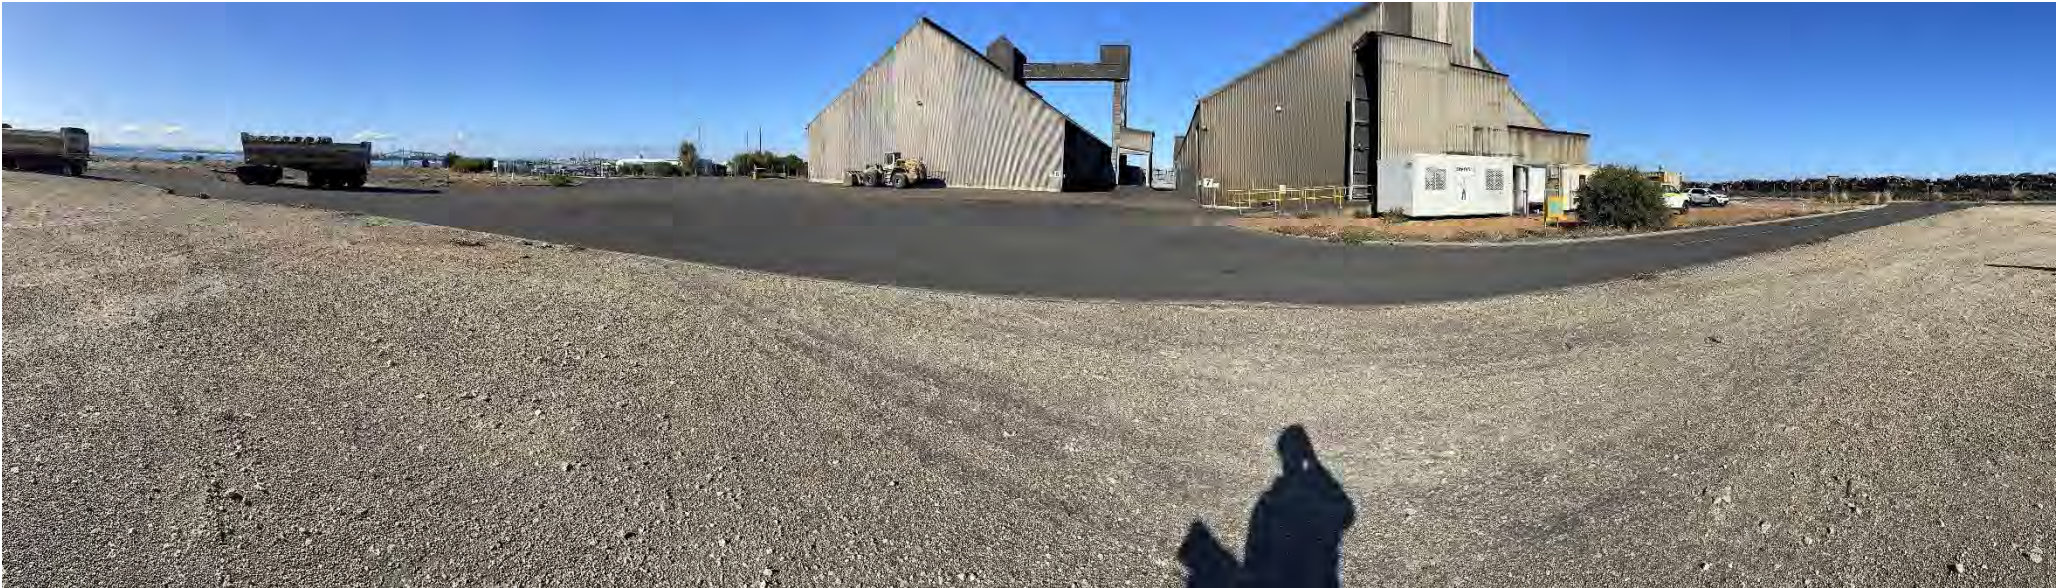
Photo 63: View of Shed 7 and site shed (right) Shed 6 (left)

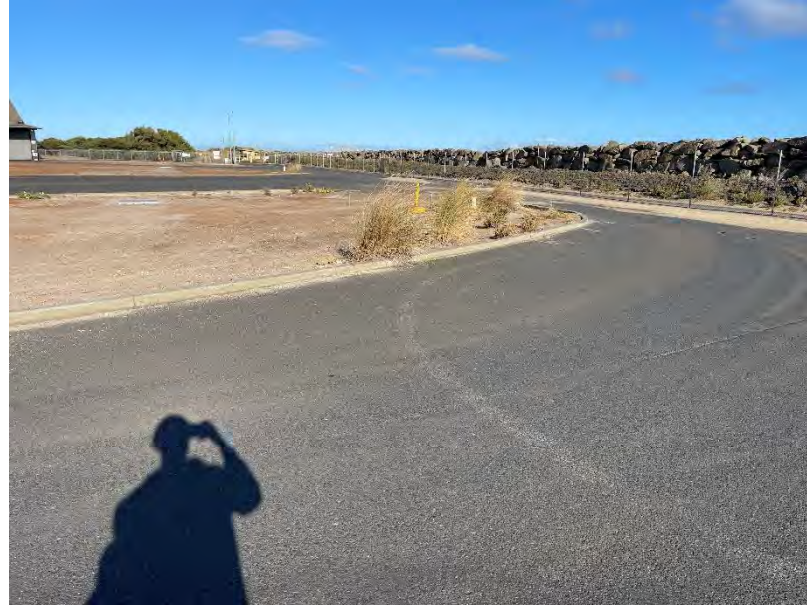
Photo 79: Damaged kerb due to heavy vehicle sweeping through kerb

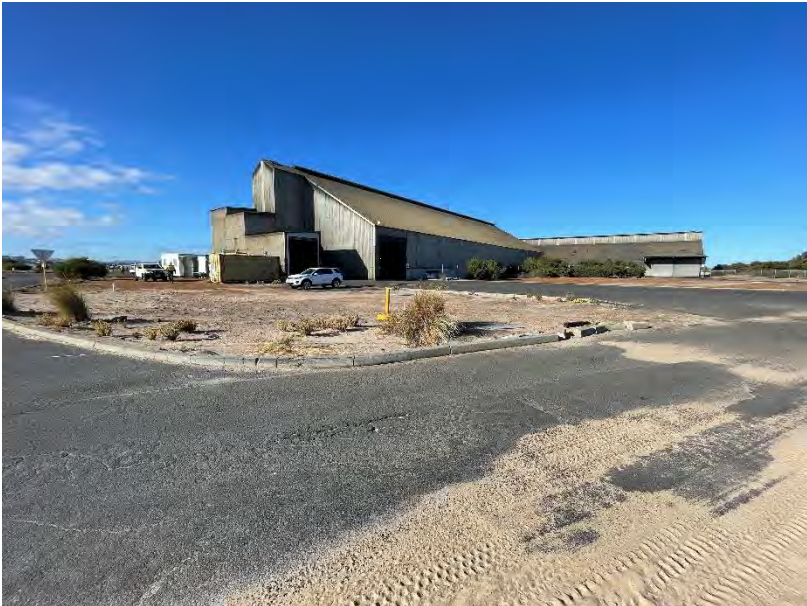
Photo 80: Damaged kerb due to heavy vehicle sweeping through kerb

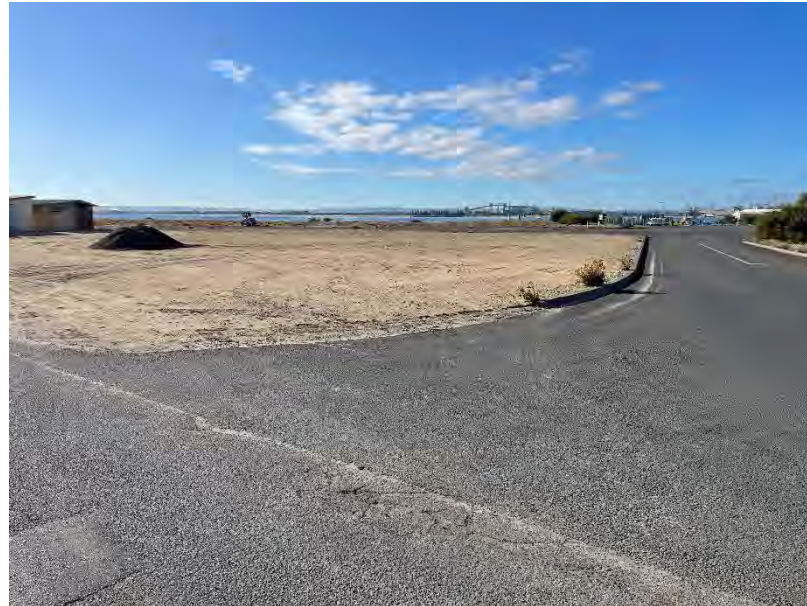
Photo 82: Missing kerb due to heavy vehicle sweeping through kerb

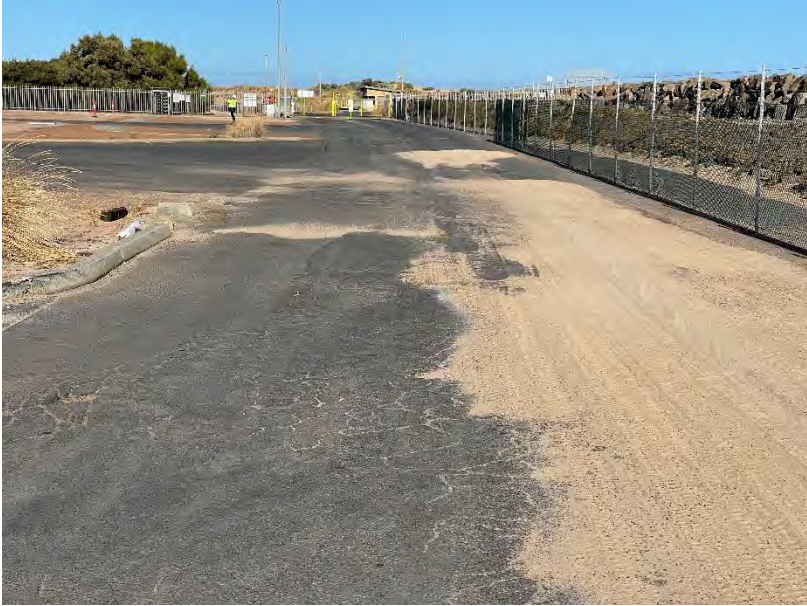
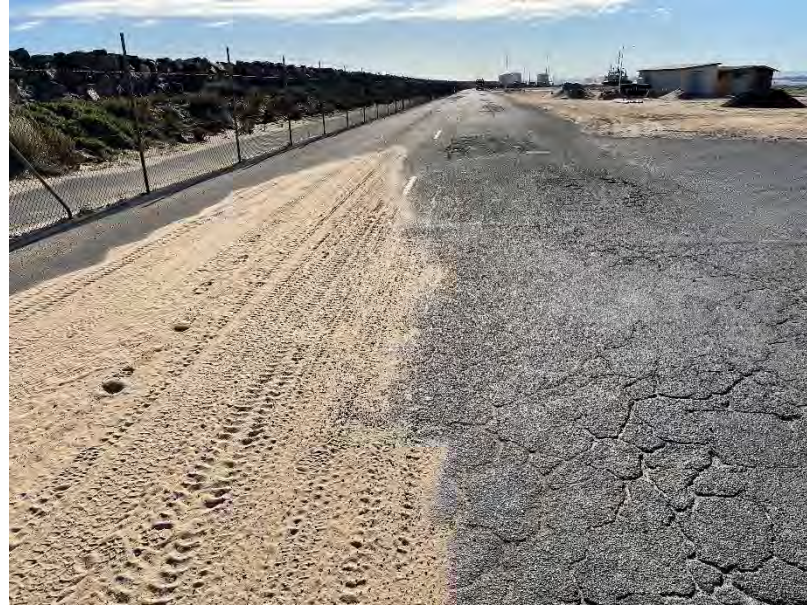
Photo 83: Outside of scope of works – full of cracks and pot-holes through the road photo 84: Outside of scope of works – full of cracks and pot-holes through the road

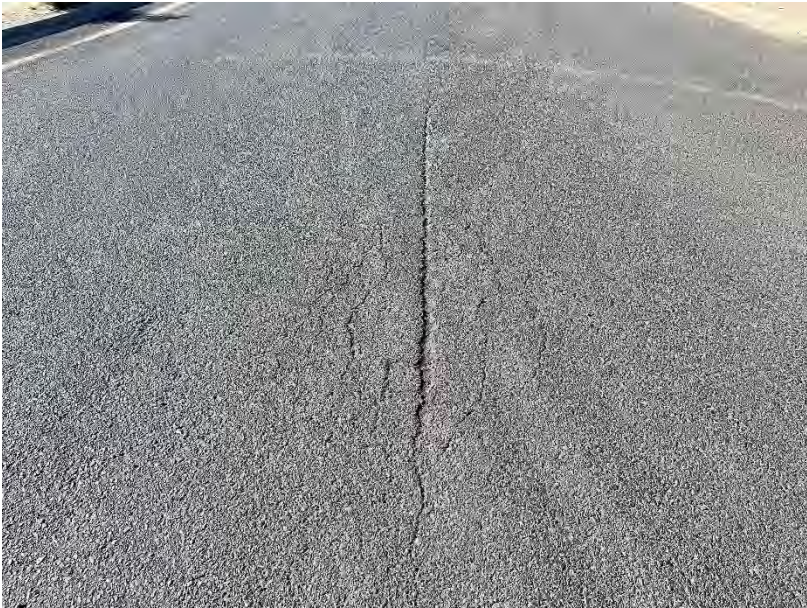
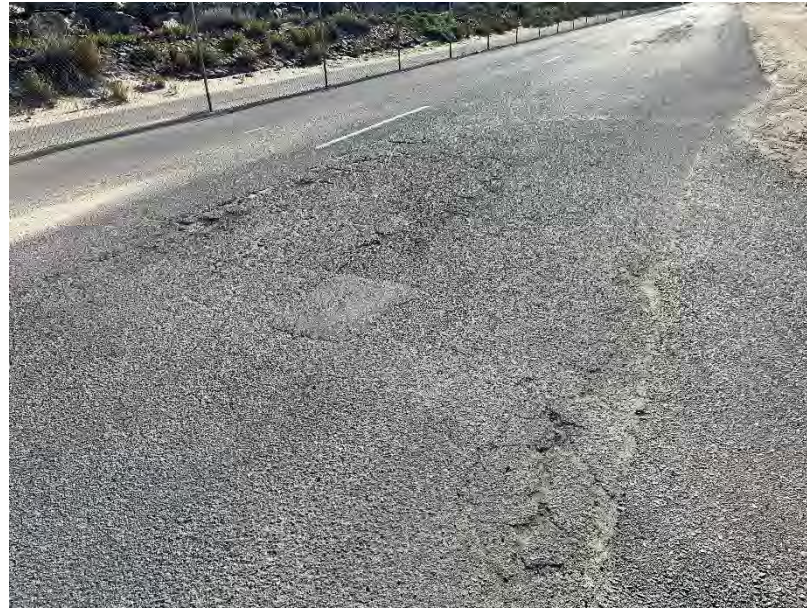
Photo 85: Outside of scope of works – full of cracks and pot-holes through the road Photo 86: Outside of scope of works – full of cracks and pot-holes through the road

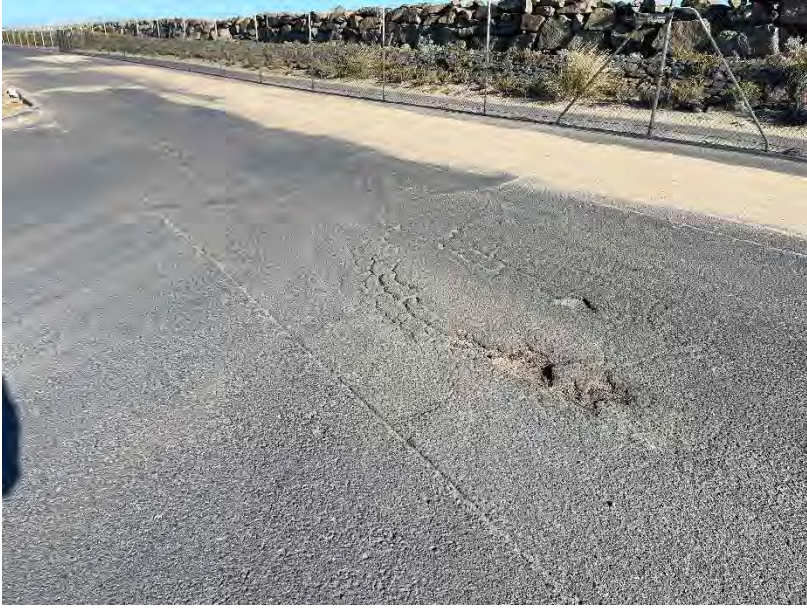
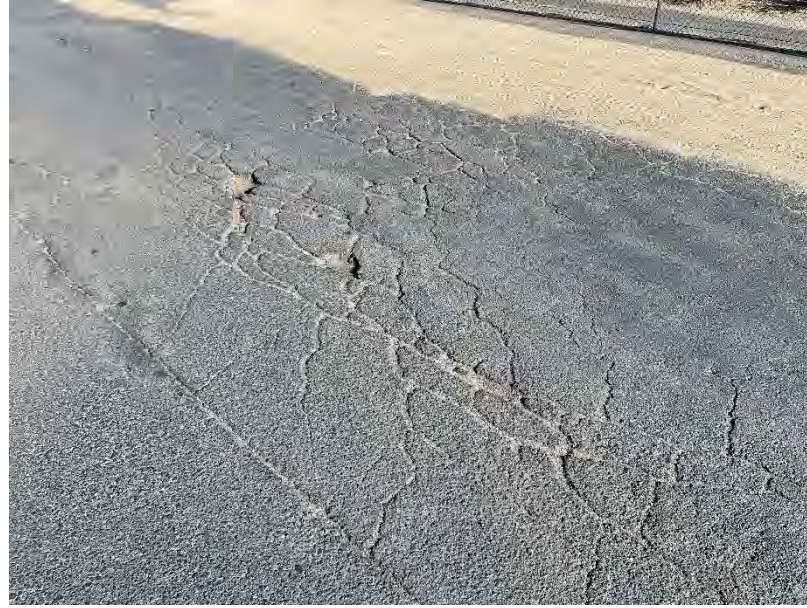
Photo 87: Outside of scope of works – full of cracks and pot-holes through the road Photo 88: Outside of scope of works – full of cracks and pot-holes through the road

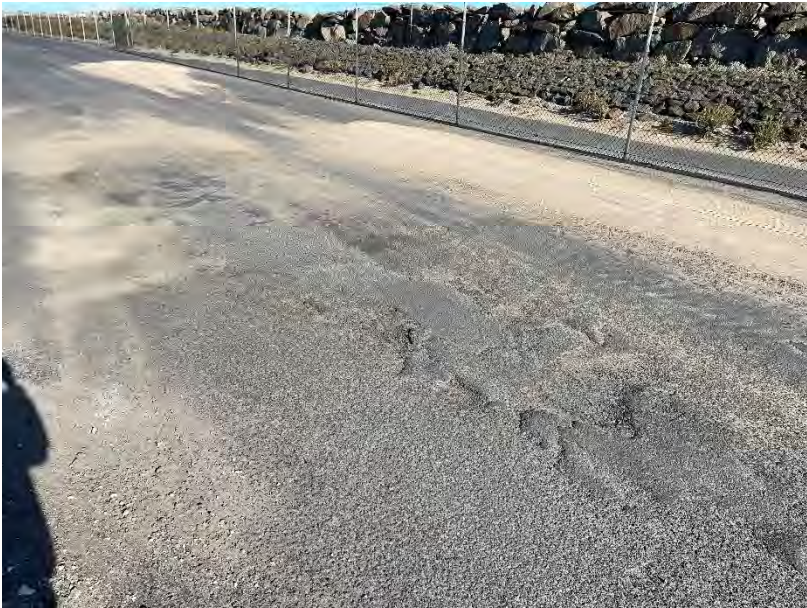
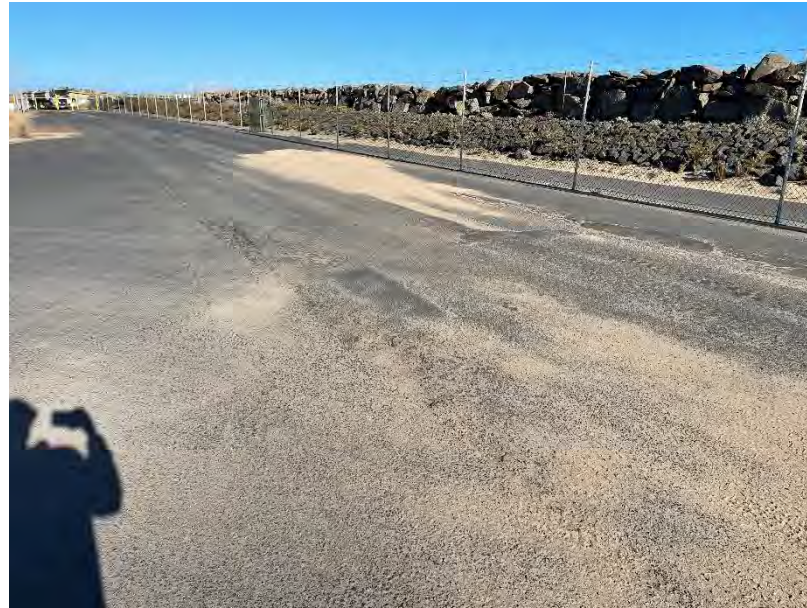
Photo 89: Outside of scope of works – full of cracks and pot-holes through the road Photo 90: Outside of scope of works – full of cracks and pot-holes through the road

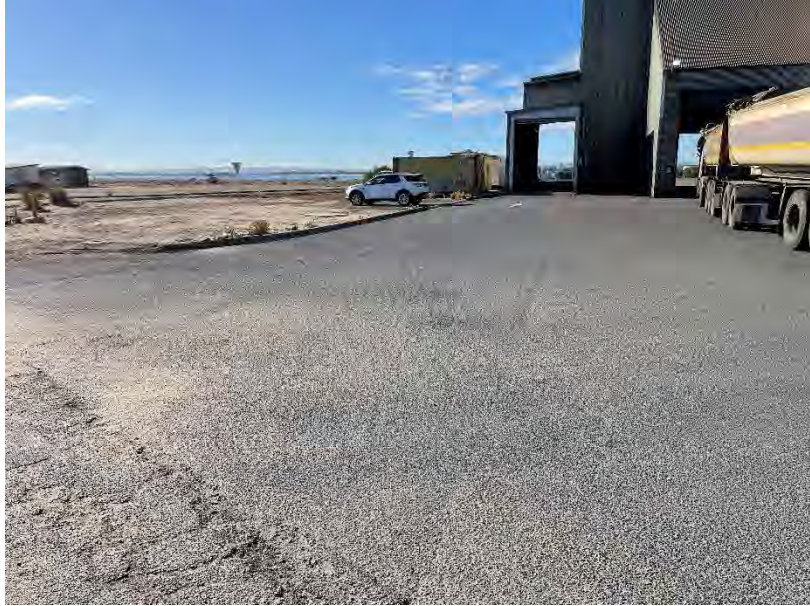
Photo 91: Missing kerb

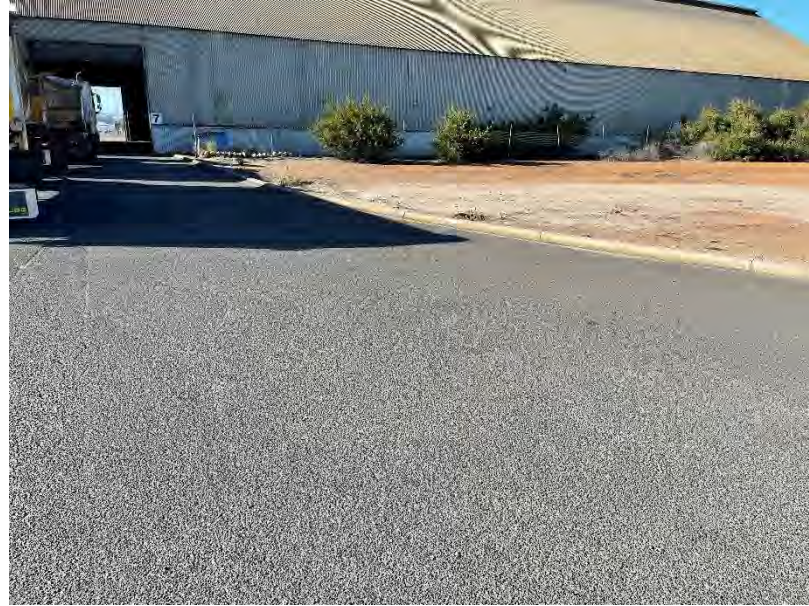
Photo 92: Road surface is generally in good condition

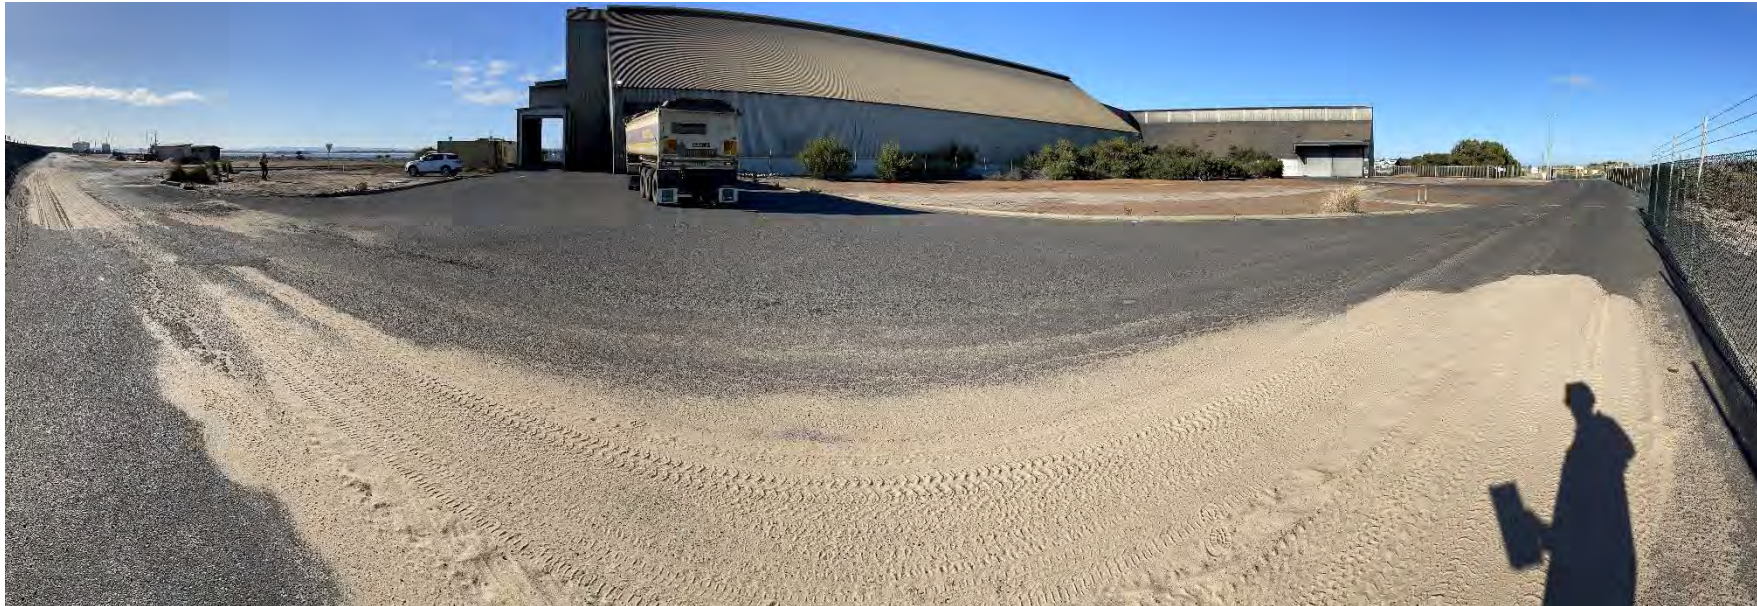
Photo 93: Within the scope of works road surface is generally in good condition

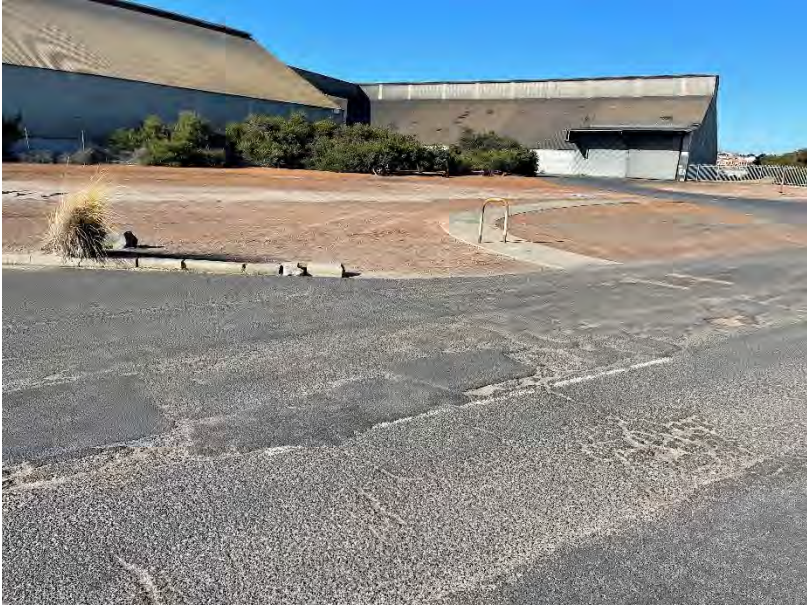
Photo 94: Damaged kerb

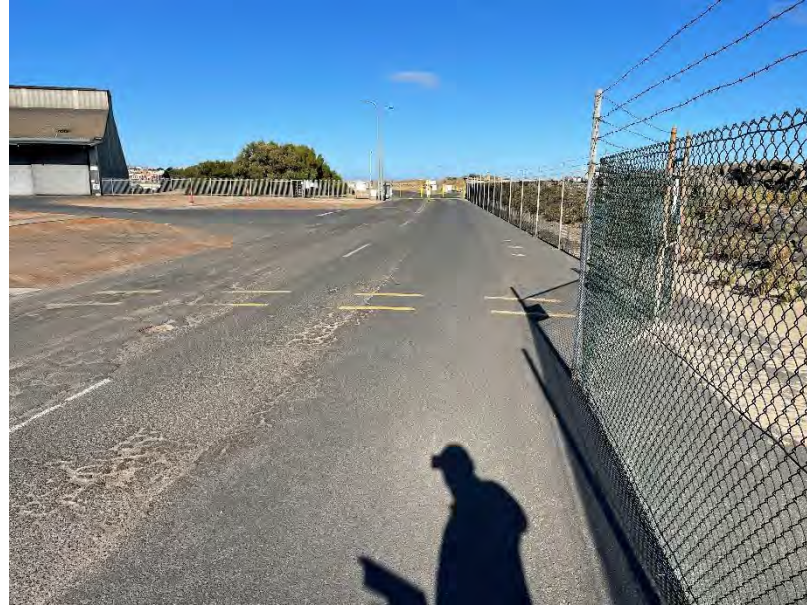
Photo 95: Re-fresh pedestrian linemarking

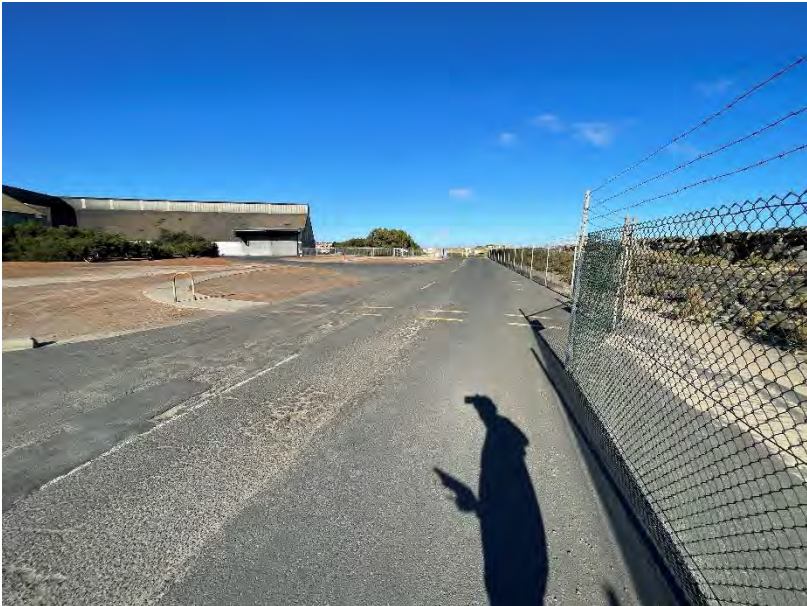
Photo 96: Outside of scope of works – full of cracks and pot-holes through the road

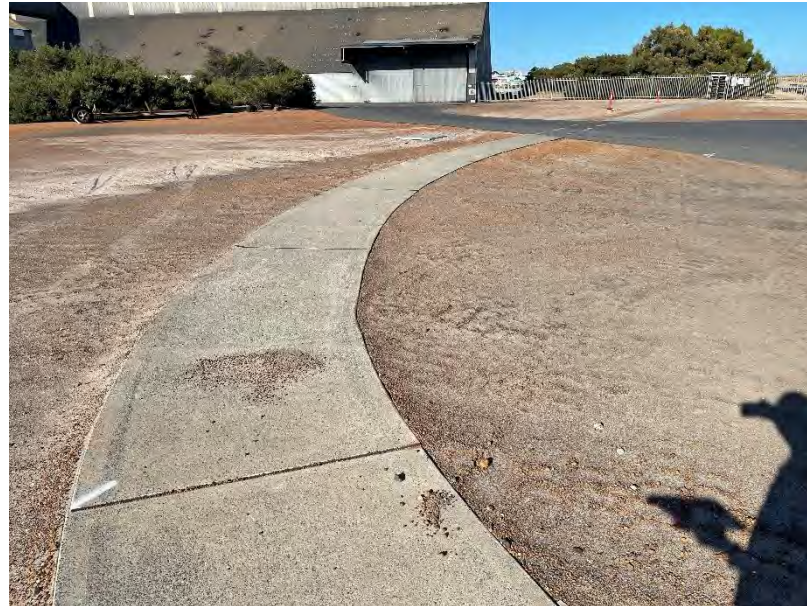
Photo 97: Concrete path in good condition

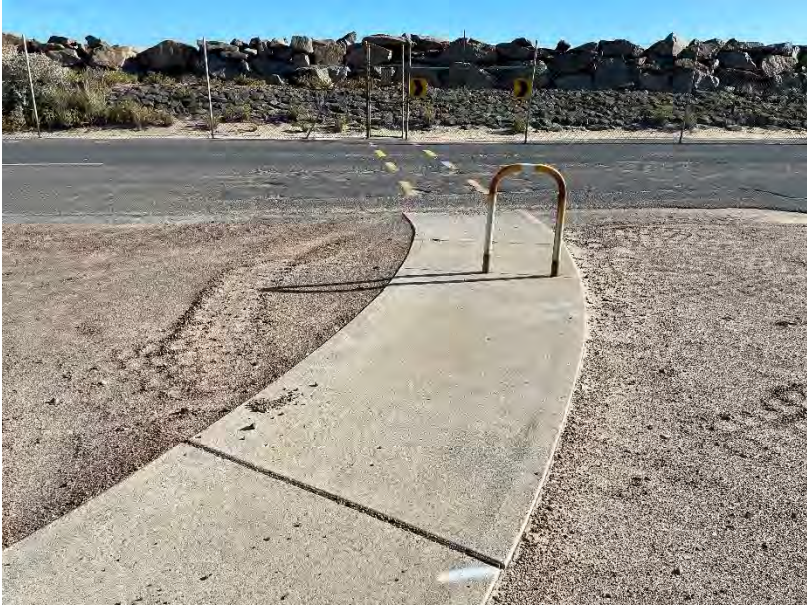
Photo 98: Grab rail requires refurbishment or consider removal.

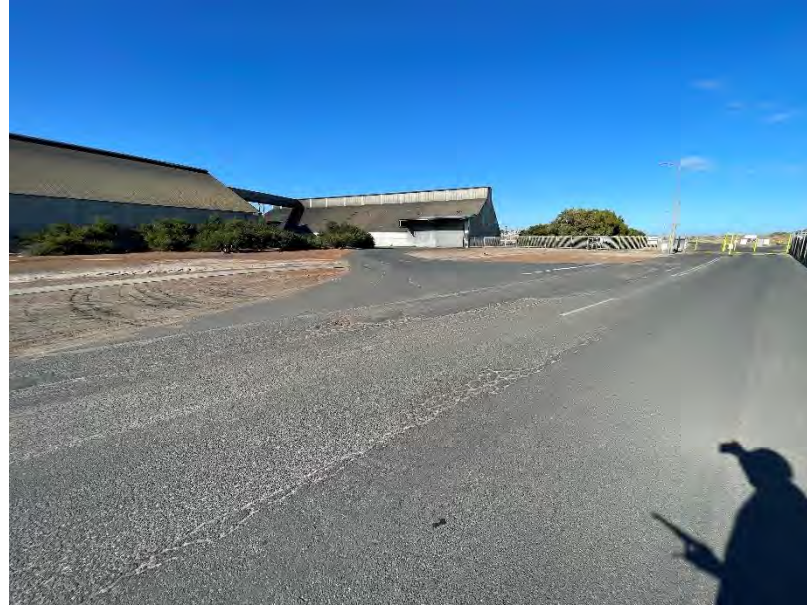
Photo 99: Access road to Shed 8 is in good condition.

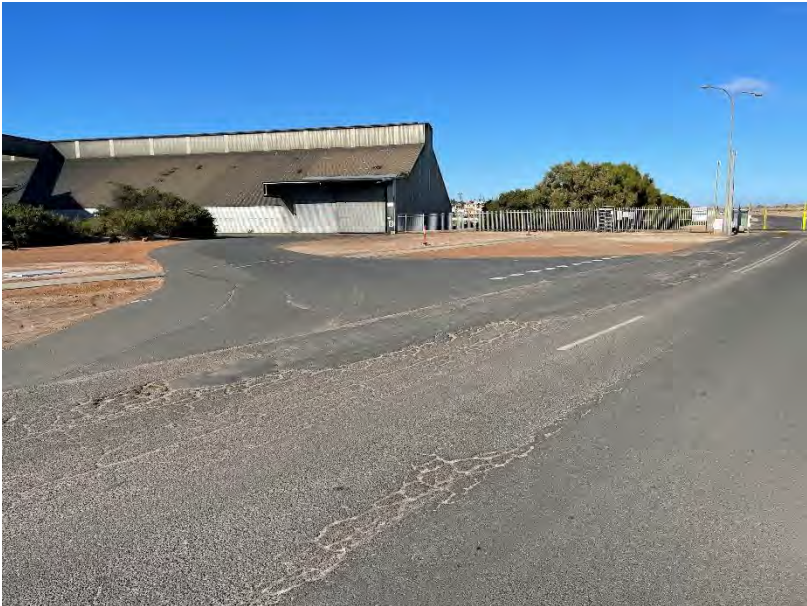
Photo 100: Re-fresh linemarking

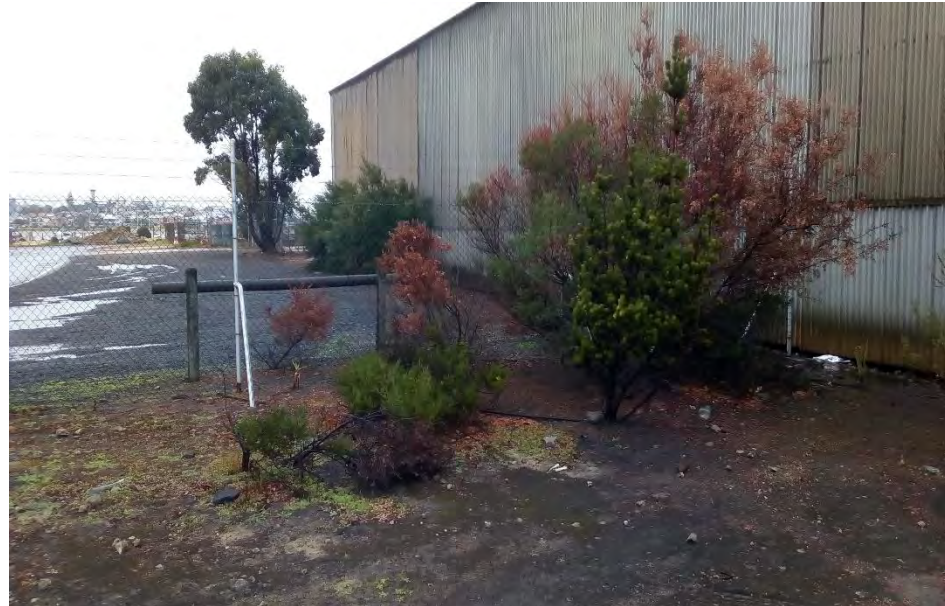
Photo 101: View to back of Shed 6, well draining soil (Wet condition)

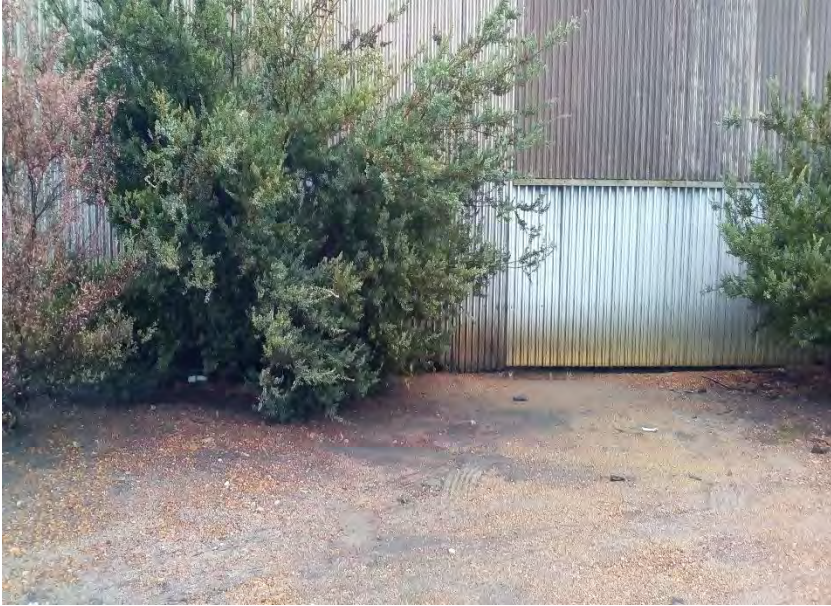
Photo 102: View to back of Shed 6, well draining soil (wet condition)

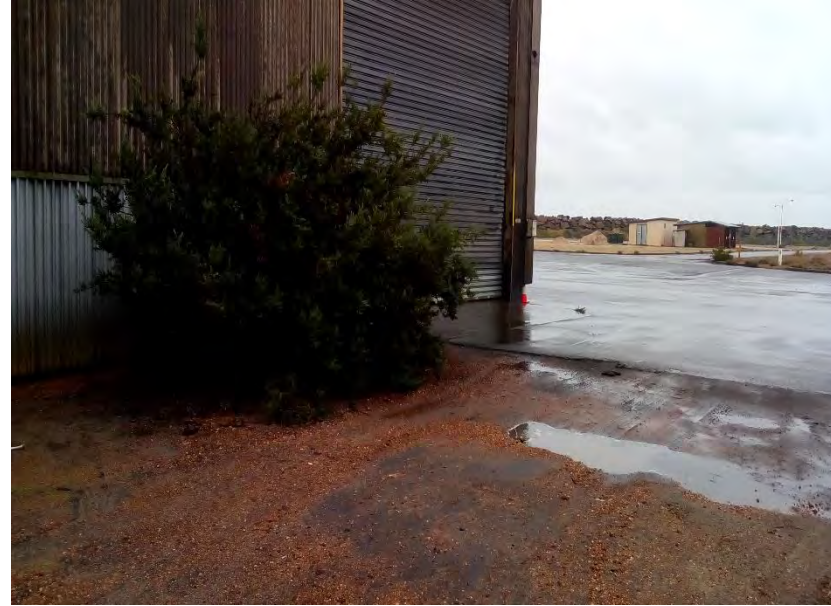
Photo 103: View to Shed 6, well draining soil with some small puddles
