APPENDIX A

SHED PLANS

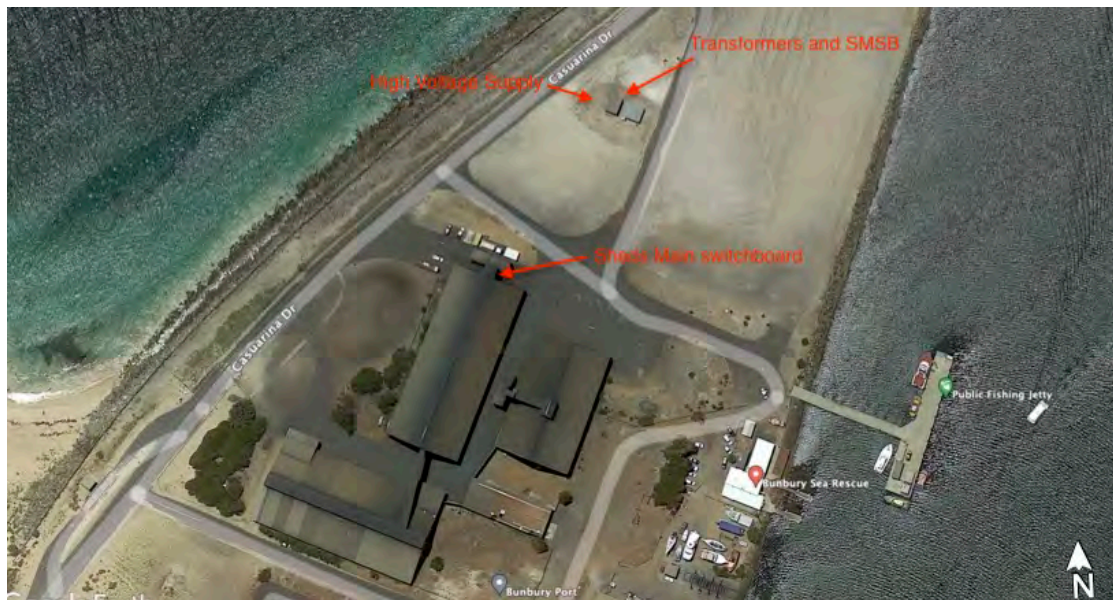
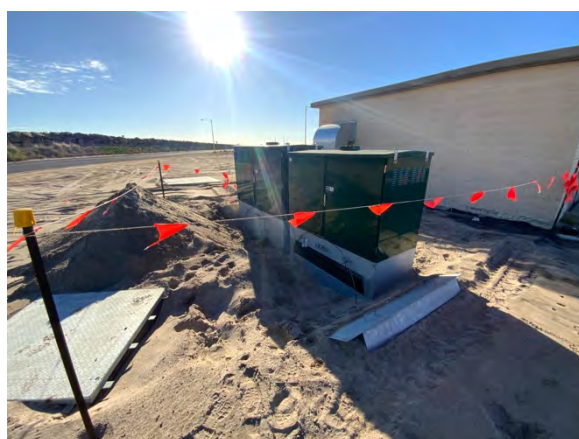
We note that the area power supply arrangement is currently being upgraded / replaced with the installation of new high voltage ring main units.

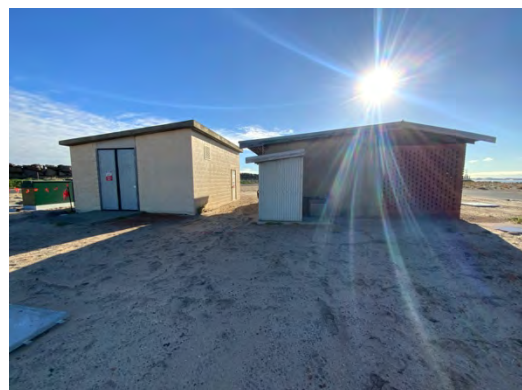
Adjacent to the high voltage ring main units are two buildings, one of which contains a transformer of Westralian manufacture.

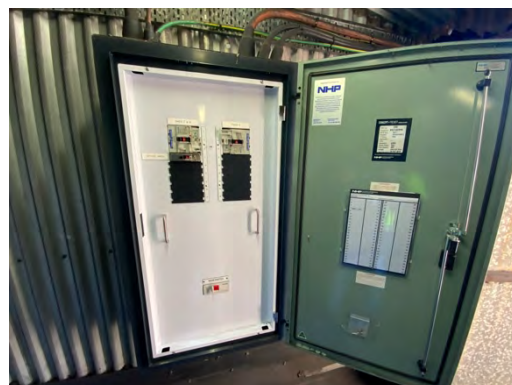
The switchboard is in good condition however due to the capacity (250 amps per phase), will not be suitable use if the buildings are converted to a public area facility.

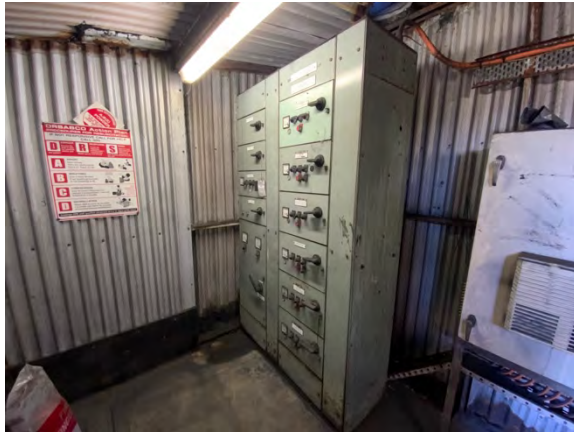
This room also contains a motor control centre (MCC) for the conveyors and controls.

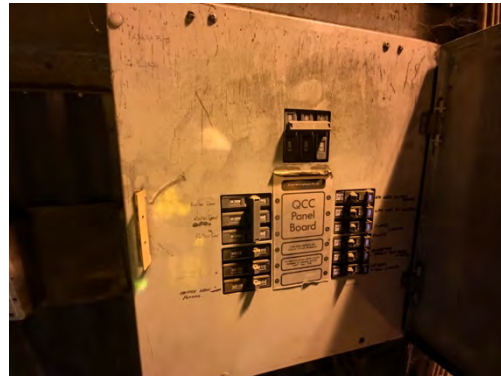
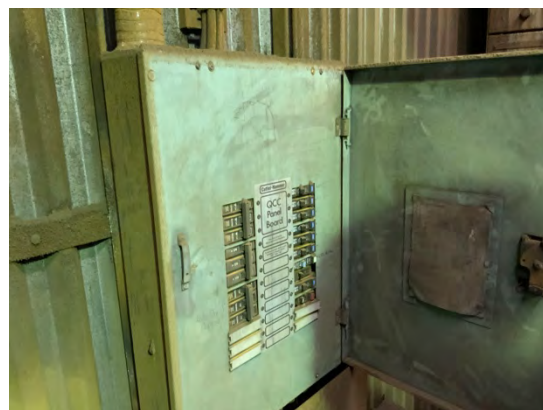
The Shed 6 light and power distribution switchboard is located in a room adjacent to the loading bay associated with this building.

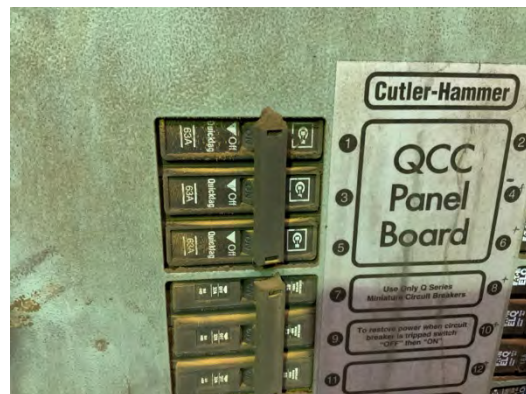
The switchboard is in poor condition and due to the environment has a large amount of minerals on and within the switchboard.

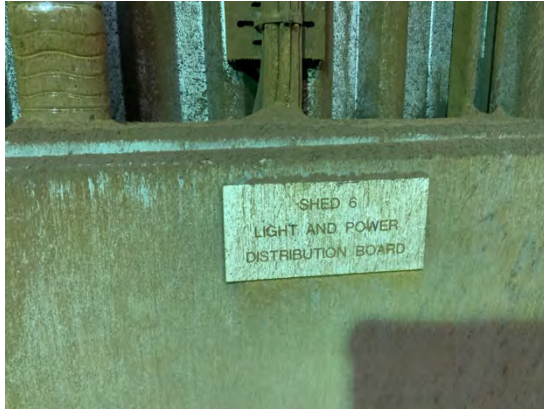
This room also contains a motor control centre (MCC) for the conveyors and controls.

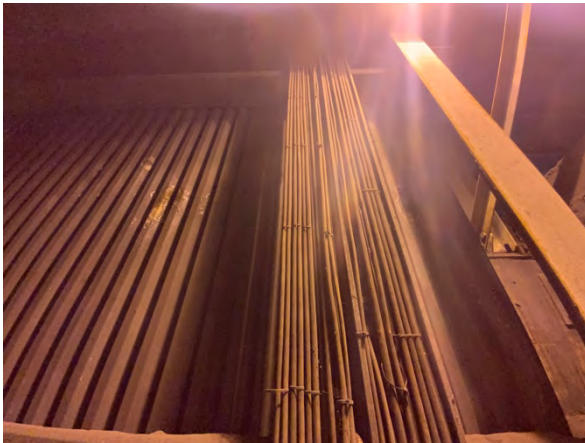
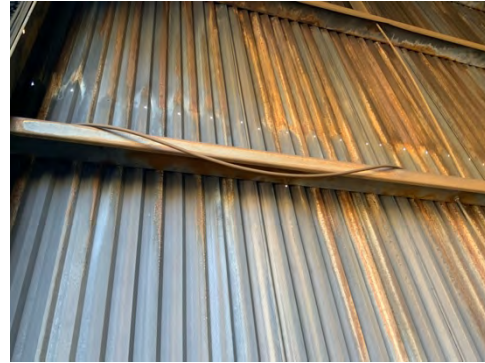
External lighting to the surrounds of the buildings is limited and does not comply with the relevant Australian Standards with regards to illumination levels.

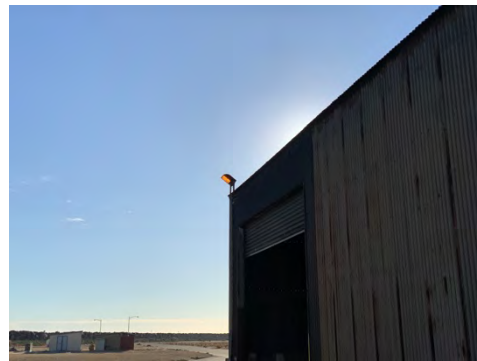
We trust the above is acceptable however if you require any further information please contact the writer on 9646 0668.
