Remobilisation of Lead and Nickel Residues in Esperance

Report of the Working Group to the Steering Committee of the Esperance Cleanup and Recovery Project

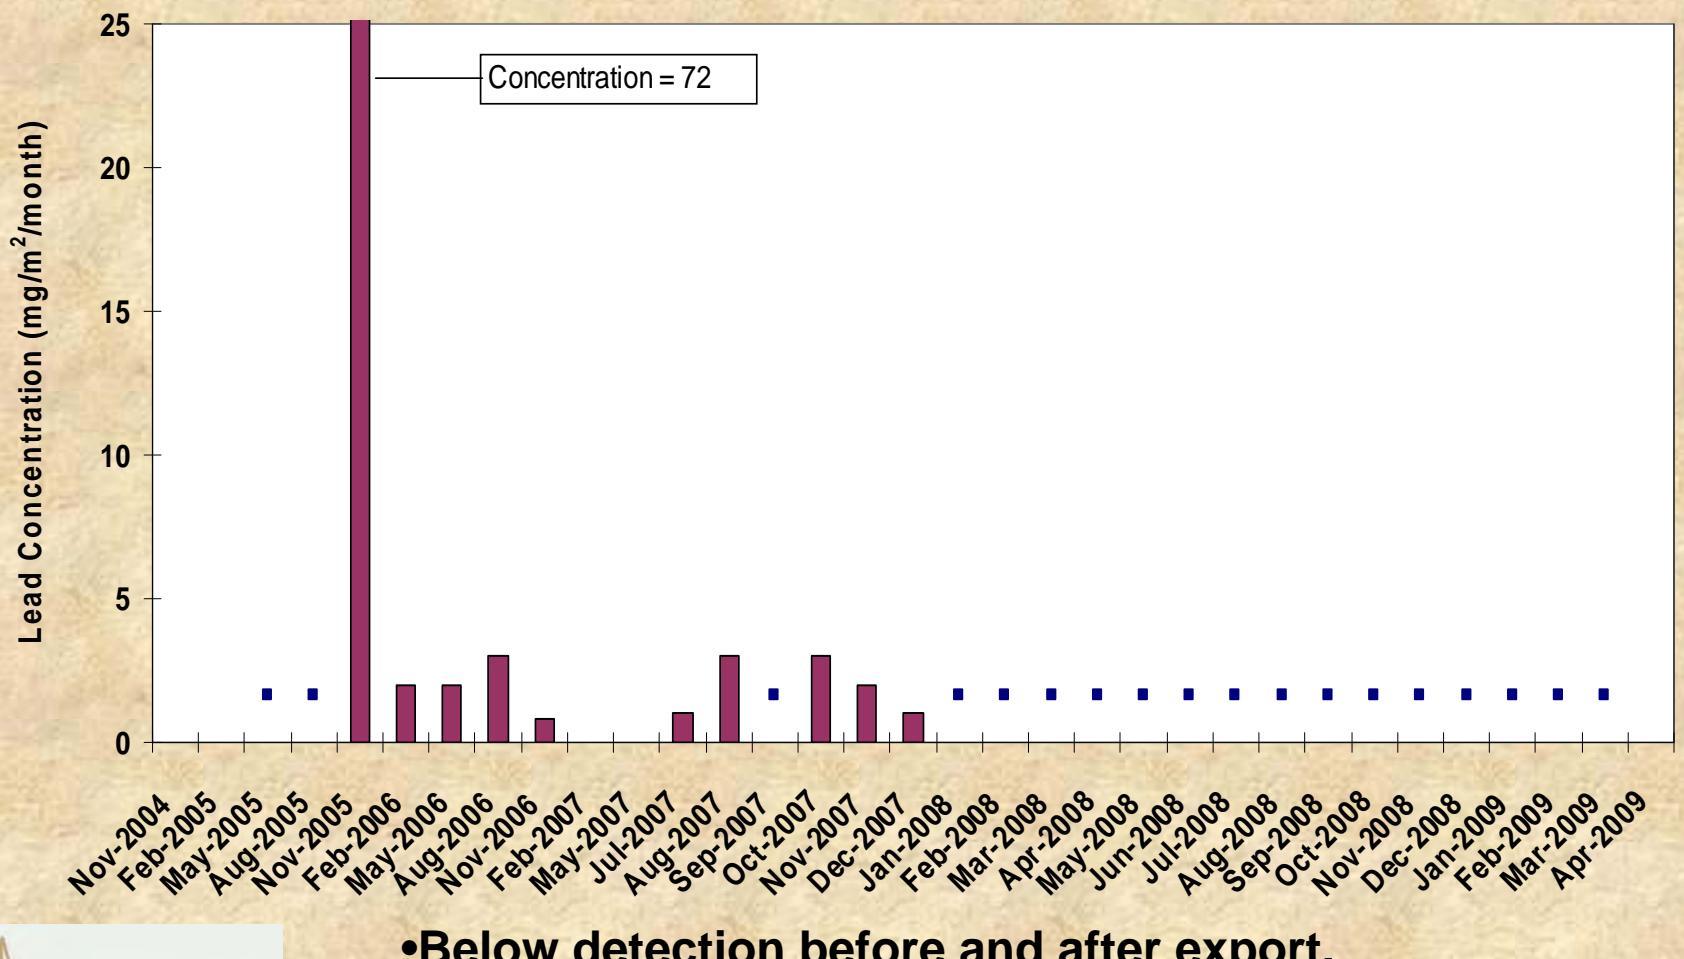
Lead Deposition on Gauge 8

Below detection before and after export.
Some lead during port cleanup, none from final export.
No standard for lead in dust deposition.

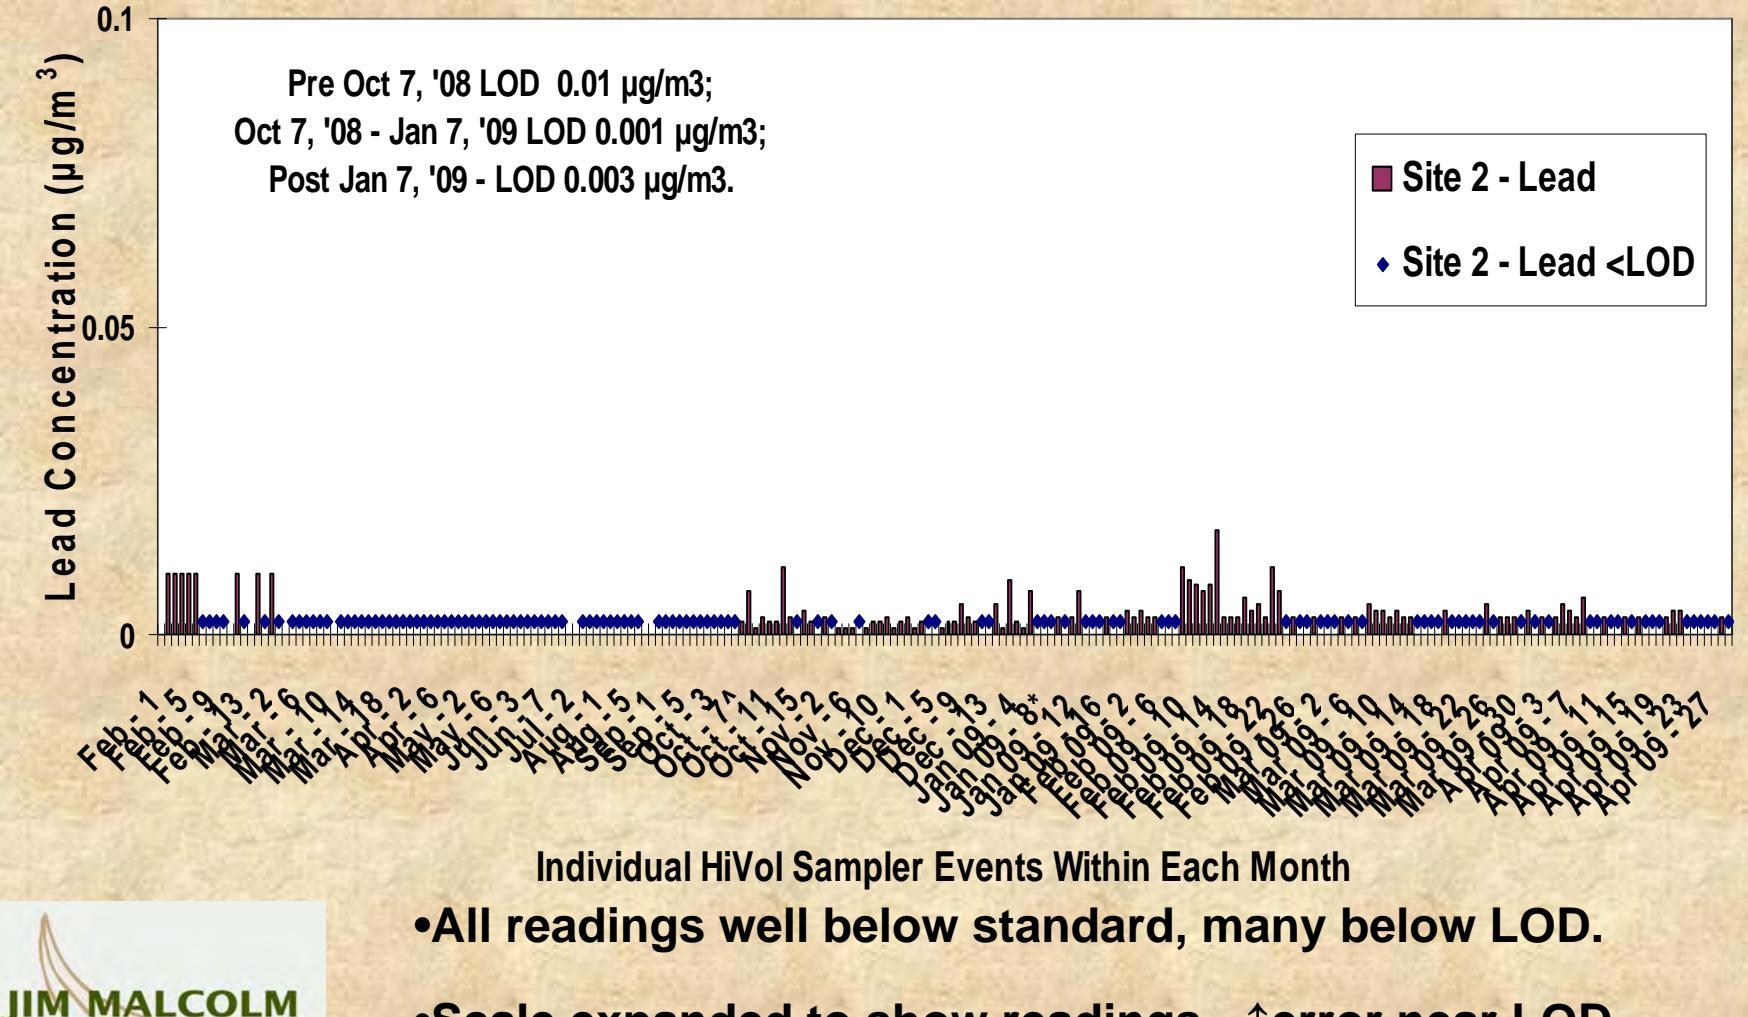
Lead Concentration at Hivol site 2

Scale expanded to show readings - ↑error near LOD.
Some lead (extremely low levels) – Port shed removal?

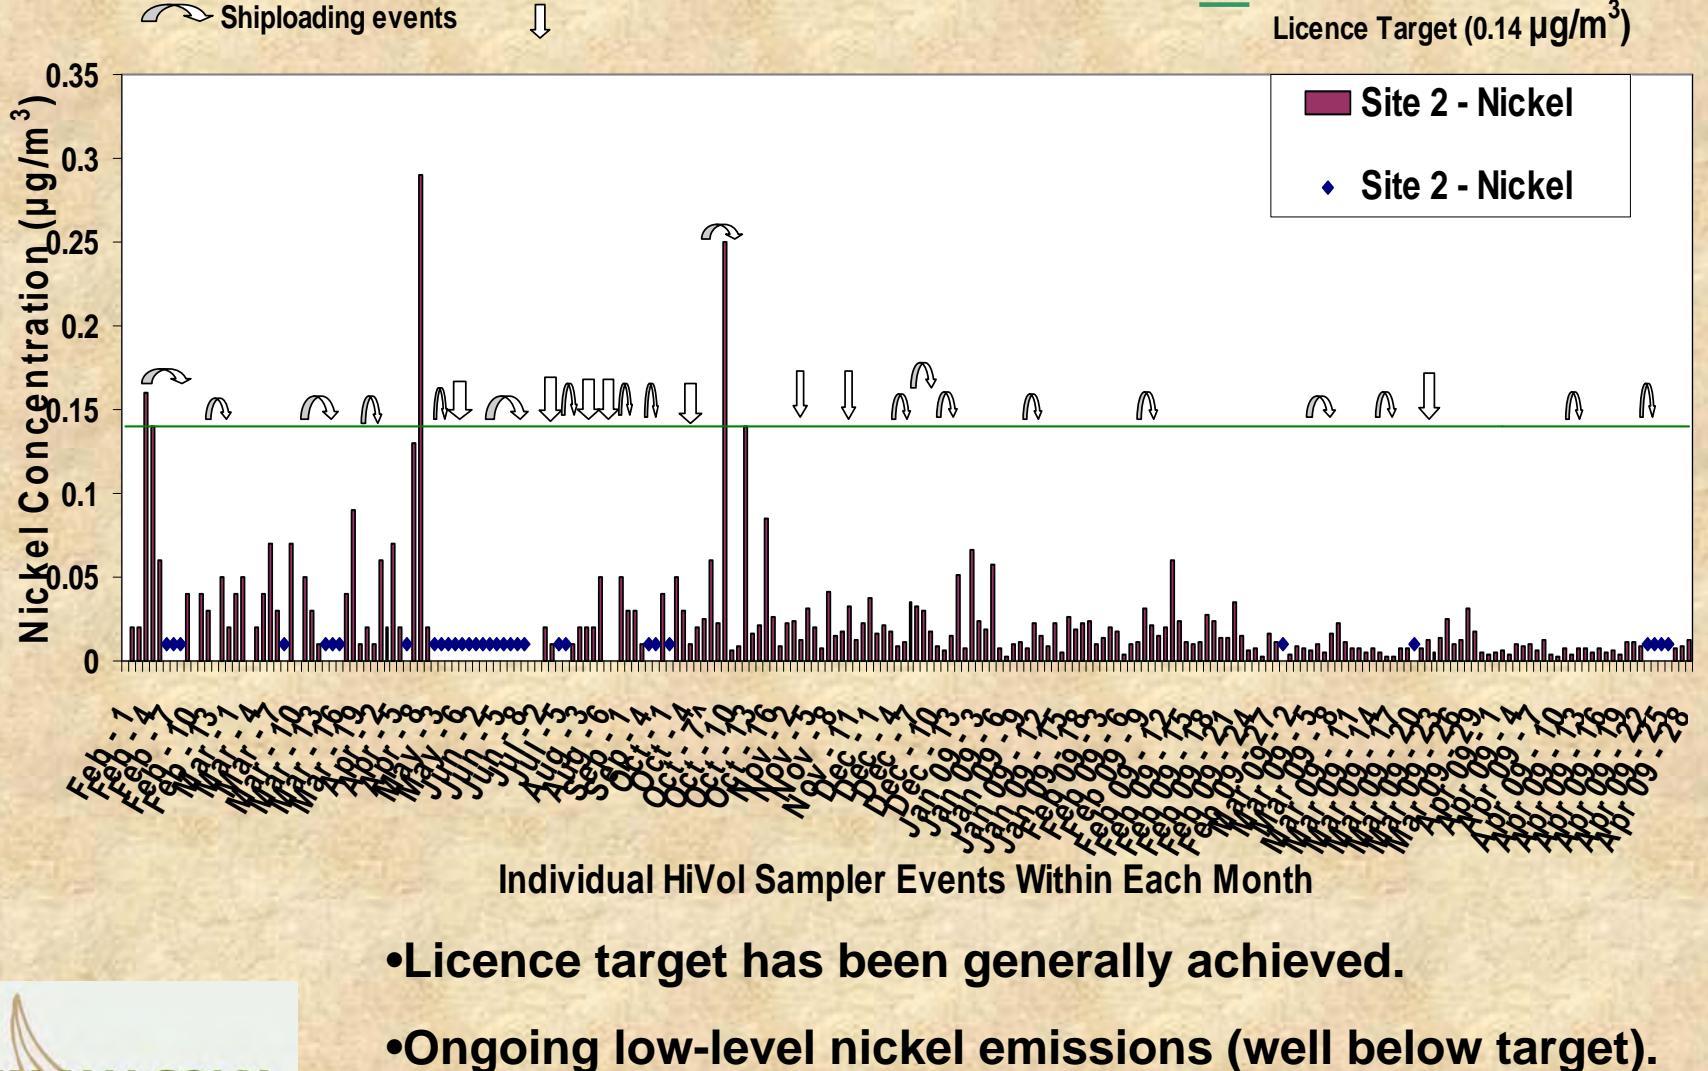
Nickel Concentration at Hivol site 2

•Recently below detection during loading.

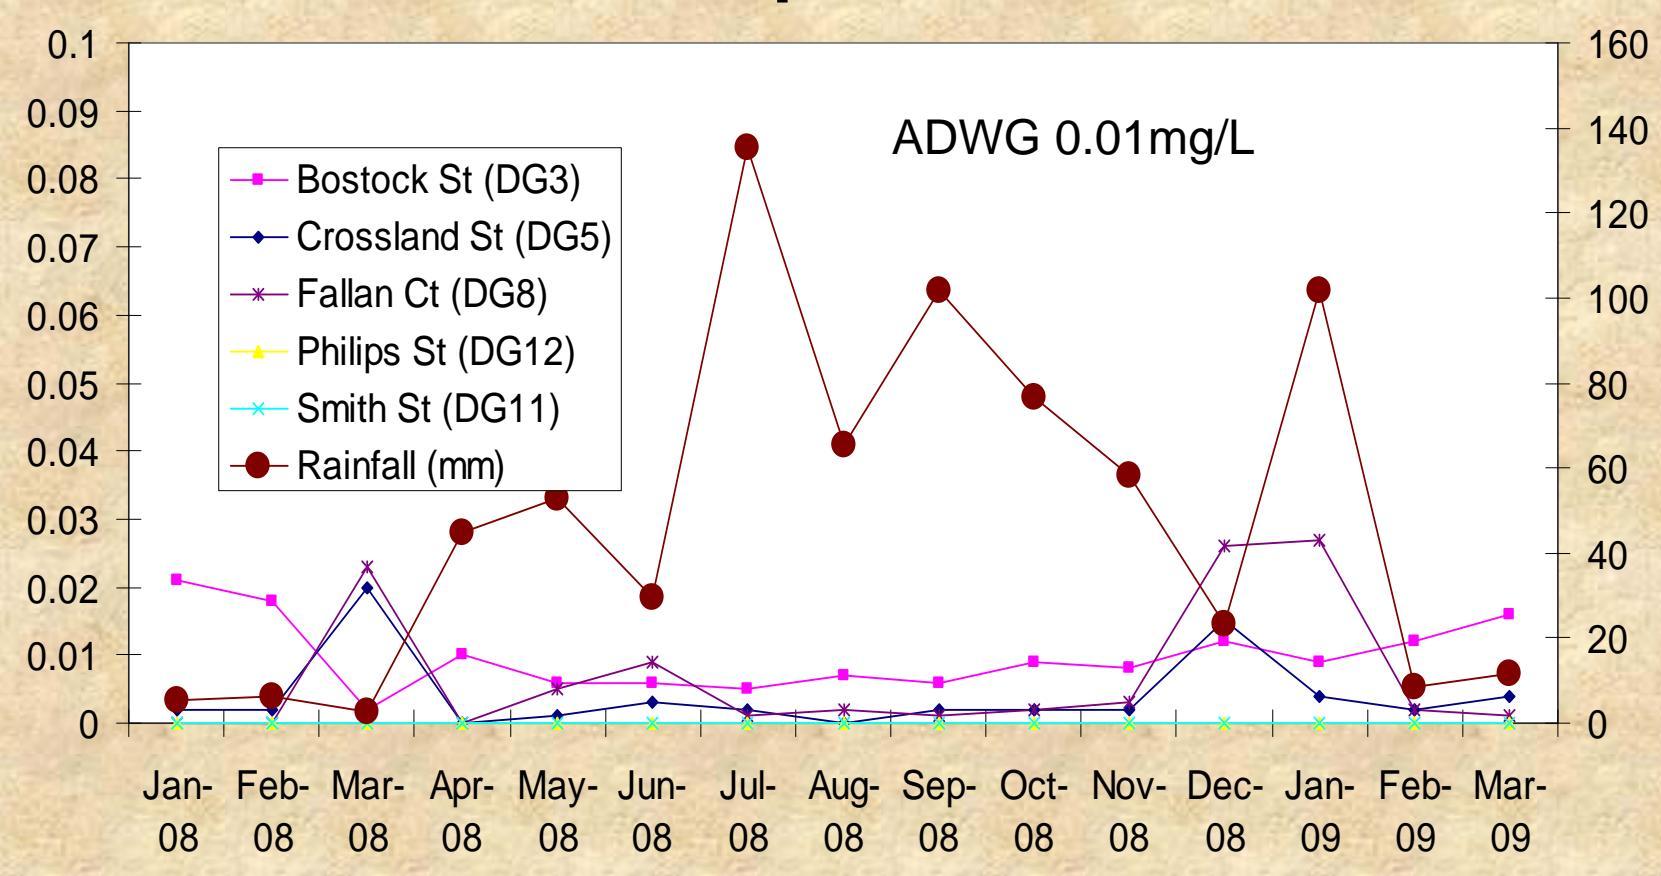
Rainfall vs Lead in Tankwater near port, 2008

Spikes unrelated to rainfall or lead dust levels.
Many confounding factors.
Potential stocks must be removed.

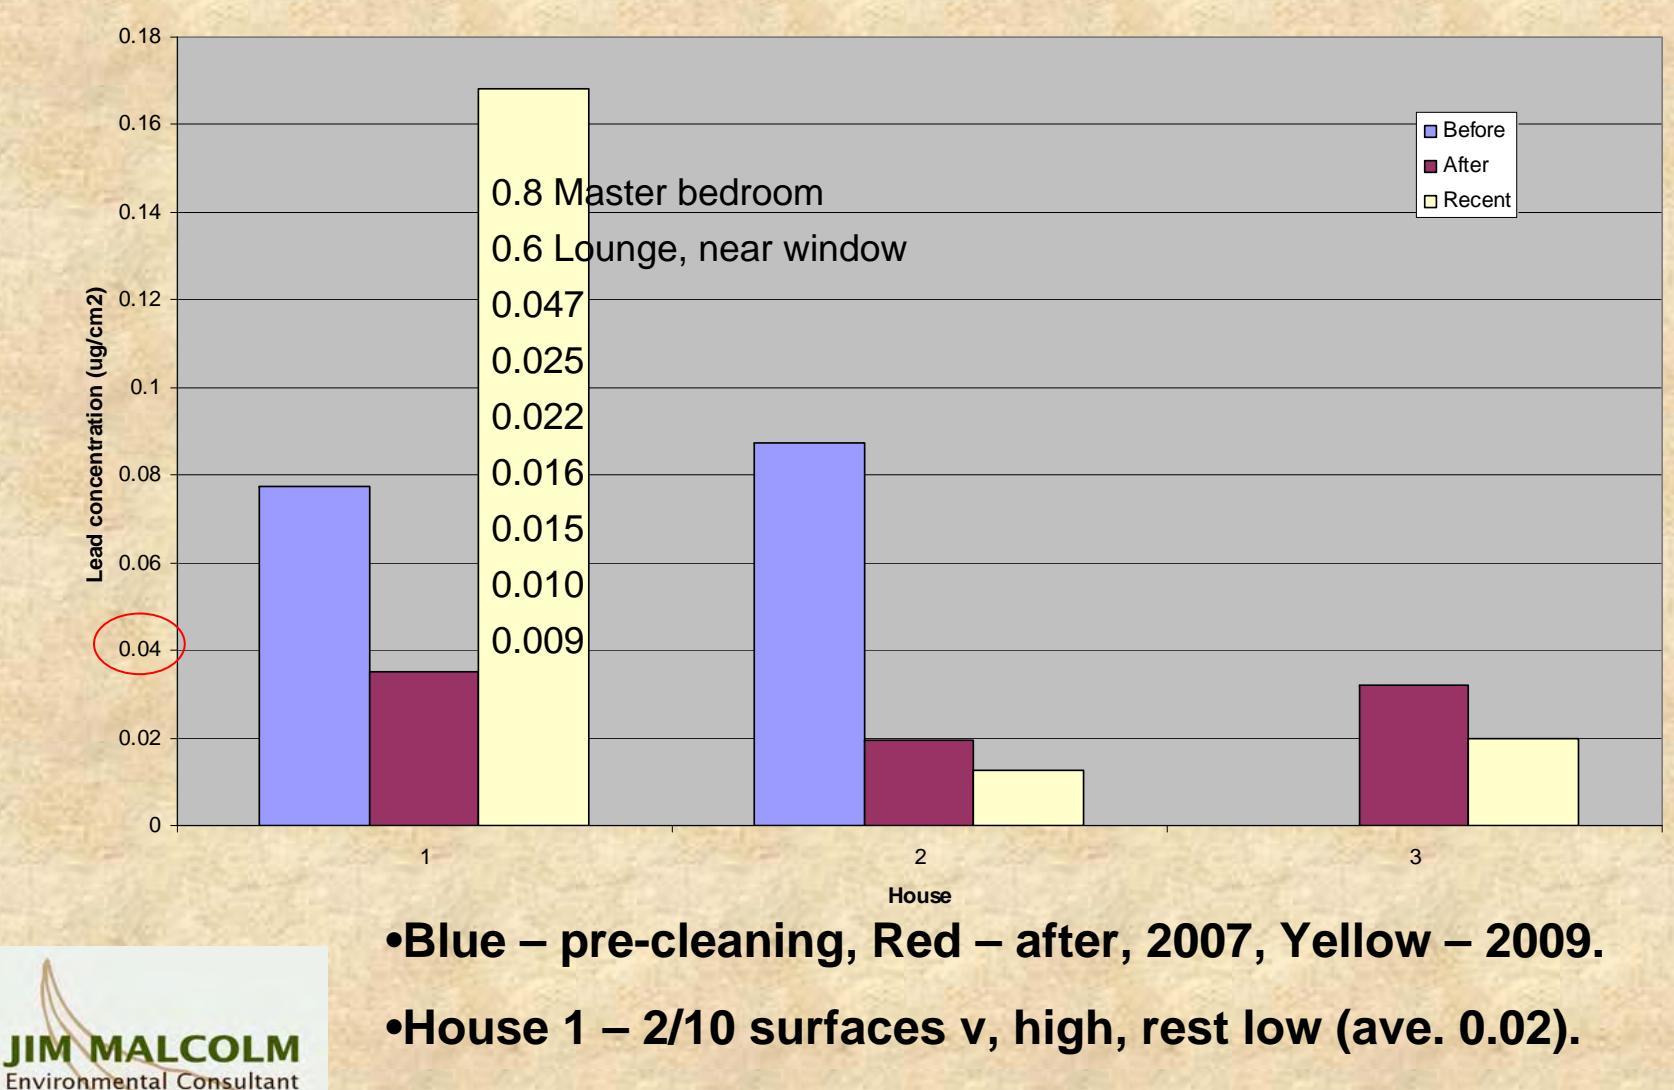
Internal lead levels in cleaned houses

Recontamination or surfaces overlooked in cleaning?

Thorough cleaning protocol with verification.

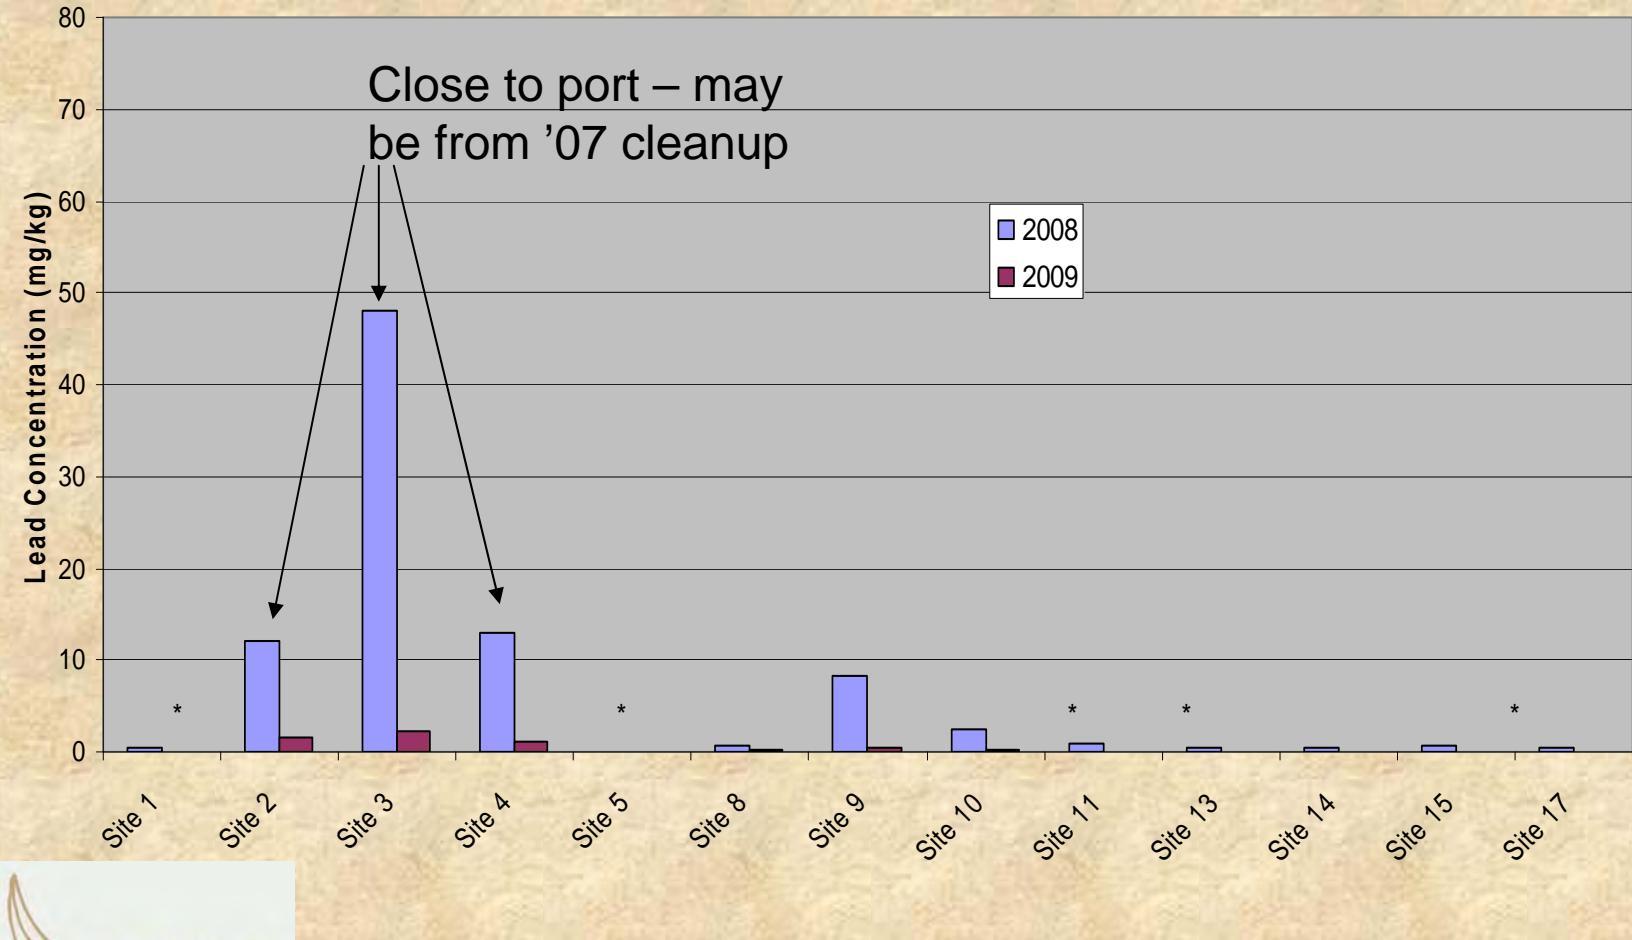
Lead in flowers March '08 vs '09

JIM MALCOLM Environmental Consultant Much lower in 2009, but some still above remote control.

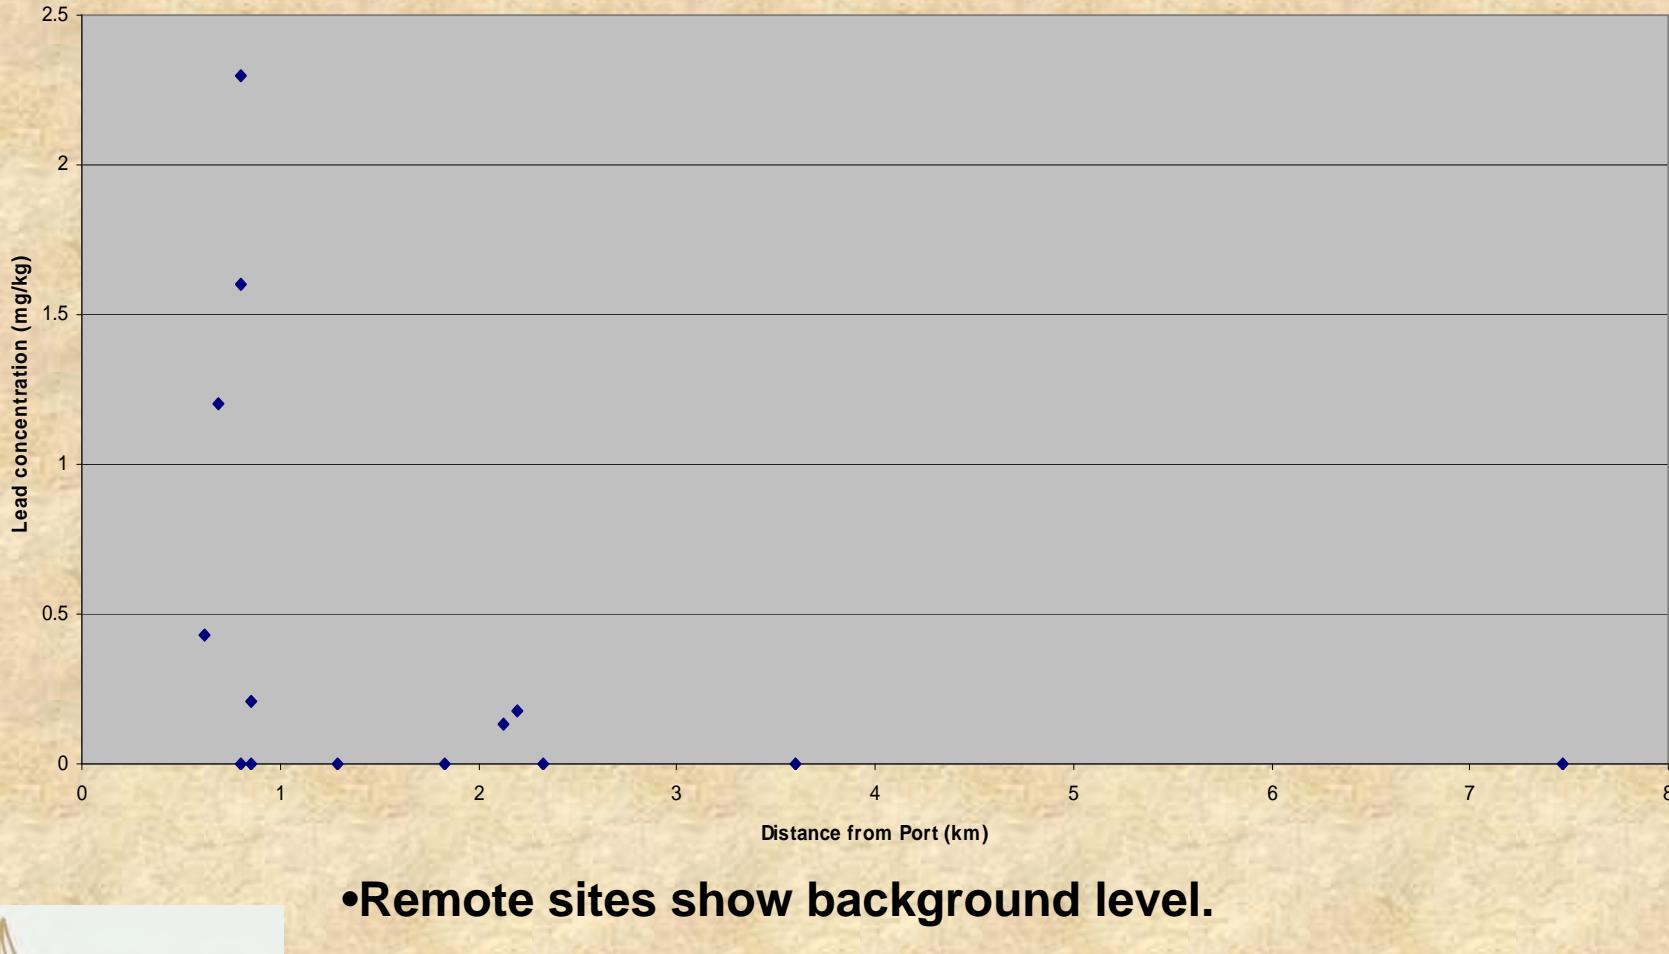
Lead in flowers ('09) vs Distance from Port

- •Some sites close to port low, but still slightly elevated.
- Traces of lead transferred from adjacent old leaves?
