## **AUGUSTA BOAT HARBOUR: ENVIRONMENTAL COMPLIANCE ASSESSMENT REPORT (2016) - EPBC APPROVAL 2008/4506**

# Augusta Boat Harbour 2016 Rehabilitation Assessment

Prepared for Department of Transport  
30 November 2016

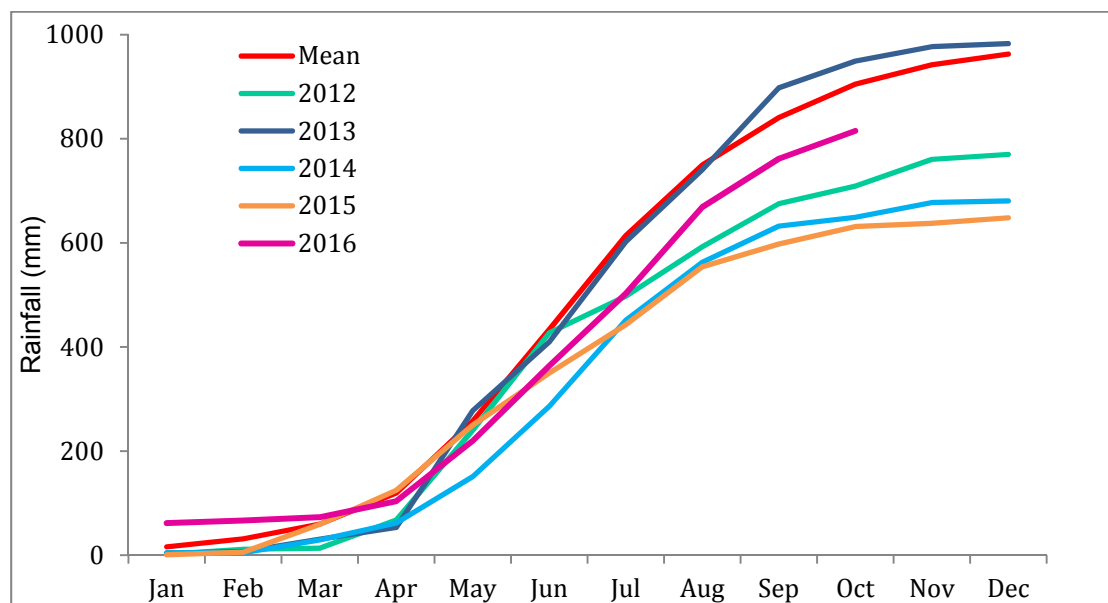
**Figure 3** Cumulative monthly rainfall totals for Cape Leeuwin Weather Station (approximately 6 km south-west of the Augusta Boat Harbour) for 2012, 2013, 2014, 2015 and January to October 2016.

Annual rainfall for Augusta was well below the long term average of 963 mm for 2012 (770 mm), 2014 (677 mm) and 2015 (648 mm) (Figure 3). In contrast, the 2013 annual total of 983 mm was slightly above the long-term average. Total rainfall from January to October 2016 totalled 815 mm, which was also below the long term average for the same period (905 mm). With the exception of January, August and September, monthly rainfall totals during 2016 were below the long term monthly averages (Figure 4).

Since native rehabilitation commenced at the Augusta Boat Harbour in mid 2012, three of the four subsequent years have experienced annual rainfall totals less than the long term average (Figure 3).
