# Bandy Creek Weir Flood Event and Underwater Investigation

The Bandy Creek Weir was overtopped on 11 February 2017 and experienced substantial damage following a flood event.

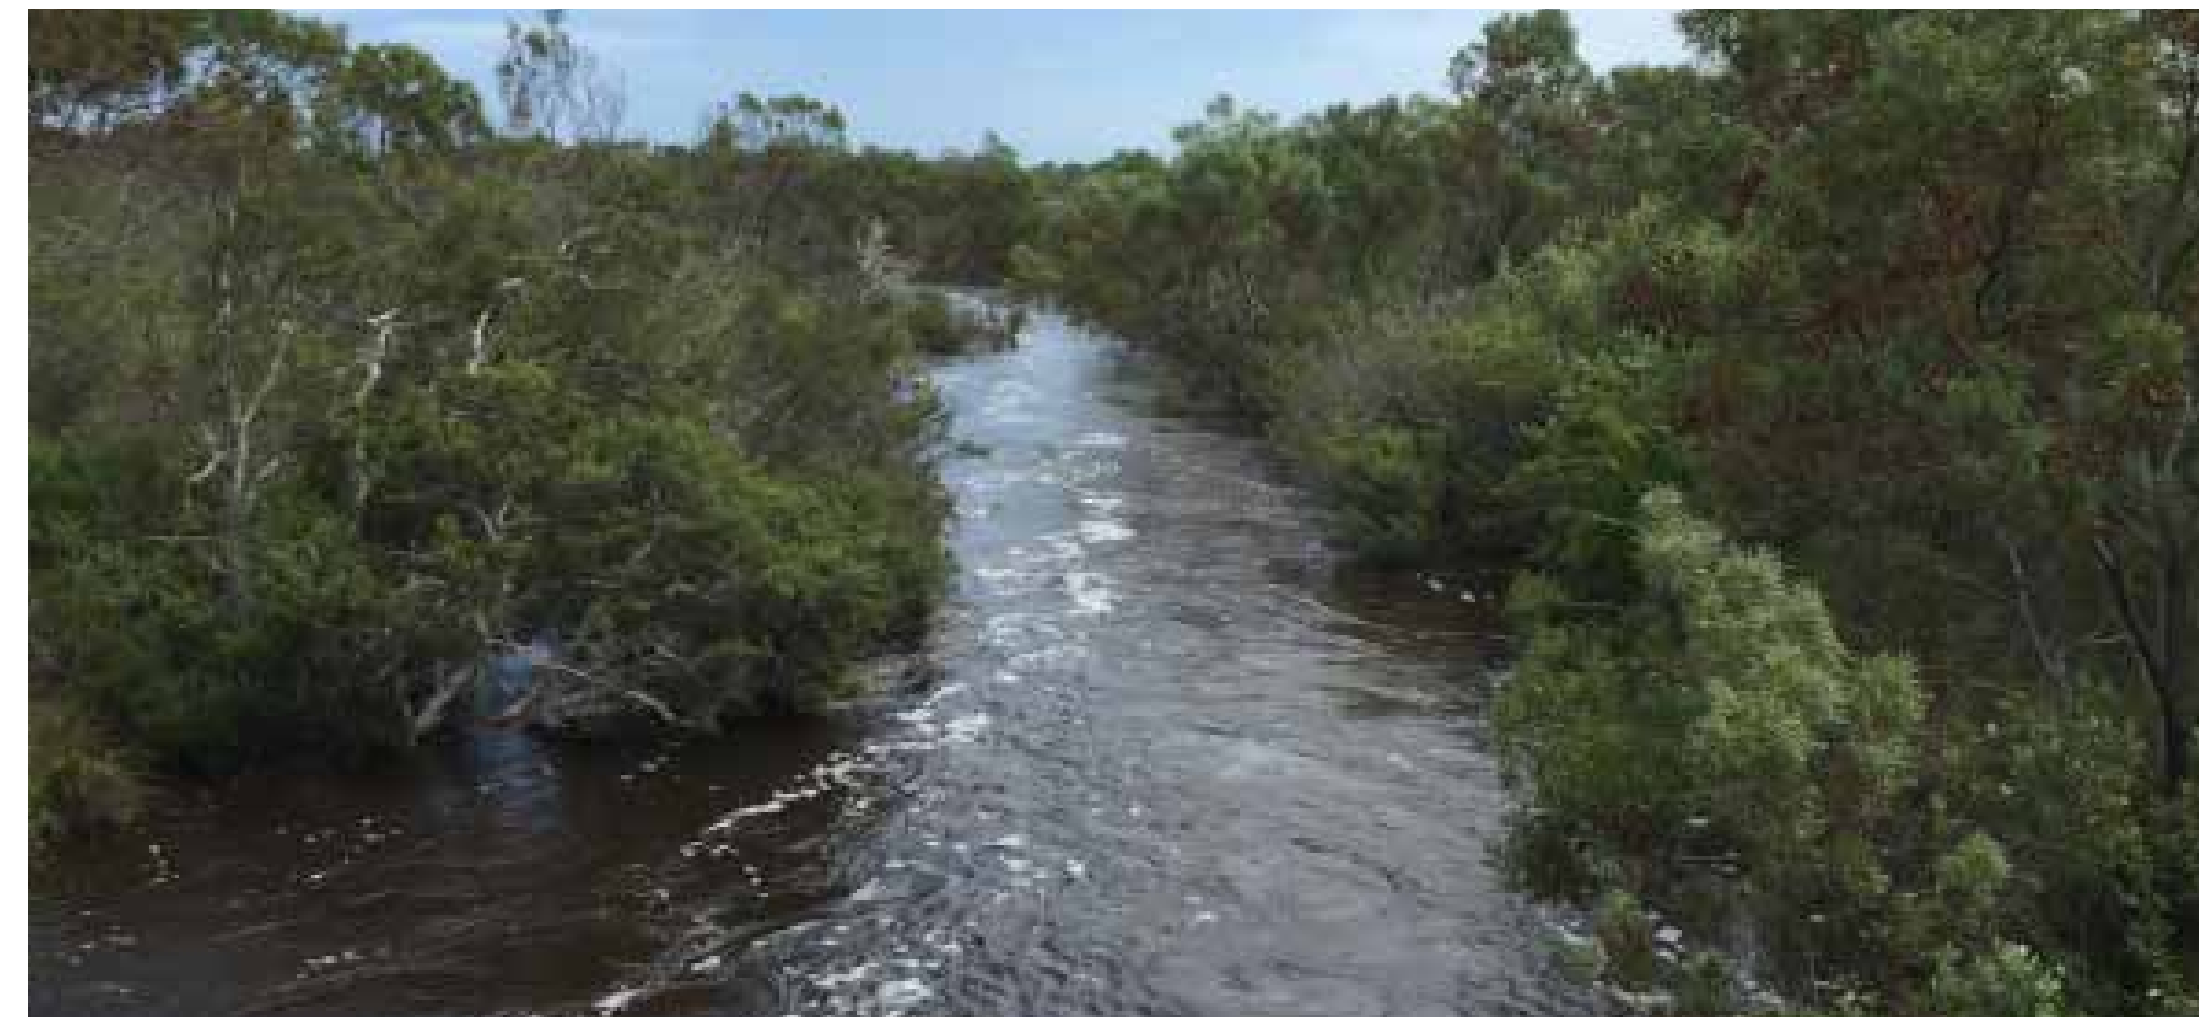
Bandy Creek flooding

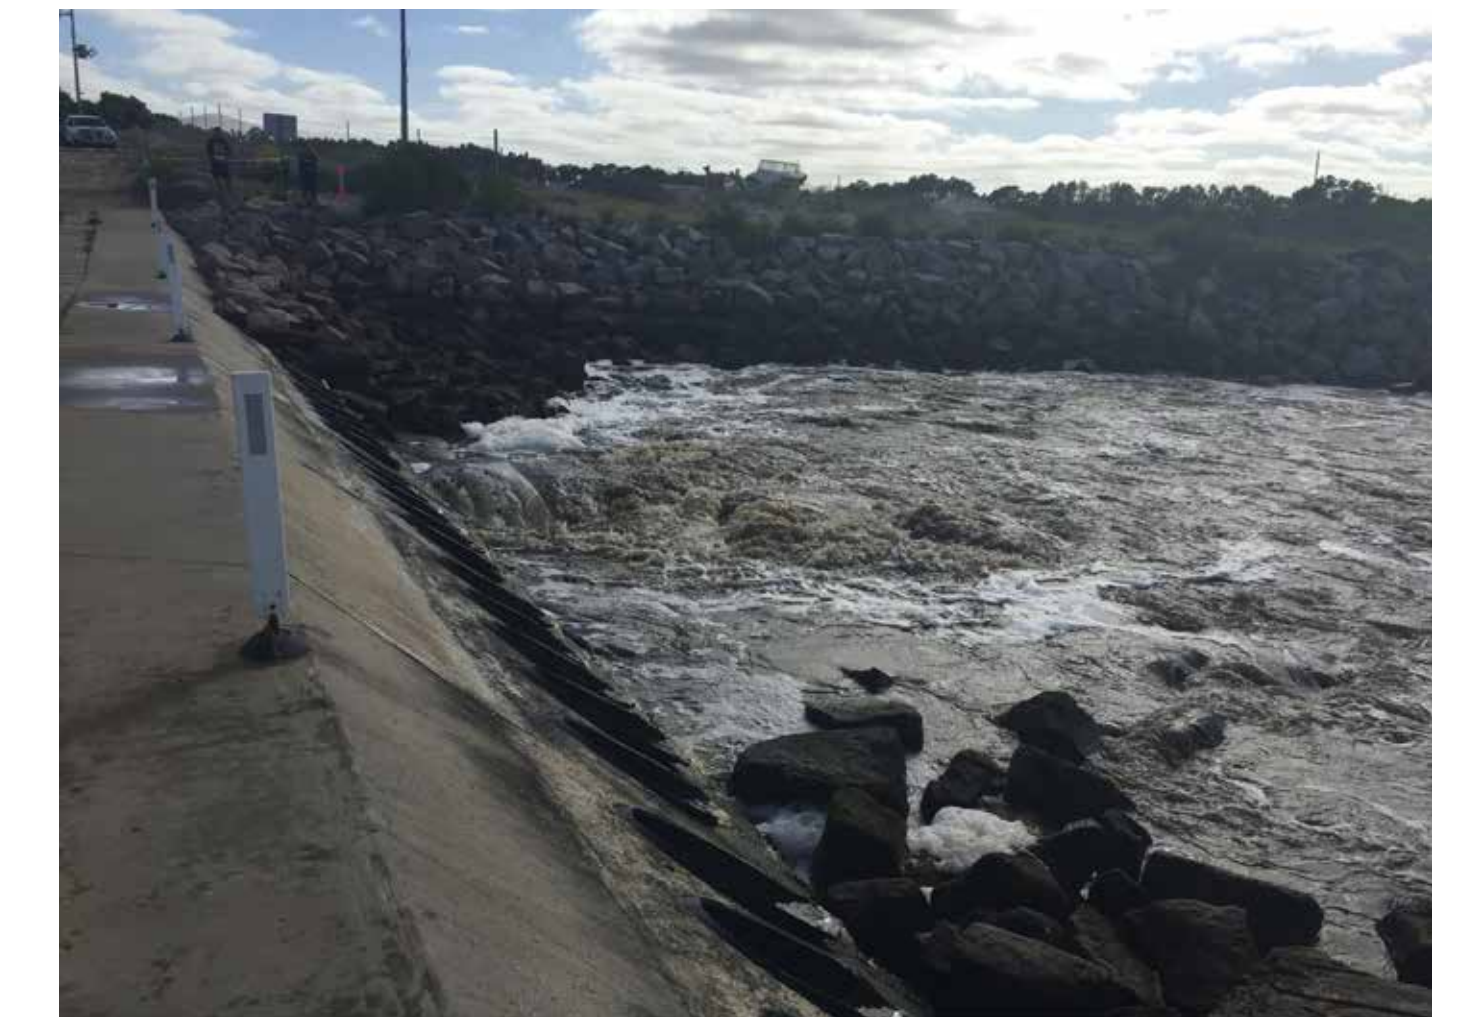
Turbulent flow downstream

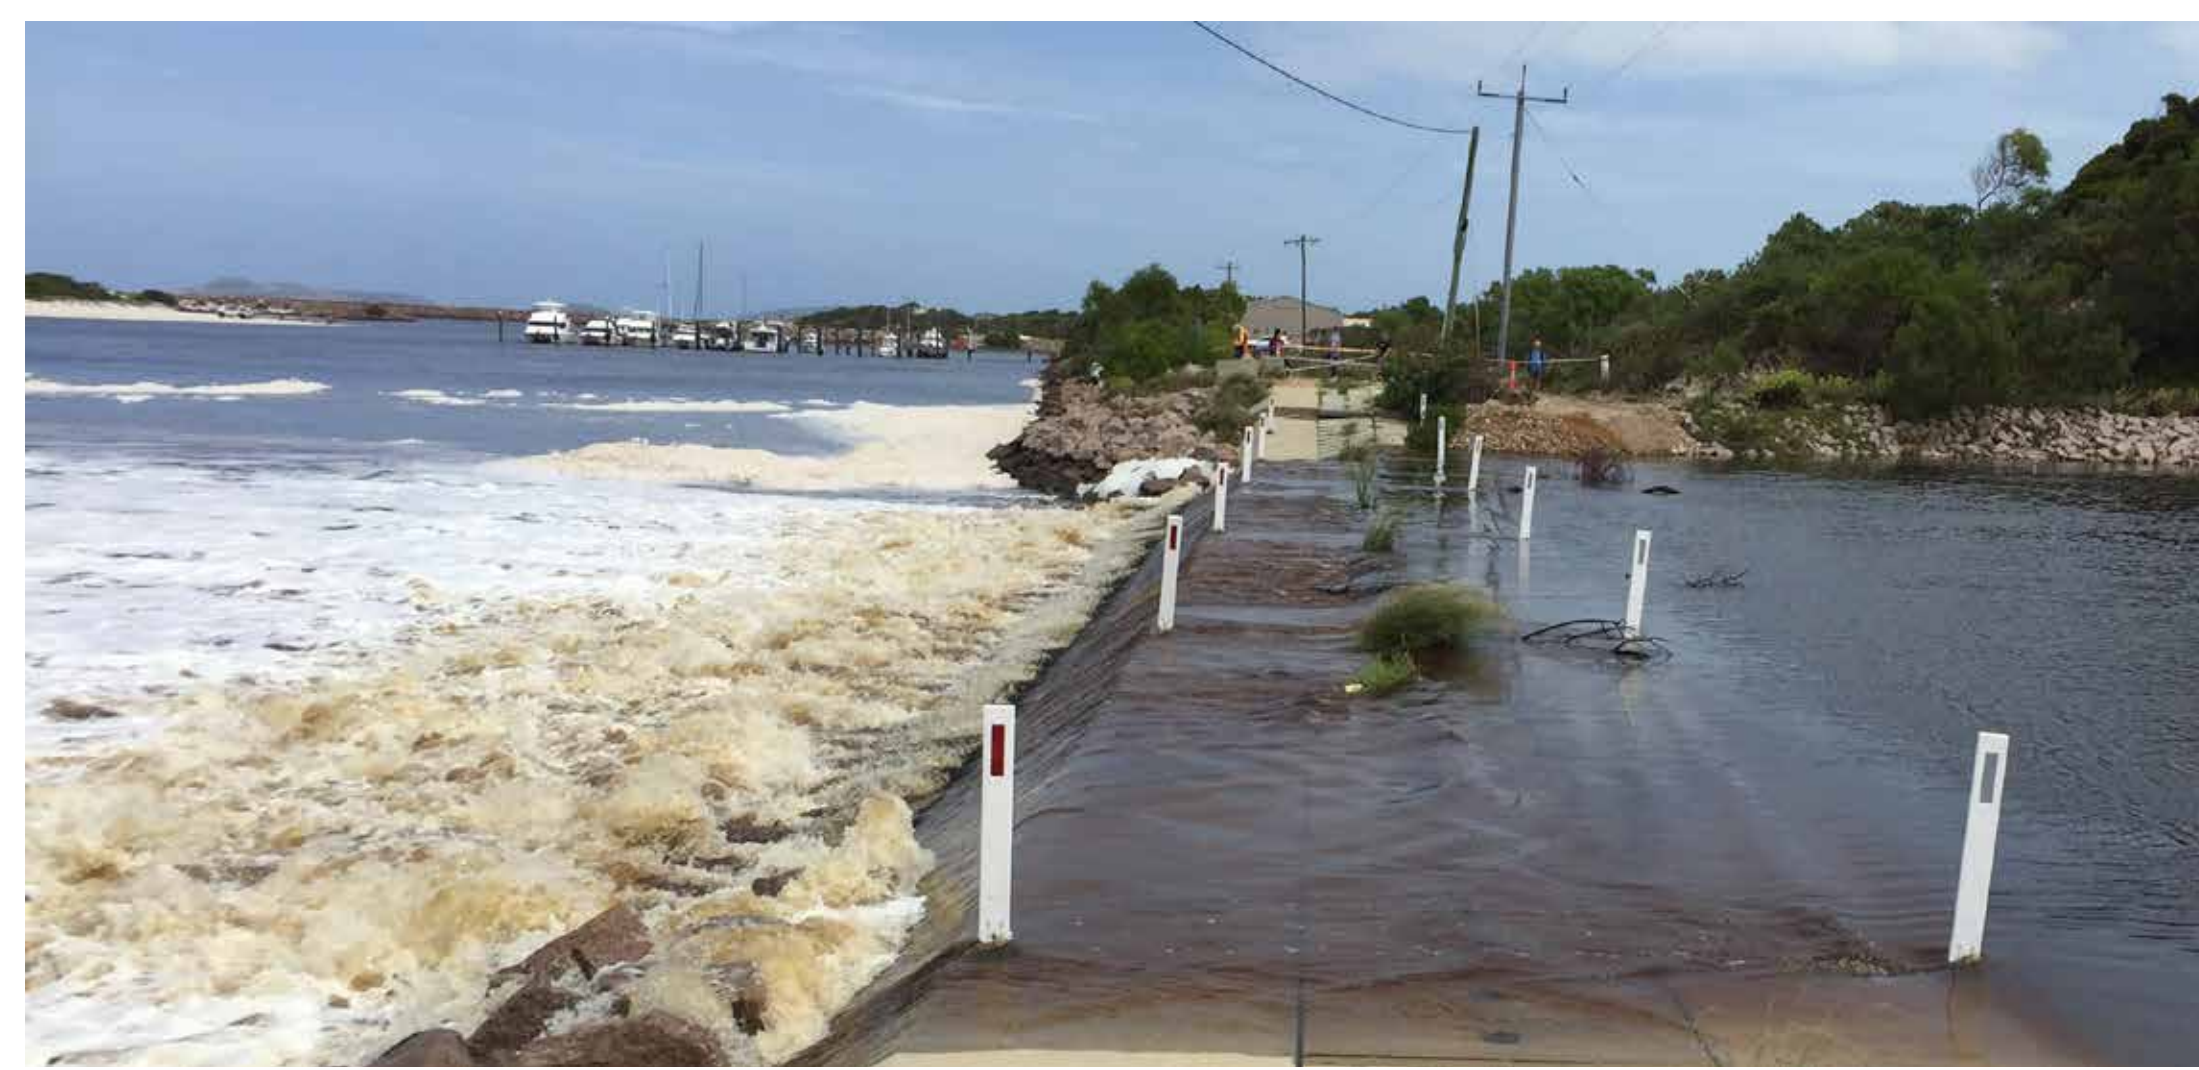
Bandy Creek Weir overtopping

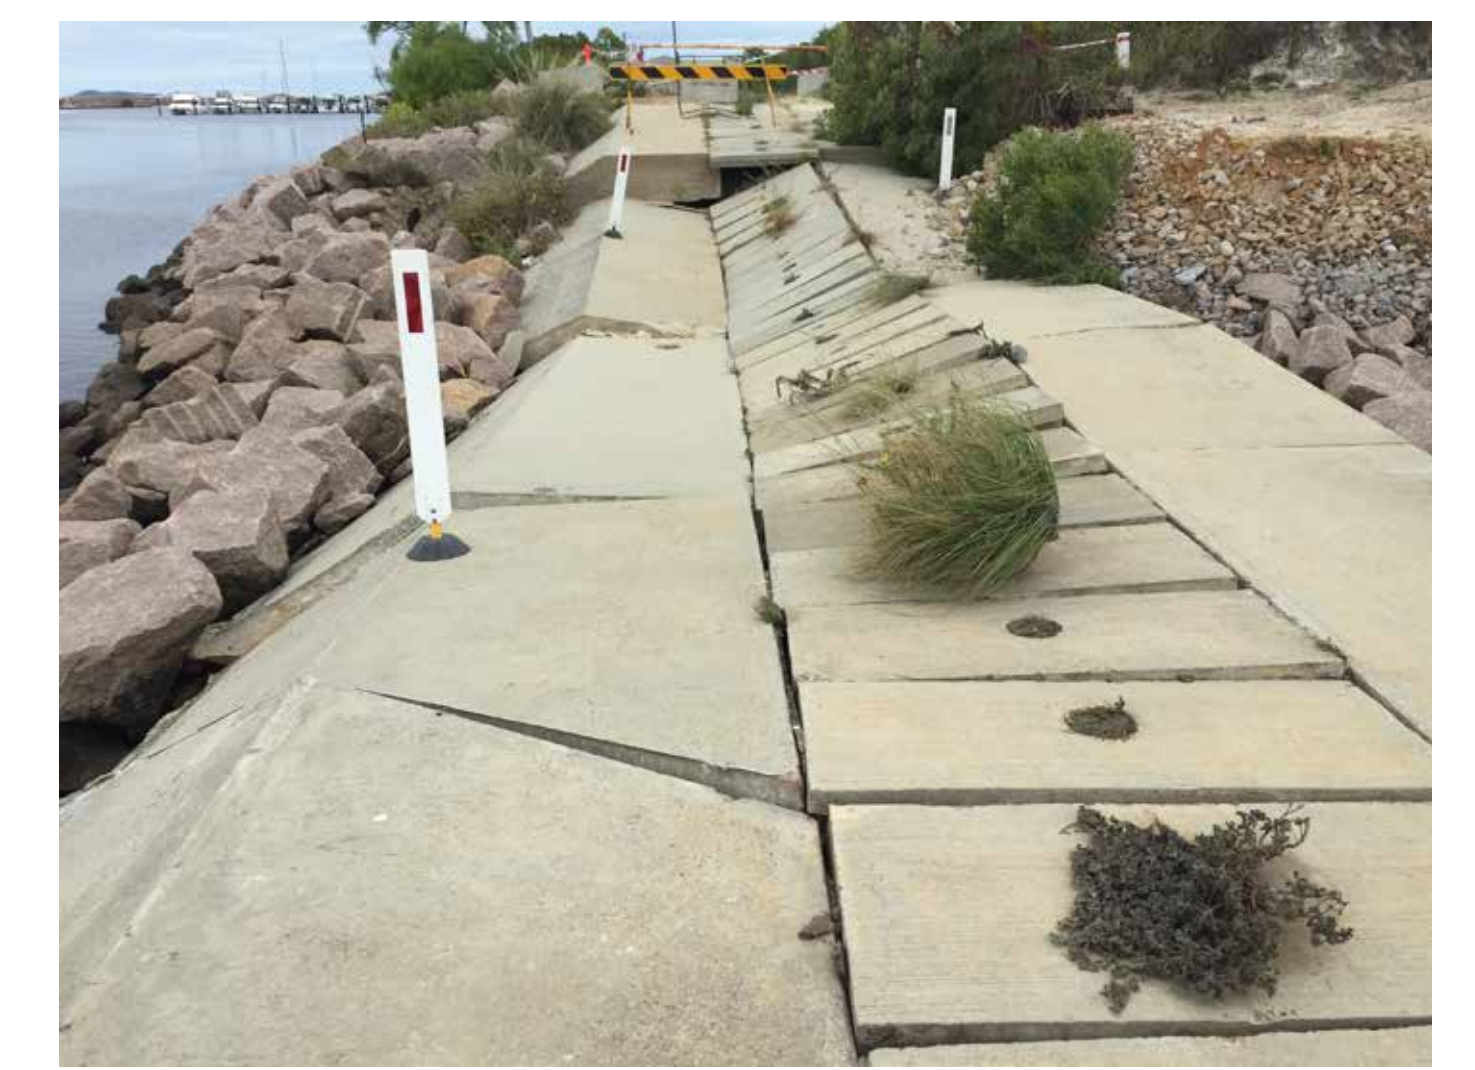
- Erosion of the foundation
- Collapse of concrete structure
- Slumping of rock revetments.

Concrete weir damaged

The extent of erosion was large and engineers recommended removal and reconstruction of the structure.

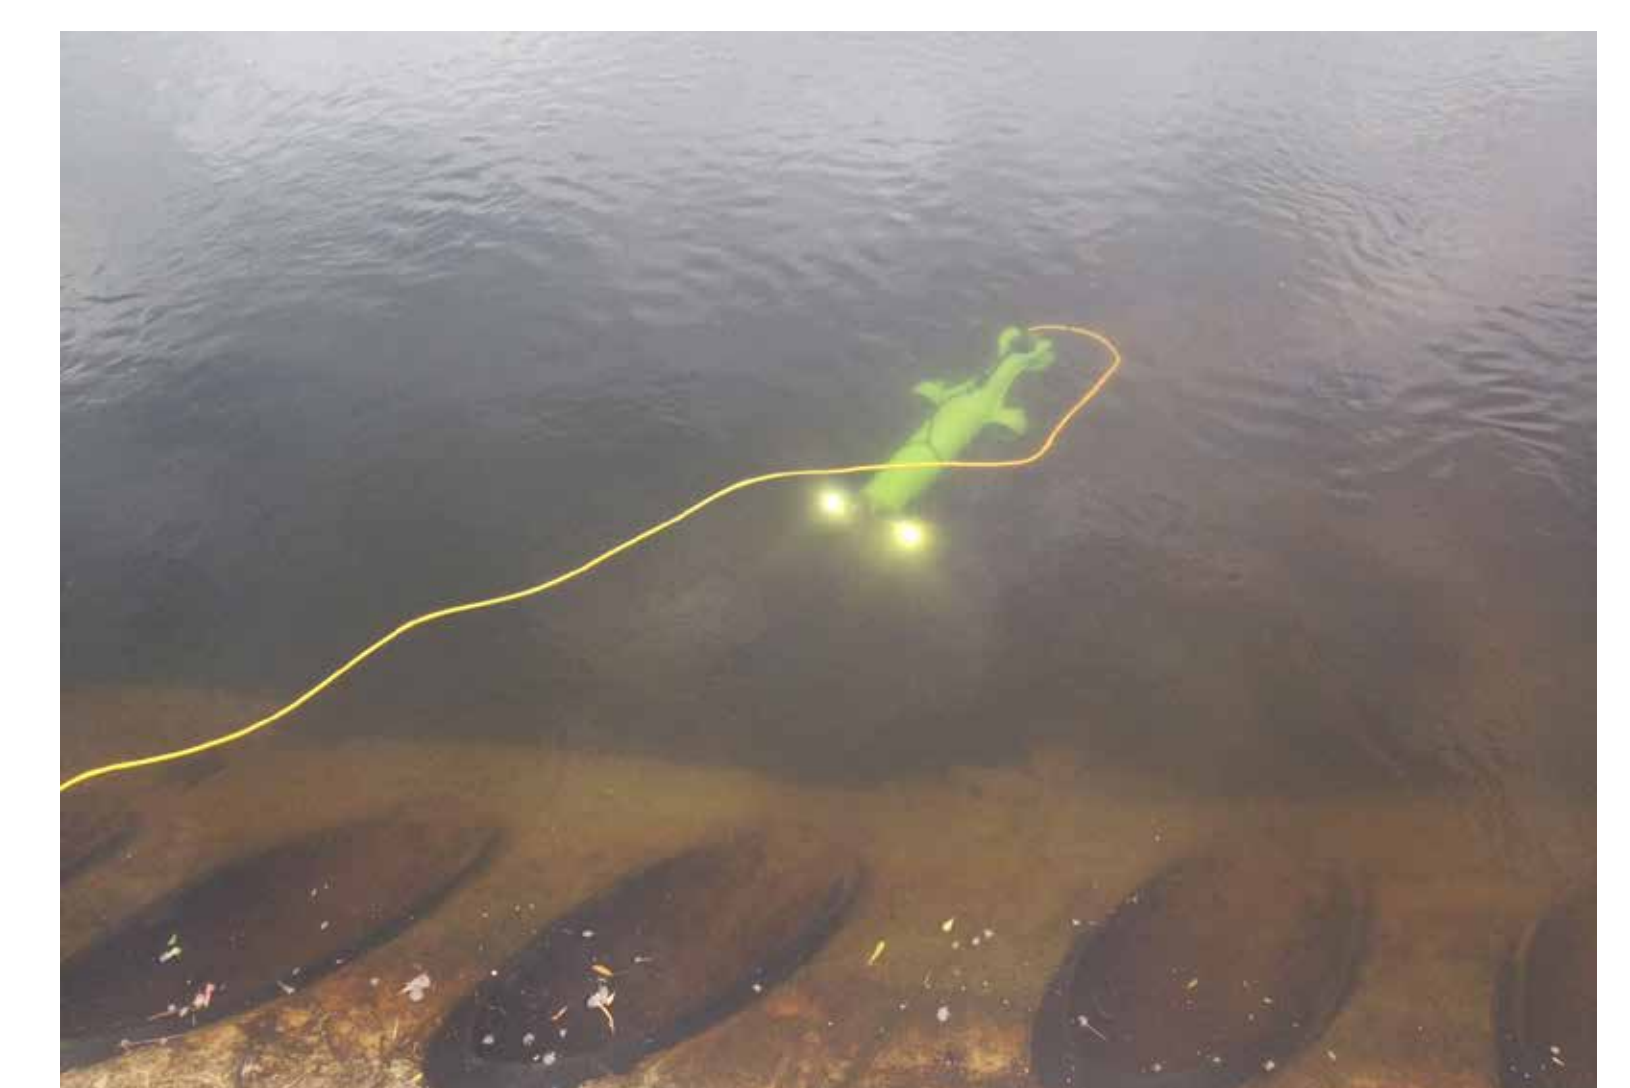
Underwater investigation using an underwater remotely operated vessel (ROV) was carried out to assess the extent of the erosion.

Remote operated vessel (ROV)

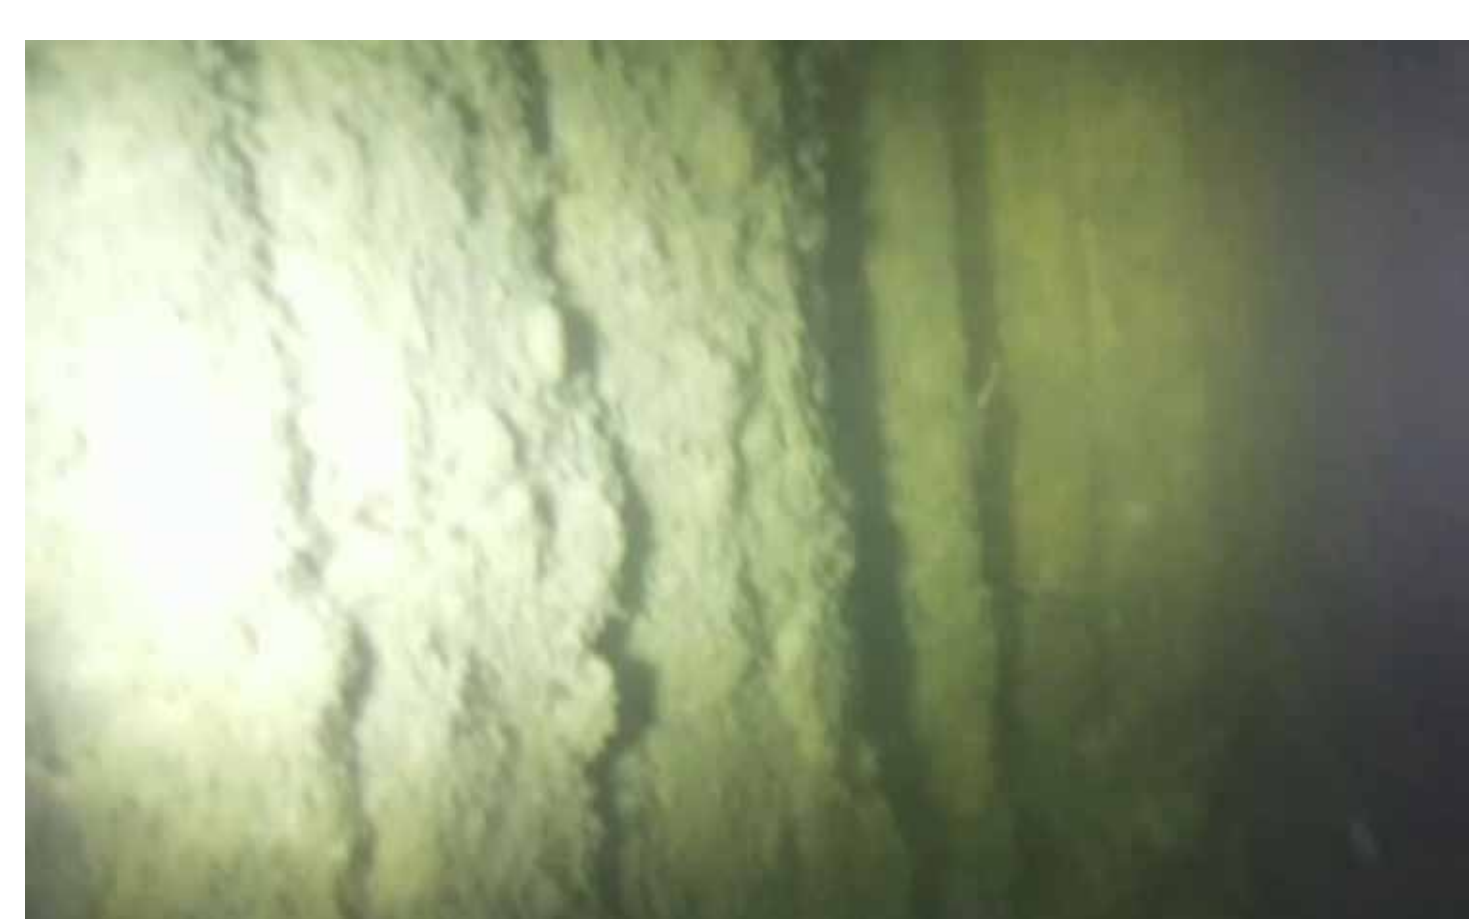
Underwater footage
