MEMORANDUM

ATTN:	Leanne Thompson	CC:	Hans Jacob, Donna West, Peter Wilkins
ORGANISATION:	Department of Water and Environmental Regulation	FROM:	Dr Katharine Thorne, Louise Synnot
PROJECT NO:	365_05	DATE:	23 March 2018
SUBJECT:	Summary of the Beadon Creek Capital Dredging Environmental Monitoring

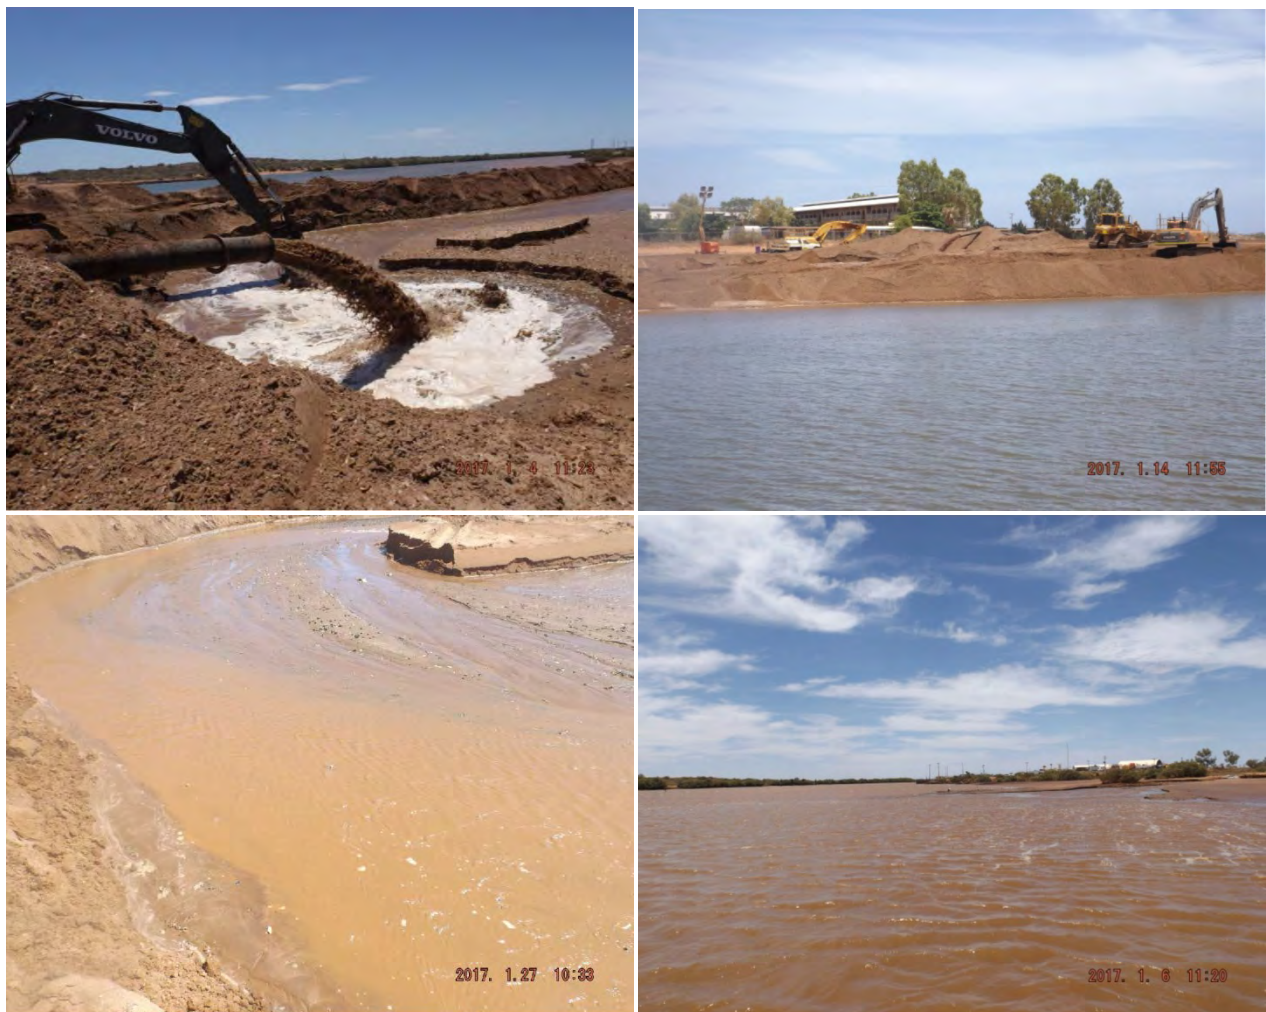
Figure 3.1 Disposal of dredged sediment to the bunded swale settlement system during the Beadon Creek 2016/17 Capital Dredging

The majority of the non-contaminated sediment outside of the TBT contaminated areas (Figure 1.1) was dredged via cutter-suction dredge (CSD) and disposed of via pipeline to a bunded swale settlement system located on Lot 13 where sediment was accumulated to be dried for wharf construction (Figure 1.1; Figure 3.1). Return water was discharged to the creek at the southern end of Lot 13 via the swale settlement system (Maritime Constructions 2016a).

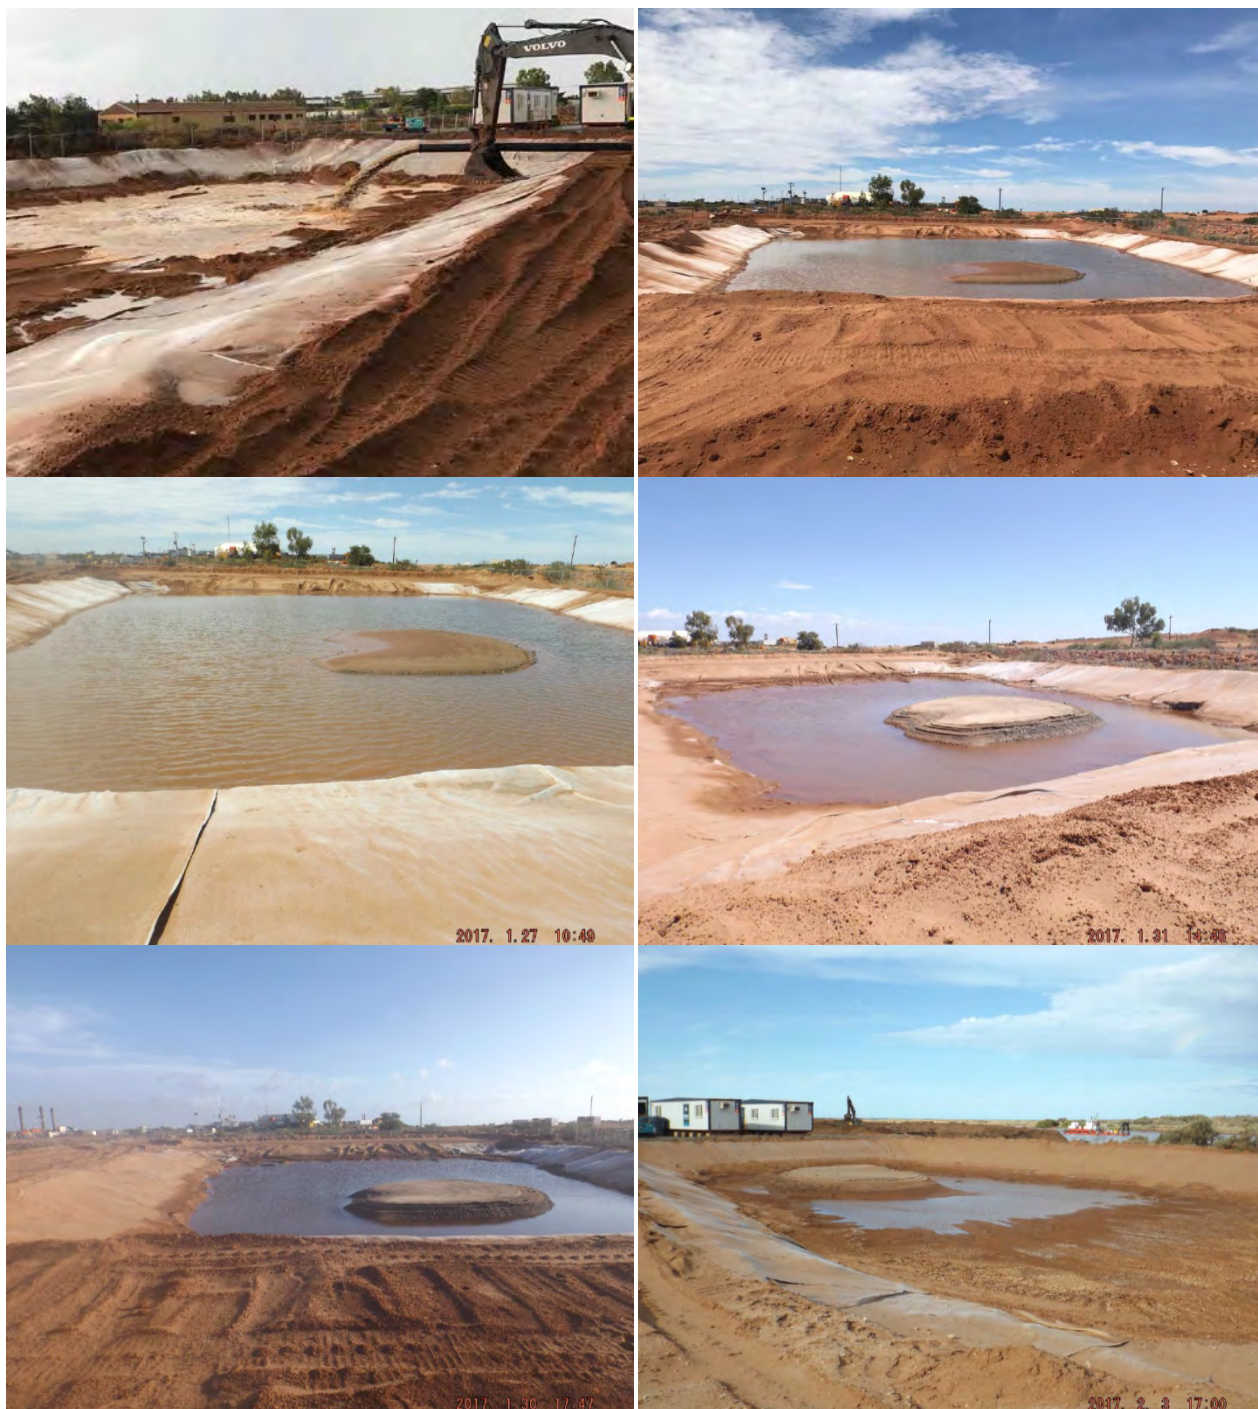
Figure 3.2 Disposal to TBT containment area (Top panel–26 January 2017) and subsequent natural dewatering during Beadon Creek 2016/17 Capital Dredging

The dredge slurry ratio required to dilute the return water from the dredging of Area A to meet the 90% species protection level (ANZECC & ARMCANZ 2000) was not practically achievable by the CSD. Therefore sediments from Area A were dredged and disposed to a fully enclosed bunded area (TBT containment area) on Lot 14, to the south the main reclamation area on Lot 13, and above high water level¹ (Figure 1.1; Figure 3.2) (BMT Oceanica 2016a, Maritime Constructions 2016a). A bentonite clay liner was used to seal the bund walls and prevented direct flow of the supernatant water into the creek. The supernatant water evaporated and seeped into the ground within approximately 8 days of dredging the Area A sediments and therefore direct return of the water to the creek was not necessary (Figure 3.2). Once de-watered, the Area A sediments were

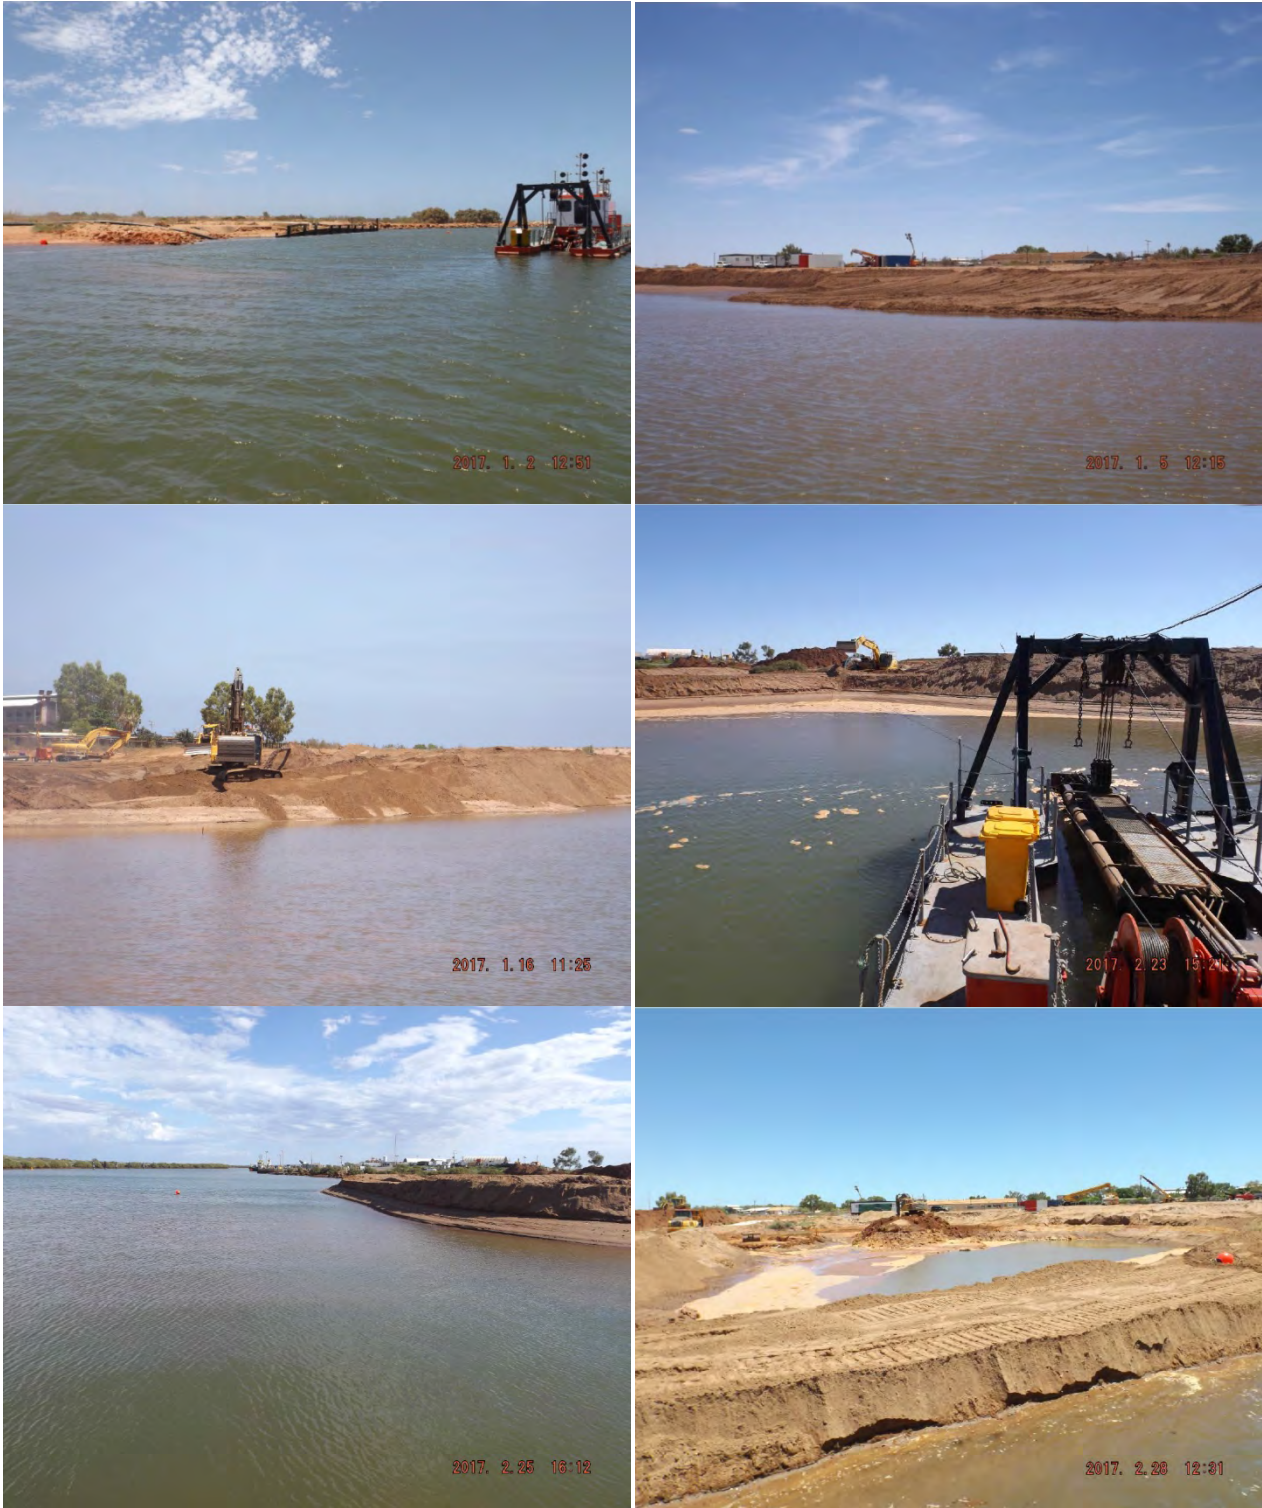
Figure 4.2 Site photographs of the dredging and disposal areas during the Beadon Creek 2016/17 Capital Dredging

To provide a record of on-site conditions during the water quality sampling for the Beadon Creek 2016/17 Capital Dredging (Figure 4.2), site photographs were taken by the Contractor on days dredging occurred. Out of 130 days of dredging, site photographs were captured on 80 days equating to a 62% compliance with monitoring commitments. Site photographs showed the plume dissipated rapidly during period of no dredging likely due to the highly dynamic nature of the creek and naturally turbid waters. Days when site photographs were not captured were a result of an oversight by the Contractor and remote imagery and/or aerial photography captured were used to monitor site activity (Section 4.2.4).

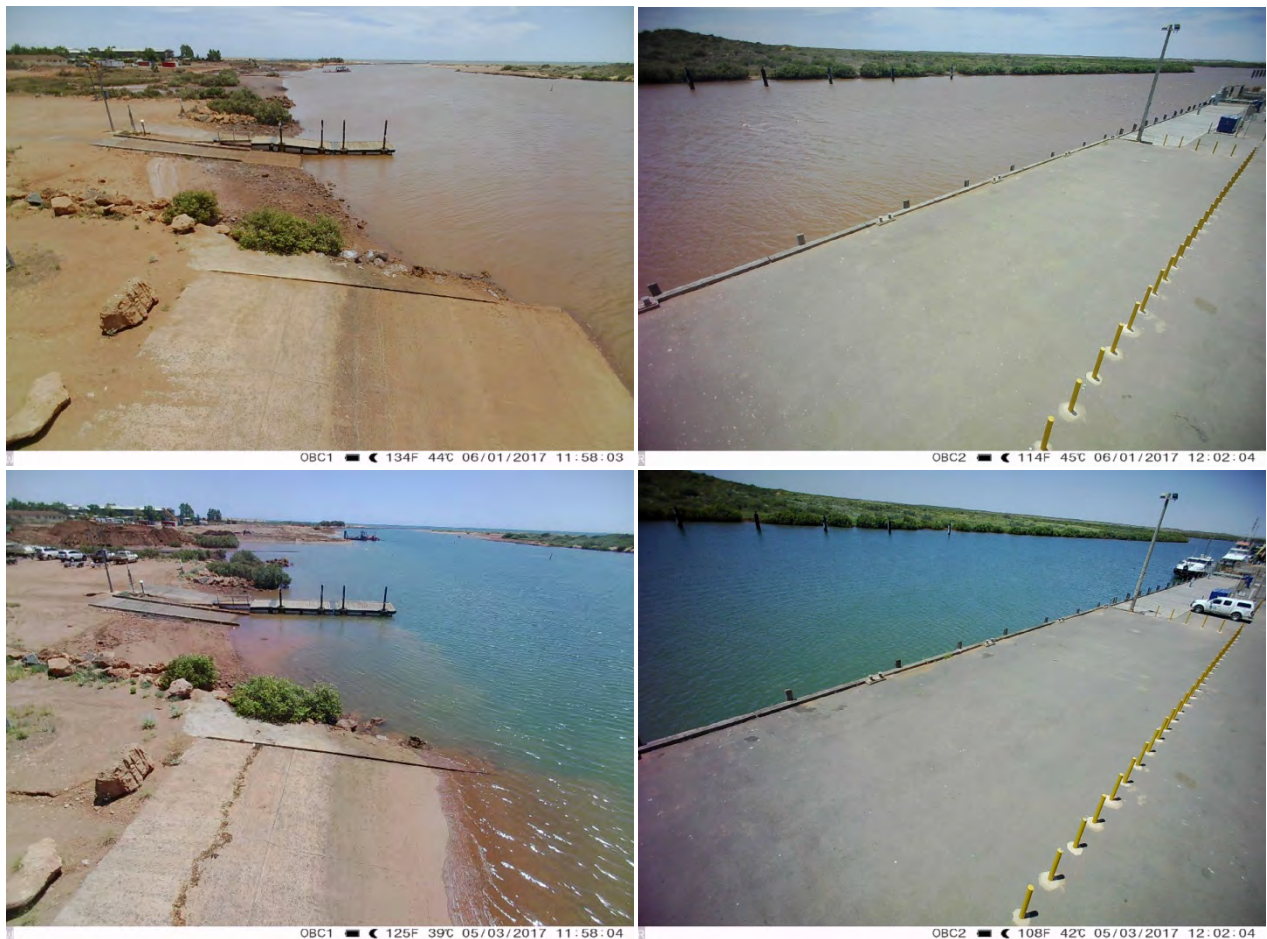
Figure 4.3 Remote images captured from units installed onshore capturing the Beadon Creek dredging and disposal area (left) and upstream (right) during the Beadon Creek 2016/17 Capital Dredging

To provide a consistent record of on-site conditions during the Beadon Creek 2016/17 Capital Dredging, images of the dredging and disposal activities were captured remotely during dredging. Prior to commencement of dredging, two remote imagery units were installed on the dredge mast on 12 December 2016 and two units were installed on a light post on 20 December 2016 to monitor dredging and disposal activities. Images were captured at hourly intervals during daylight hours. Images captured by the units were reviewed and no environmental incidents were observed. Additionally the images indicate naturally high levels of turbidity in the creek occurring intermittently throughout the campaign and the plume dissipating on days where there was no dredging (Figure 4.3, Figure 4.4).

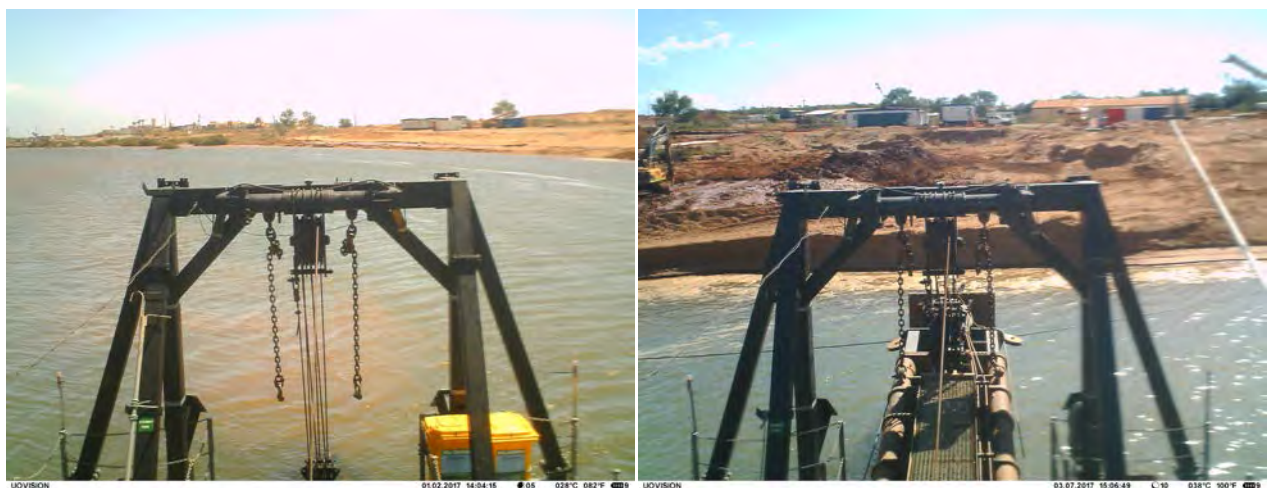
Figure 4.4 Remote images captured from units installed on the dredge mast during the Beadon Creek 2016/17 Capital Dredging
