#### EPBA 2019/8520 Port Hedland Spoilbank Marina Annual Compliance Report 2024/2025

Prepared for: Department of Transport and Major Infrastructure

Prepared by: Jack Munns & Jemima Dimbleby Date: 29 August 2025

This document forms the Annual Compliance Report (ACR) for the 2024/2025 reporting period, as required under Condition 14 of *Environment Protection and Biodiversity Conservation Act 1999* approval (EPBC 2019/8520) for the Spoilbank Marina Project.

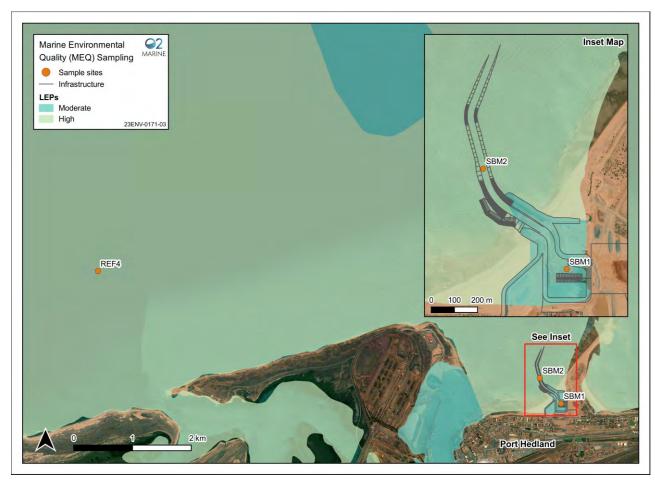
Figure 1: Water quality sampling locations

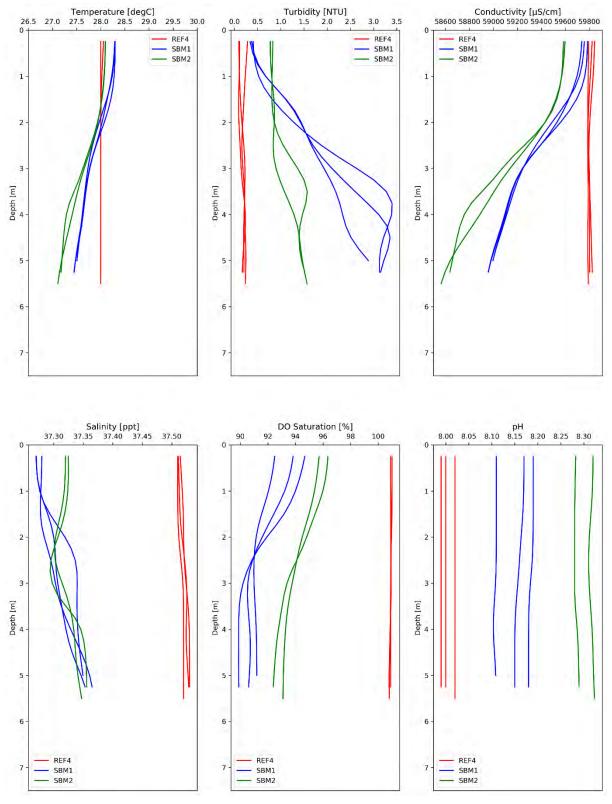
Figure 2: Physico-chemical profiles collected at the Spoilbank Marine during October 2024.

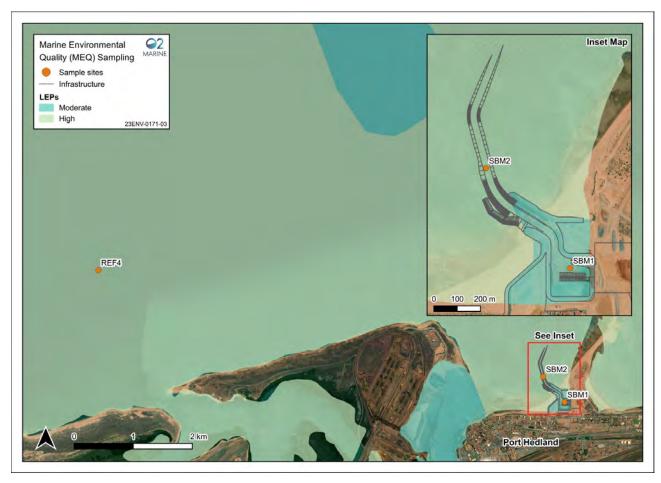
Figure 1: Water quality sampling locations

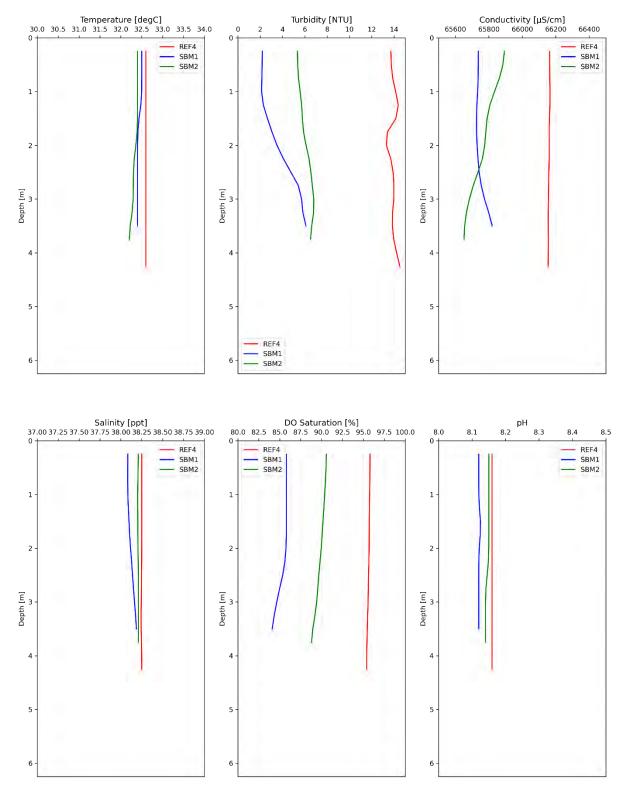
Figure 2: Physico-chemical profiles collected at the Spoilbank Marine during February 2025.

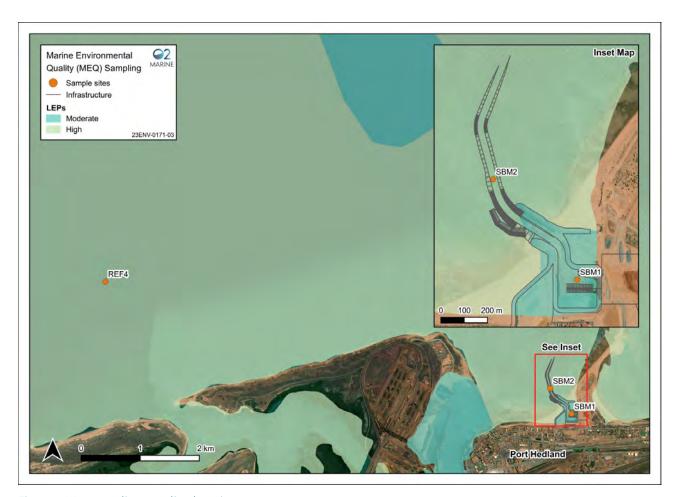
Figure 1: Water quality sampling locations

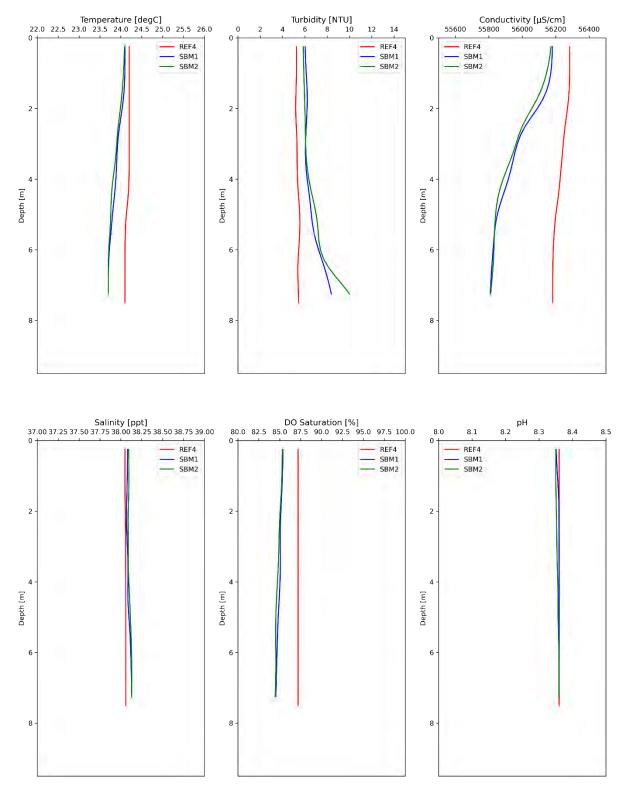
Figure 2: Physico-chemical profiles collected at the Spoilbank Marine during May 2025.

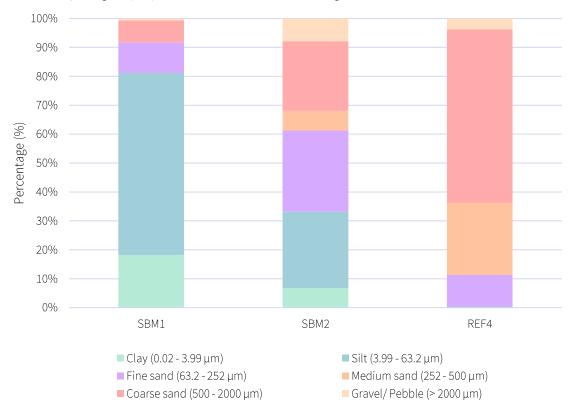
The particle size distribution (PSD) results are summarised Figure 3. Finer sediments, indicated by higher proportions of clay, silt and fine sand were typically observed at the Spoilbank Marina sites located within and just outside of the marina. Sediments at the reference location REF4 were dominated by a higher proportion of medium and coarse grain sand.

Figure 3: Particle size distribution analysis results

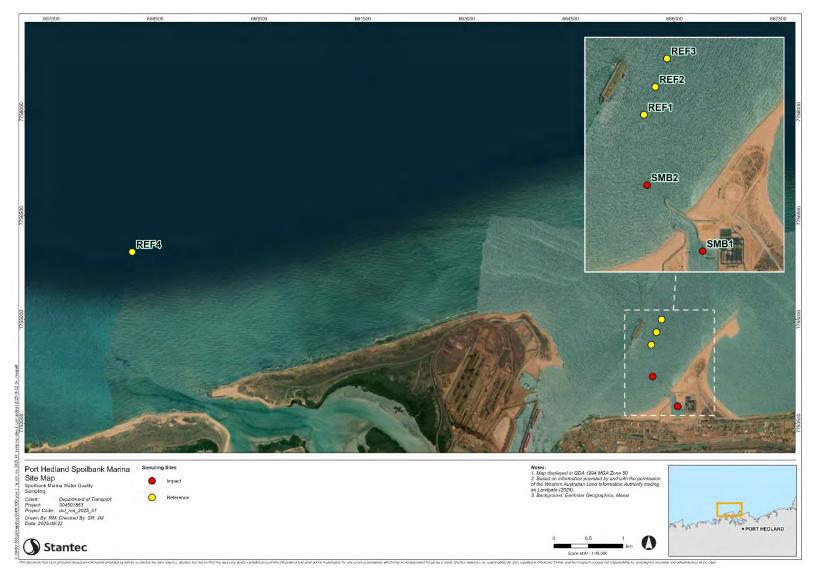
Figure 1. Water quality sampling sites at the Port Hedland Spoilbank Marina.

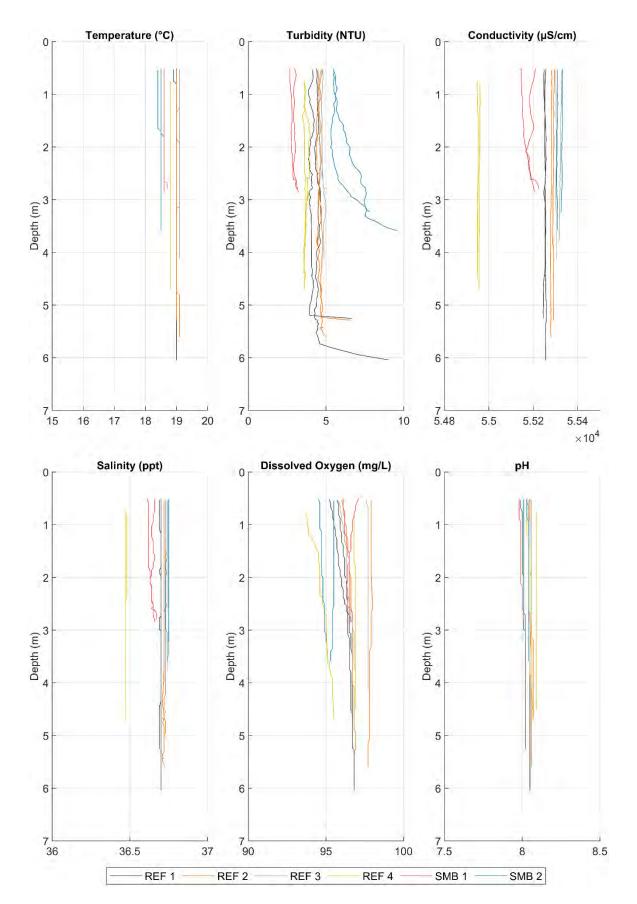
Figure 2. Physicochemical water column profiles displaying two casts from each site.

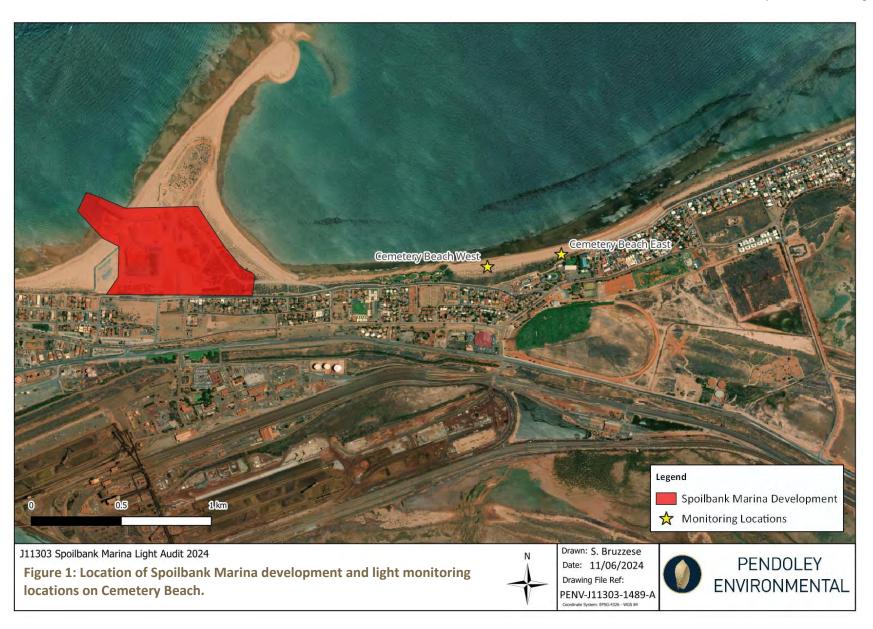
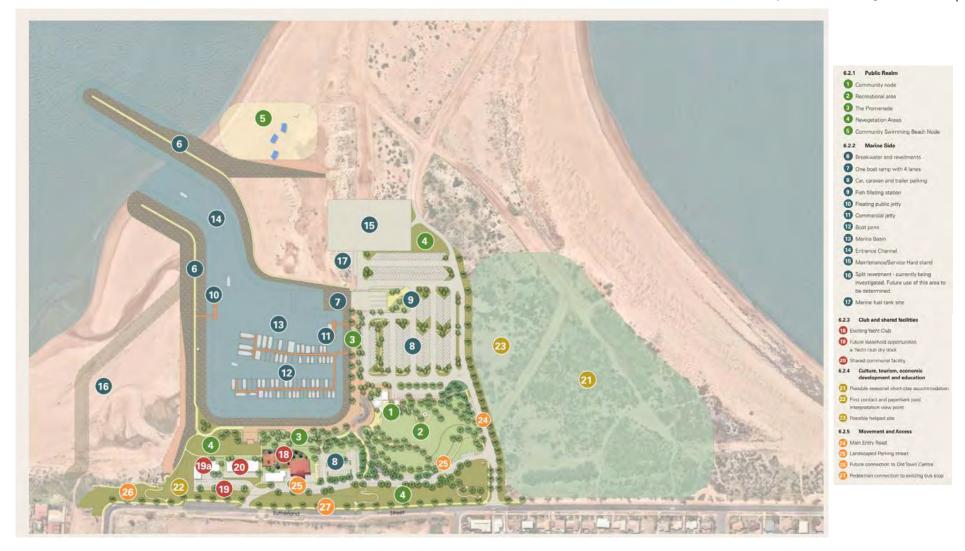
Figure 2: Spoilbank Marina and Waterfront Masterplan. Source: Port Hedland Marina and Waterfront Masterplan (Town of Port Hedland 2019)

The Marina development is described in the Port Hedland Marina and Waterfront Masterplan (Town of Port Hedland 2019) and includes the following components (**Figure 2**):

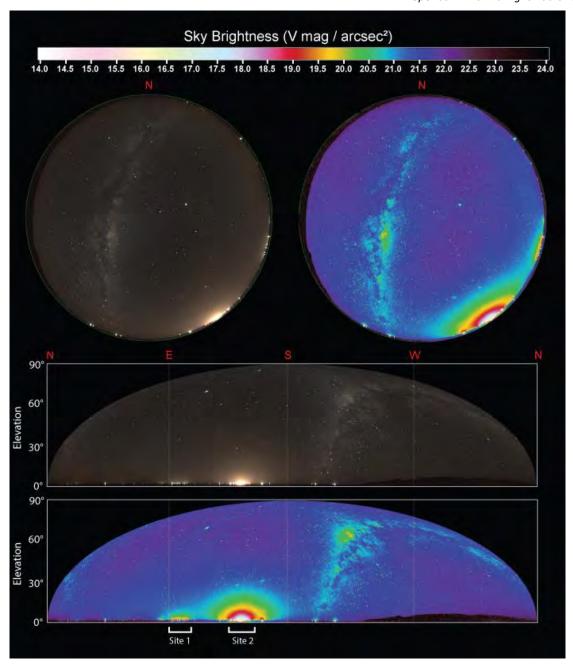
**Figure 4: Example outputs from Sky42 camera data analysis:** a. Raw circular fisheye image; b. Processed circular image; c. Raw "unwrapped" projected all-sky benchmark image; d. Processed "unwrapped" projected all-sky benchmark image.

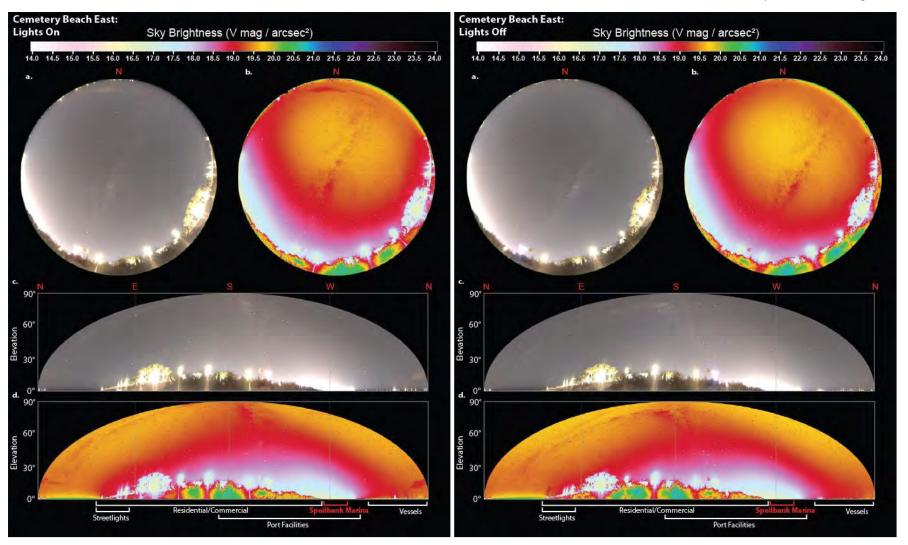
Figure 6: Artificial light monitoring results as observed from Cemetery Beach East for both lighting activated/deactivated scenarios. Left (L): Spoilbank Marina lights are activated, right (R): Spoilbank Marina lights are switched off. Subfigures: a. Raw circular fisheye image; b. Processed circular image; c. Raw "unwrapped" projected all-sky image.

Data was successfully captured from the two survey locations during each night of monitoring, with the clearest imagery captured on the 3<sup>rd</sup> and 4<sup>th</sup> of July 2024. The Spoilbank Marina lighting was switched off on the 4<sup>th</sup> of July (Marina Lights Off) and this data was used as a benchmark to analyse the existing artificial lighting environment. The Spoilbank Marina lighting was active on the 3<sup>rd</sup> of July (Marina Lights On), and this data was used to determine the change in sky brightness from each monitoring location due to the Spoilbank Marina lighting.

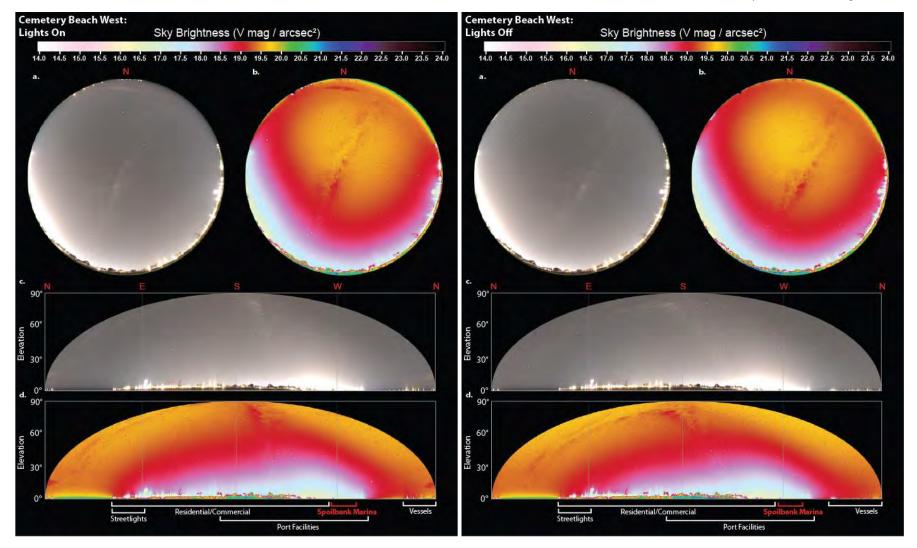
Figure 7: Artificial light monitoring results as observed from Cemetery Beach West for both lighting activated/deactivated scenarios. Left (L): Spoilbank Marina lights are activated, right (R): Spoilbank Marina lights are switched off. Subfigures: a. Raw circular fisheye image; b. Processed circular image; c. Raw "unwrapped" projected all-sky image; d. Processed "unwrapped" projected all-sky image.

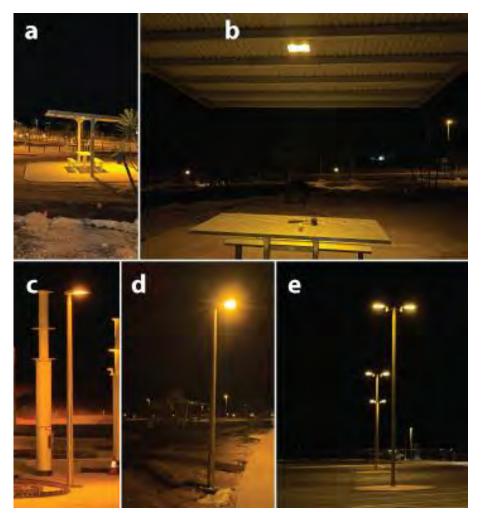
**Figure 8: Images of lighting poles and shelters:** a. Shelter side view (PLS420); b. Shelter close view (PLS420); c. 4m single headed pole (VL530); d. 6m single headed pole (VL540); e. 8m dual head pole (VLF540-D).

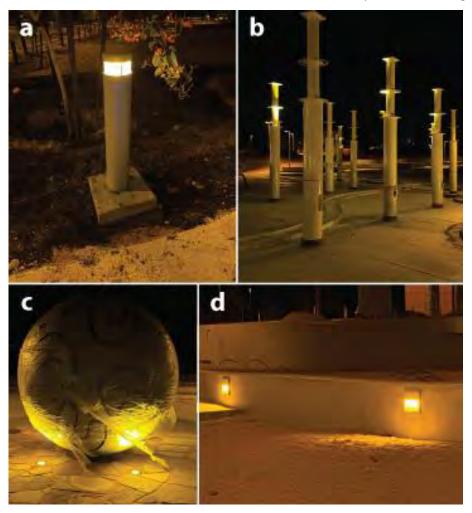
Figure 9: Images of bollard lighting, pole uplights, floor uplights, and inset wall mounted lights: a. Bollard light (KTY234); b. pole mounted uplight (FLC121); c. floor mounted uplight (ETC320); d. Inset wall mounted lights (QRI354).

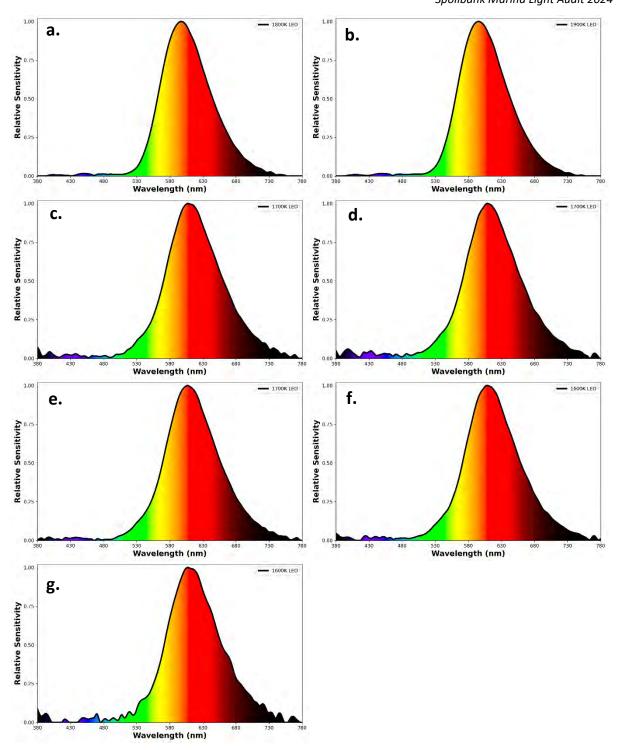
The spectral characteristics of the lights matched the lighting design, with all light types identified as PC Amber LEDs with CCT ranging from 1600 K to 1900 K (**Table 5**). Selected characteristic spectral outputs for each light type (light ID) are displayed in **Figure 10**. The selected spectra provide an overview of the light types identified throughout the survey, although slight variations may be observed between individual light sources of the same type.

**Figure 10: Measured spectral outputs of land side PC Amber LED lighting:** a. ECT320; b. FLC121; c. KTY234; d. PLS420; e. QRI354; f. VFL530; g. VFL540.

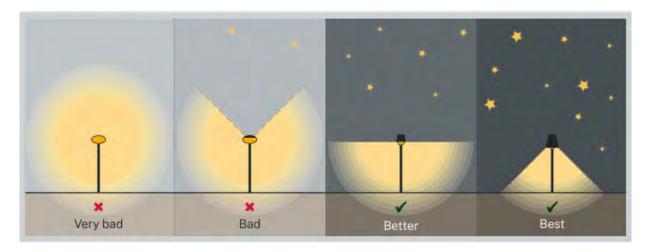
Refers to the amount of light contained under an opaque shield. Shielding can range from no shielding (left) where light scatters upwards into the sky, to fully shielded (right) where all light is directed downwards, and no light is lost above the horizontal.

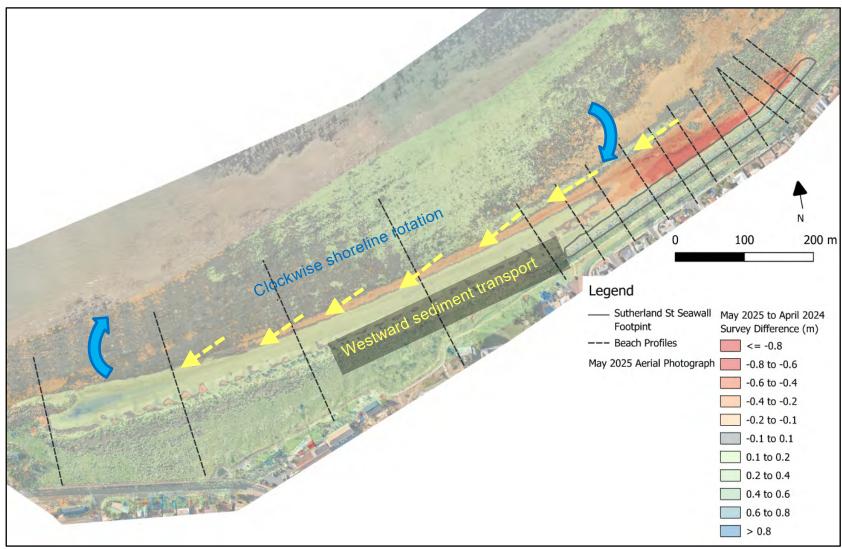
A survey difference plot comparing the April 2024 to May 2025 surveys in the vicinity of Cemetery Beach is shown in Figure 2.1. This plot shows a clockwise rotation at Cemetery Beach, due to net westward transport of sediment has occurred over the past year. This is a reversal of the usual prevailing eastward net sediment transport processes along the Port Hedland coastline. This is likely due to effects from Severe Tropical Cyclone (TC) Zelia. TC Zelia crossed the Pilbara coastline on 14 February 2025 around 100 km east of Port Hedland. This would usually not represent a major concern for the study area coastline in terms of inundation, extreme wave conditions and erosion, as the most severe winds at the time of crossing would be oriented in an offshore direction. However the path of TC Zelia included an approximately 36 hour period where the cyclone stayed near stationary about 130 kilometres north-northwest of Port Hedland and underwent a period of intensification (BoM 2025). This resulted in a discrete period of persistent strong easterly to north easterly wind and wave conditions at Port Hedland which caused the westward sediment transport.

Figure 2.1 May 2025 to April 2024 Survey Difference – Cemetery Beach & Sutherland St Seawall

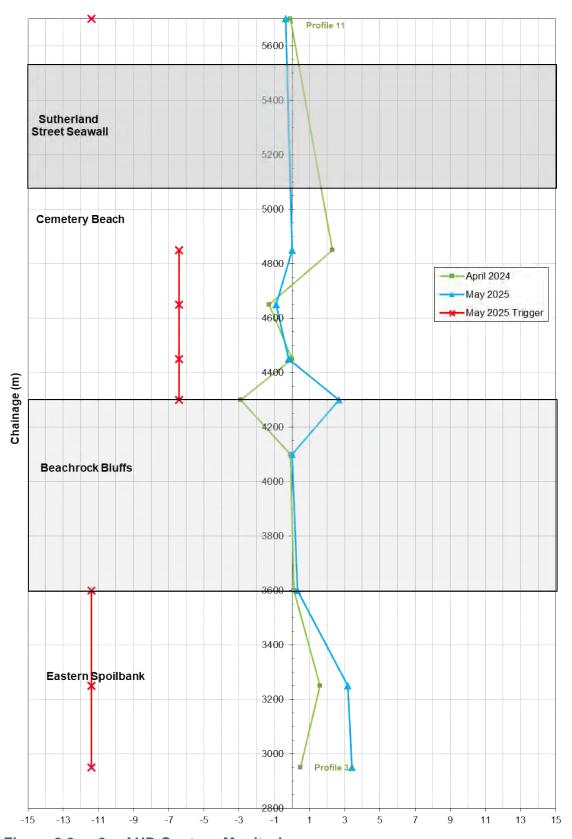
Figure 2.2 0 mAHD Contour Monitoring

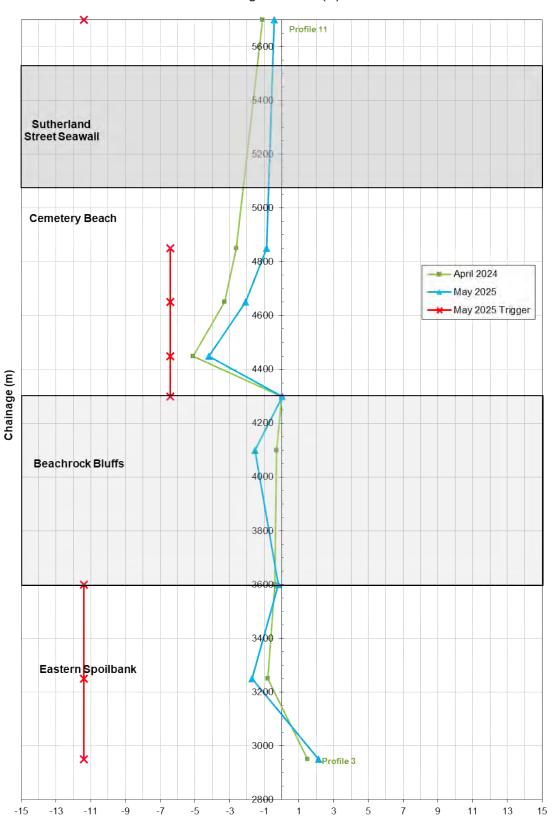
Figure 2.3 +4 mAHD Contour Monitoring

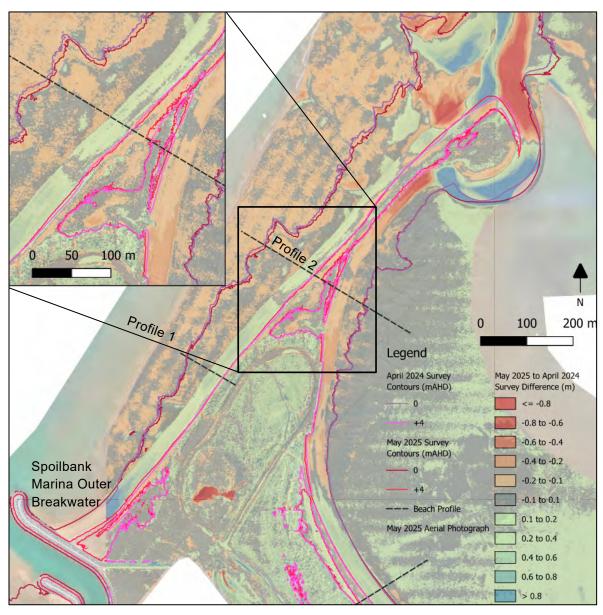
The coastal monitoring triggers have not been exceeded at Profiles 1 and 2.

Figure 2.4 May 2025 to April 2024 Difference Plot - Spoilbank

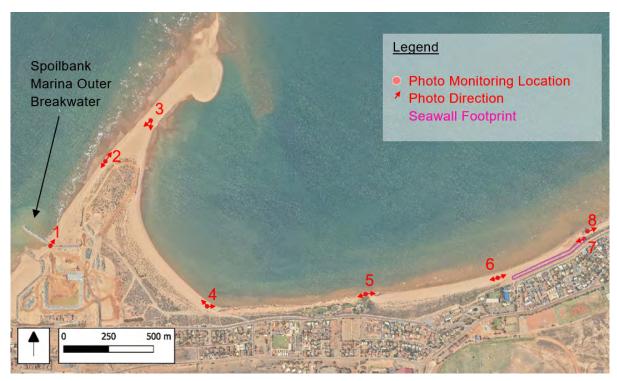
These photographs indicate similar shoreline changes to the aerial topographic survey and beach profiles, including accumulation at the Spoilbank Marina Outer Breakwater Sand Trap and erosion of the shoreline fronting the eastern end of the Sutherland St Seawall.

Figure 2.5 Photographic Monitoring Locations

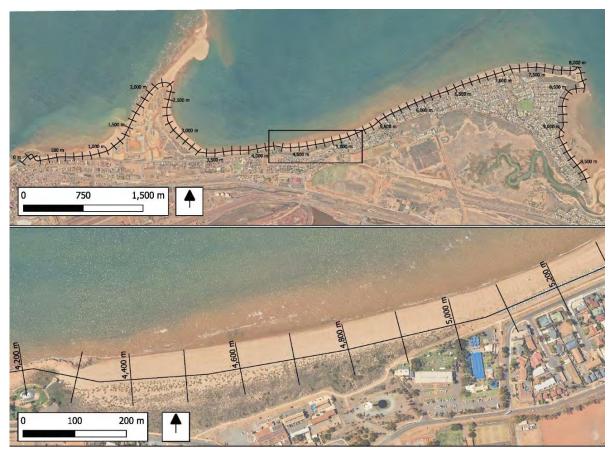
MRA has purchased the October 2024 orthorectified aerial image (the most recent available) from Landgate and mapped the vegetation line for this round of monitoring. All vegetation line mapping completed by MRA has been in accordance with DoT's methodology and specification of mapping (DoT 2009). Relative movements of the coastal vegetation line have been estimated at 100 m intervals along the study coast. These chainages are presented in Figure 2.6. The shoreline movement plan is included in Appendix C.

Figure 2.6 Shoreline Mapping Chainage Plan

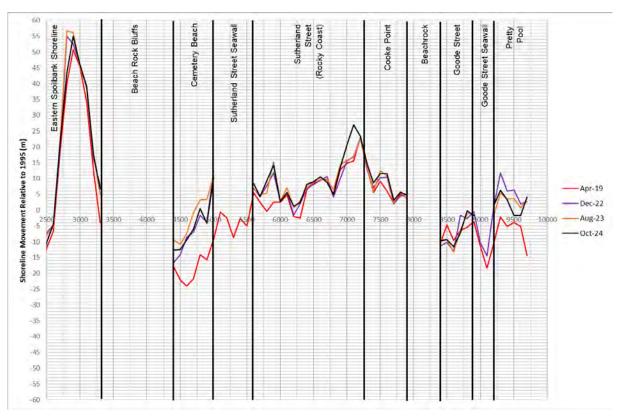
A shoreline movement plot for the area from the eastern Spoilbank shoreline to Pretty Pool is provided in Figure 2.7. For context, the position relative to the 1995 vegetation line is shown, and for clarity, only mapped vegetation lines from April 2019, December 2022, August 2023 and October 2024 are presented.

- Apparent 13 m of recession of the vegetation line at one location (Chainage 2,800 m) on the eastern Spoilbank shoreline. This is due to an isolated loss of ephemeral vegetation between August 2023 and October 2024 in this single location and not notable shoreline change. This is shown in Figure 2.8.
- Apparent recession of the vegetation line to the west of the Sutherland Street Seawall. This apparent recession is up to a maximum of around 7 m at Chainage 4,900 m, though the shoreline position is still very similar to the shoreline position mapped from the December 2022 aerial image. This is discussed further below.
- Apparent 11 m of accretion of the vegetation line at one location, Chainage 7,100 m, on the rocky coast stretch of coast to the east of the Sutherland Street Seawall. This is due to recent growth of ephemeral vegetation in this area.

Figure 2.7 Shoreline Movements Relative to 1995

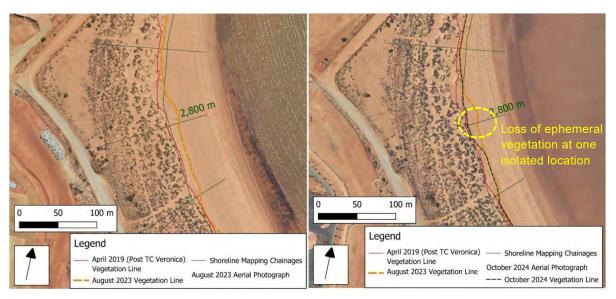
Figure 2.8 Isolated Loss of Ephemeral Vegetation at Chainage 2,800 m between 2023 (left) & 2024 (right)

The topographic surveys show beach and dune levels have increased through this area in the past year. Comparing the aerial images in Figure 2.8, it can be seen that much of the vegetation, including the remaining seaward vegetation, has increased. This confirms that the apparent recession is an artefact of the vegetation line mapping process, and is not indicative of coastal erosion. Hence this is not considered an exceedance of Trigger 1.

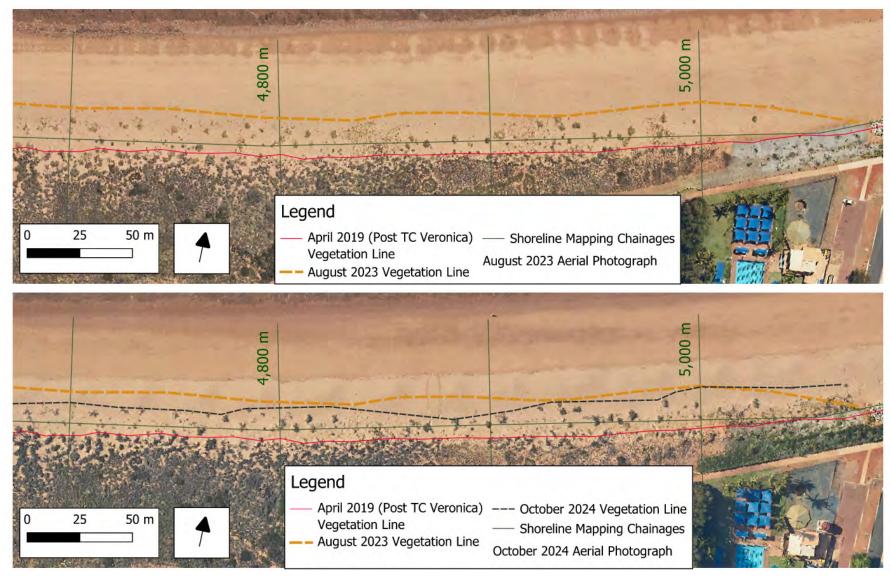
Figure 2.9 Vegetation Lines with the August 2023 (top) and October 2024 (bottom) Aerial Photographs
