## **BREMER BAY**

### **Investigation into the Stabilisation of Fishery Beach**

Technical Report Number 471

Department for Planning and Infrastructure  
New Coastal Assets Directorate  
Marine House, 1 Essex Street, Fremantle WA  
PO Box 402 Fremantle, Western Australia 6959

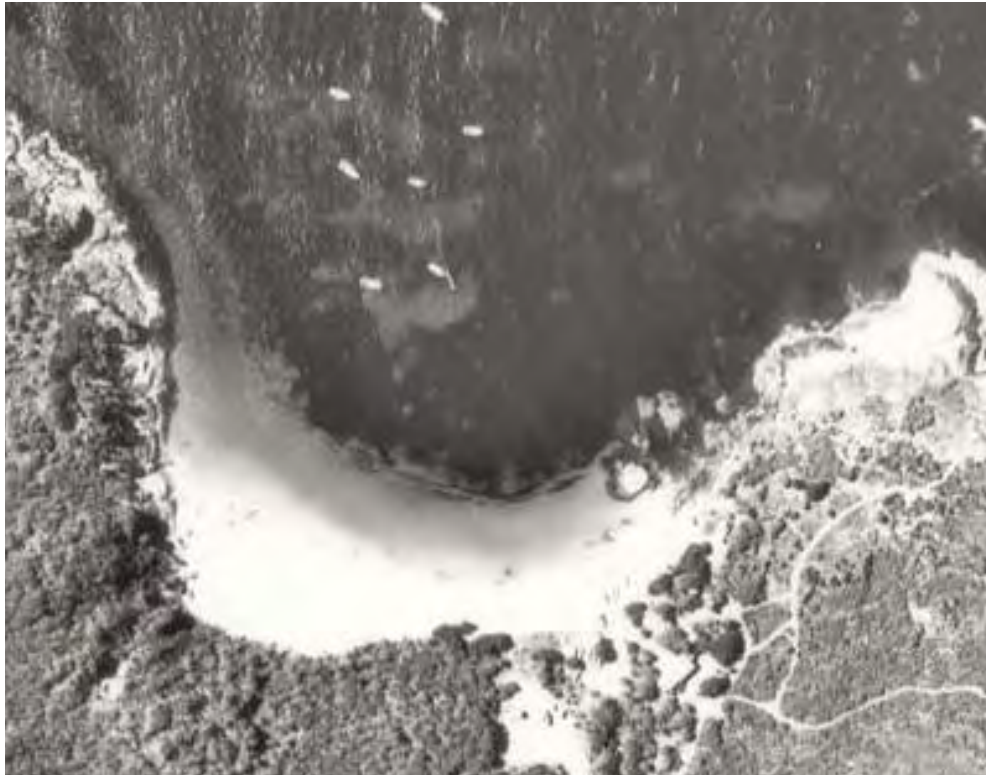
The construction of the harbour breakwater in 1996 at Bremer Bay caused the permanent realignment of Fishery Beach. The realignment resulted in the movement of sediment from the western end of the beach to the eastern end, as can be seen in Figure 2 and Figure 3. The realignment subsequently caused ongoing erosion of a dune into a scarp at the western end of the beach, and siltation of the boat ramps at the eastern end of the beach. Sand removal from the boat ramps has been undertaken, typically annually, to maintain adequate depths for boat launching. This work has been completed in partnership between DPI and the Shire of Jerramungup.

**Figure 2: Aerial photograph of Fishery Beach in February 1991, before construction of the boat harbour breakwater.**
