### ABH Compliance Assessment Report (EPBC 2008/4506)

## Augusta Boat Harbour 2014 Compliance Assessment Report (EPBC 2008/4506)

17 December 2014  
42908044 : M&C3883/R1771/0

Prepared for:  
Department of Transport

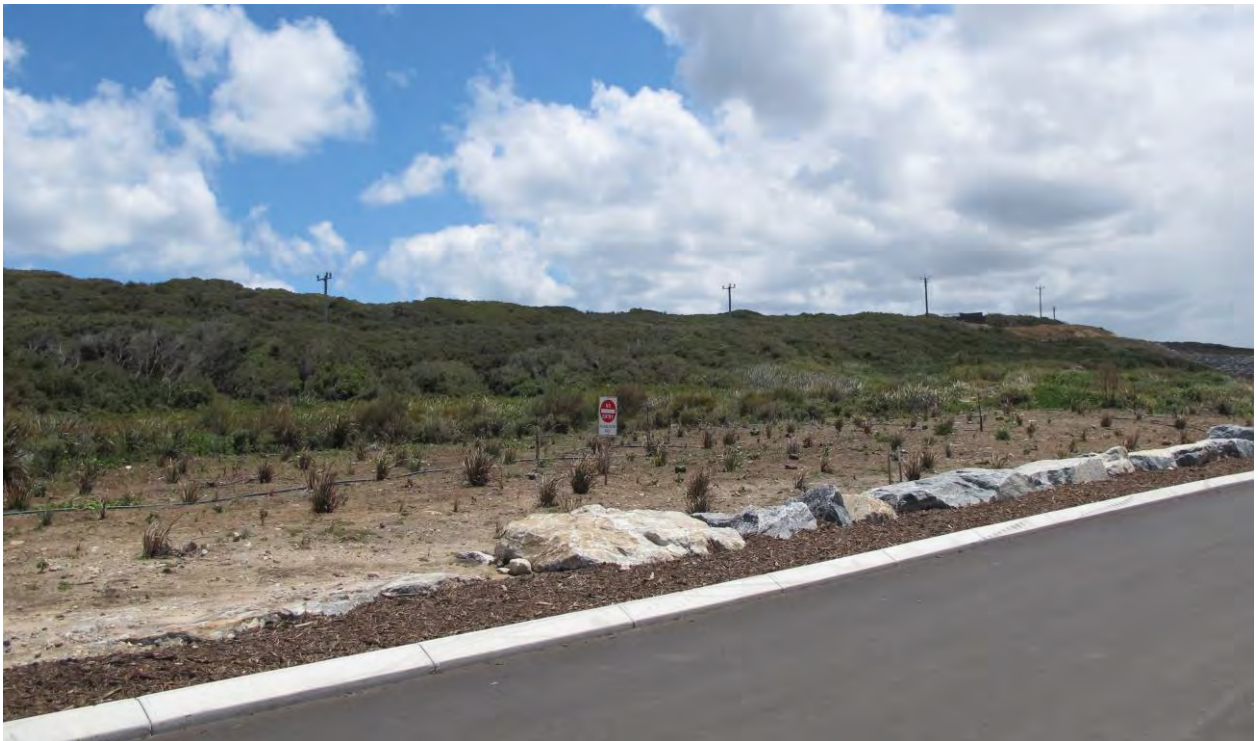
PLATE 2 2014 Rehabilitation Block - Old Site Office
