CONDITION REPORT
SHEDS 6, 7 & 8
OUTER HARBOUR PORT, BUNBURY

WML
Consulting Engineers

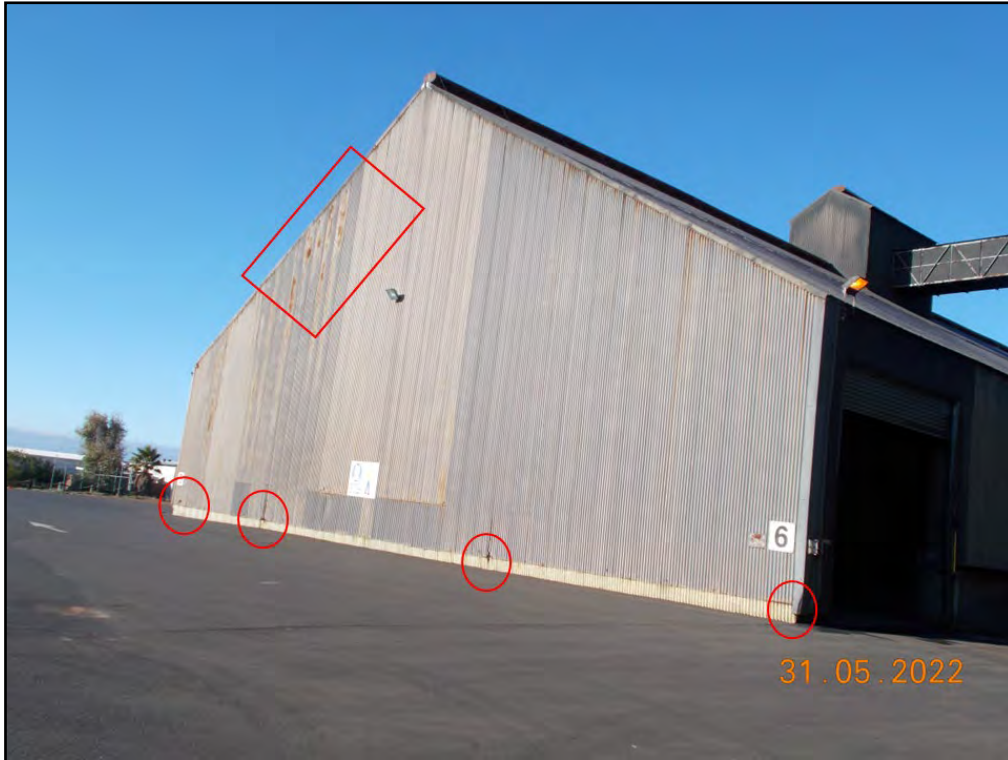
Photograph 2 Impact Damage Observed During Inspection and Corrosion of Sheeting

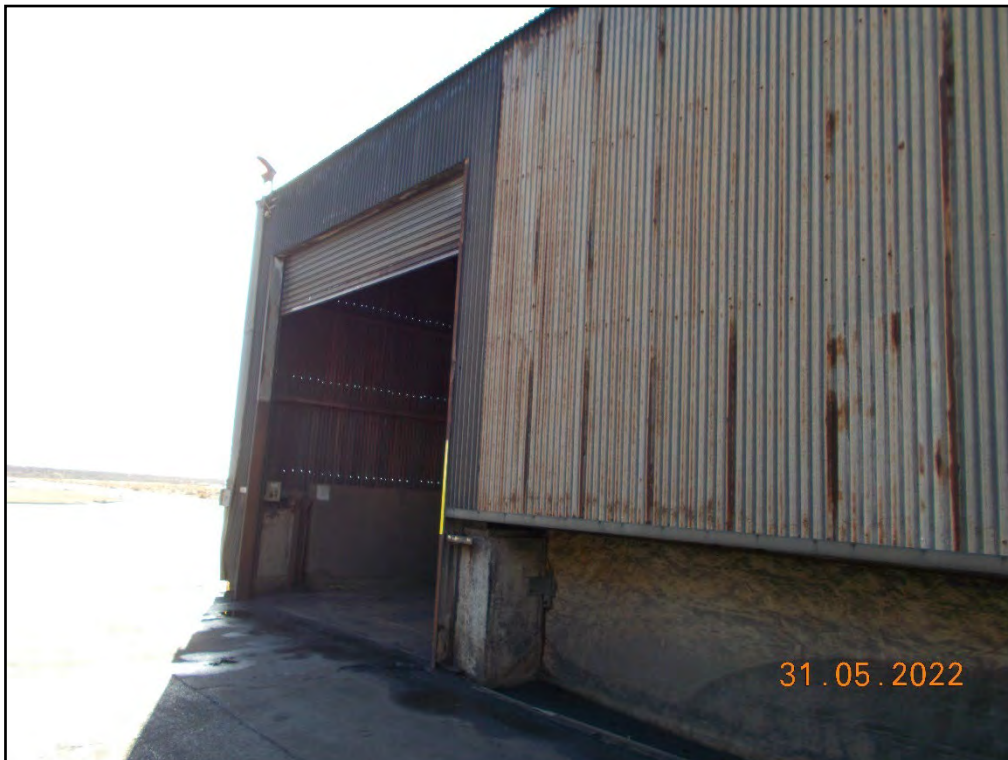
Photograph 3 Corrosion on Wall Sheeting

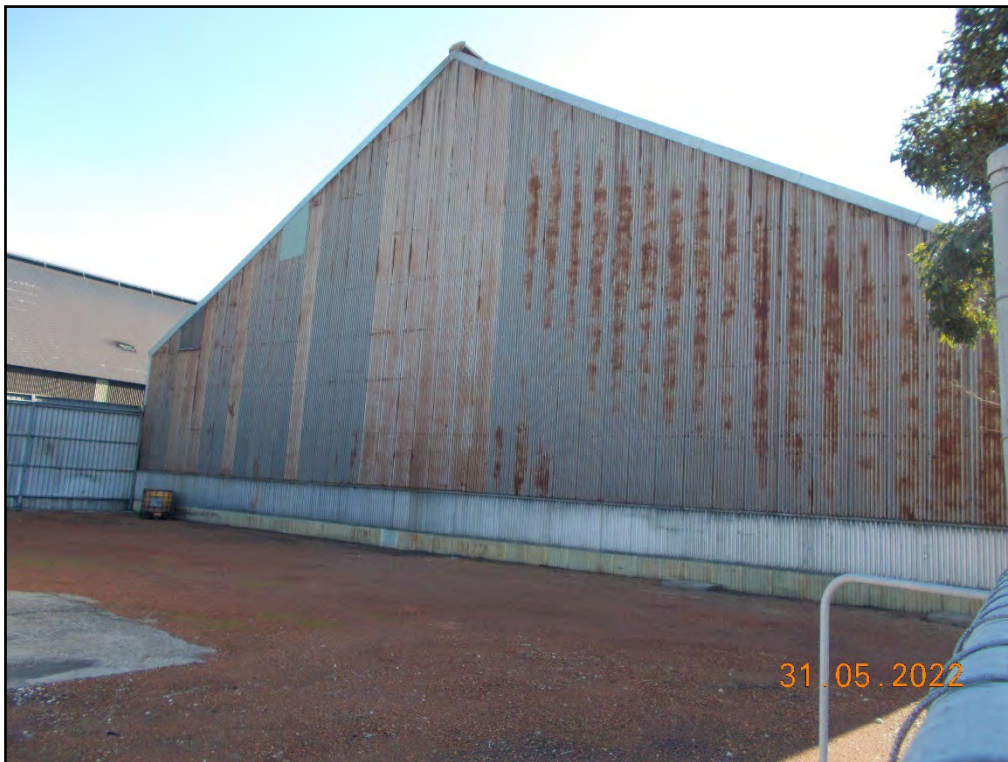
Photograph 7 Corrosion on Wall Sheeting

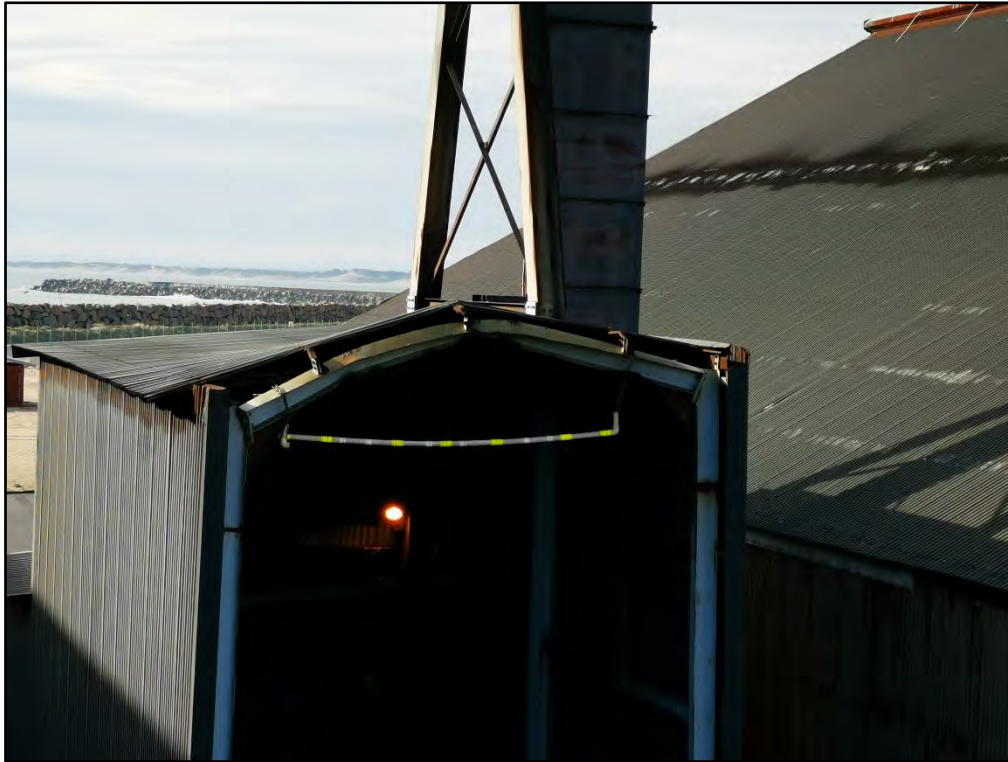
There was significant deterioration observed in the unloading bay due to corrosion. Majority of girts and purlins are corroded and can be seen in Photograph 15. Additionally, significant damage was observed in the unloading bay due to impact of vehicle which can be seen in Photograph 12 and Photograph 13.

Photograph 12 Impact Damage on Rafter in Unloading Bay

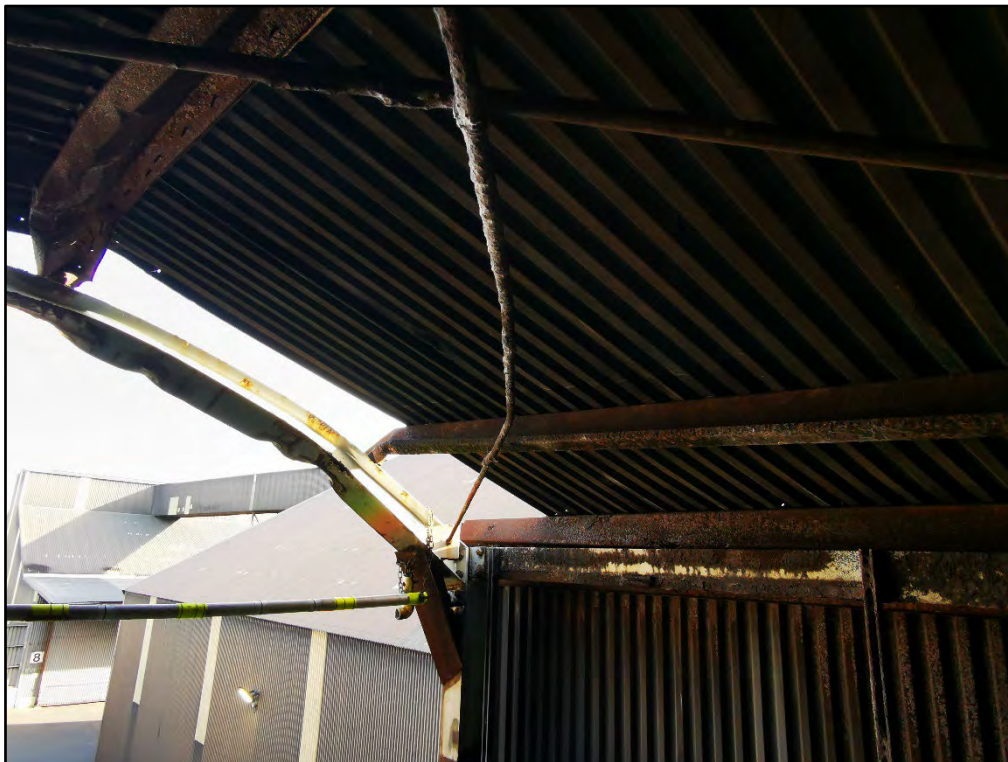
Photograph 13 Damage to Purlins, Bracings and Roof Sheeting Due to Impact

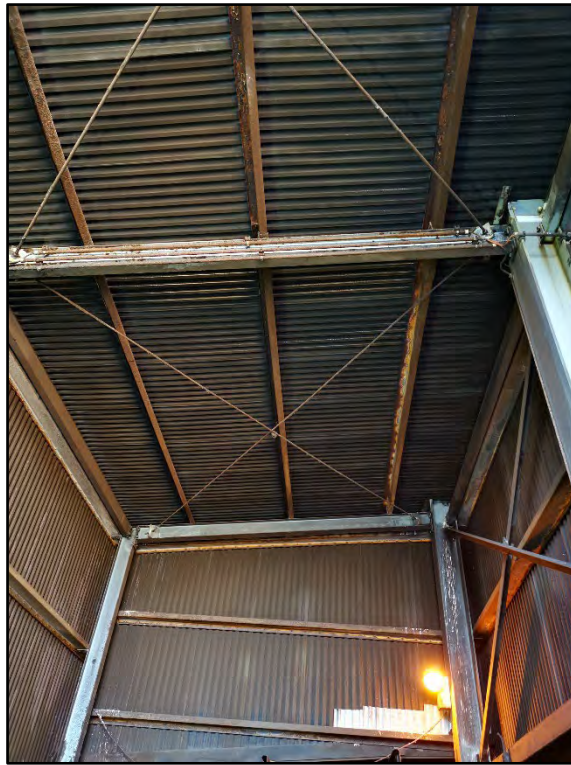
Photograph 14 Surface Corrosion of Purlins, Columns and Rafters

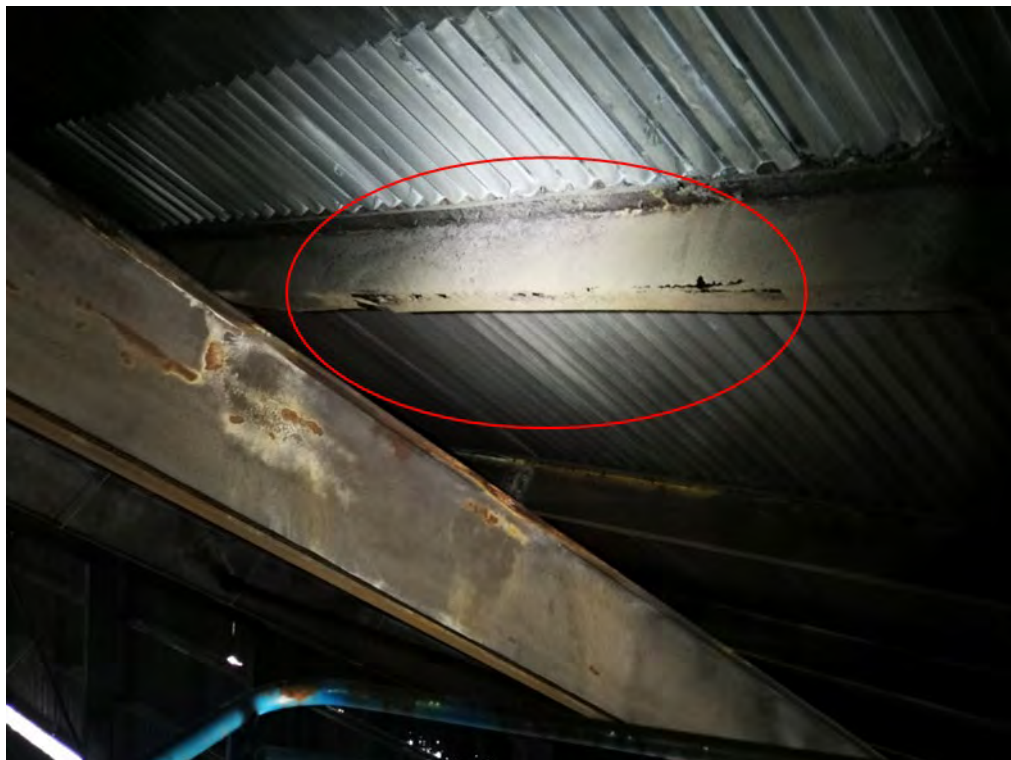
Photograph 22 Deteriorated Purlin due to Corrosion

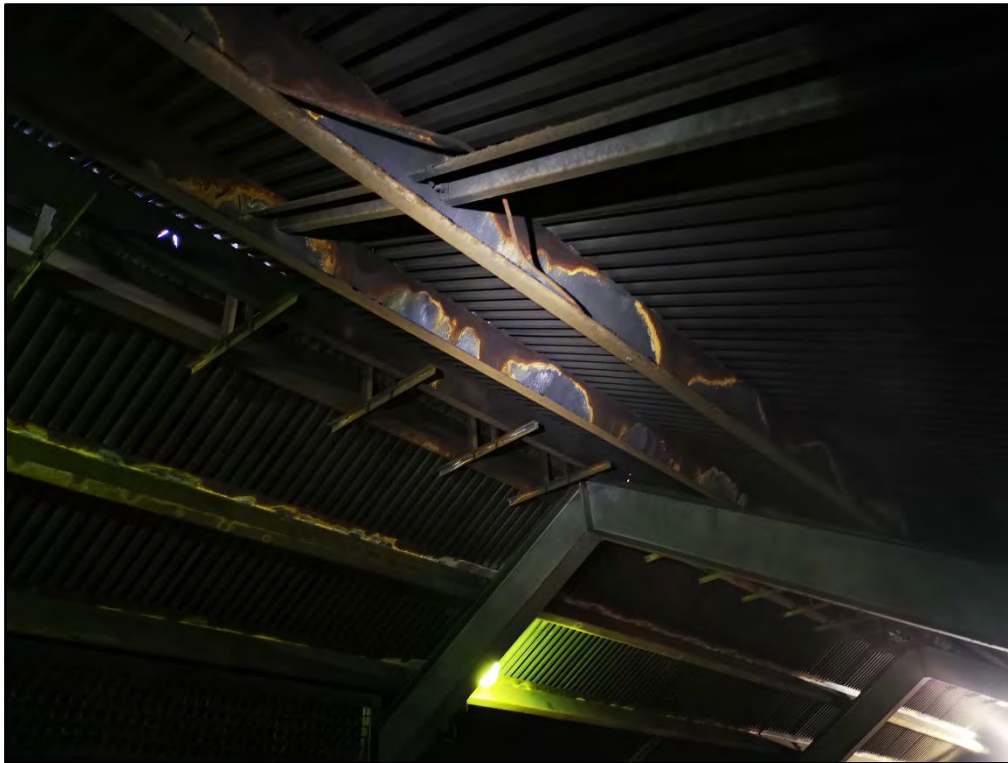
Photograph 27 Surface Corrosion of Purlins

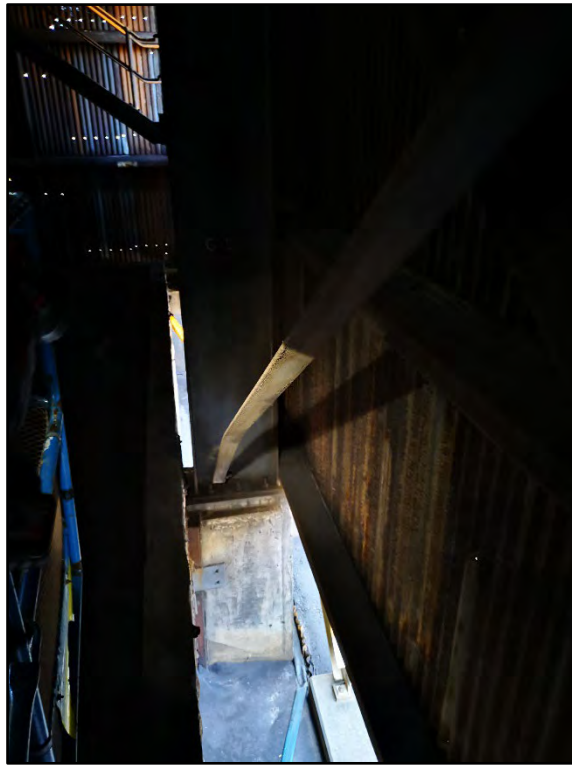
Photograph 29 Bent Cross Brace

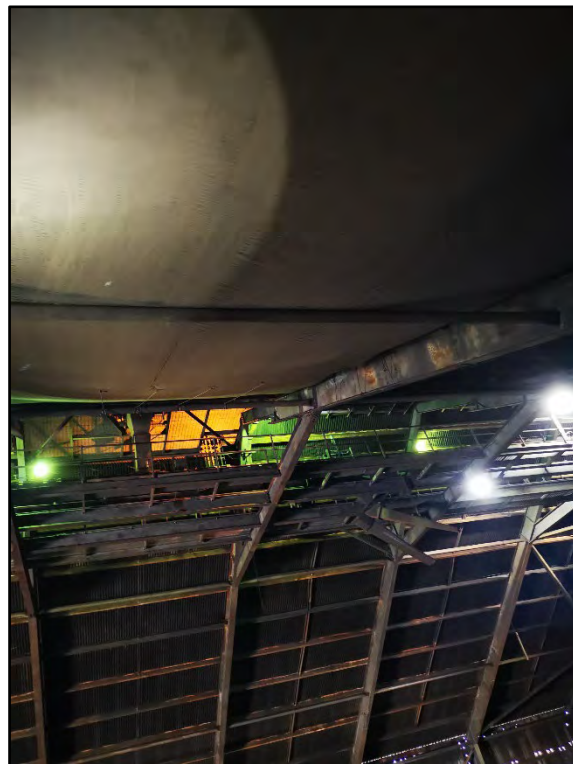
Photograph 32 Bay 6 in Shed 6 was Covered with Tarpaulin

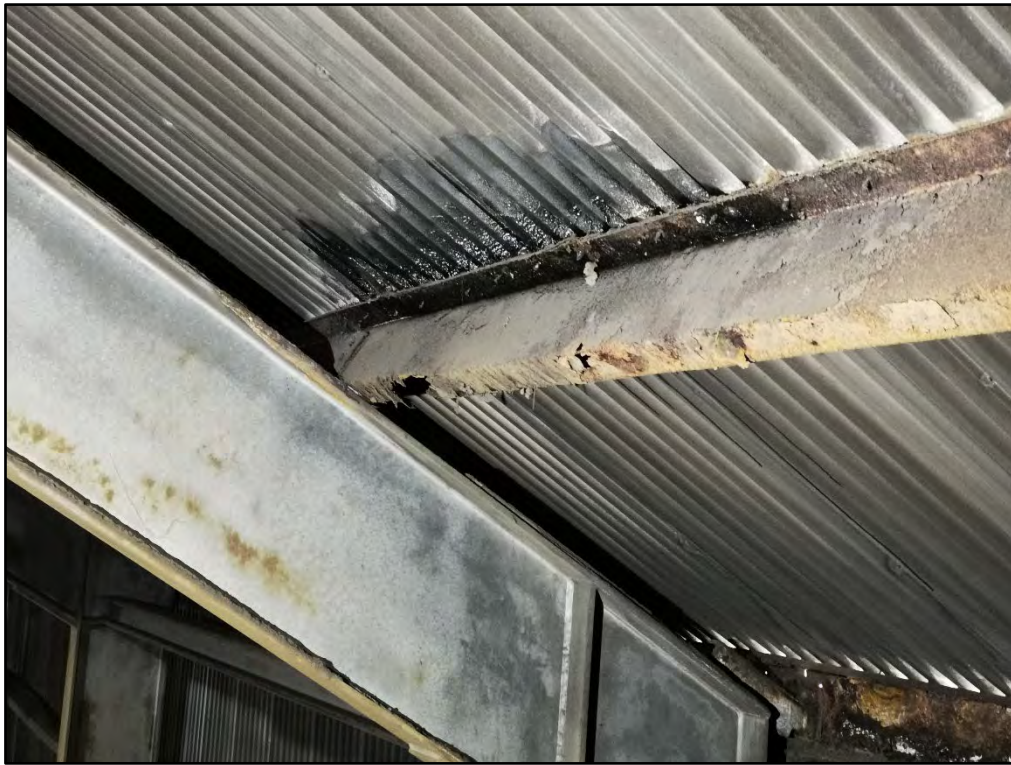
Photograph 35 Deteriorated Purlin due to Corrosion

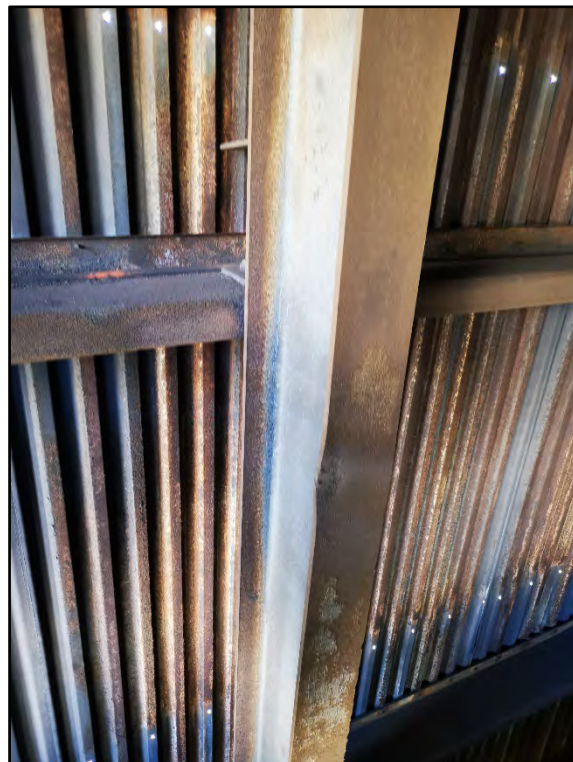
Photograph 36 Impact Damage of Column

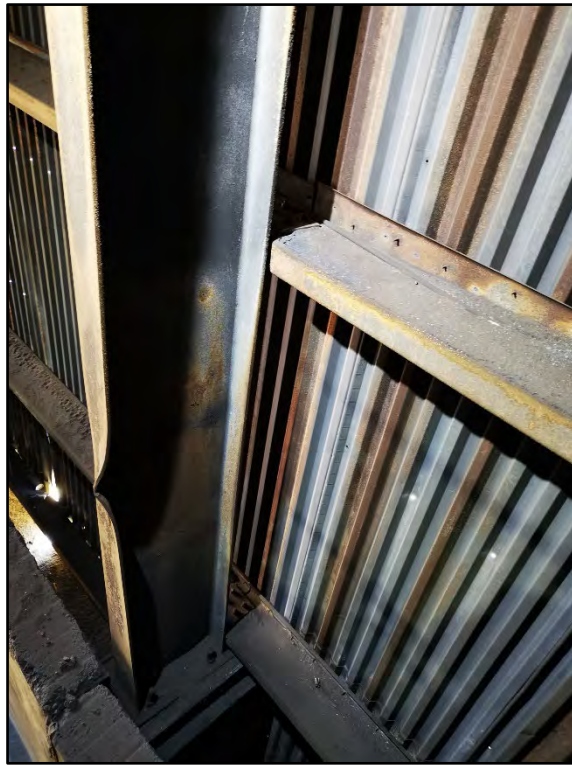
Photograph 37 Impact Damage of Column

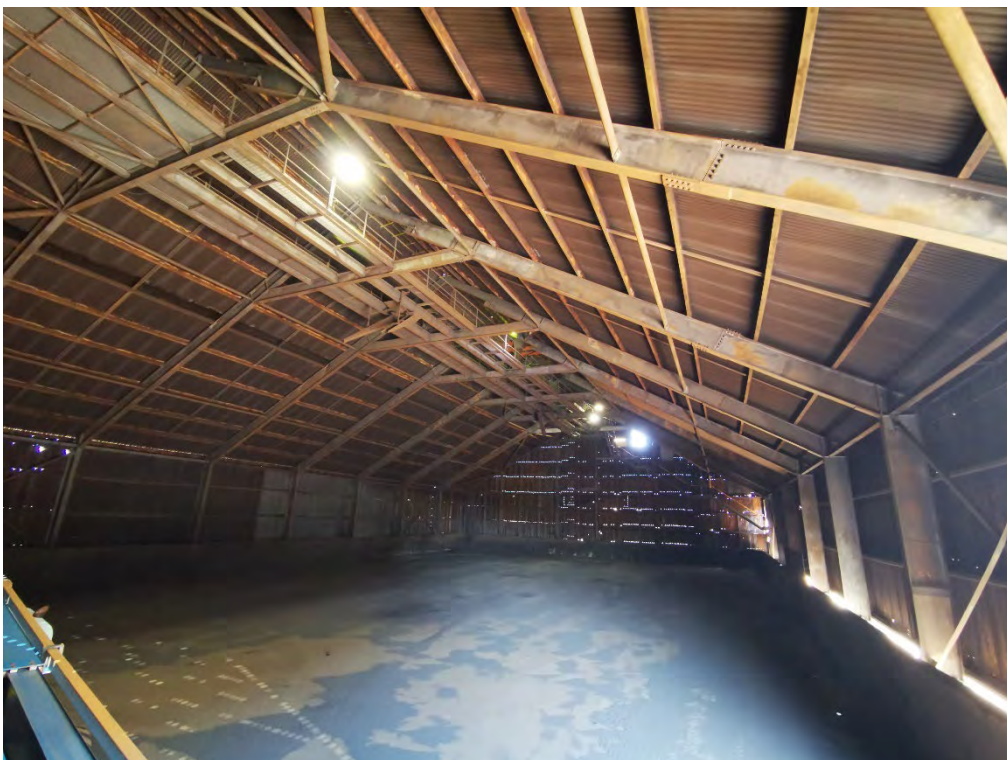
Photograph 38 Surface Corrosion of Roof Sheetting

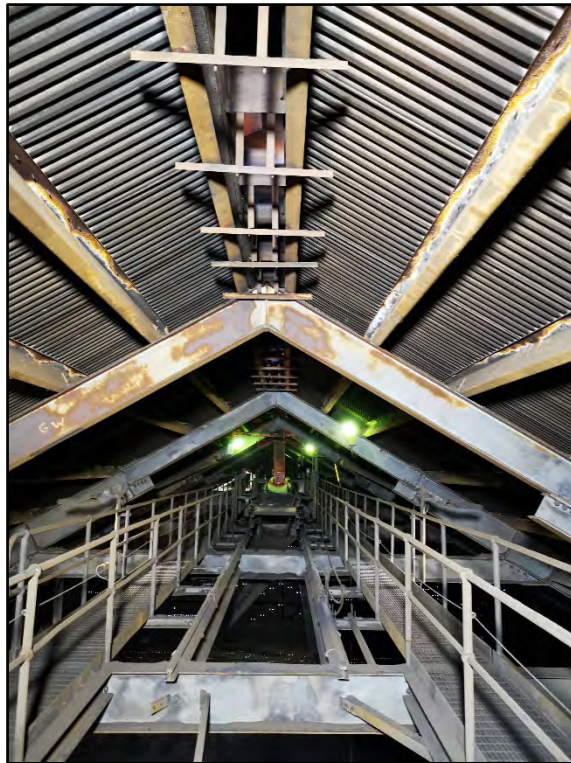
Photograph 39 Surface Corrosion of Purlins and Rafters on Walkway and Conveyor

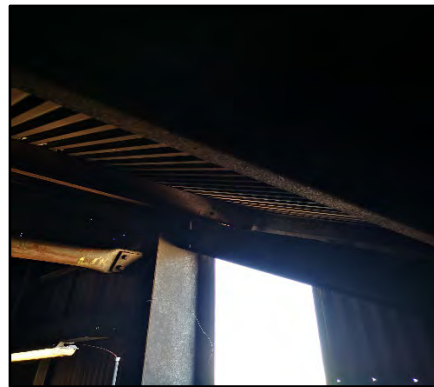
Photograph 43 Shed 6 South Side Sheet Missing on 01 September 2022

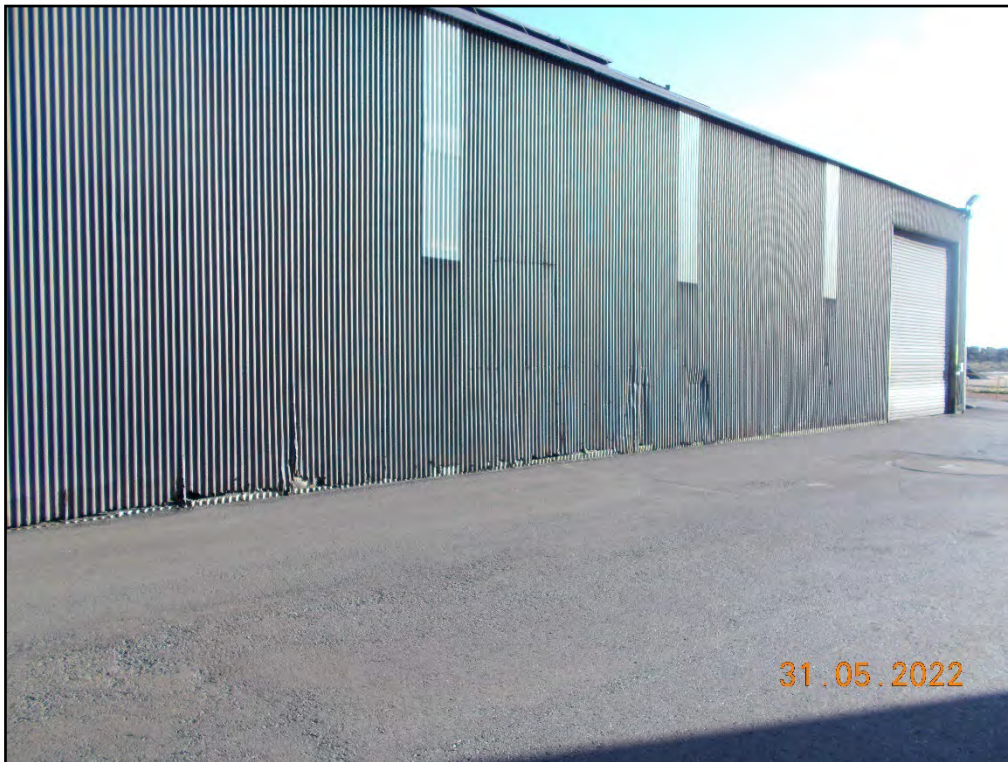
Photograph 45 Impact Damage and corrosion Observed

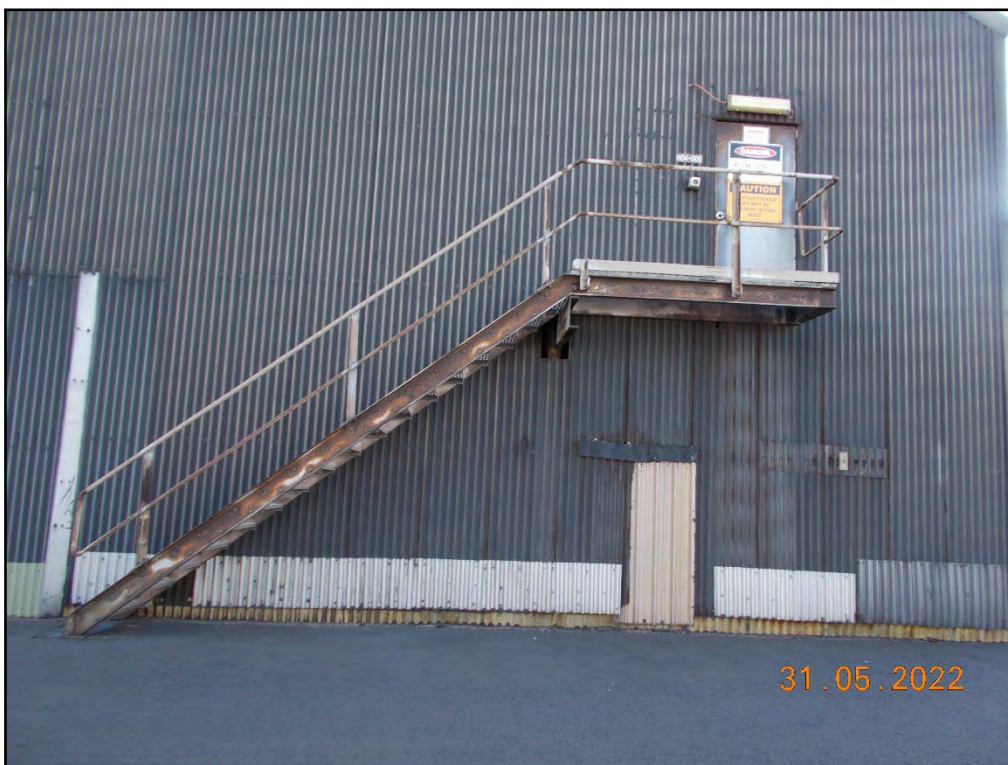
Photograph 49 Stair Stringers Heavily Corroded, wall sheeting patched to lower edge

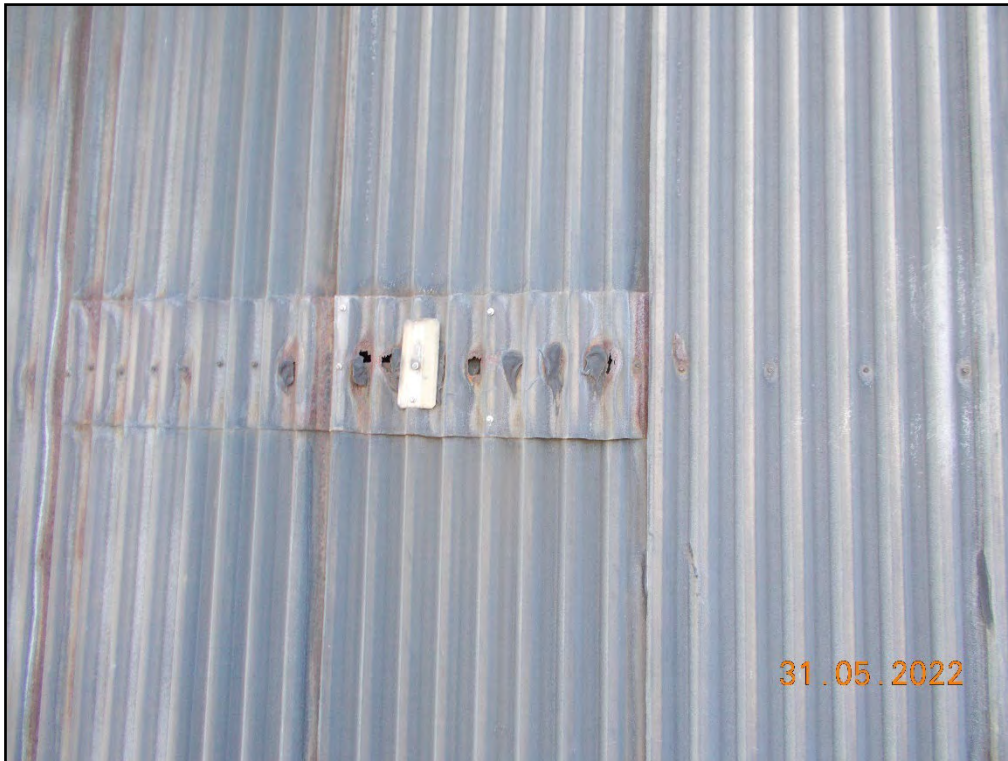
Photograph 50 Patching to Wall Sheeting

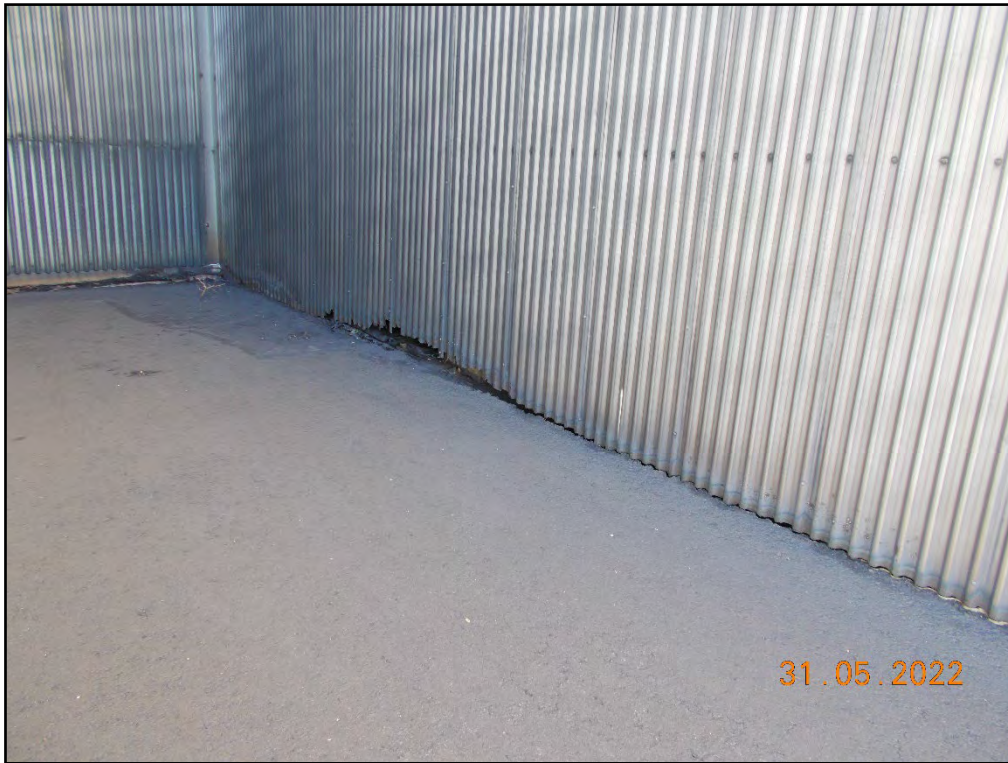
Photograph 52 Damage Observed Due to Corrosion

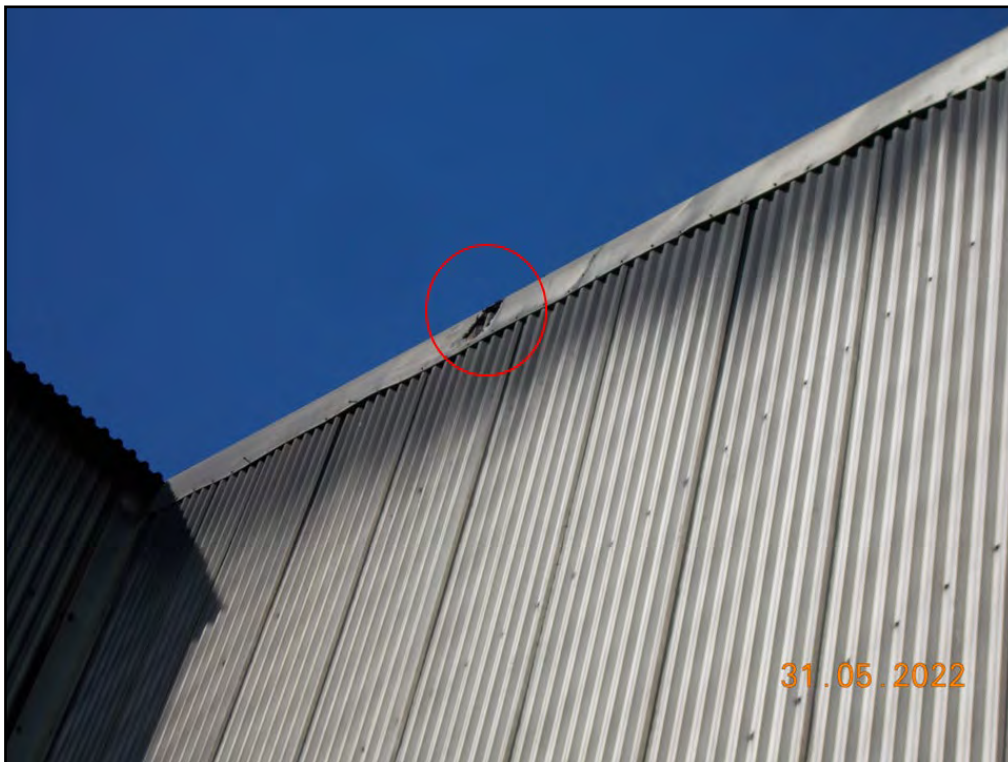
Photograph 53 Deterioration Observed to the Flashing North Side of Shed 7

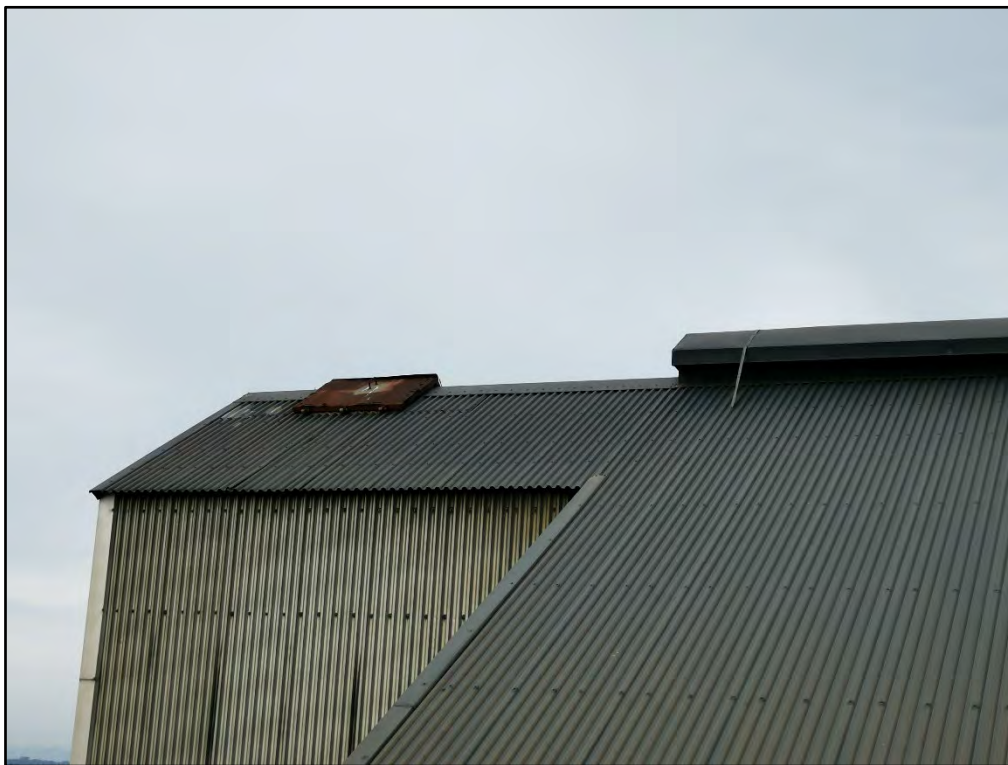
Photograph 55 Corrosion of Access Door

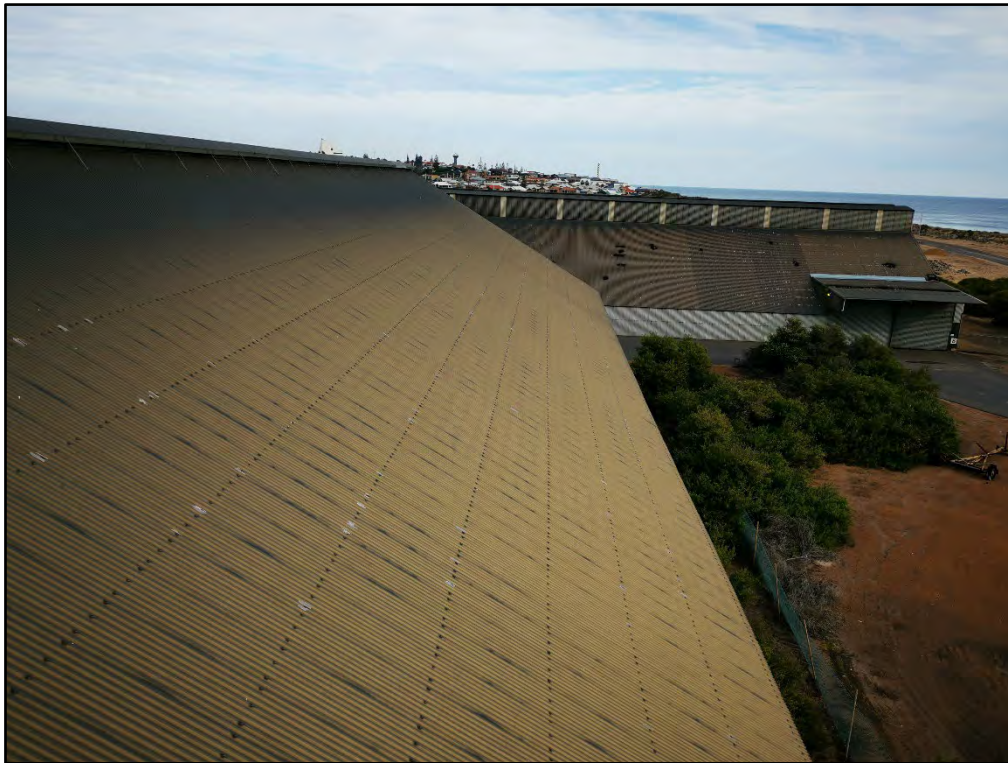
Photograph 56 No Significant Corrosion

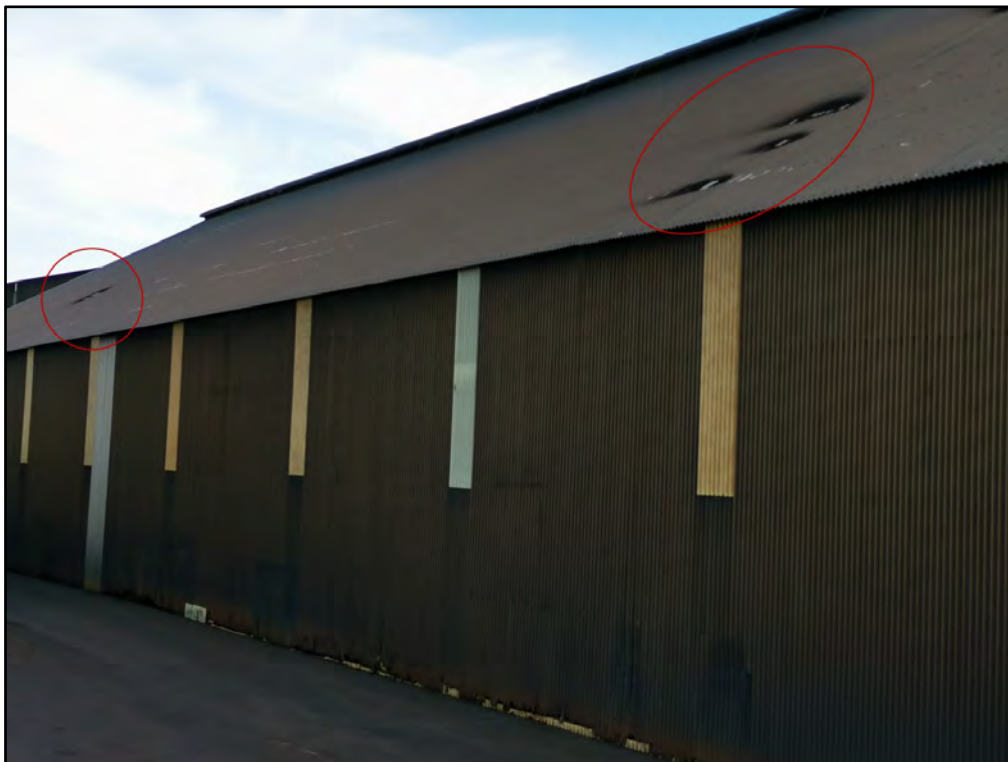
Photograph 57 Patch Work on Roof Sheeting

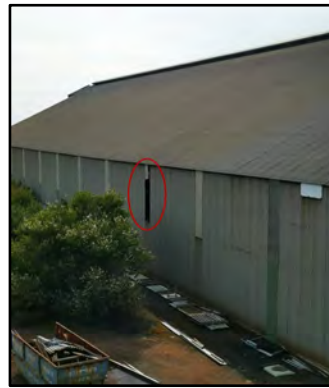
Photograph 60 Shed 7 Eastern Side Sheet Missing on 02 September 2022

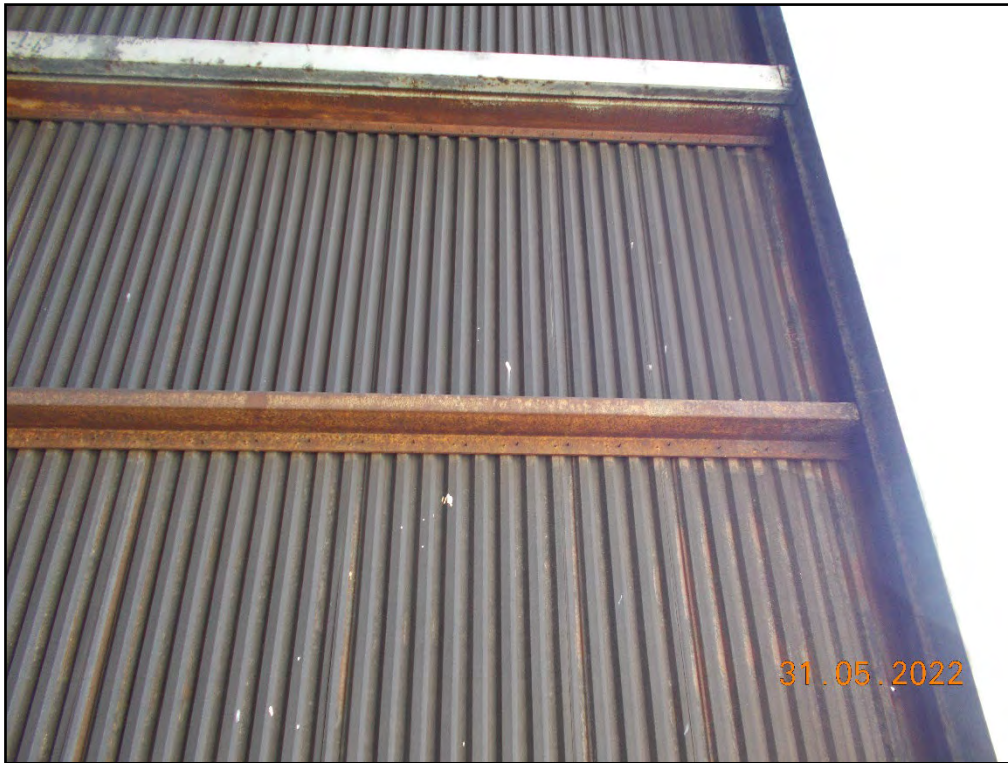
Photograph 63 Surface Corrosion of Girts

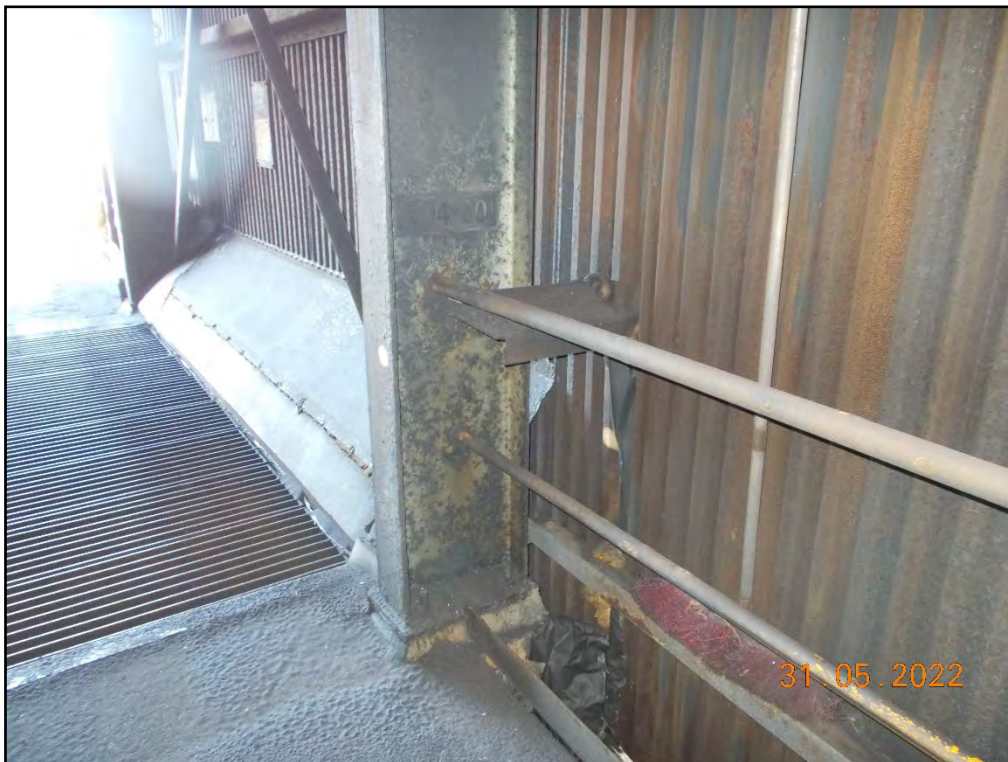
Photograph 64 Corrosion of Wall Sheeting

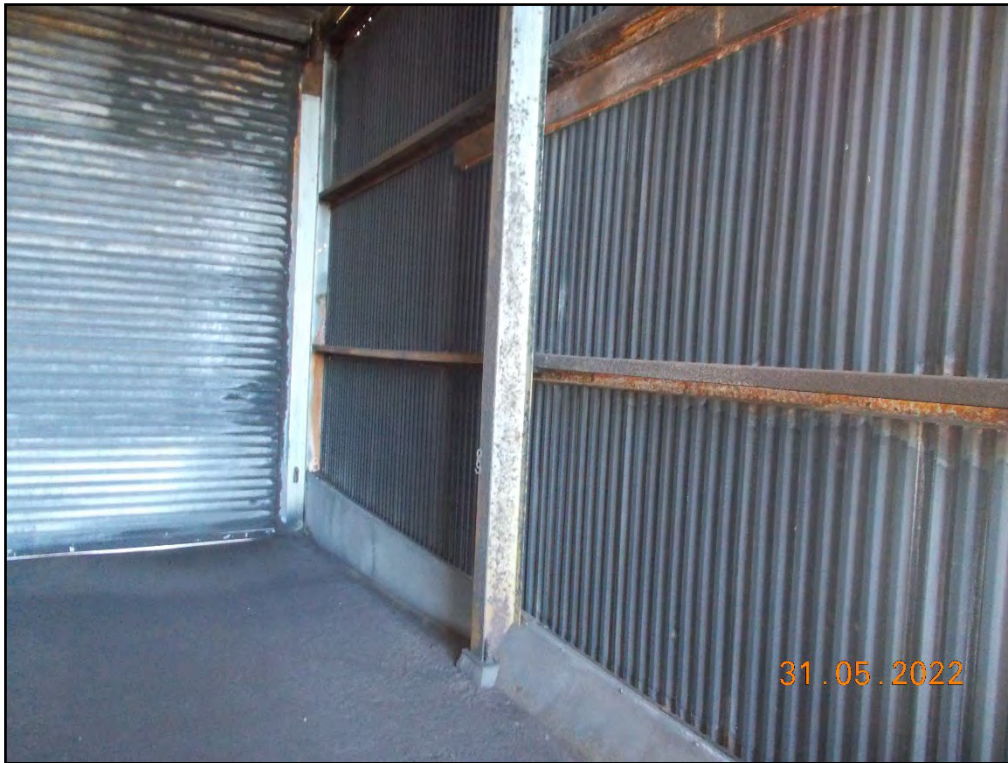
Photograph 65 Heavy Corrosion of Girts

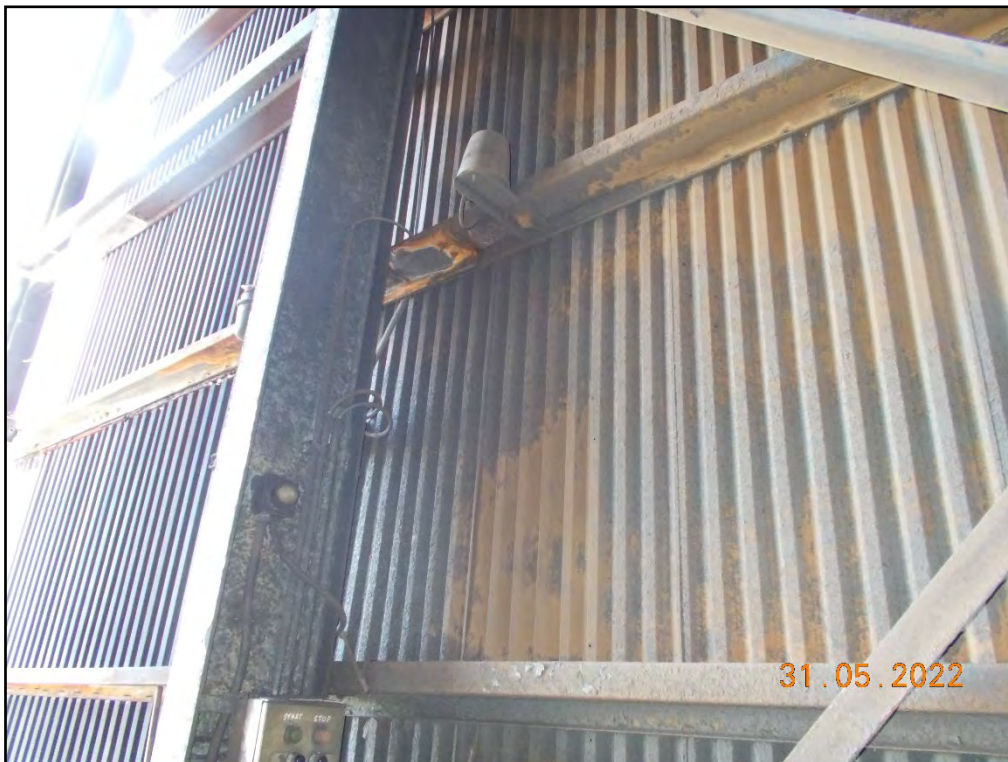
Photograph 66 Heavy Corrosion of Girts

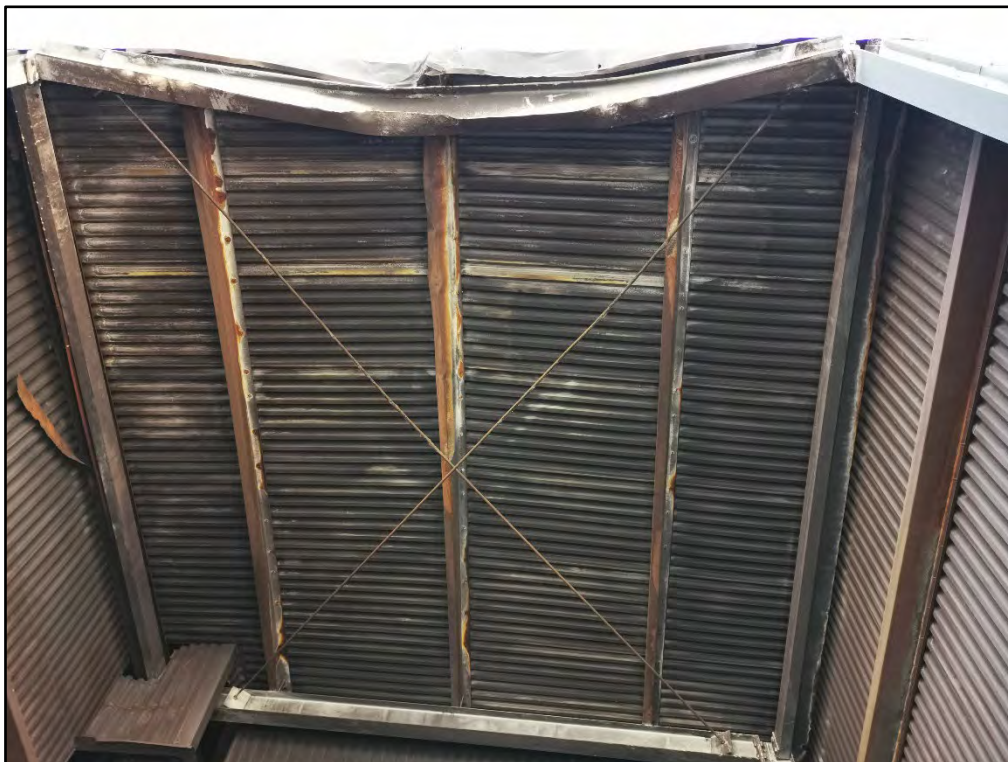
There was significant deterioration observed in the unloading bay due to corrosion. The girts were heavily corroded and, in some cases, sectional loss can be seen in Photograph 62. Additionally, a significant damage was observed in the unloading bay due to impact of vehicle which can be seen in Photograph 67 and Photograph 68.

Photograph 68 Impact Damage Due to Vehicle

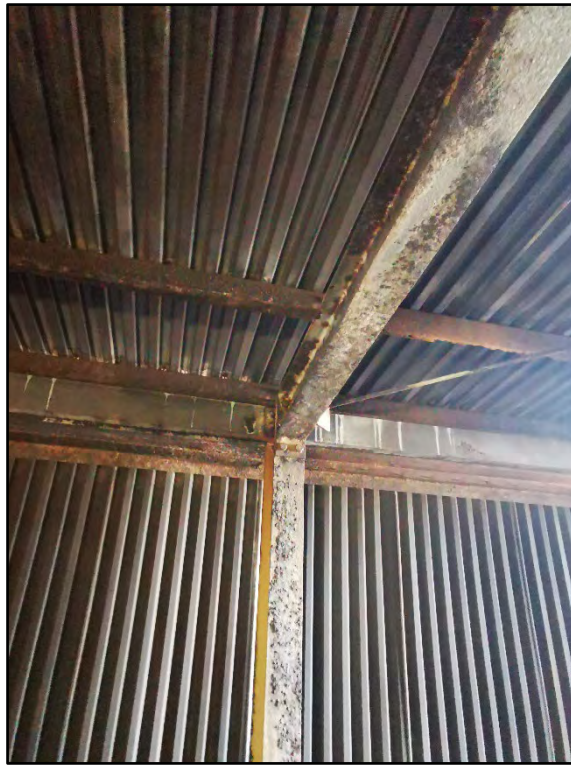
Photograph 69 Surface Corrosion of Columns, Rafter, and Purlins

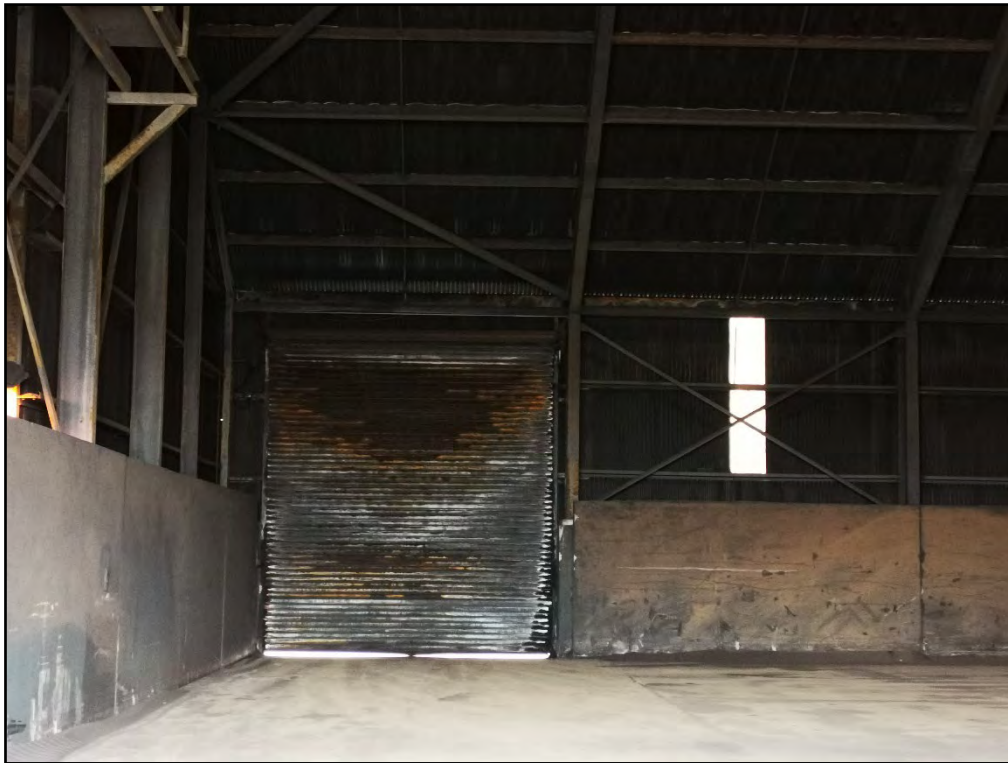
Photograph 74 Door Frame Showing Signs of Corrosion

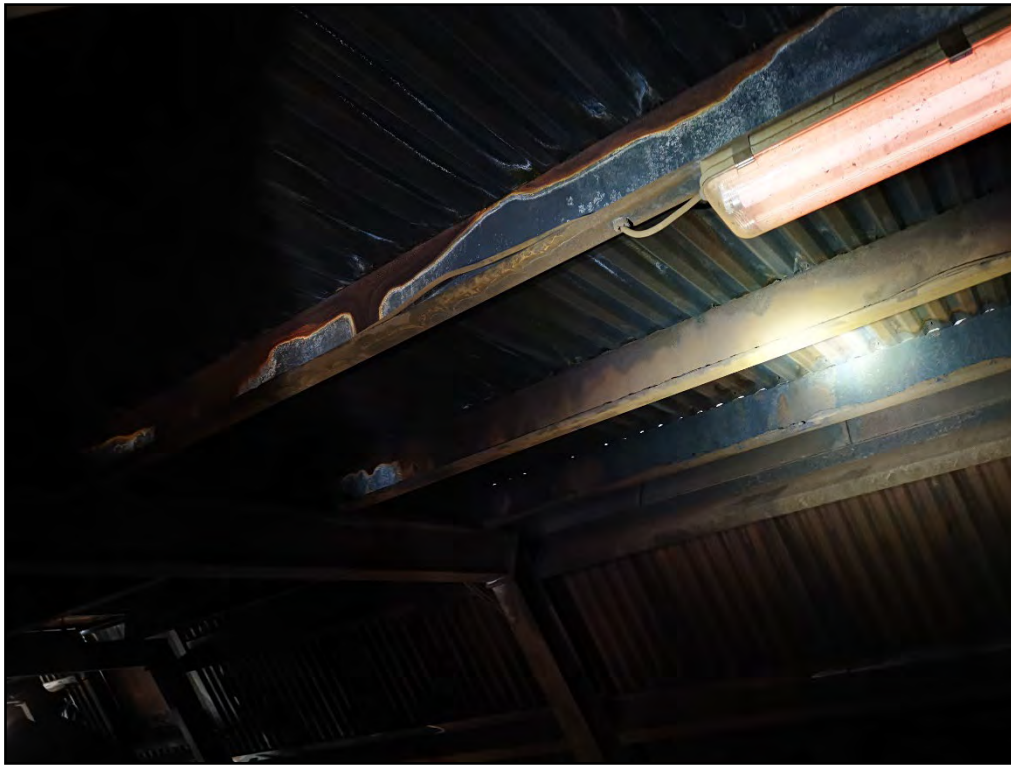
Photograph 76 Surface Corrosion of Purlins

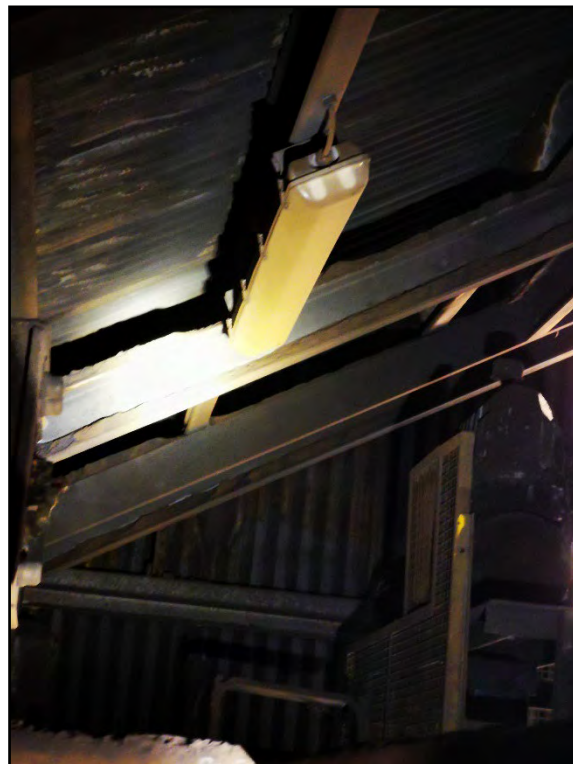
Photograph 77 Surface Corrosion of Purlin and Roof Sheeting and Product Deposit on Flanges of UB Section
