CONDITION REPORT
SHEDS 6, 7 & 8
OUTER HARBOUR PORT, BUNBURY

WML
Consulting Engineers

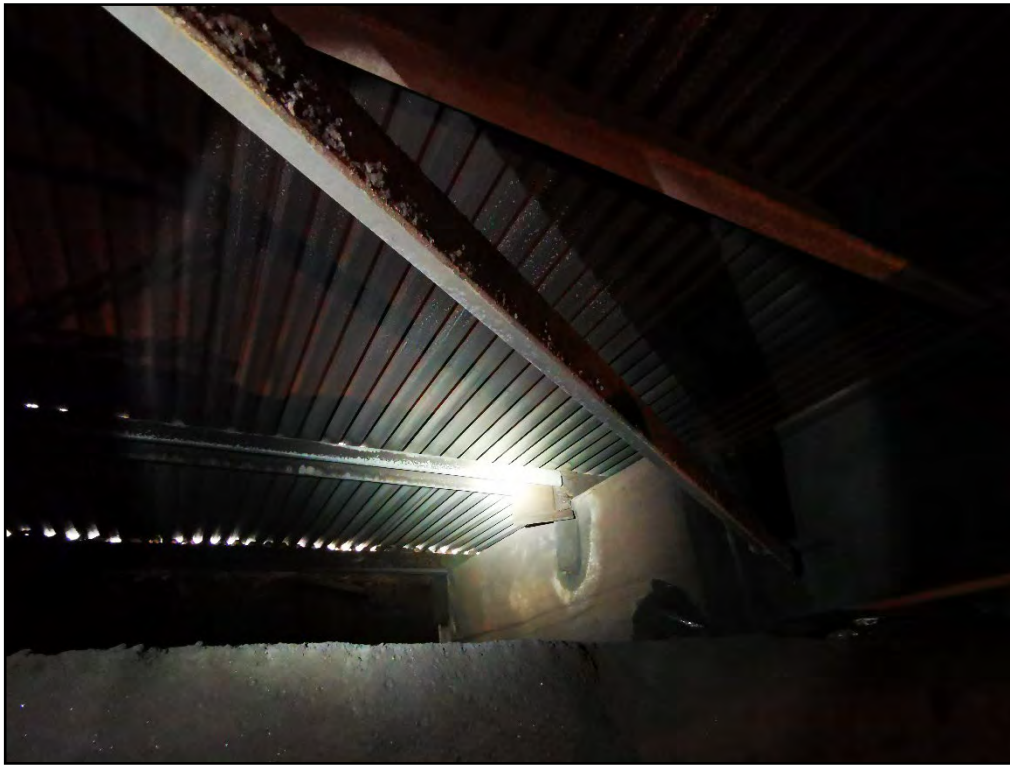
Photograph 88 Wall Girt Missing

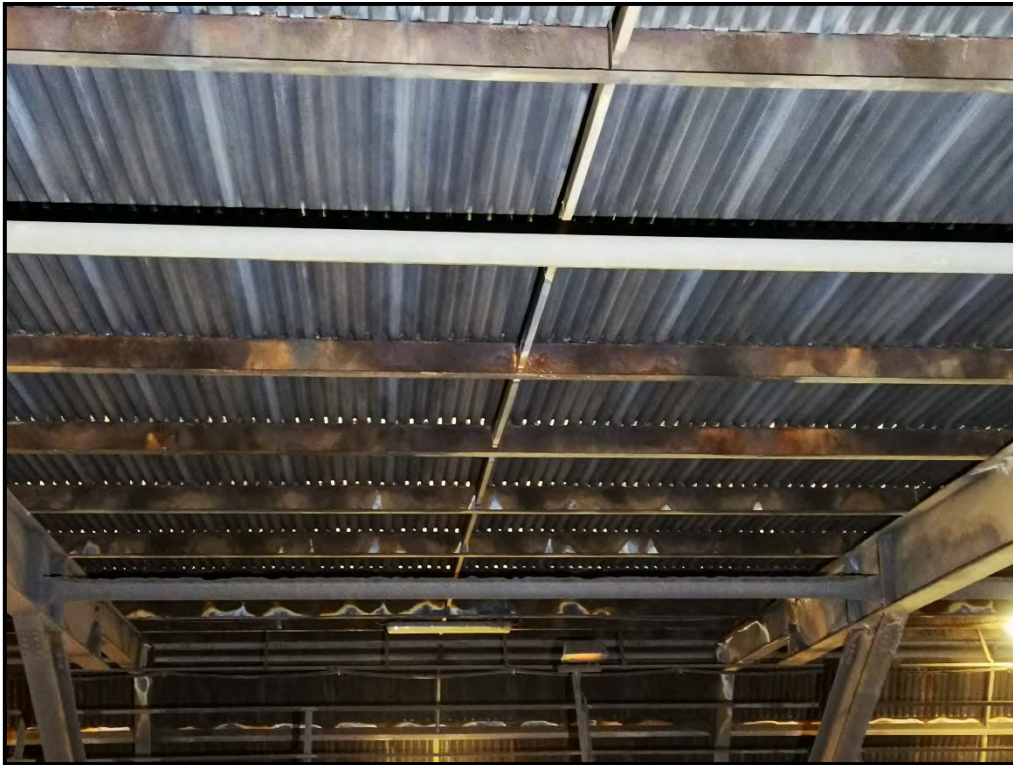
Photograph 92 Surface Corrosion of Purlins and Rafters

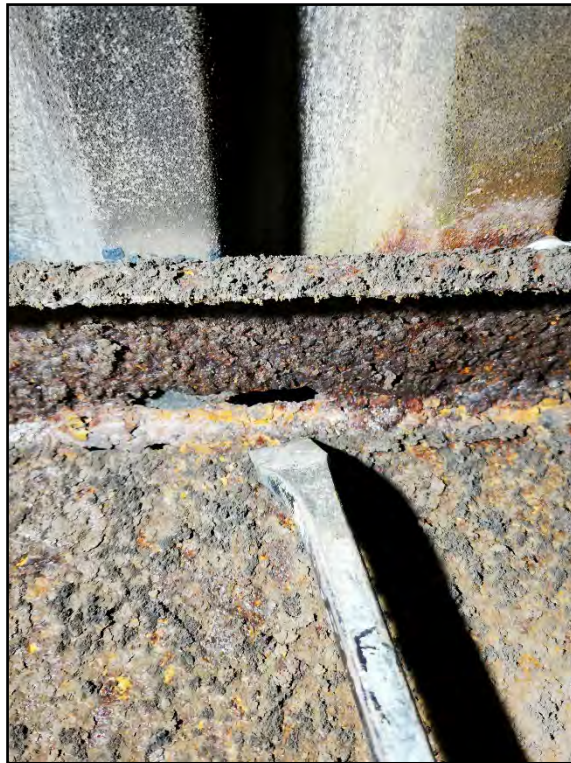
Photograph 94 Sectional Loss of Purlin Due to Corrosion

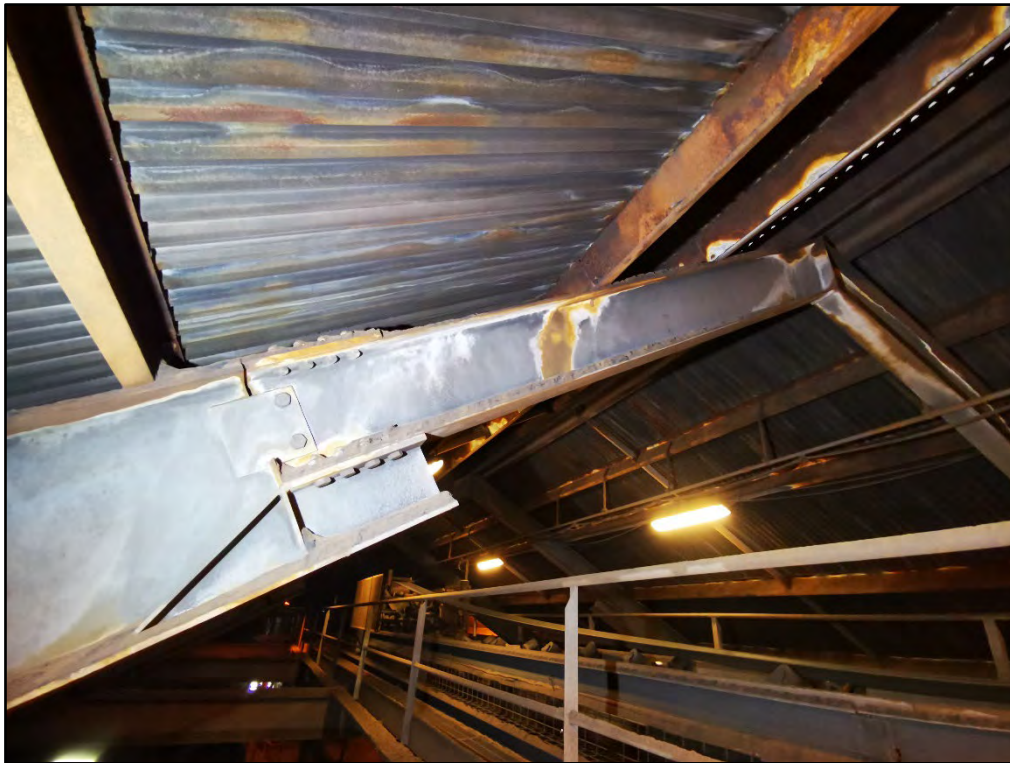
Photograph 96 Surface Corrosion of Purlins and Rafters

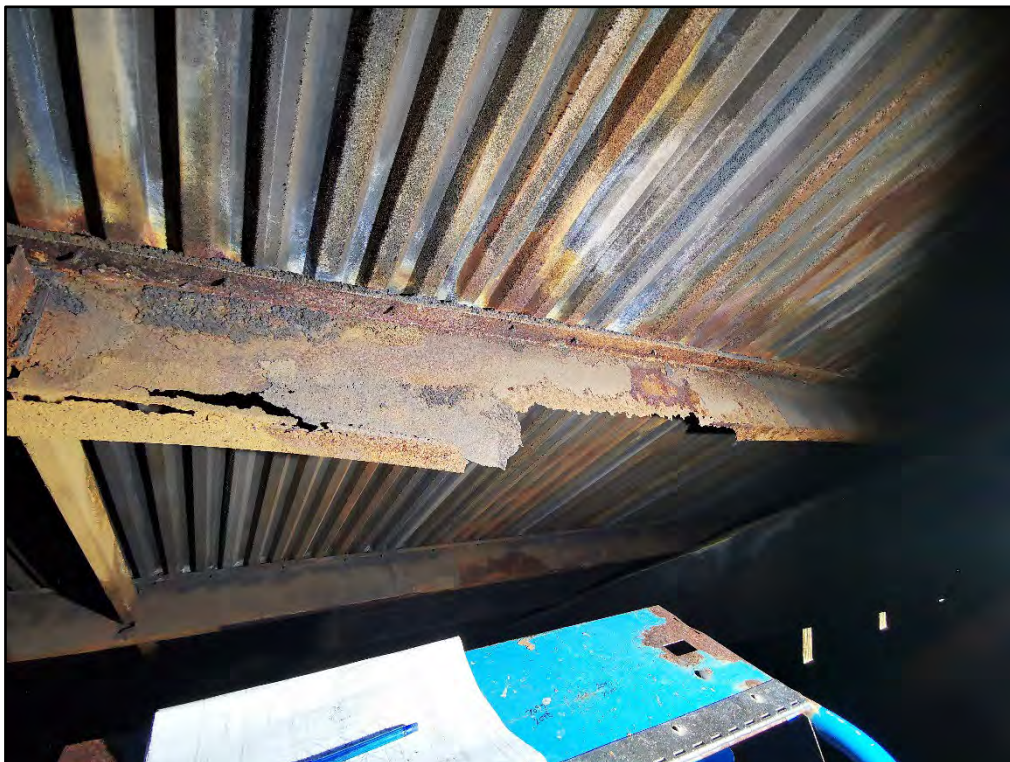
Photograph 97 Sectional Loss of Purlin and Corrosion of Roof Sheeting

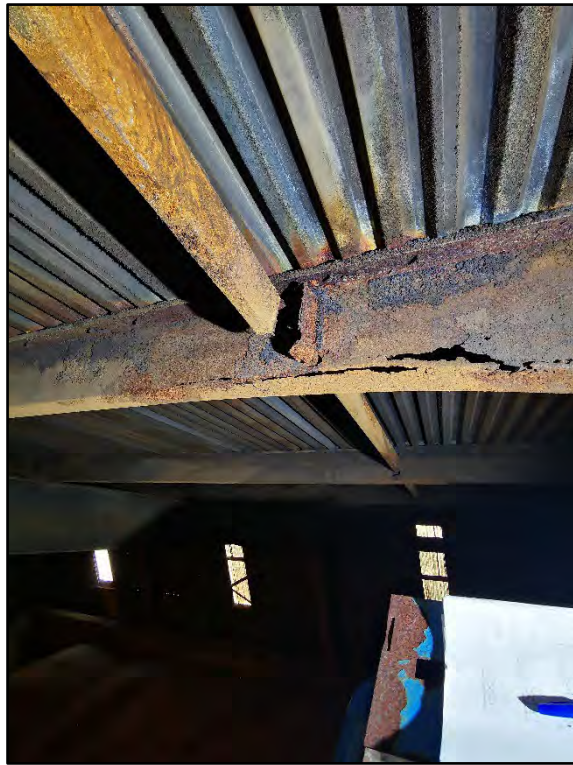
Photograph 98 Failure of purlin and bridging Due to Corrosion

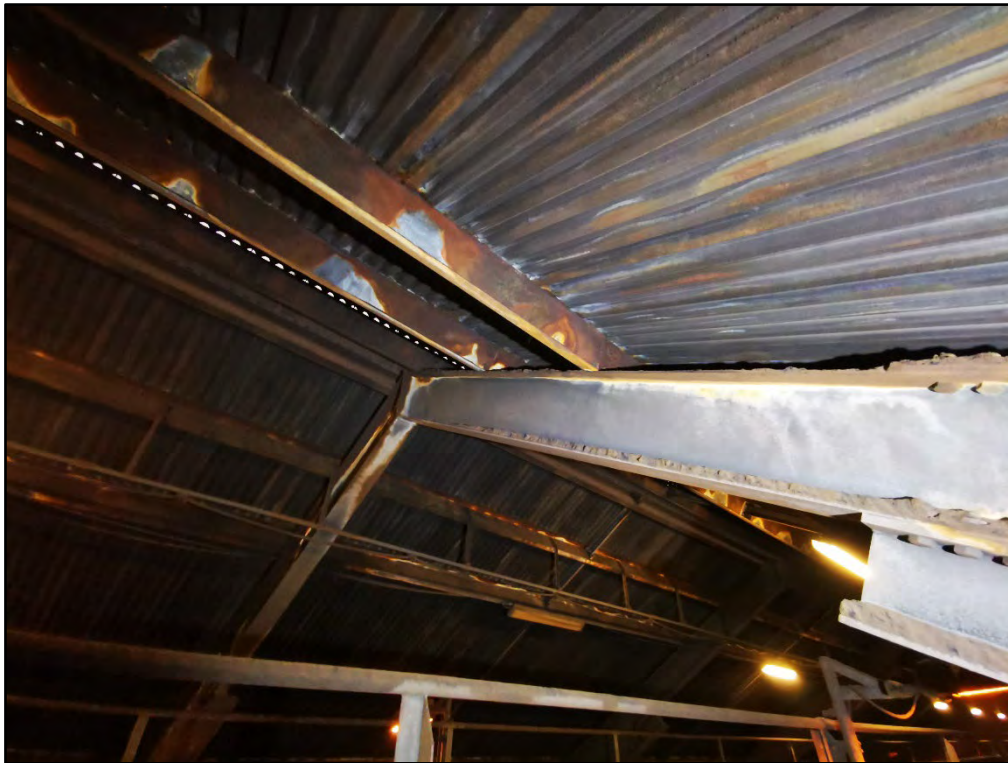
Photograph 100 Surface Corrosion of Rafters, Purlin and Roof Sheeting with Product Deposit

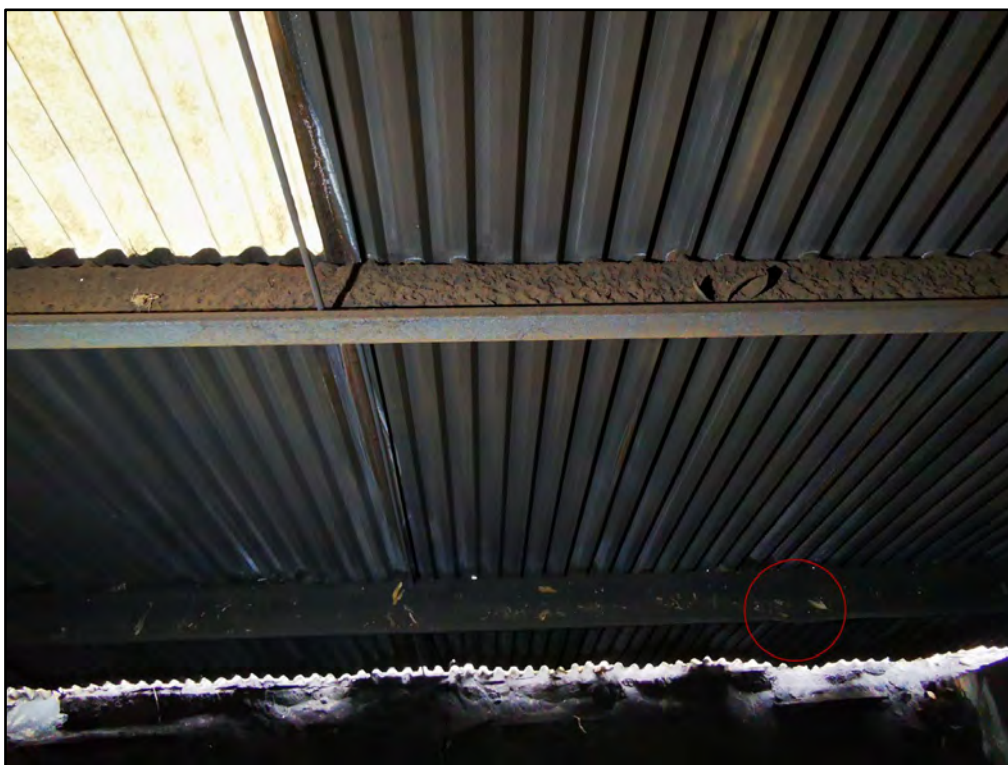
Photograph 101 Damage to Girt Due to Product Deposit

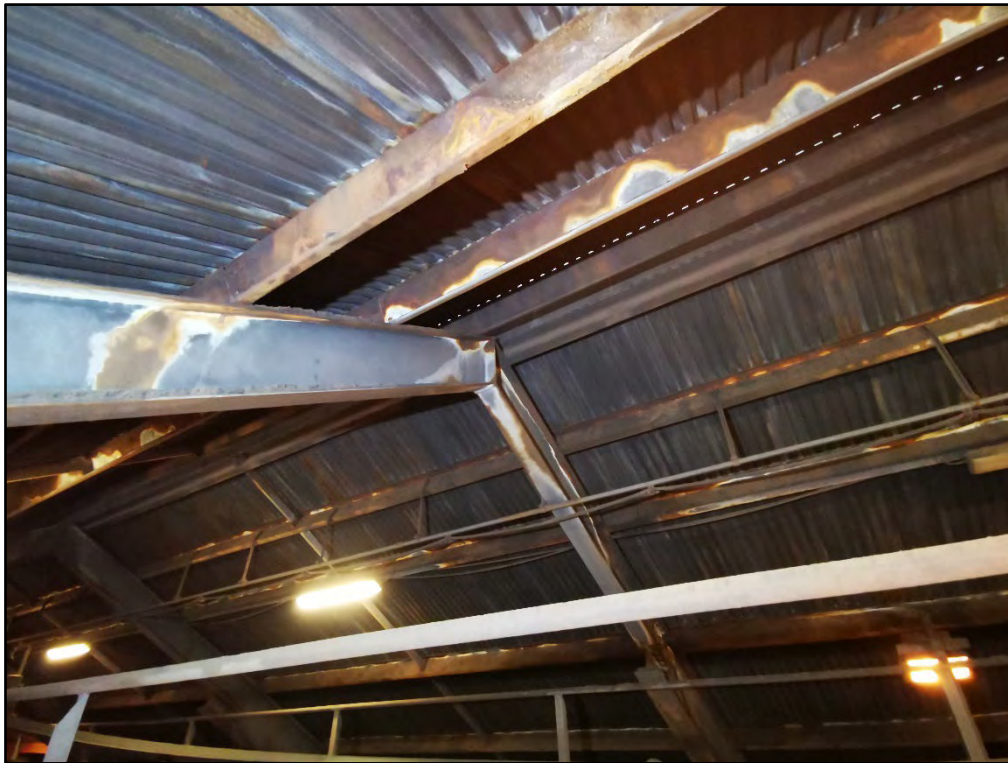
Figure 102 Surface Corrosion of Rafters, Purlins and Roof Sheeting

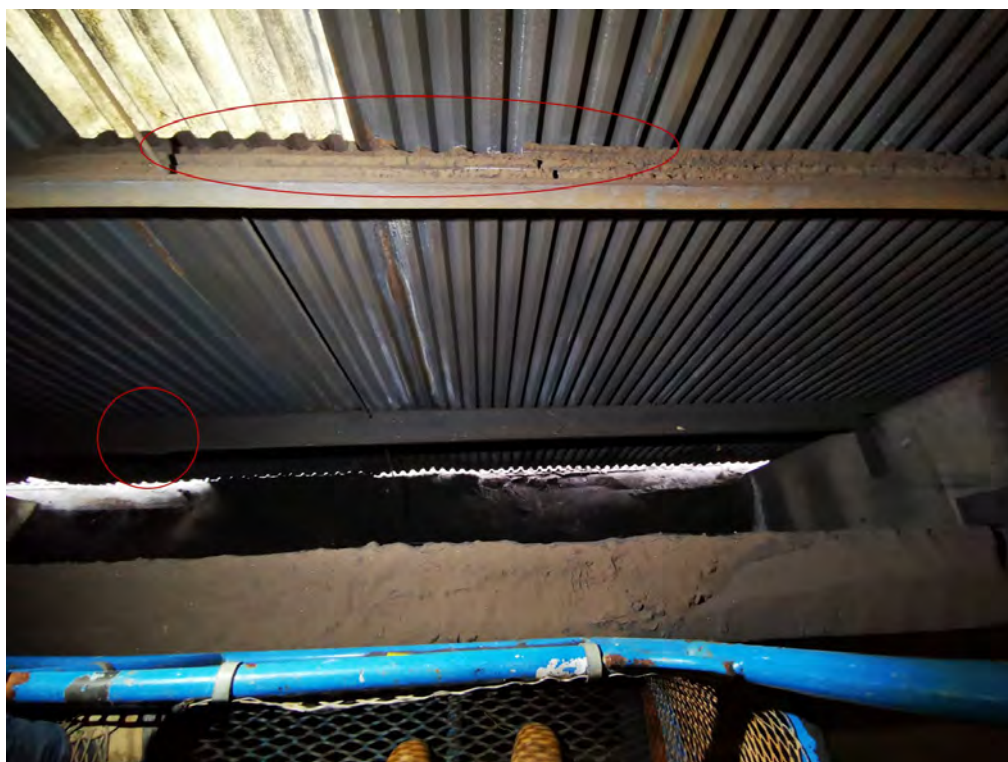
Photograph 103 Sectional Loss and Damage of Girt Due to Product Deposit

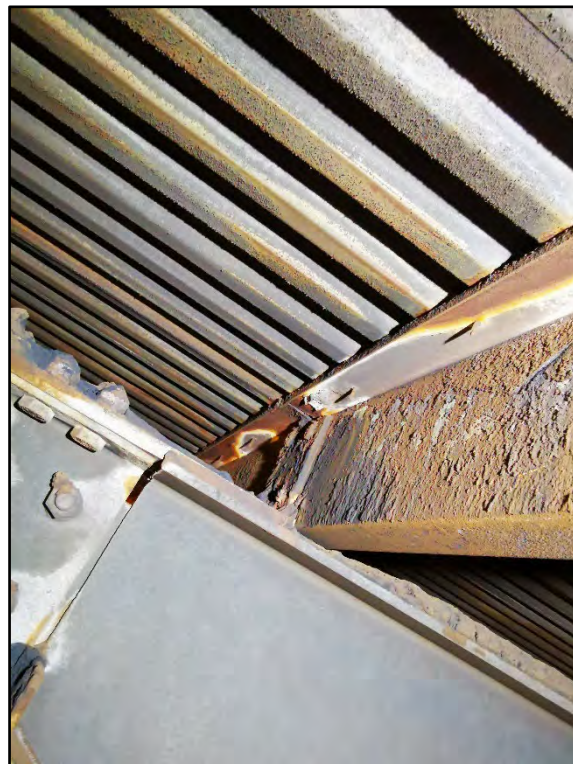
Photograph 105 Surface Corrosion of Bolts, Rafter and Purlin Due to Product Deposit

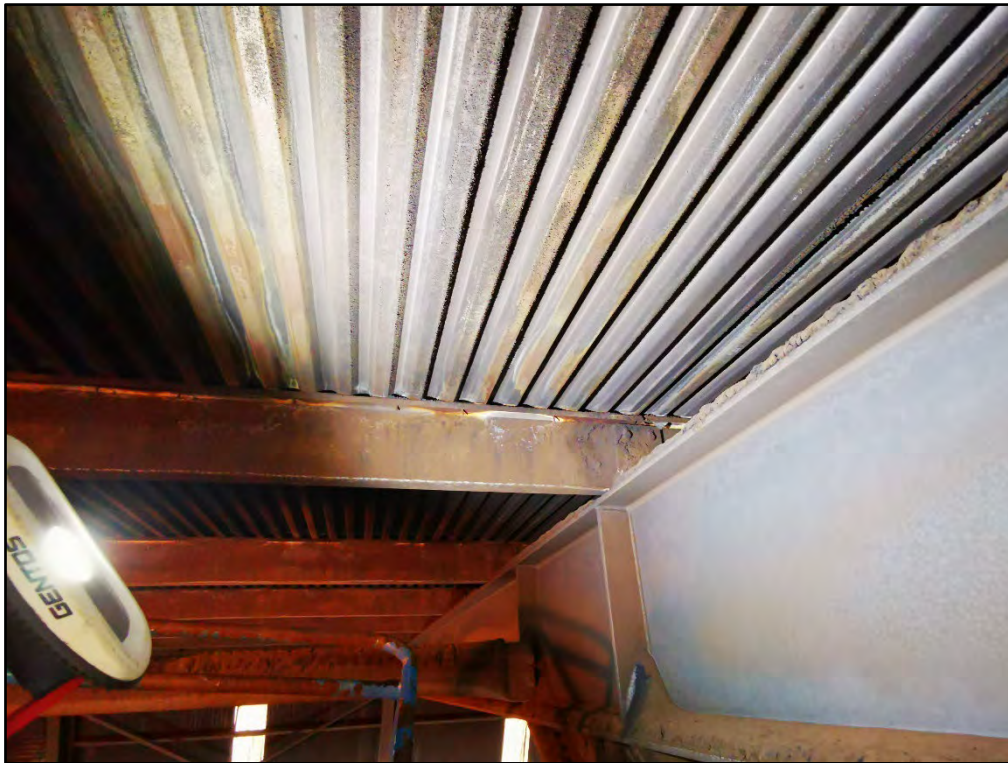
Photograph 106 Surface Corrosion of Bolts, Rafter and Purlin Due to Product Deposit

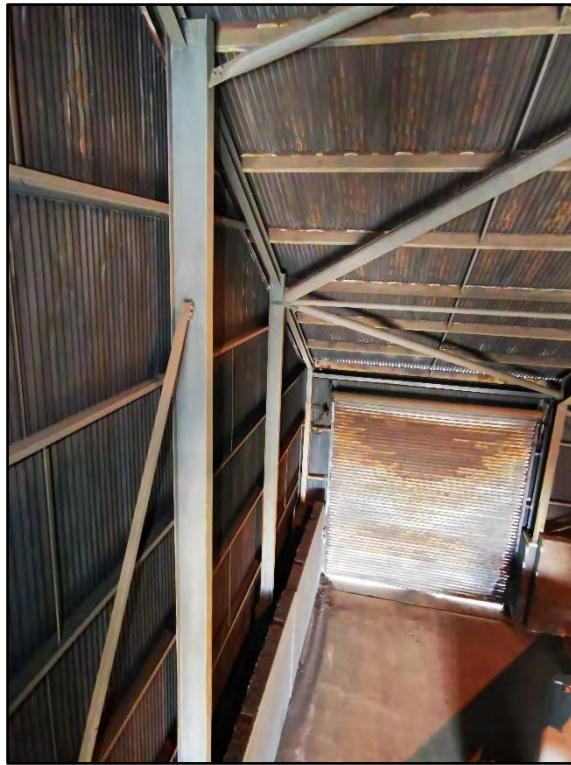
Photograph 108 Surface Corrosion of Purlins, Girts, and Sheeting

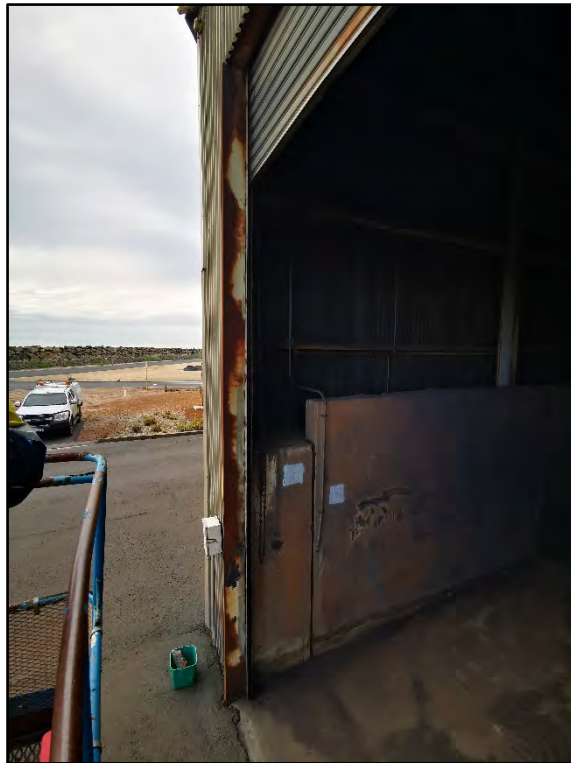
Photograph 114 Surface Corrosion of Door Frame

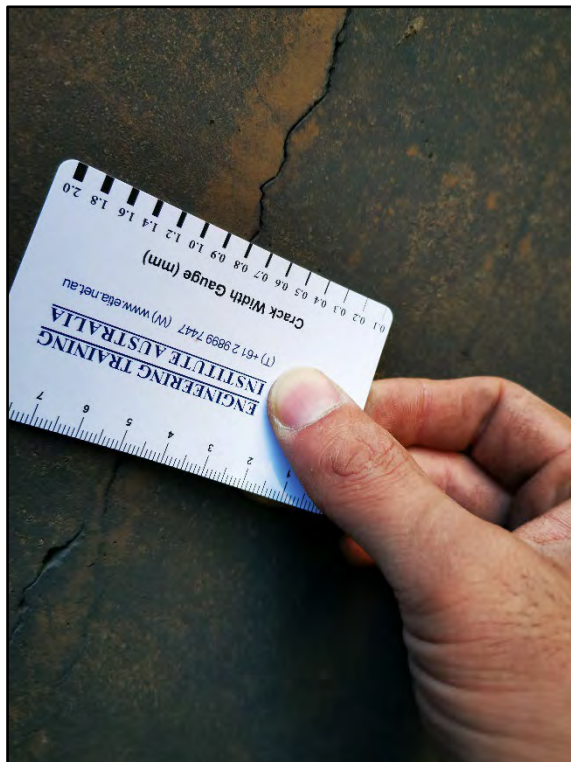
Photograph 115 Surface Crack on the Wall

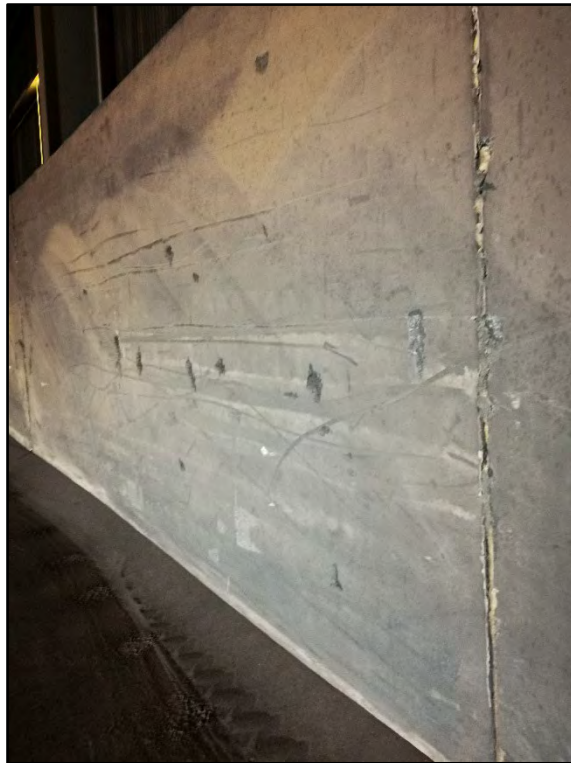
Photograph 118 Minor Impact Damages Due to Loader

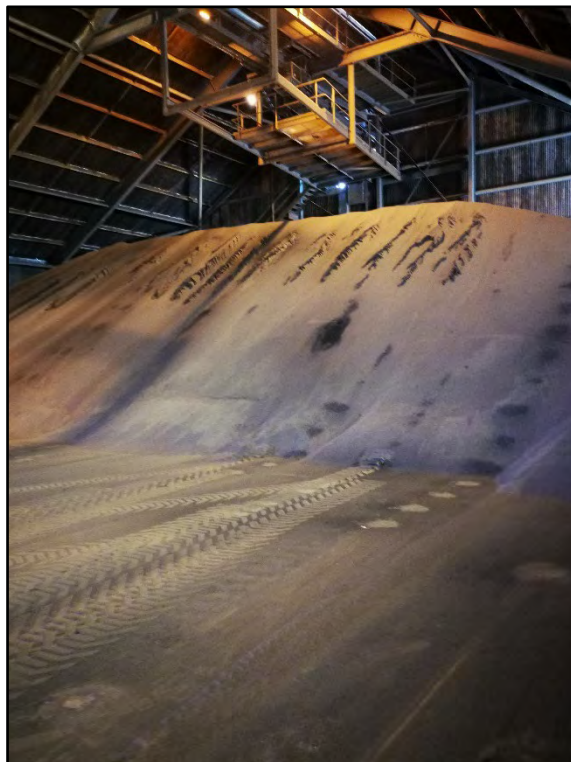
Photograph 119 No Slab Damage or Crack Observed

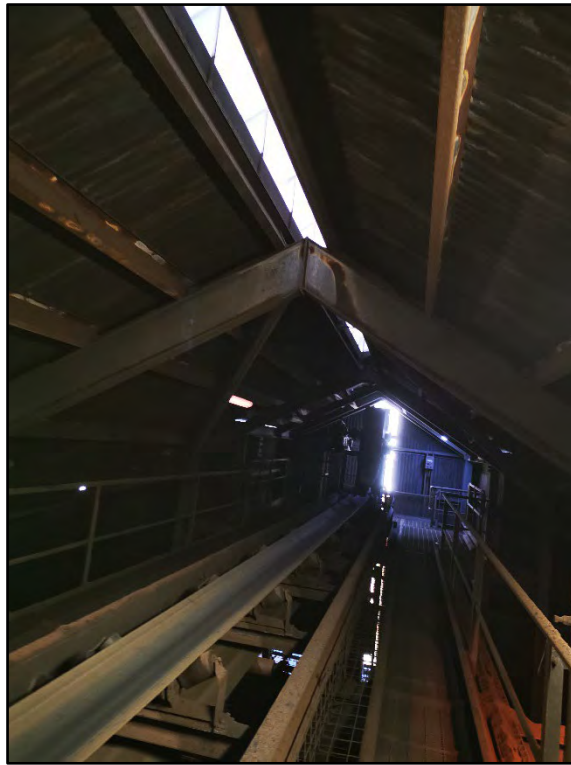
Photograph 120 Surface Corrosion of Purlins on Conveyor and Walkway

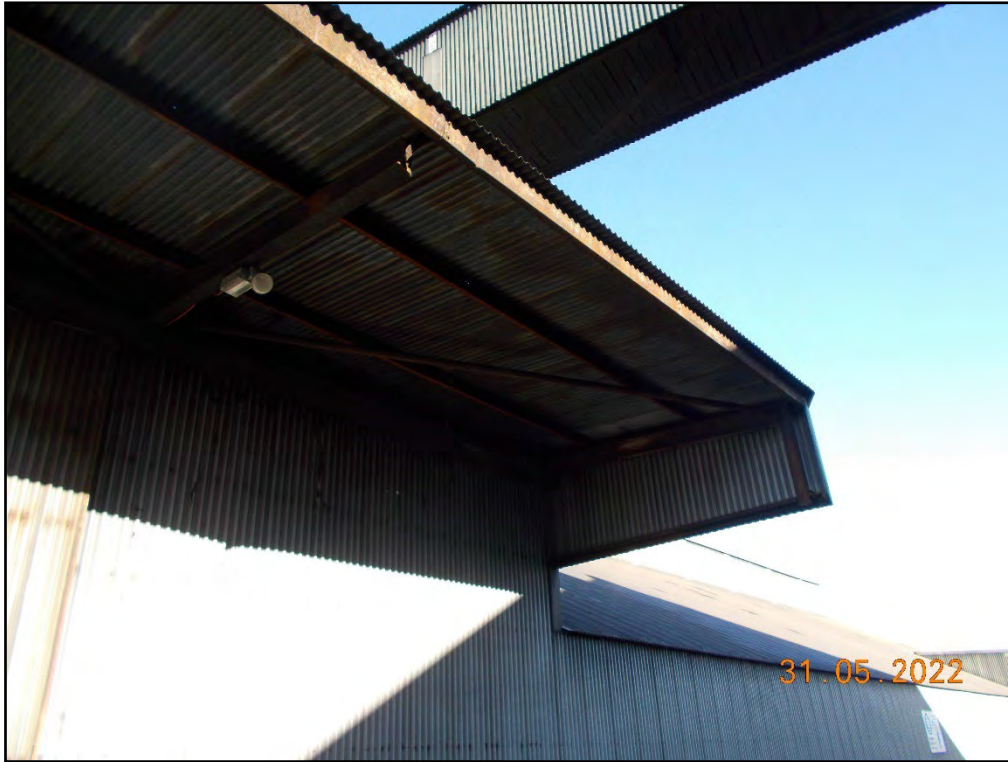
Photograph 122 Corrosion of Rafters and Purlins.

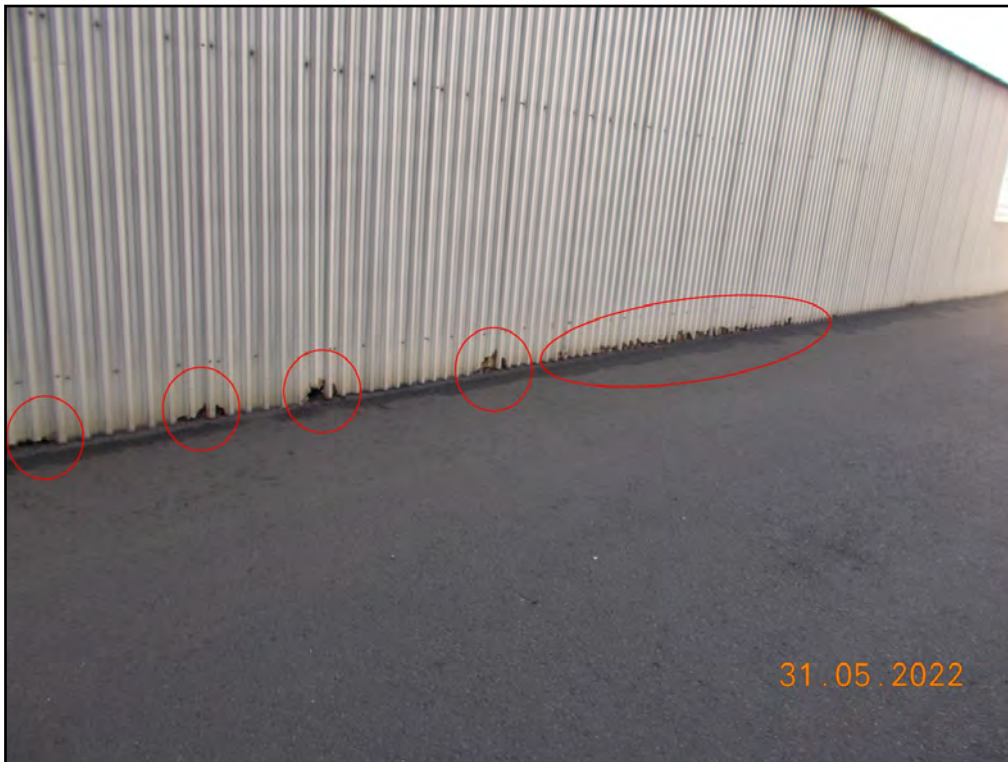
Photograph 123 Corrosion Deterioration Observed at the Bottom

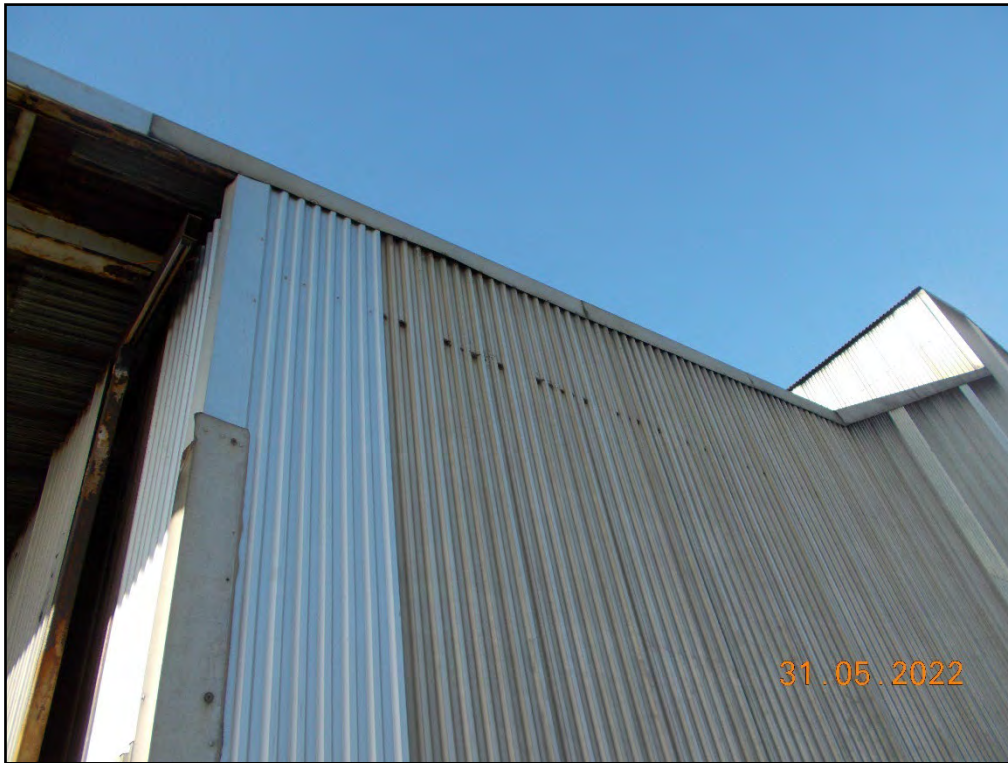
Photograph 126 Corrosion of Door Frame

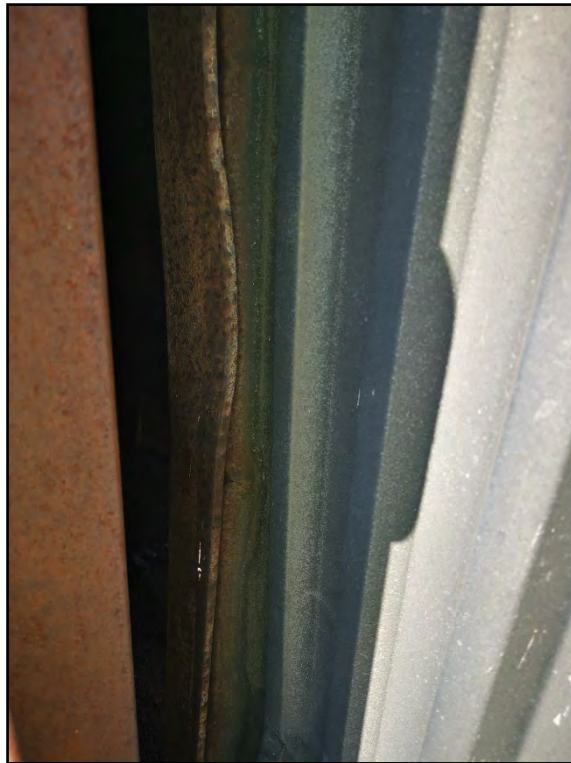
Photograph 128 Damage Due to Impact

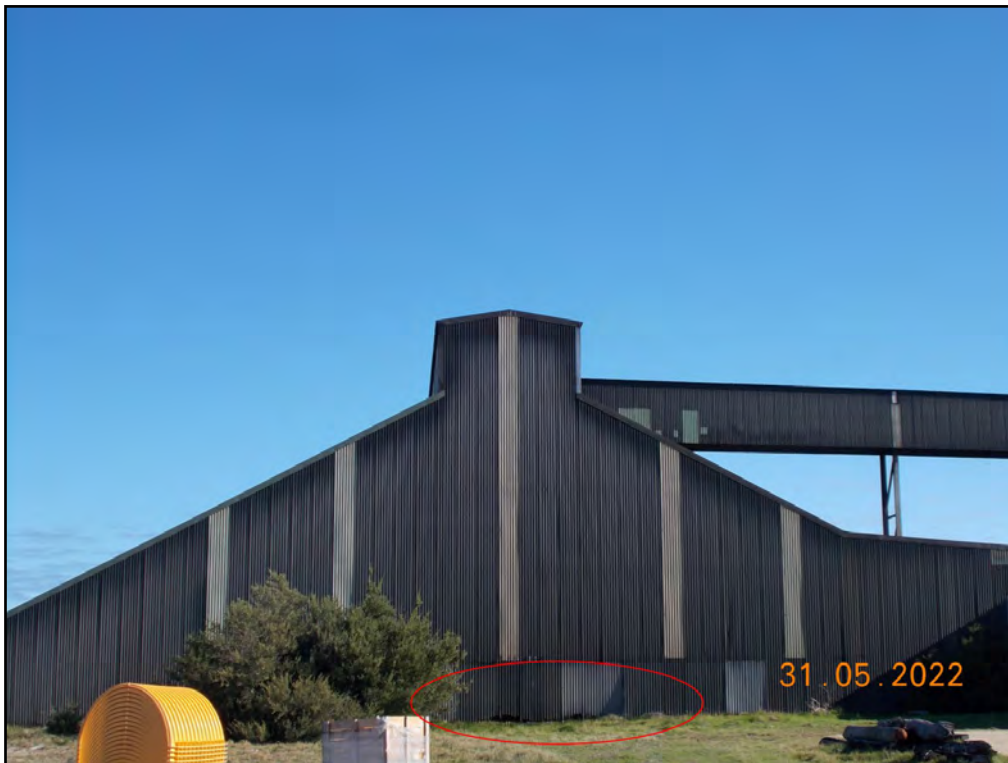
Photograph 131 Deterioration at the Bottom of Wall Sheeting

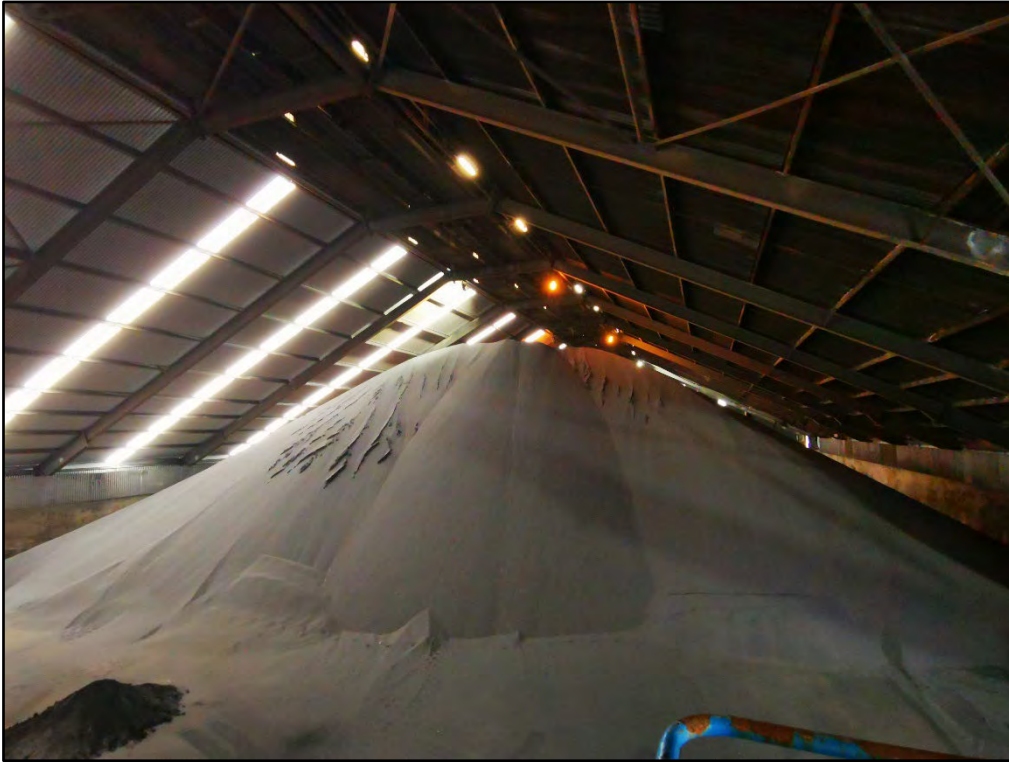
Photograph 134 Product Inside the Shed Restricted the Access

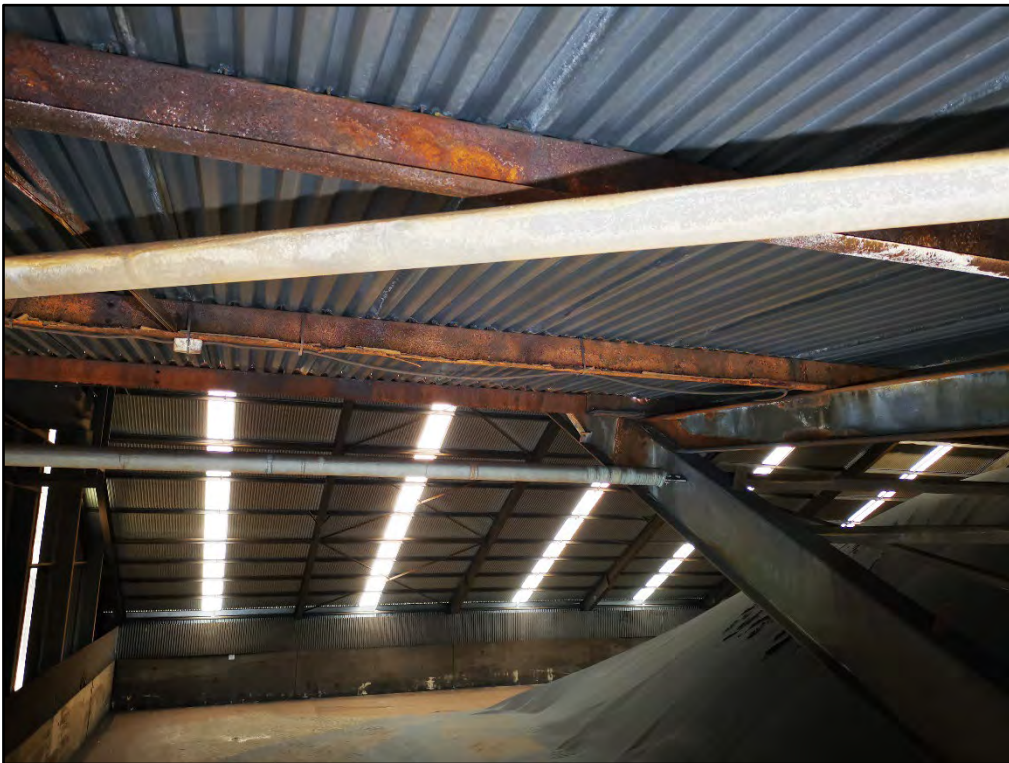
Photograph 135 Deteriorated Purlin due to Corrosion

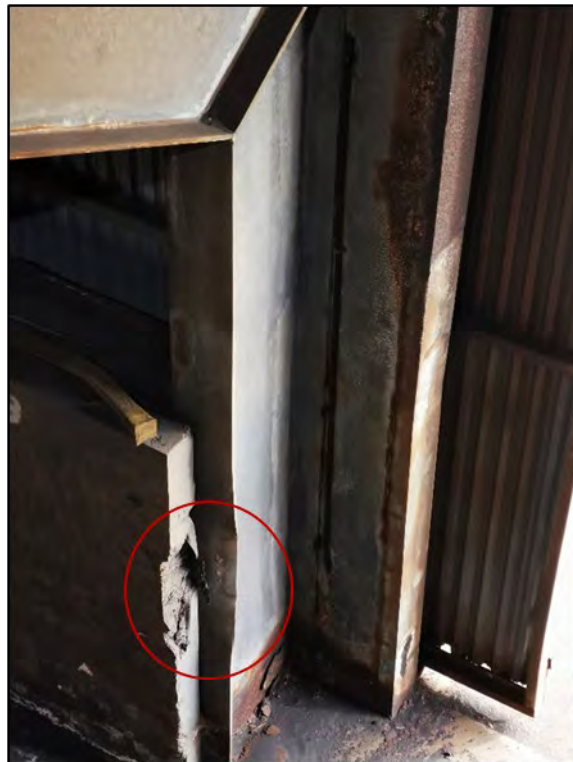
Photograph 137 Damaged Concrete Wall and Impact damage to Column Bay H-3

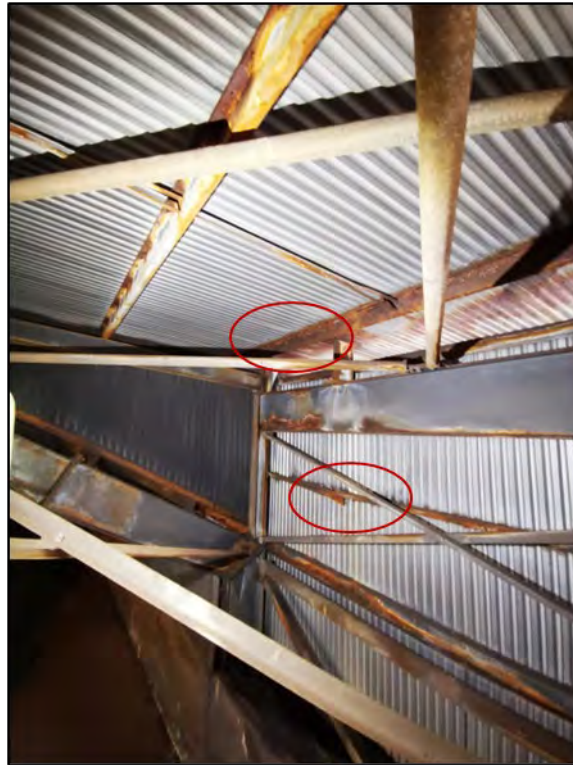
Photograph 138 Deteriorated Girts, purlins due to Corrosion and Surface Corrosion of Beams and Columns

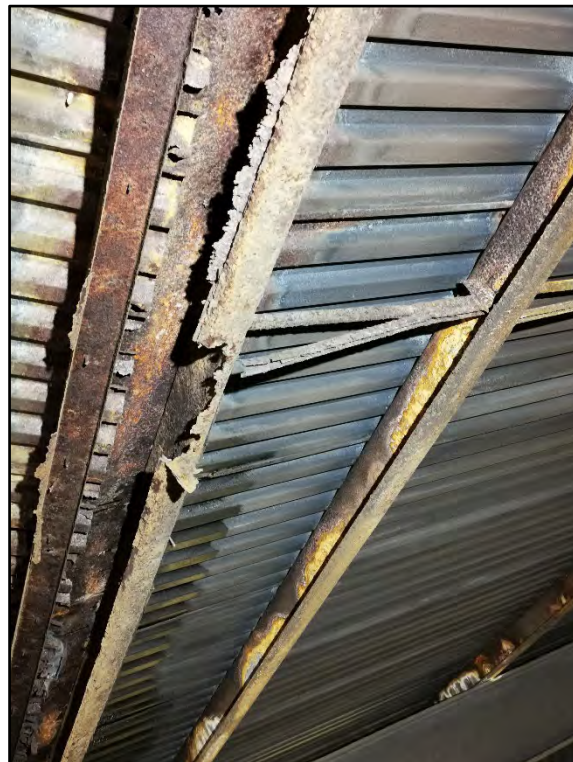
Photograph 139 Deterioration of Purlin

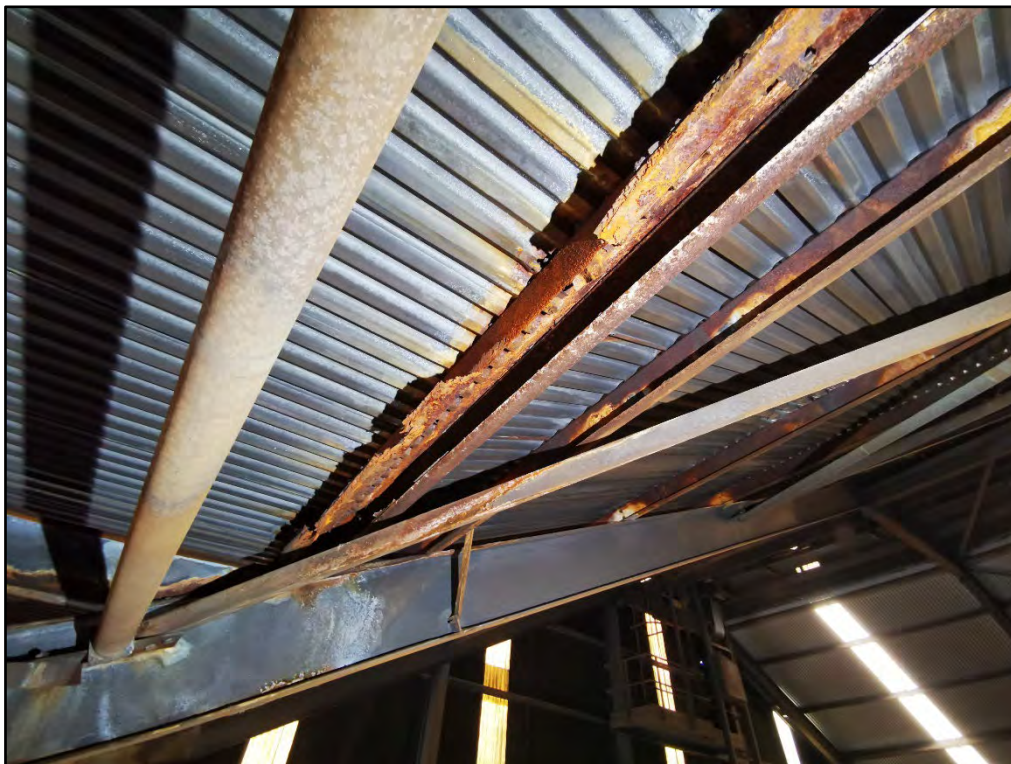
Photograph 141 Daeteriorated Purlin due to Corrosion

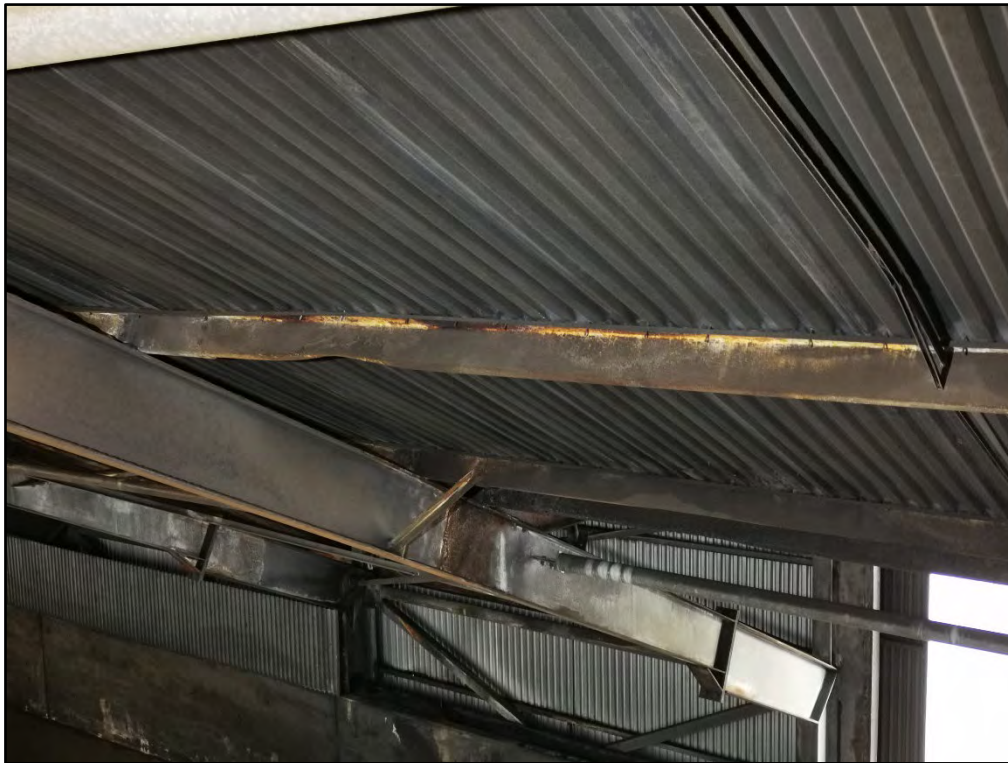
Photograph 142 Damaged Purlin due to Impact

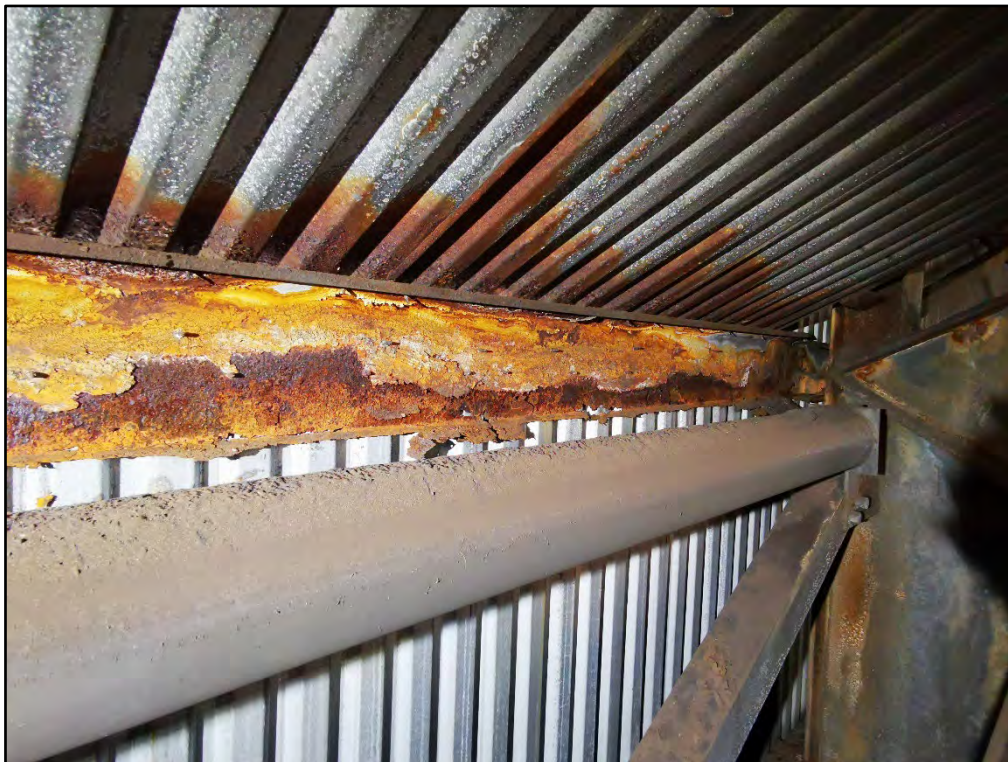
Photograph 143 Corroded Fascia Purlin

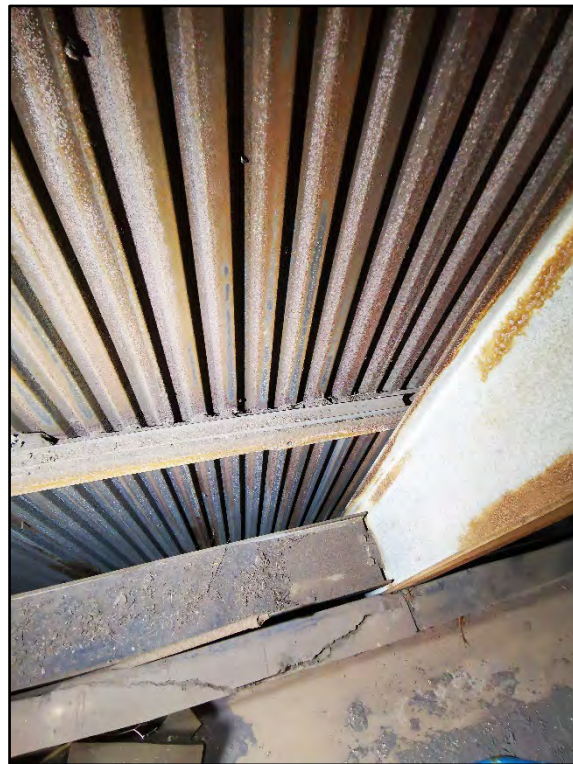
Photograph 145 Cracked Concrete Wall

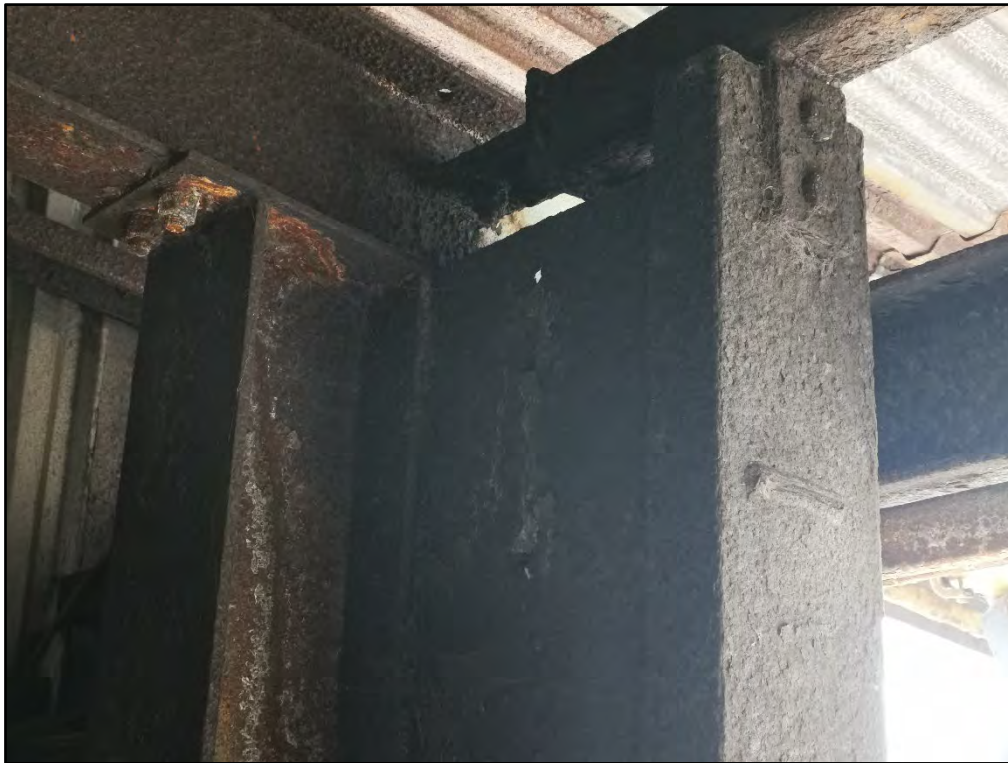
Photograph 146 Heavily Corroded Steel Members

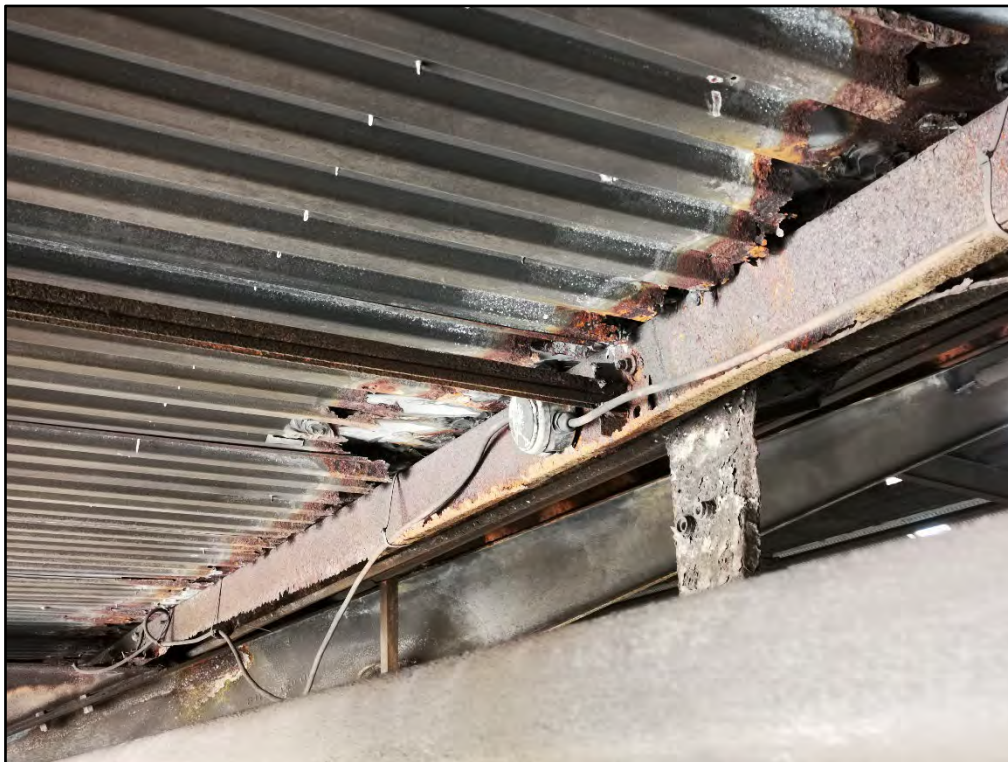
Photograph 147 Deterioration Purlin due to Corrosion

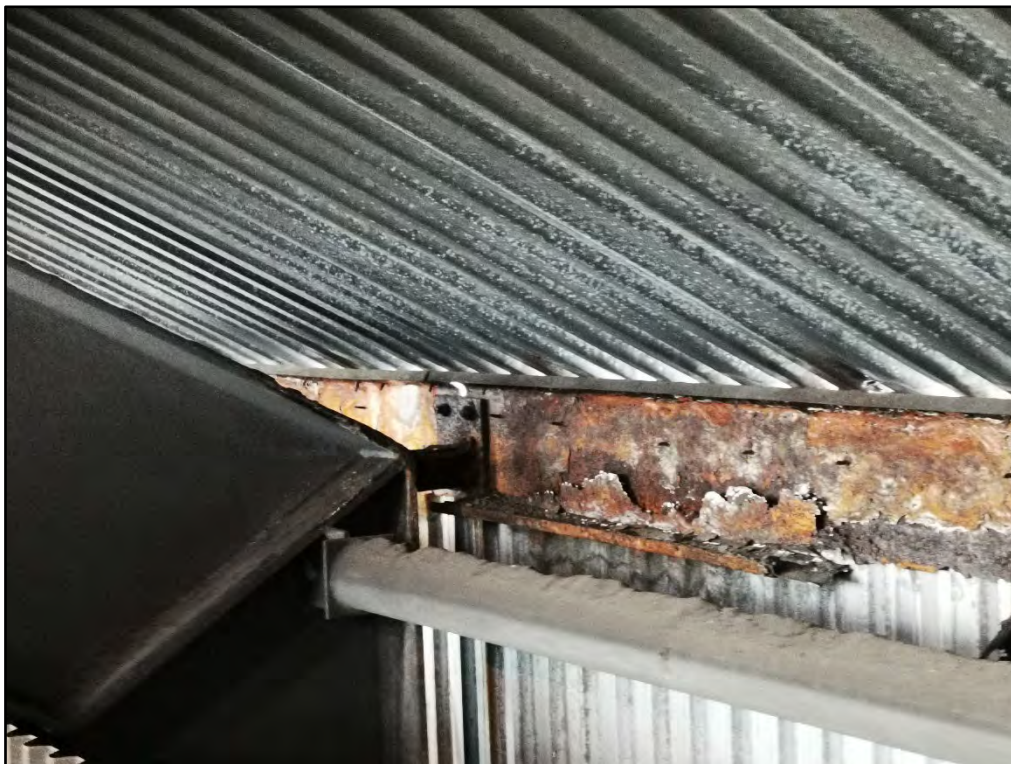
Photograph 153 Deterioration to Fascia Purlin due to Corrosion
