CONDITION REPORT
SHEDS 6, 7 & 8
OUTER HARBOUR PORT, BUNBURY

WML
Consulting Engineers

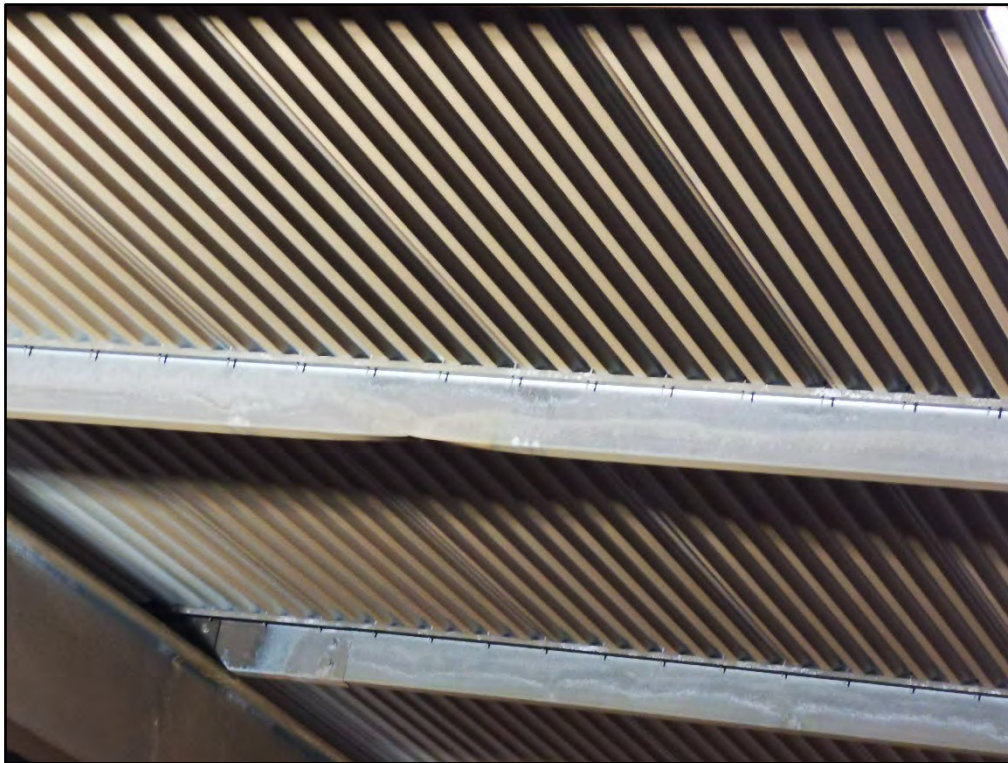
Photograph 154 Damaged Purlin due to Impact in South Side

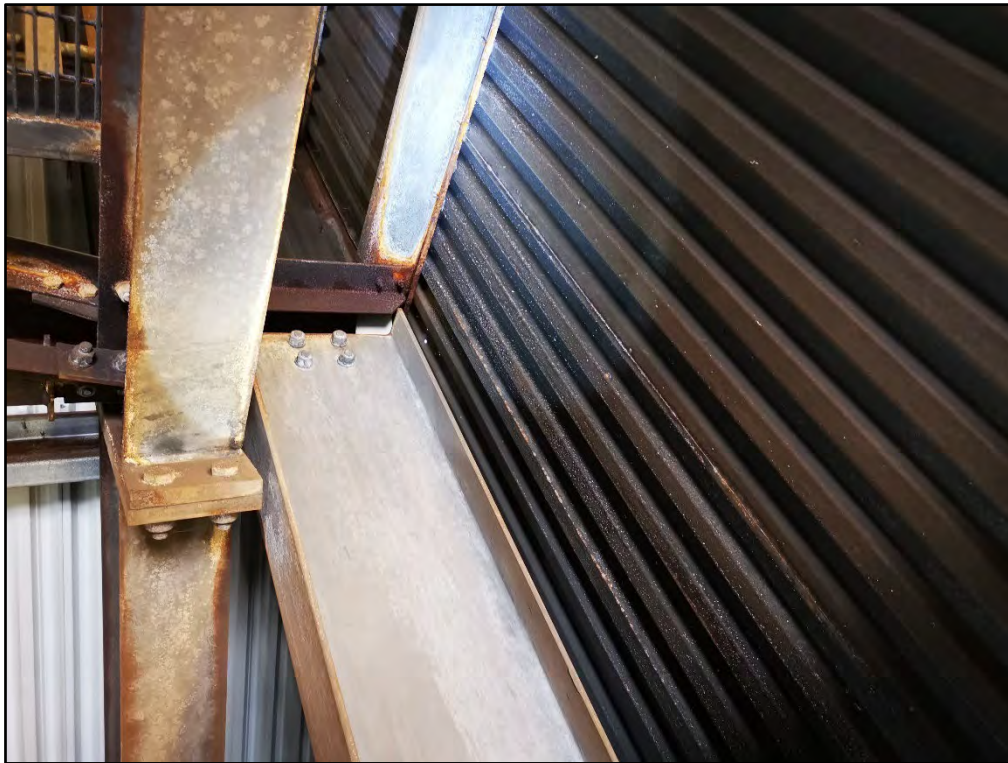
Photograph 160 Heavily Corroded EA Section

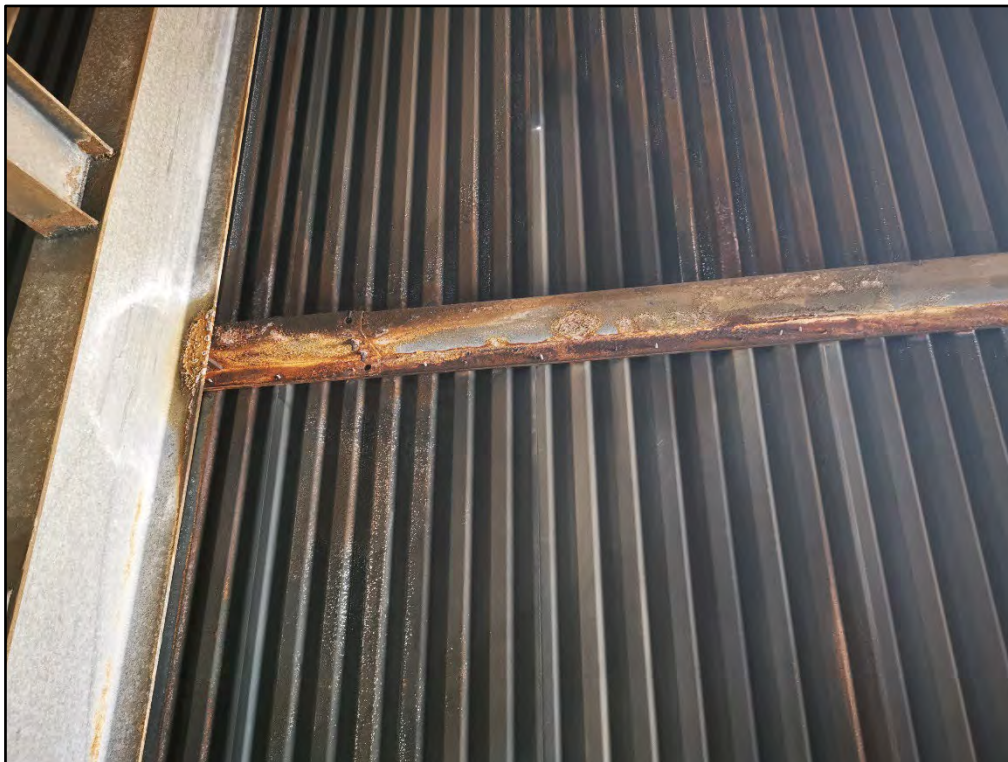
Photograph 161 Heavily Corroded Wall Girt

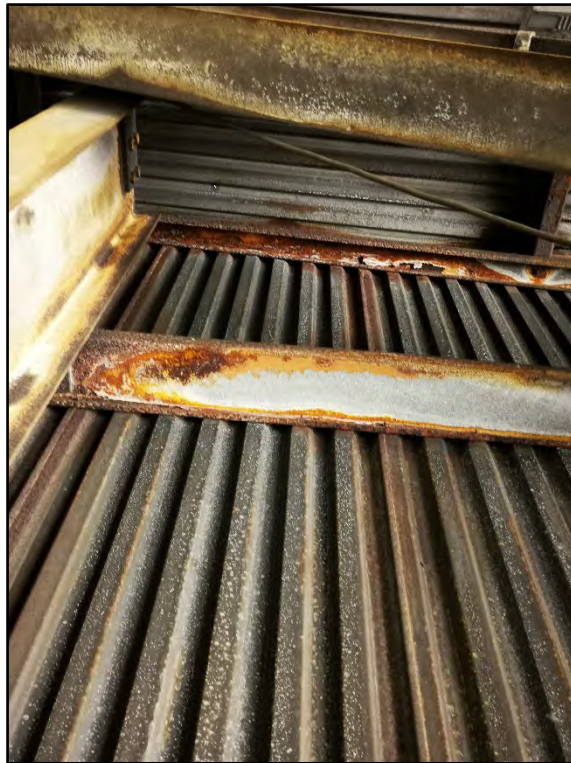
Photograph 162 Delamination of Wall Girts due to Corrosion

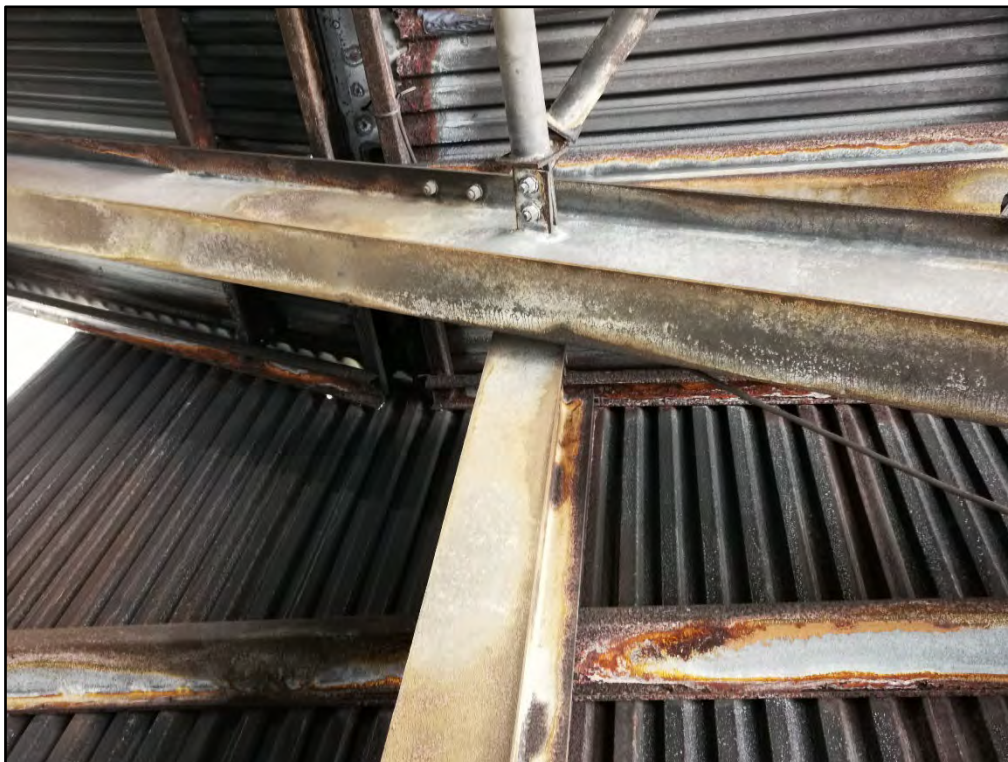
Photograph 163 Delamination of Wall Girts due to Corrosion

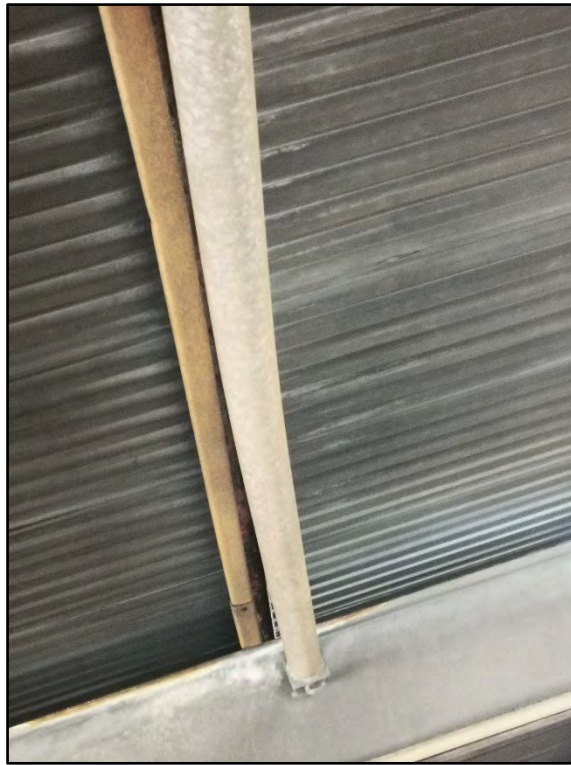
Photograph 164 Deformed CHS Section

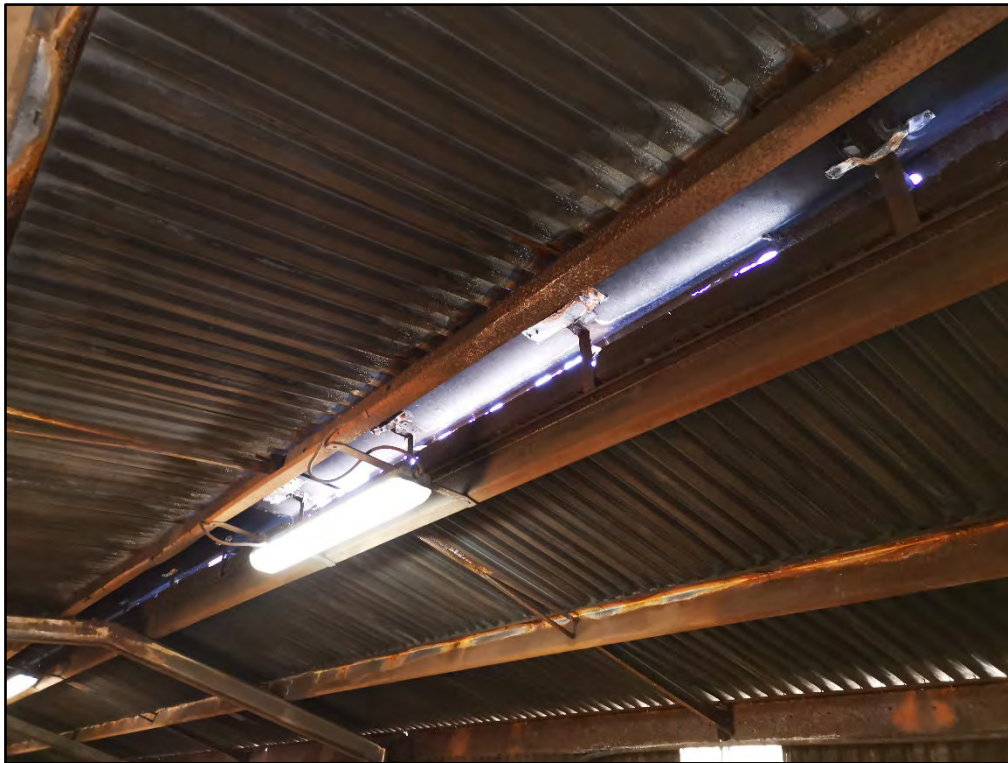
Photograph 166 Heavily Corroded Purlins on Conveyor and Walkway

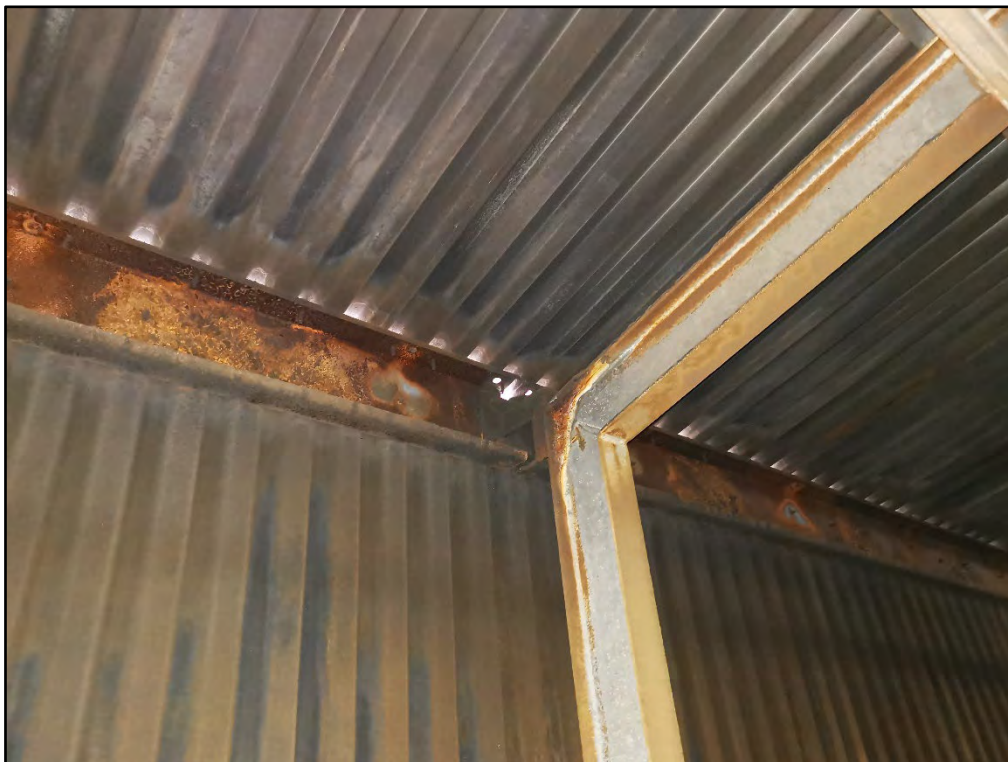
Photograph 167 Heavily Corroded Fascia Purlin on Conveyor and Walkway

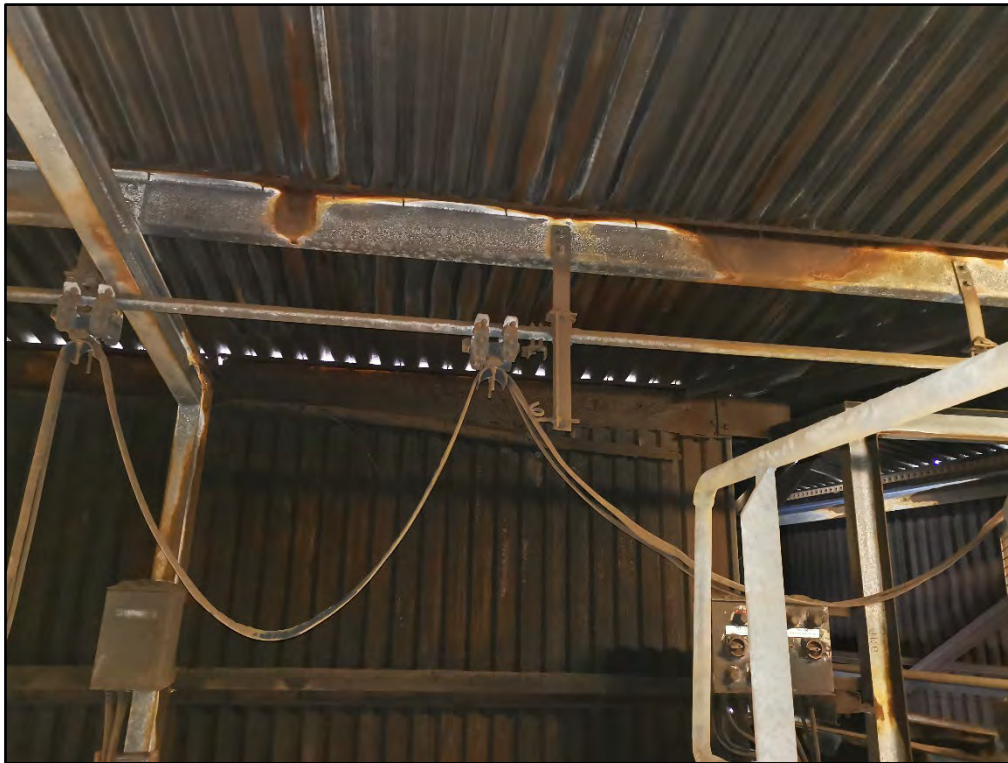
Photograph 168 Sectional Loss of Fascia Purlin and Surface Corrosion of Purlins and Girts

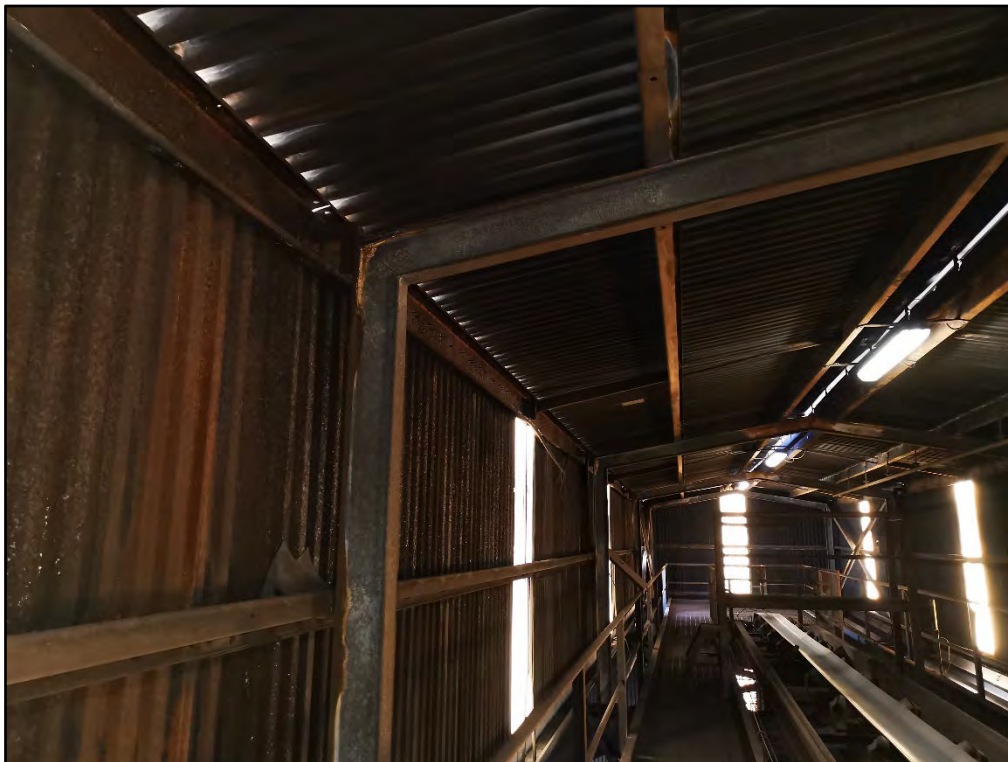
Photograph 169 Surface Corrosion of Steel Members and Damaged Fascia Purlin
