Appendix D.35. Waikiki Beach, Rockingham

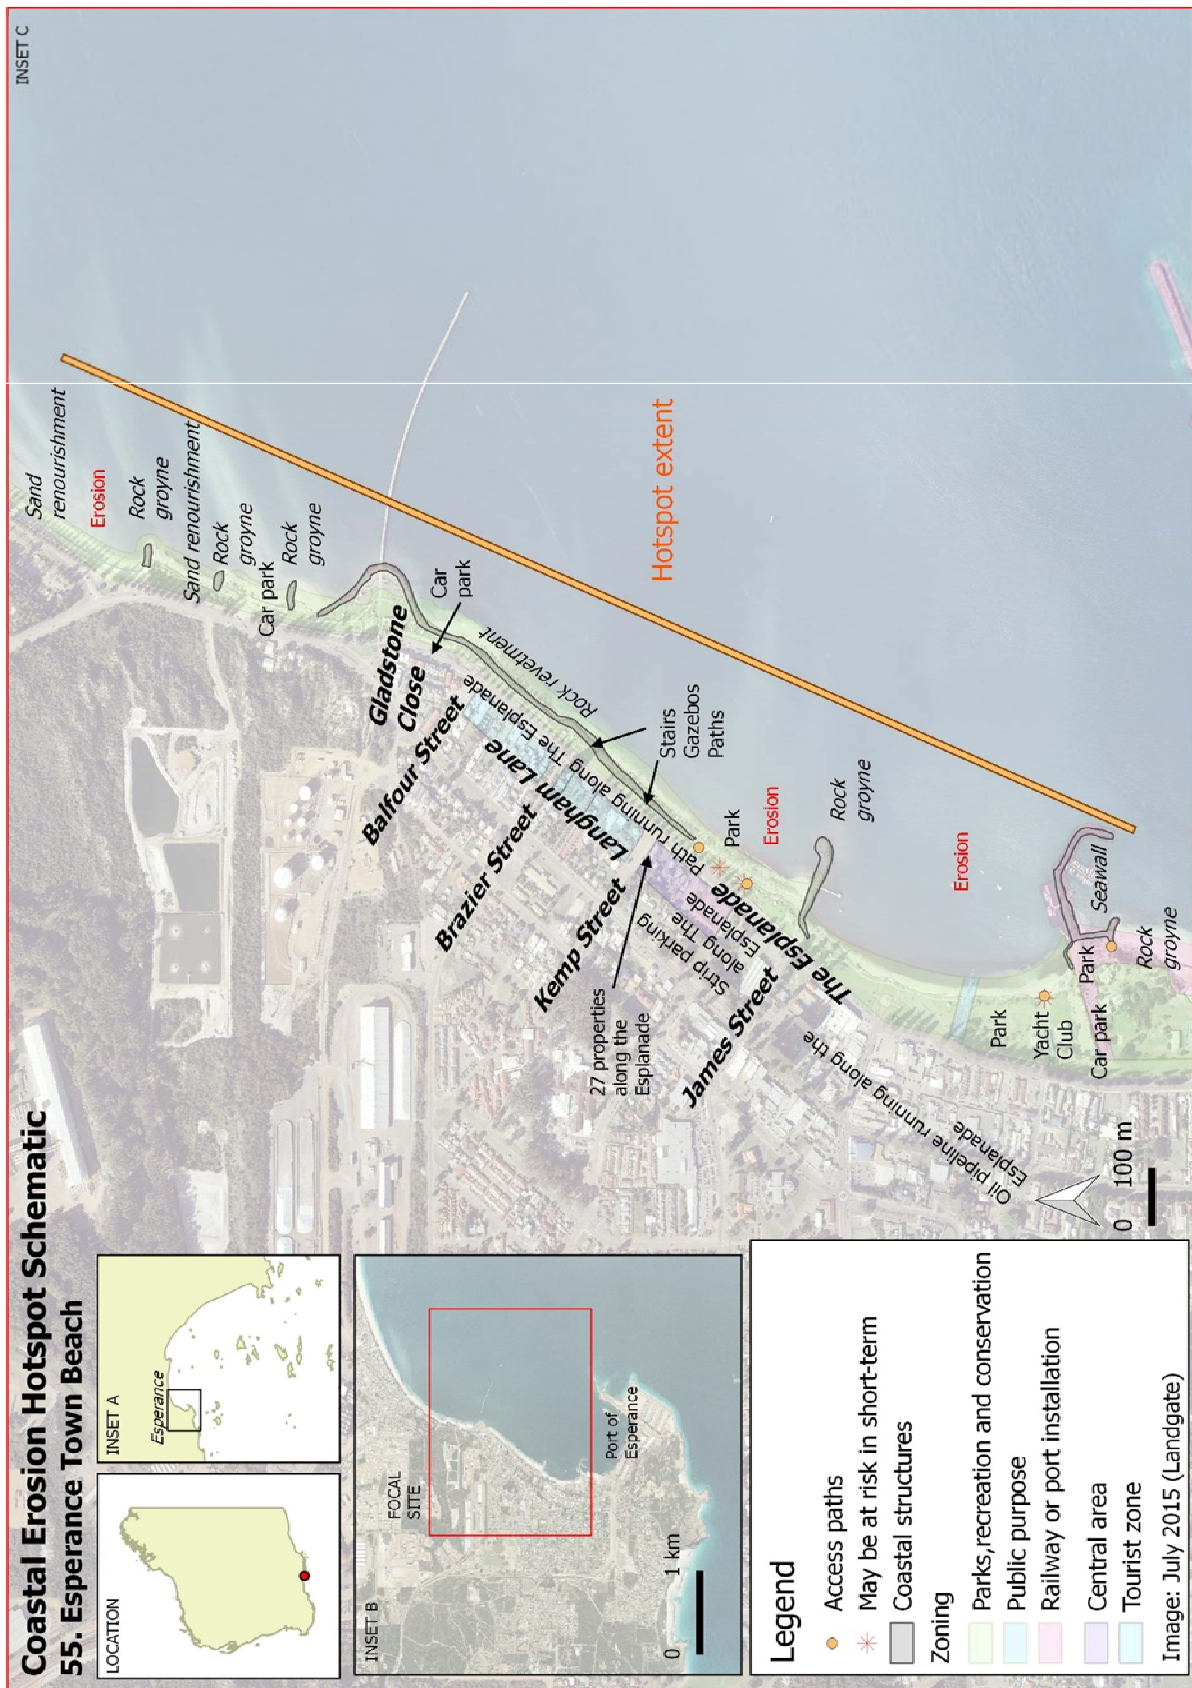
Figure D-55: Esperance Town Beach schematic

Extent of erosion problem and hotspot characteristics	<p>Grey Settlement for 250m north of the rocky headland.</p> <p>Hotspot characteristics:</p> <ul style="list-style-type: none"> • Infrastructure close to the existing shore, or landward of progressively and rapidly eroding coast (proximity). • Sites typically subject to progressive or episodic erosion (instability). • Very highly valued by the community, as nominated by local government (community).
CHRMAP status and findings	<p>CHRMAP Status: Complete</p> <p>Hazard Assessment: BMT JFA (2014) - Area north of Norsman Rd identified as immediate medium risk of erosion, remaining area as immediate low risk.</p> <p>Management & Adaptation Options: BMT JFA (2016) - Study area Dempster Head to Bandy Creek Boat Harbour (BCBH). Recommendations: west of Norsman Road immediately and ongoing maintenance of existing coastal protection structures. East from Norsman Road (eastern groyne) adaptation options:</p> <p>2010 - Accommodate with reduction in foreshore buffer or Protect (1st km) 2060 - Accommodate with reduction in foreshore buffer or Protect (2 km's) 2110 - Managed retreat or Protect (all the way to BCBH)</p> <p>Additional Comments: Large portions of the site are protected by existing seawalls and/or groynes, with periodic sand nourishment undertaken by the Shire.</p> <p>Reports: BMT JFA (2016) Esperance Coastal Hazard Adaptation Strategy. Prepared for the Shire of Esperance. Report 224.10-01, Rev. 0, Jul-2016. BMT JFA (2014) Esperance Coastal Hazard and Vulnerability Assessment. Prepared for the Shire of Esperance. Report 224.01-01, Rev. 0, Nov-2014.</p>

Coastal dynamics studies for a level 3 assessment. Further detail in Table 4-2.	Ongoing coastal movement data collection
Assets susceptible to erosion hazard in Imminent timeframe (0–5 years)	3 public assets susceptible to erosion hazard. stairs access, park (James St (not behind rock revetment)), access paths (2)
Assets susceptible to erosion hazard in Expected timeframe (5–25 years)	<p>6 public assets susceptible to erosion hazard. Stairs access, 3 parks (2 at Yacht Club, James Street (not behind rock revetment)), and access paths (2).</p> <p>Services: *Oil pipeline.</p> <p>Leasehold: Esperance Bay Yacht Club</p>

Assets susceptible to erosion hazard in Projected timeframe (25+ years)	20 public assets susceptible to erosion hazard. Esplanade, Langham Lane, Kemp Street, Brazier Street, Balfour Street, Gladstone Close, *path, stairs access, *car park (Gladstone Close), *strip parking, car park (James street), 4 parks (2 at Yacht Club, James Street (not behind rock revetment)*town beach), *gazebos, 2 non-rigid access. Services: Oil pipeline, power, water, gas, telecommunications. Leasehold: Esperance Bay Yacht Club building Private property: 27 along the Esplanade
Existing management	Avoid (N), Retreat (N), Accommodate (N), Protect (Y - Rock groynes, with coastal revetment. Ongoing sand renourishment)
Management options for Imminent timeframe (0–5 years)	Avoid (N), Retreat (N), Accommodate (N), Protect (Y - Maintain existing structures for seawall at southern beaches and tanker jetty headland. Ongoing sand renourishment with beach grade sand N of tanker jetty) Preparation of planning frameworks for retreat in next level of management and identify funding mechanisms. Review lease agreements with Yacht Club to clarify responsibilities for coastal erosion mitigation

Trigger for next level management, monitoring and alternate management option (Expected timeframe 5–25 years)	Trigger for next level management: Goldfields Rd facilities threatened by acute erosion; Revetment damage >10%; Monitoring: Buffer width; structural assessment (annual) Alternate option: N/A
Management and adaptation options for Projected timeframe (25+ years).	Avoid (N), Retreat (Y -Removal of carparks and relocation of caravan park along Goldfields Road. Truncate Goldfields Rd, with coastal access via Phyllis St. Removal of the oil pipeline may support increased use of retreat), Accommodate (N), Protect (Y - Revetment likely to require replacement. Ongoing sand renourishment for selected areas)
Works to avoid to achieve long-term plans	Permanent or high value infrastructure placed along Goldfields Rd.
