## **Entrance Reconfiguration Concept**

Jurien Bay Boat Harbour - May 2024

# **Entrance Reconfiguration Concept Jurien Bay Boat Harbour**

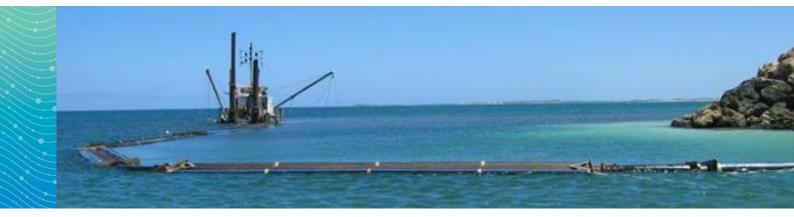
Dredging at Jurien Bay Boat Harbour

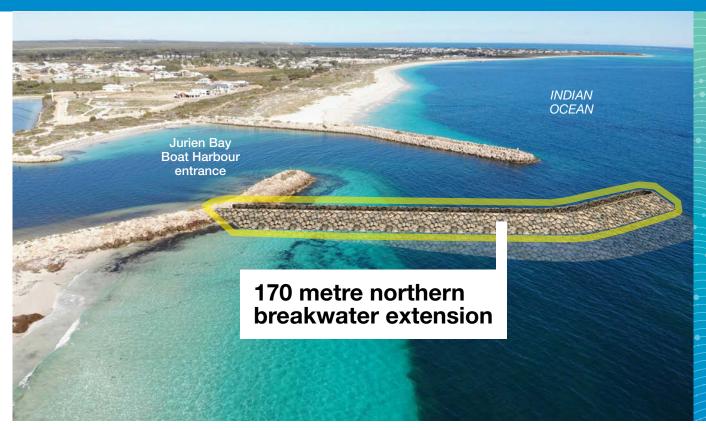
The Jurien Bay Boat Harbour northern breakwater extension

A structural modification to the northern breakwater by the addition of a large spur groyne proved to be the most effective when modelled against tides, wind, wave and wrack movement.

The JBBH project will be delivered by DoT with State funding. The 170 metre spur groyne addition to the northern breakwater reconfigures the entrance, limiting the ability for seagrass to enter the harbour. The works will include import of rock material by truck and placement of this material using large earthmoving equipment to construct the spur groyne. If possible, DoT will aim to align the works with a maintenance dredging campaign for cost efficiency.
