## CI-117B

### Vehicle Safety and Standards Circular to Industry

### Tilt Tray Vehicles

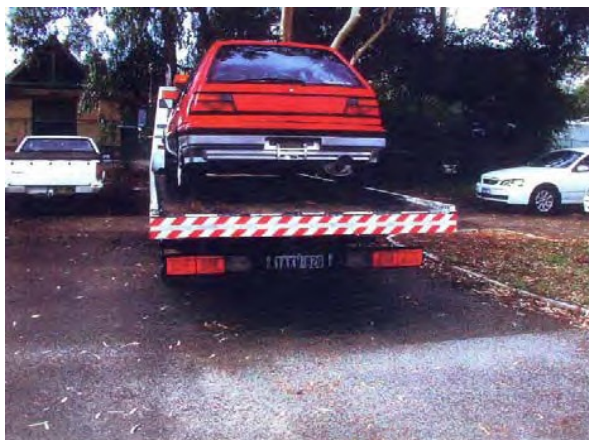
#### Provision of a conspicuity strip

The backing material to which the conspicuity strip is attached should be at least 8mm thick x 150mm high x width of tray.

The detachable strip may be attached by either a hinge or by vertical pins that locate it onto the rear of the tilt tray.

Reflective tape at least 100mm high x width of tray must be adhered to the backing strip.

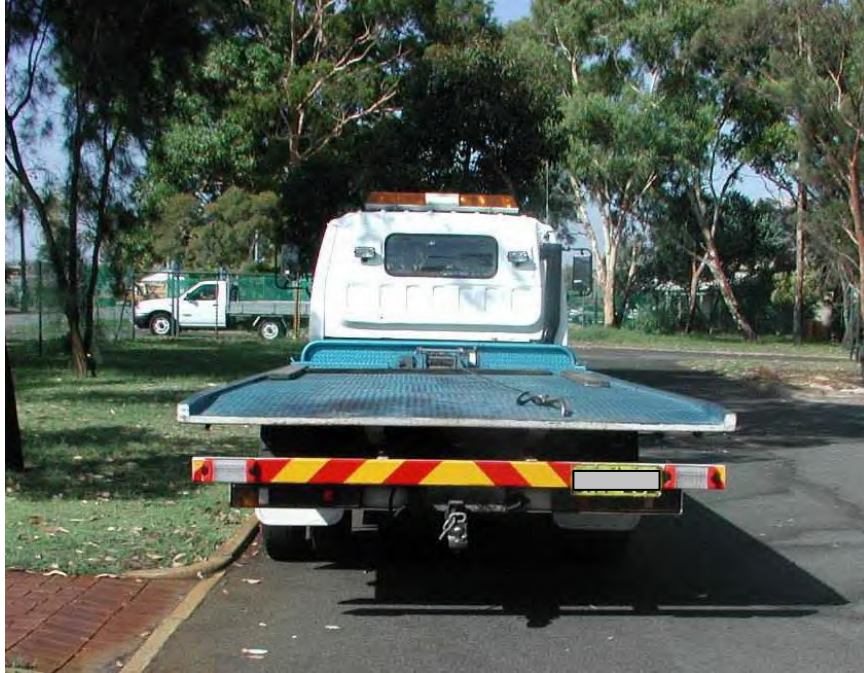
## Provision of an under run protector bar

This system uses a steel section, usually a RHS at least 75mm x 50mm, appropriately secured to the truck chassis. The section should not exceed 100 mm.

This must be flush with the rear of the tray.

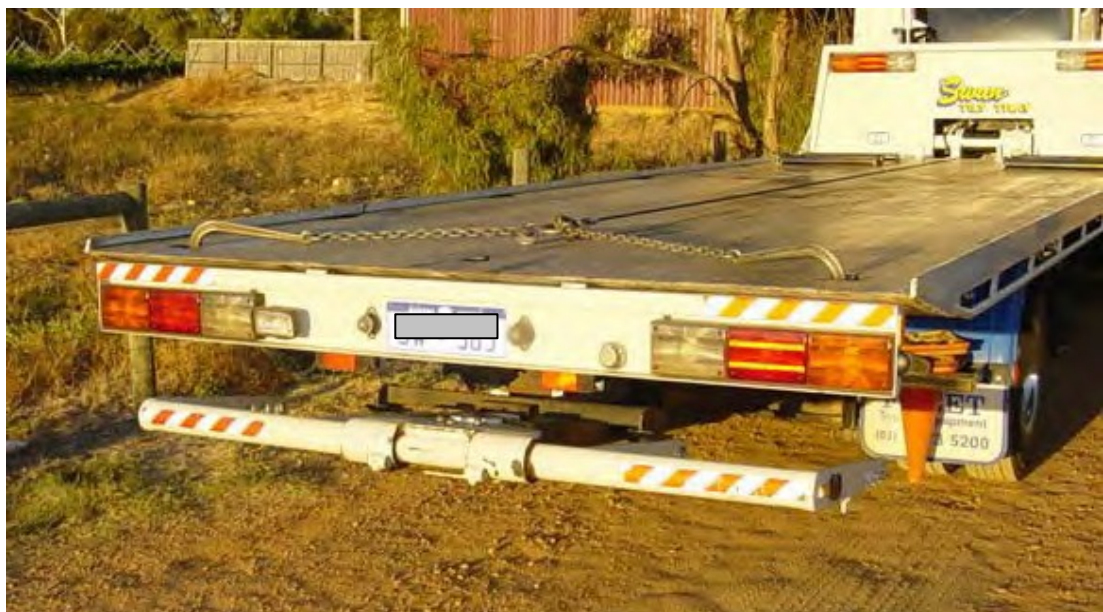
## Provision of an under run protector light bar & wheel lift

This system incorporates an appropriate under run protector light bar positioned just above the wheel lift. Reflective tape shall be used as shown.

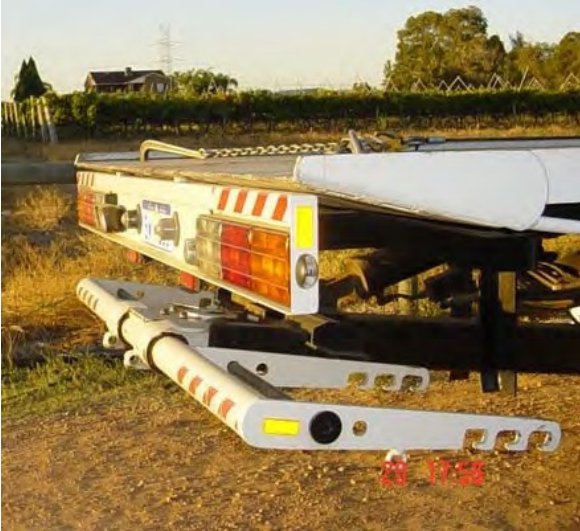
This comprises of an under protector light bar that pivots as the tilt tray is lowered to the ground. It has a wheel lift attachment fitted. Reflective tape shall be used as shown.

Light bar in normal position

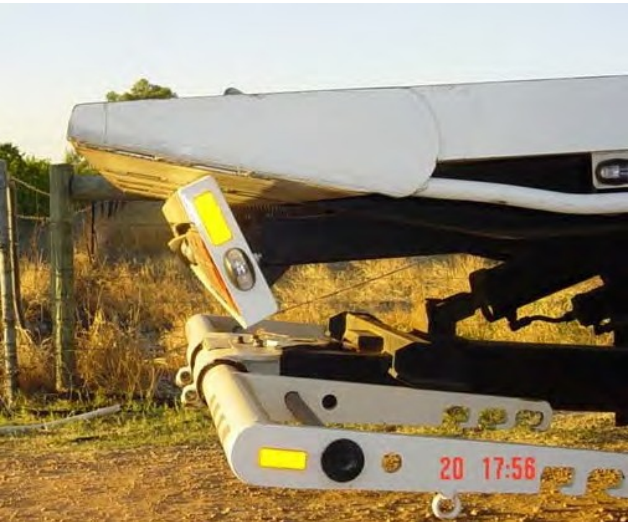
Light bar tilts as tray begins to move rearwards
