Review of Sand Bypassing at Dawesville and Mandurah

Coastal Engineering Investigation

Technical Report 446

July 2006

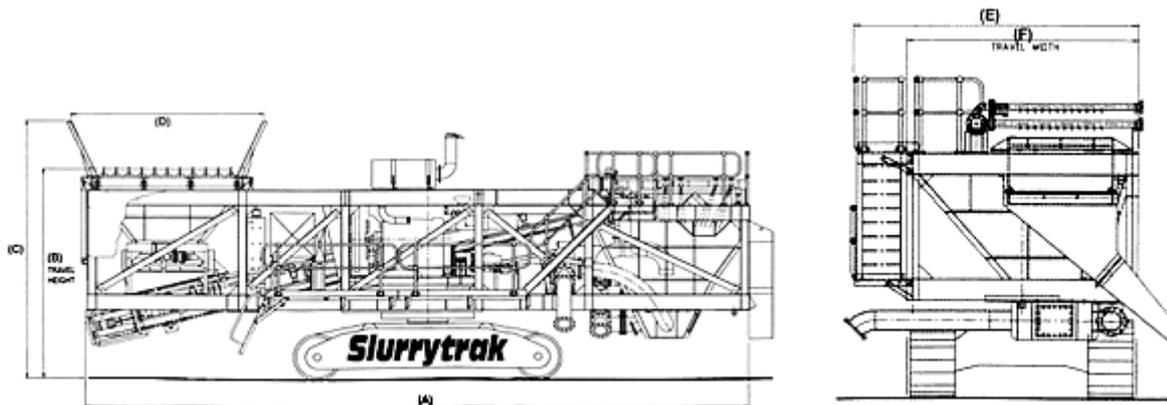
Figure 2 – Mobile screening and bypassing plant 'Slurrytrak'

1. Sand excavation from a designated sand trap up drift of the entrance using conventional land-based earthmoving equipment.
2. Sand feed directly into 'Slurrytrak', a mobile screening and pumping unit (refer to **Figure 2**). Sand is screened for debris and then mixed with water to form slurry.
3. Slurry pumping through a pipeline under the channel to a single disposal area up drift of the entrance.
4. Sand deposition directly onto the beach at the disposal area, generally above high water level.

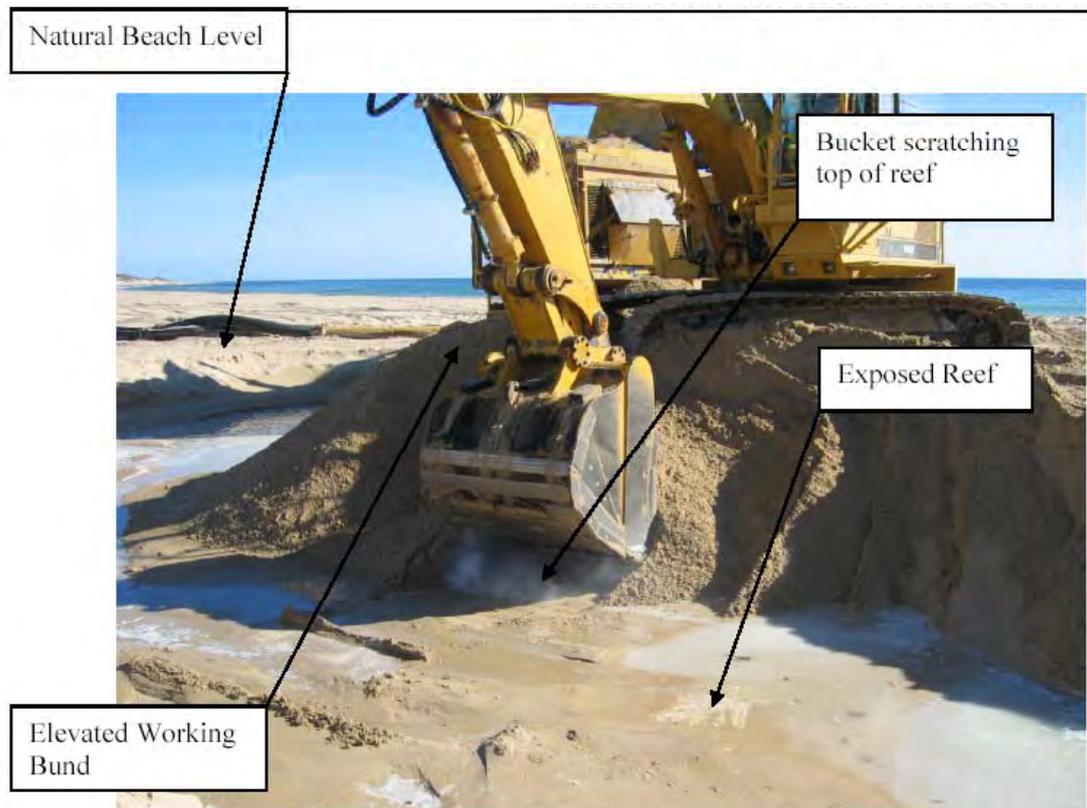
Figure 3 – Typical excavation at Dawesville; note exposed rock reef (JFA, 2005)

Under the current operations, sand excavation begins at the spur groyne and moves south, with strips being excavated perpendicular to the beach. The current aim is to excavate the maximum possible volume of sand from Area A before moving on to Area B. In most areas, the beach is excavated down to the level of the underlying rock. A typical excavation is shown in the following **Figure 3**.

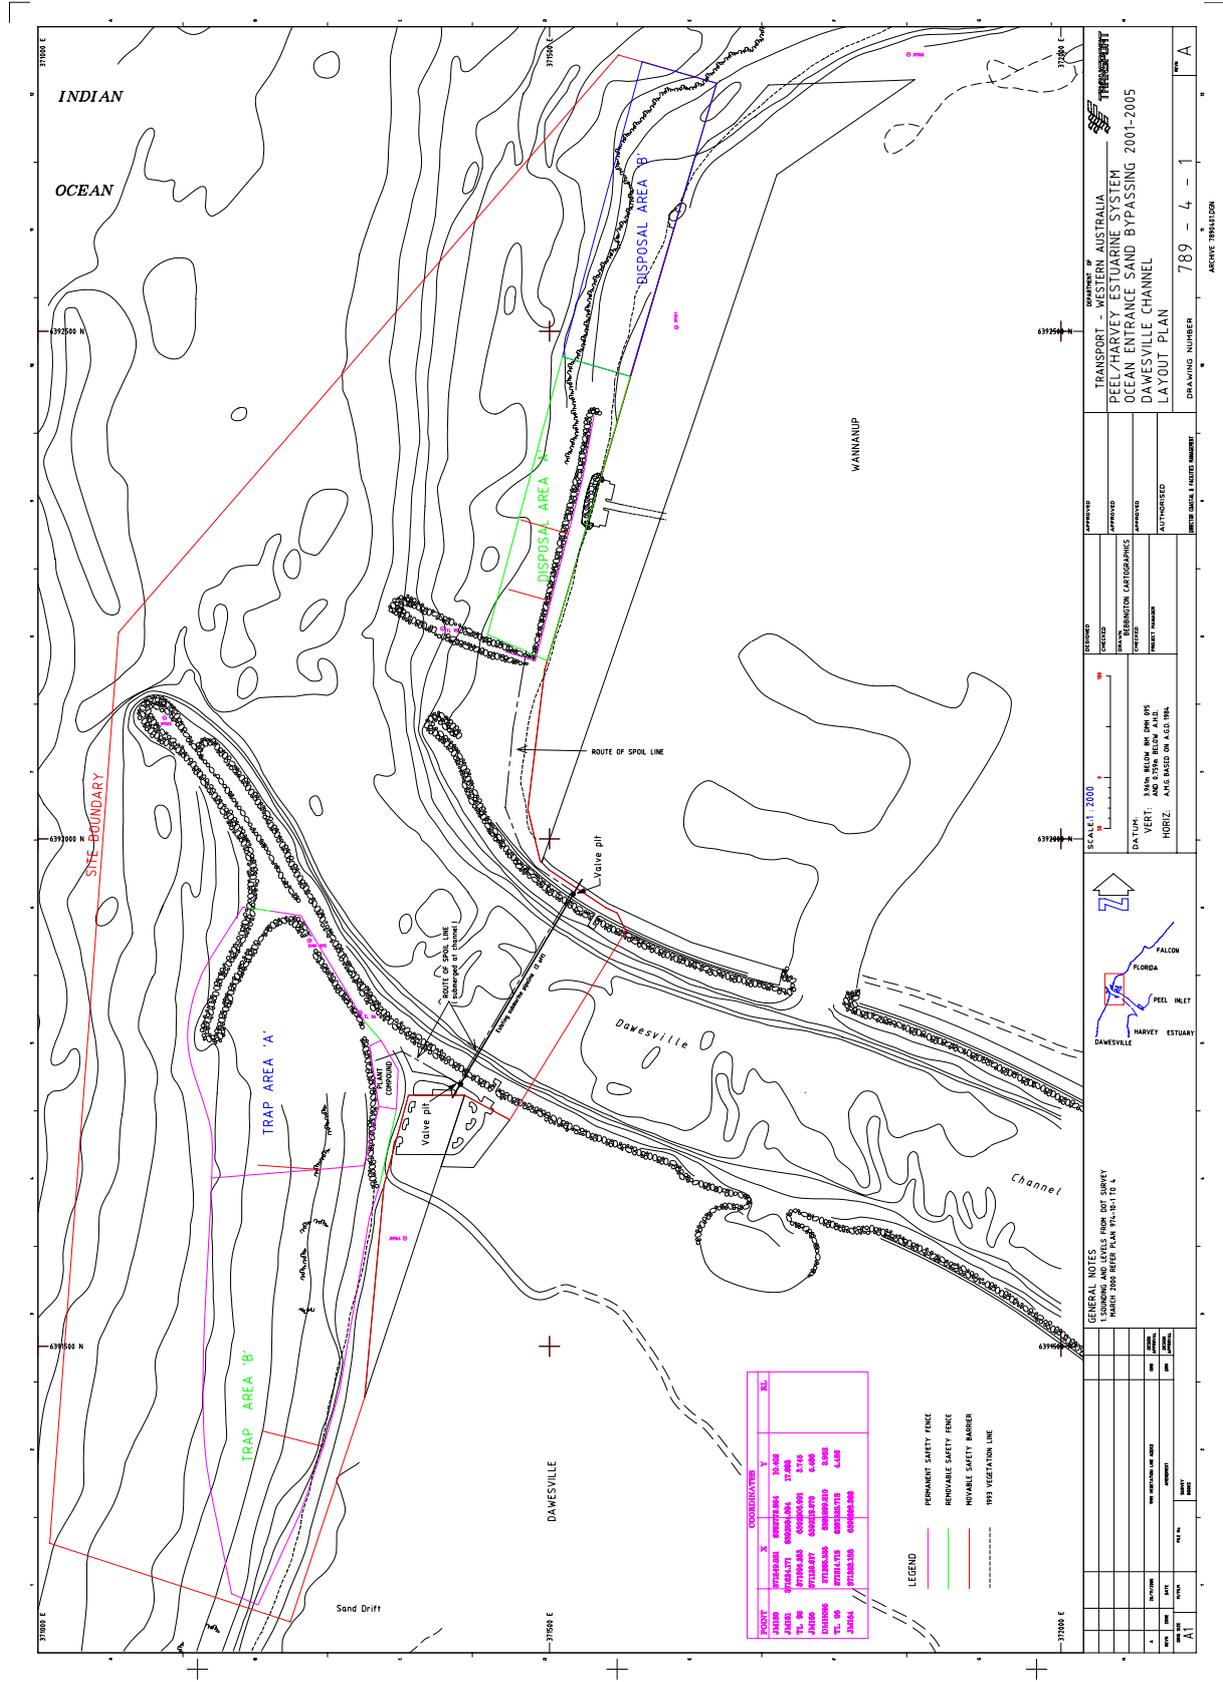
Figure 4 – Dawesville Channel Layout Plan (DPI 789-4-1)

The channel entrance and bypassing areas, described in more detail below, are shown in **Figure 4** (DPI 789-4-1) presented at the end of this section. This figure is an extract from the 2001-2005 contract documents.

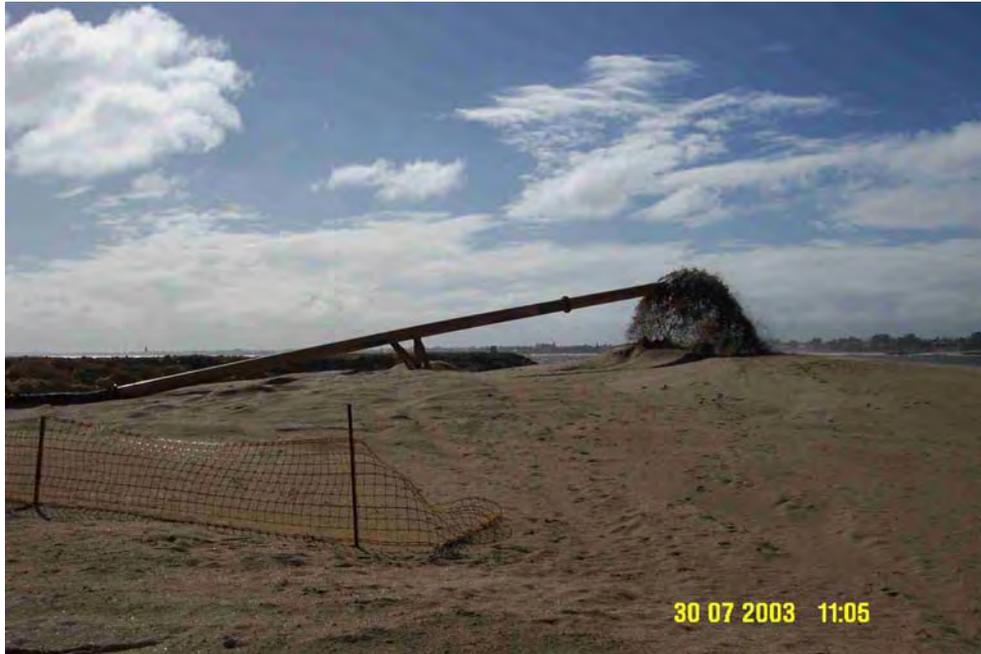
Figure 5 – Disposal of spoil at Mandurah by ‘rainbow’ discharge

The disposal area is located at the end of the wave-reflecting wall approximately 600m east of the channel entrance. Under the current contract (2000-2005; 2006) the designated disposal area extends approximately 200m along the beach. Sand is currently disposed at the corner of the beach in a 'rainbow' (refer to **Figure 5**). CGC have found that sand moves away from the disposal area relatively quickly and that altering the discharge point, due to sand build up, is not often required.

At Mandurah, it is recommended that spoil disposal to the end of the reflecting wall be maintained. However, it is suggested that a trial be undertaken to dispose of spoil to the seaward face of the reflecting wall, at its eastern end, to assess the dispersion to the beach. Under south-westerly swell conditions, it is likely that the disposed spoil would rapidly be driven to the beach. If successful, an outlet layout similar to the one provided in is recommended. A balanced dispersion either side of the reflecting wall would ensure that the corner of the beach is maintained, but also that the visual impact of disposal is minimised. In combination with this scheme, it is recommended that the practise of 'rainbowing', although more efficient at dispersion to the beach, be avoided to further improve aesthetics. With the use of a number of outlets, rainbowing is considered unnecessary to disperse sediments.

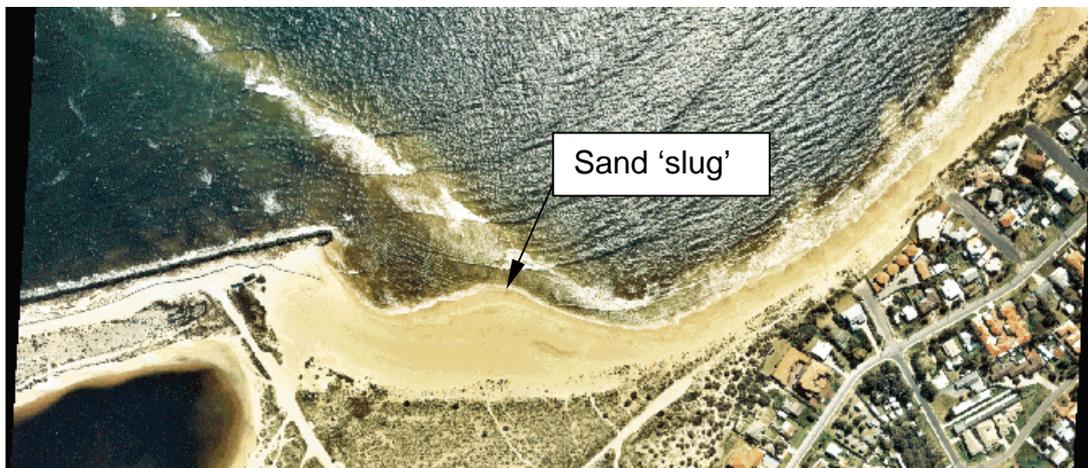
Figure 7 – Aerial Photograph: Mandurah, September 1996

These conditions lead to seasonal trends of sand movement. It is found that the majority of sand is driven northward over winter under south-westerly storms, resulting in a predominant south-north littoral drift. Previous studies have identified that the majority of sand movement occurs in 'slugs', estimated between 10,000-30,000m³, following winter storm events. These slugs have been identified on historic aerial photographs between Roberts Point and Mandurah Ocean Entrance and to the west of Mandurah Ocean Entrance; an example is seen in **Figure 7**, below.

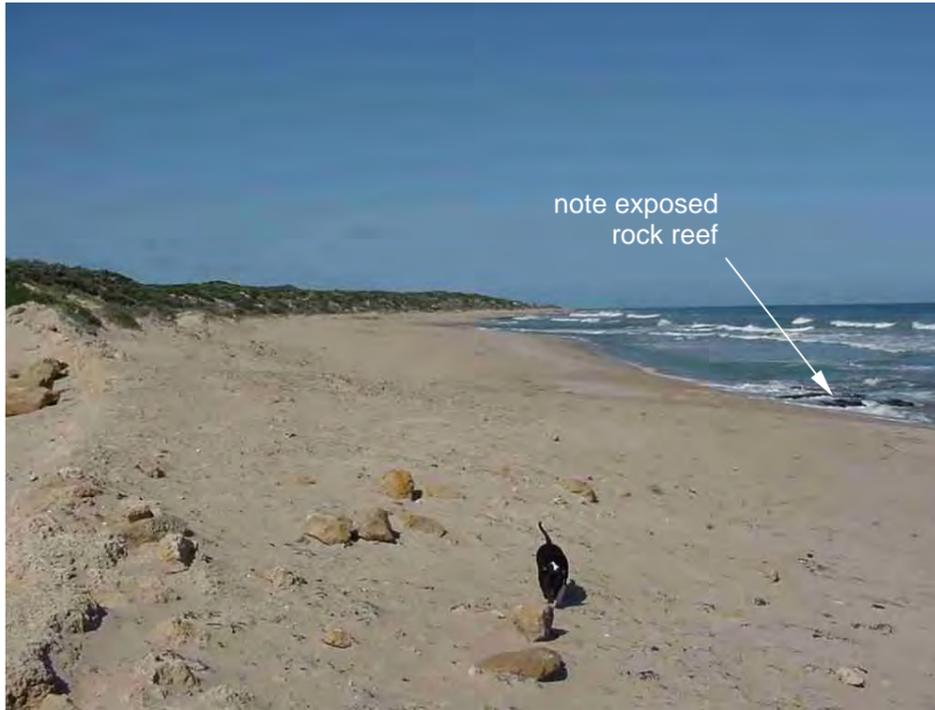
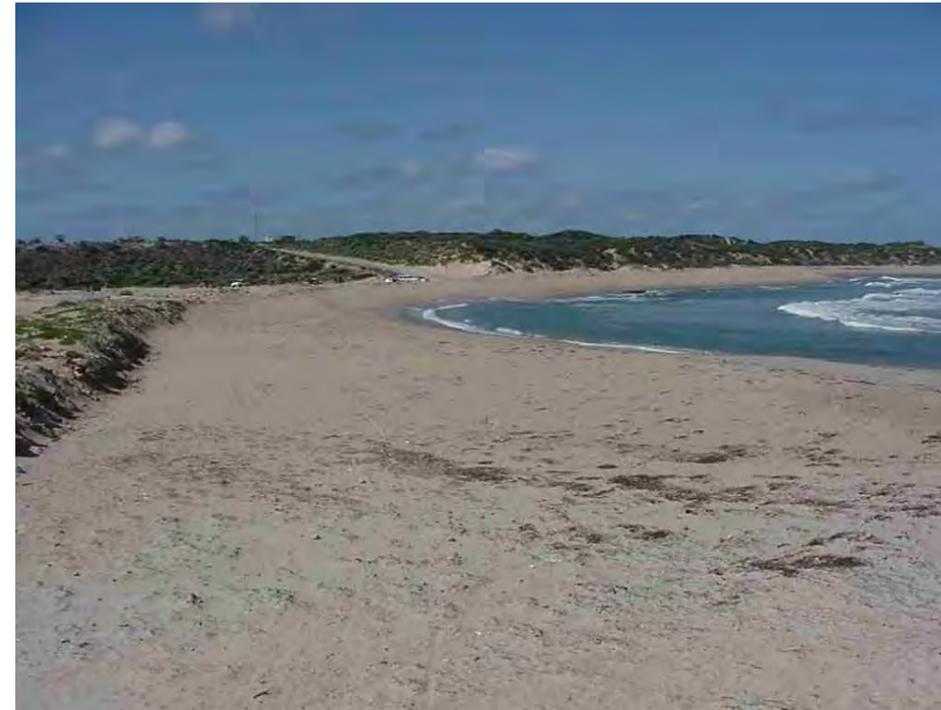
Figure 9 – Dawesville Sand Trap

September 1999 – Following a 'stormy' year note the relatively steep beach profile and high elevation at the back of the beach

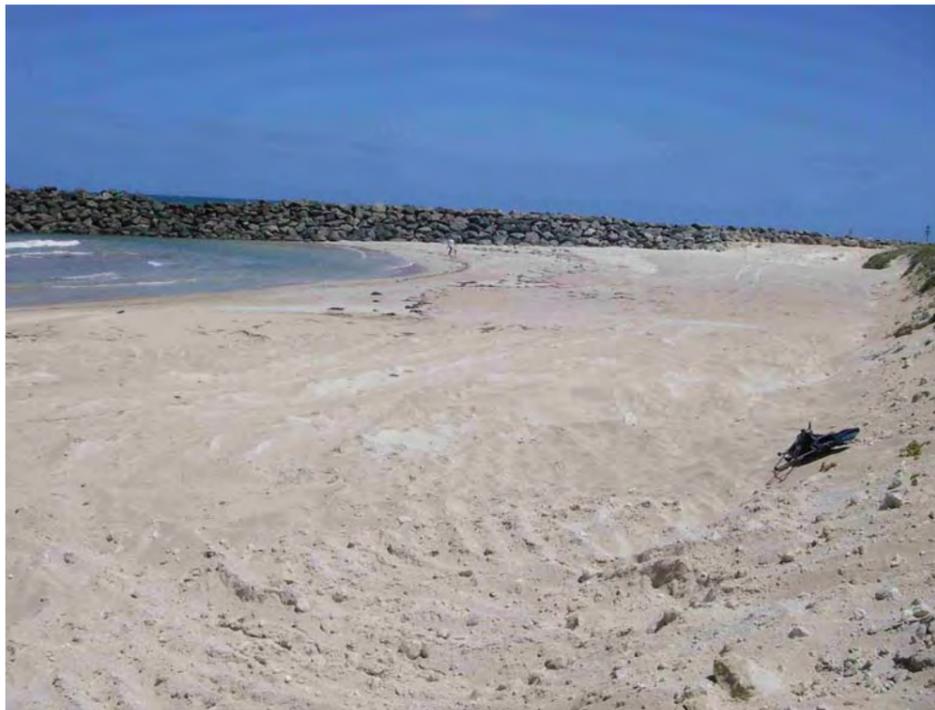
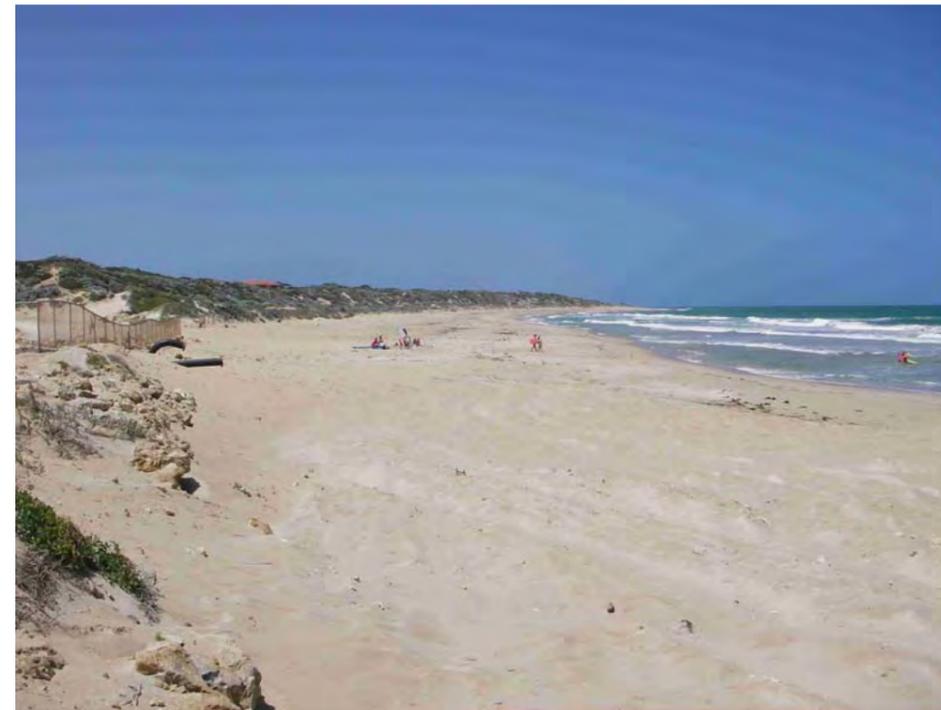
December 2005 – Following a relatively calm year note the relatively flat low beach profile
