### ABH Compliance Assessment Report (EPBC 2008/4506)

## Augusta Boat Harbour 2014 Compliance Assessment Report (EPBC 2008/4506)

17 December 2014  
42908044 : M&C3883/R1771/0

Prepared for:  
Department of Transport

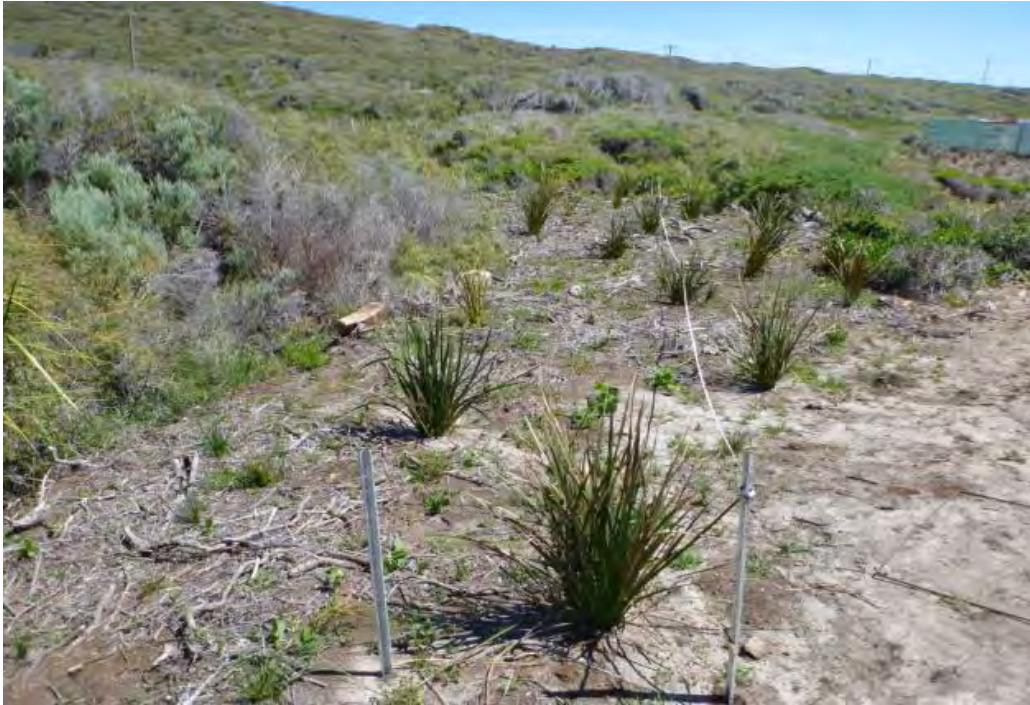
PLATE 1                    Transect 1 in the 2012 rehabilitation block - at 5 months old (Jun 2012)

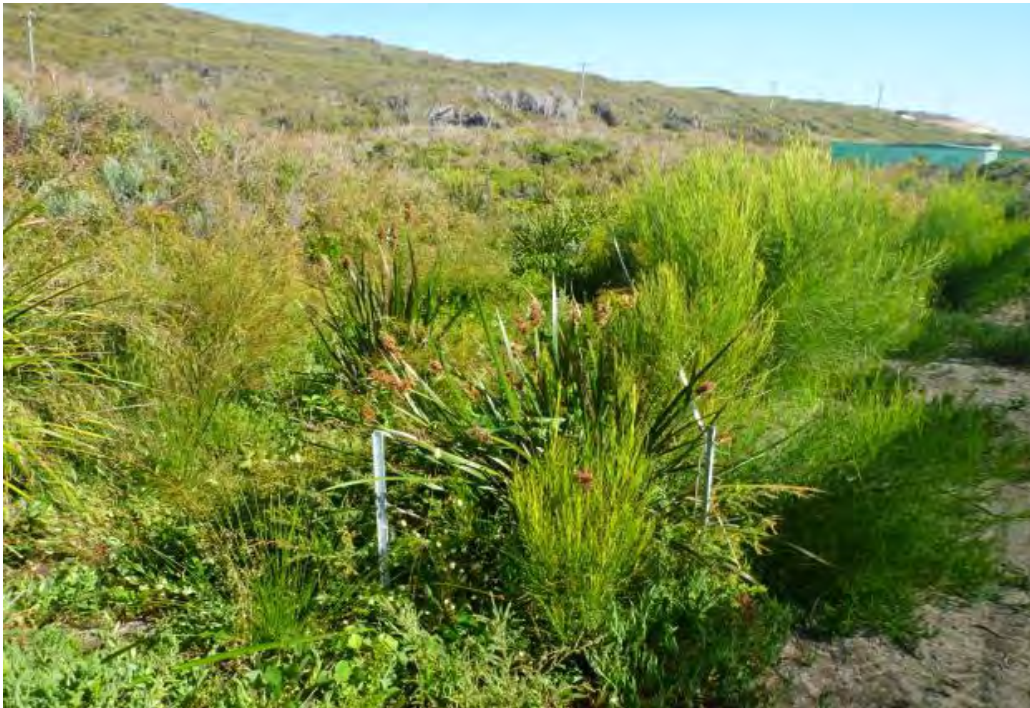
PLATE 2                    Transect 1 in the 2012 rehabilitation block - at 17 months old (Nov 2013)

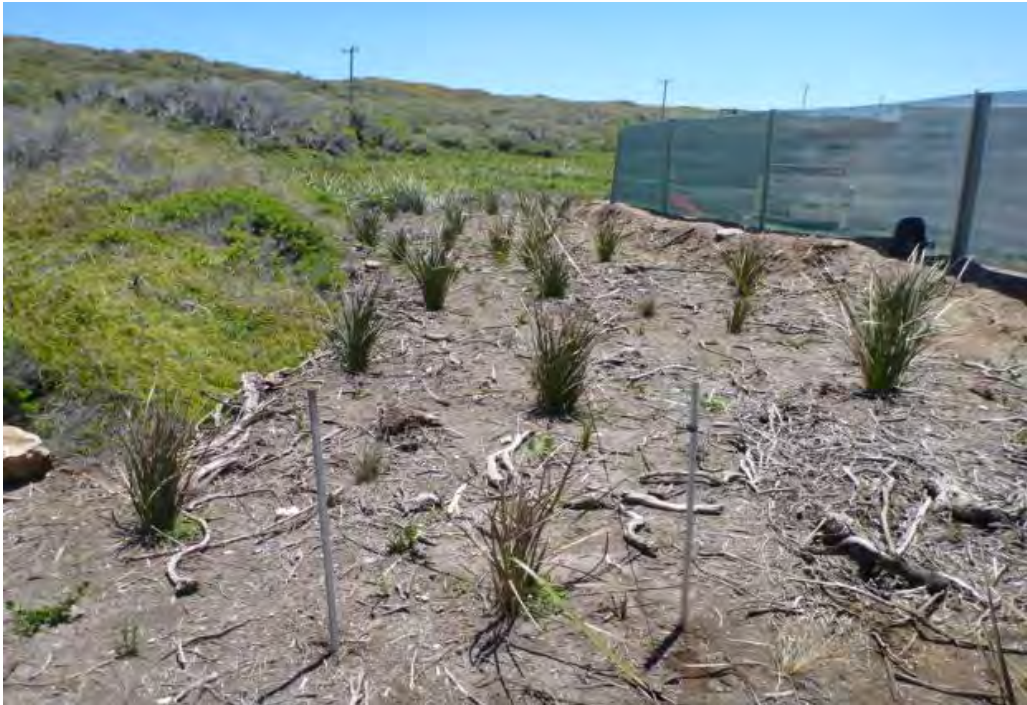
PLATE 3                      Transect 2 in the 2012 rehabilitation block at 5 months old (Jun 2012)

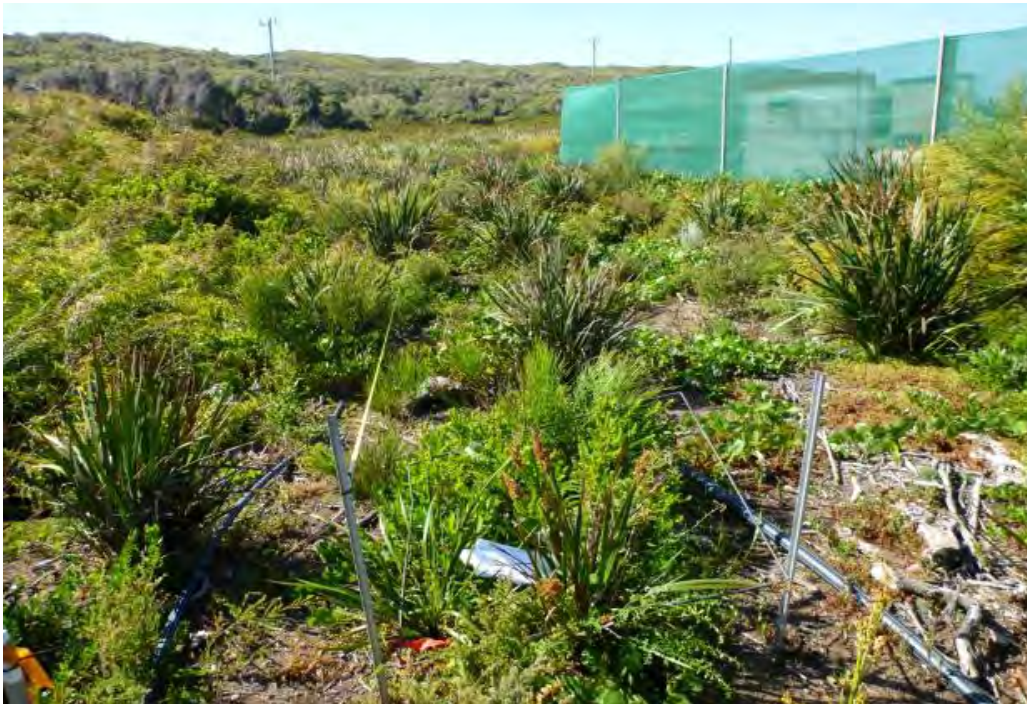
PLATE 4                      Transect 2 in the 2012 rehabilitation block - at 17 months old (Nov 2013)

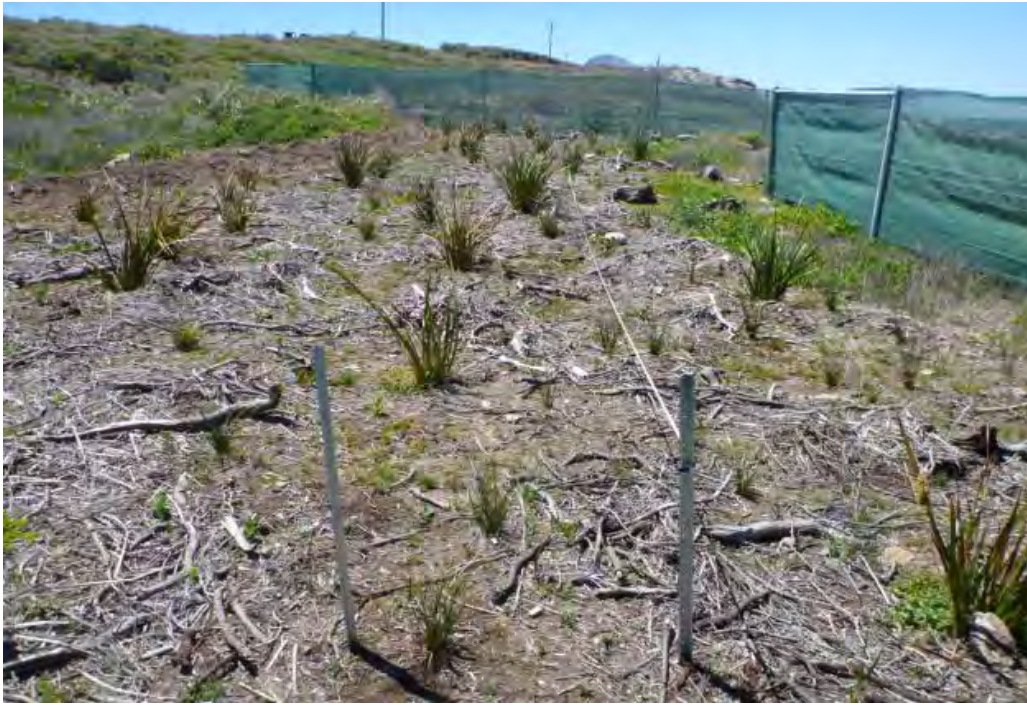
PLATE 5                      Transect 3 in the 2012 rehabilitation block – at 5 months old (Jun 2012)

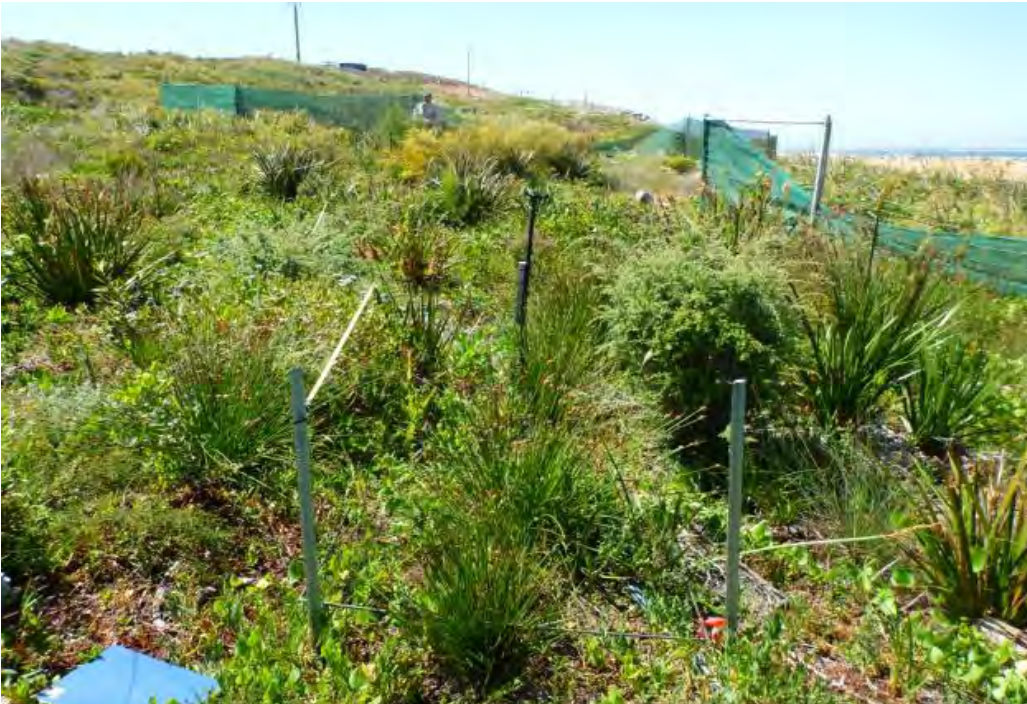
PLATE 6                      Transect 3 in the 2012 rehabilitation block – at 17 months old (Nov 2013)

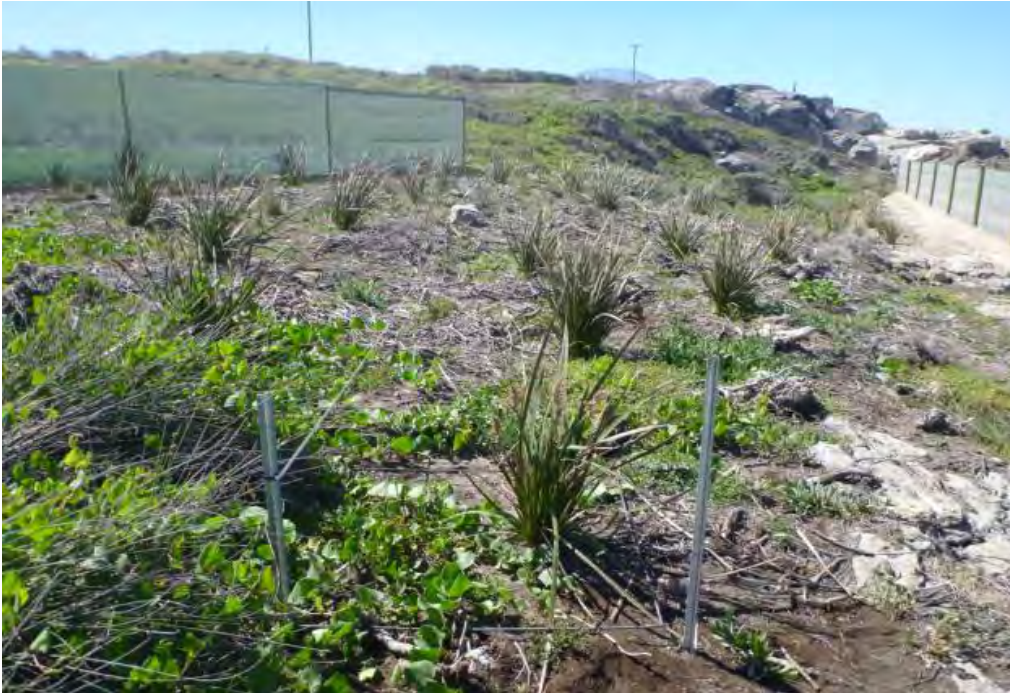
PLATE 7                      Transect 4 in the 2012 rehabilitation - at 5 months old (Jun 2012)

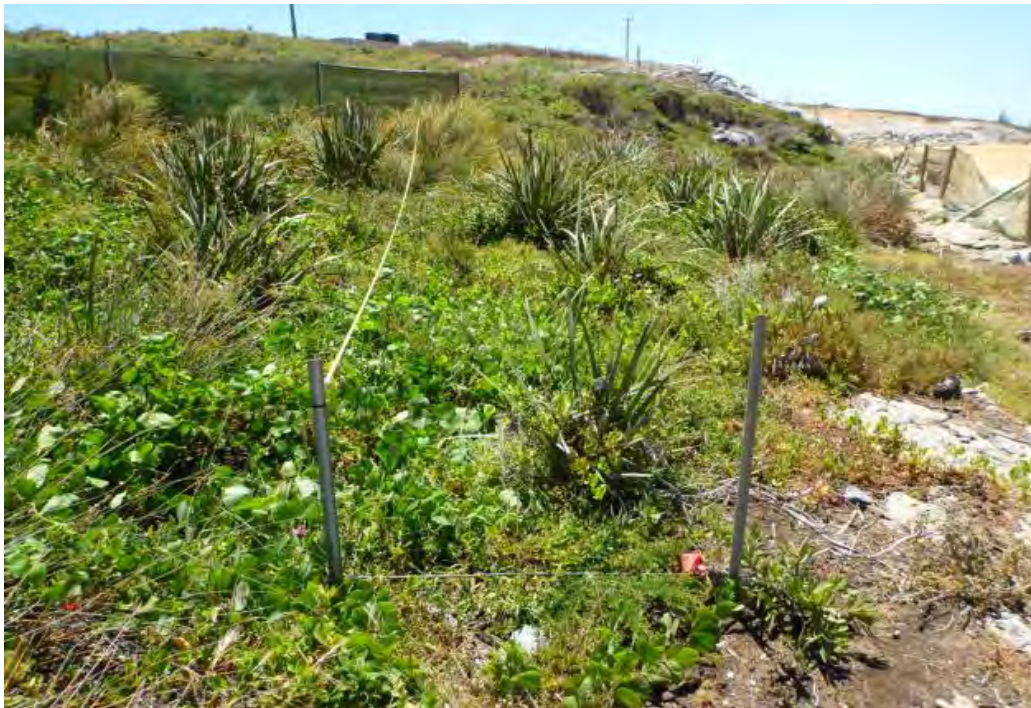
PLATE 8                      Transect 4 in the 2012 rehabilitation block - at 17 months old (Nov 2013)

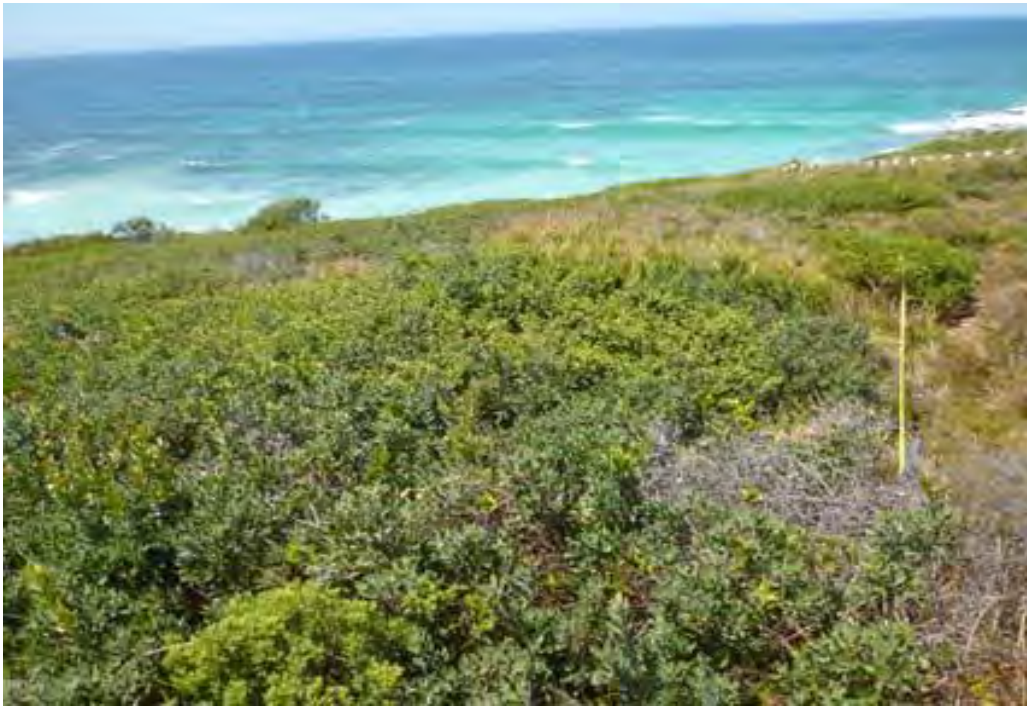
PLATE 9

Transect 1, Analogue Site - Nov 2012

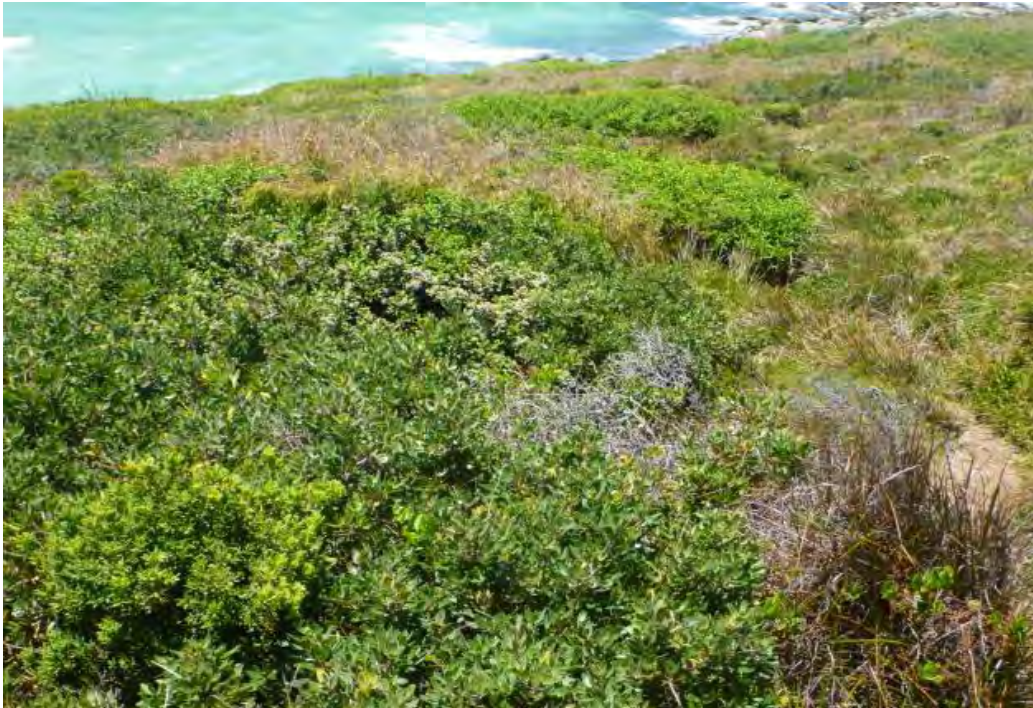
PLATE 10

Transect 1, Analogue Site - Nov 2013

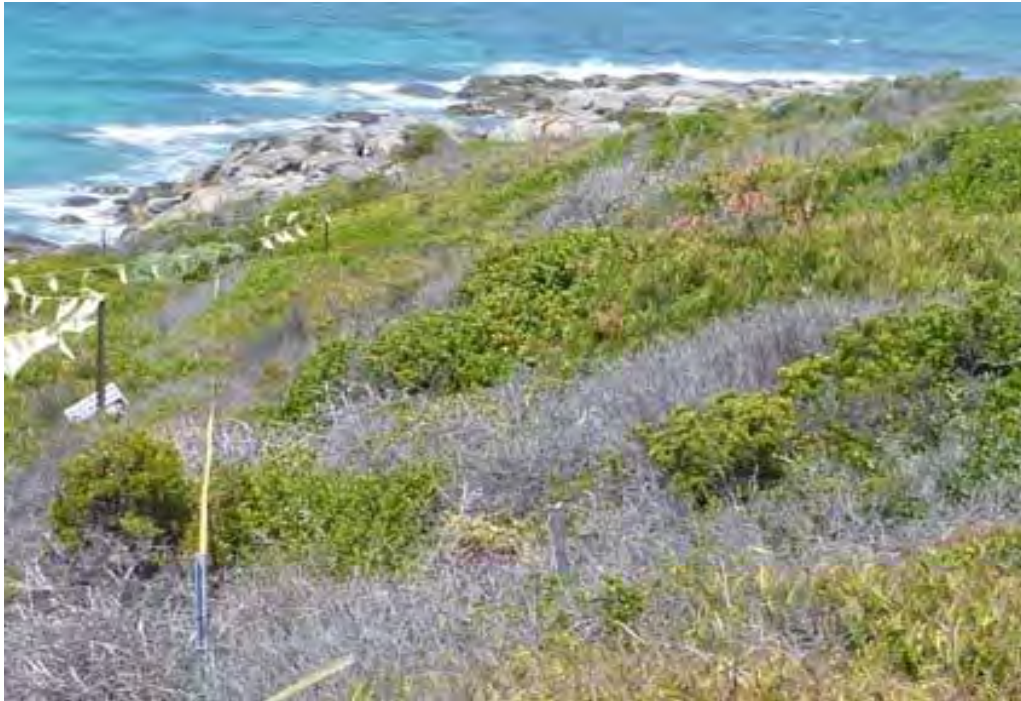
PLATE 11      Transect 2, Analogue Site - Nov 2012

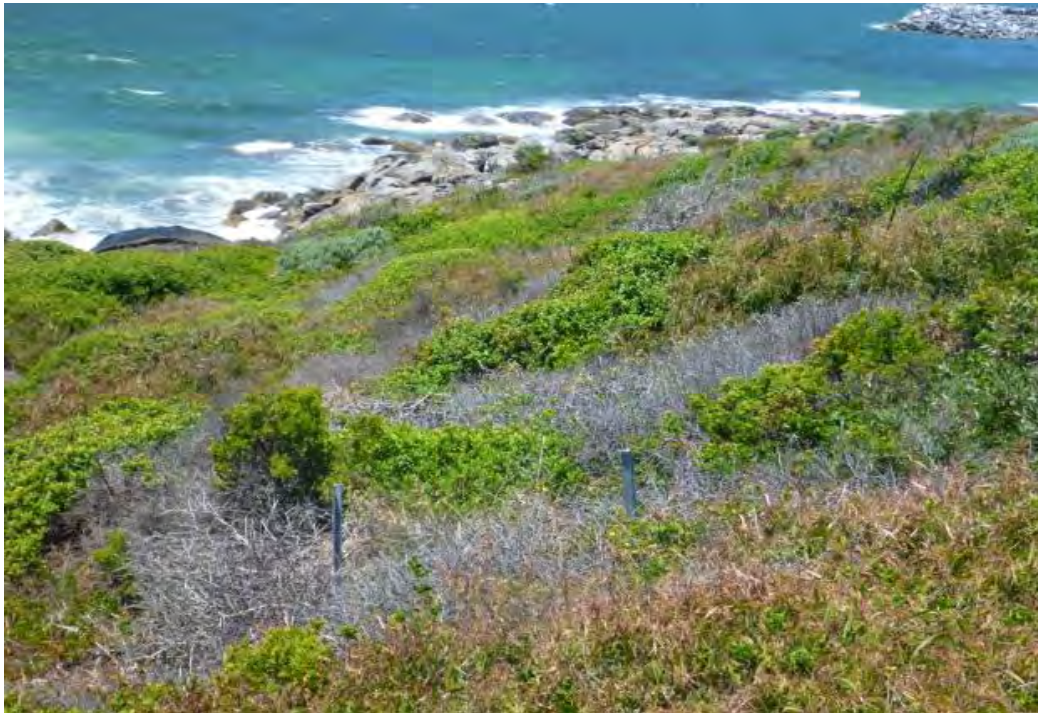
PLATE 12      Transect 2, Analogue Site - Nov 2013

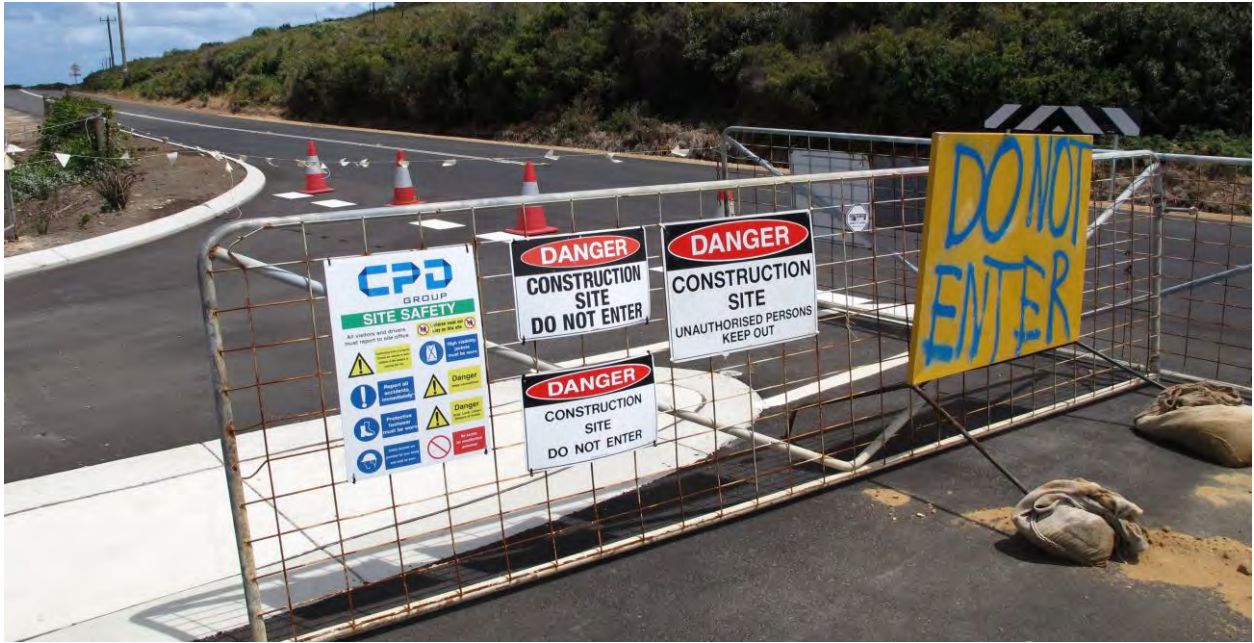
PLATE 1 Front Gate of Site 2014

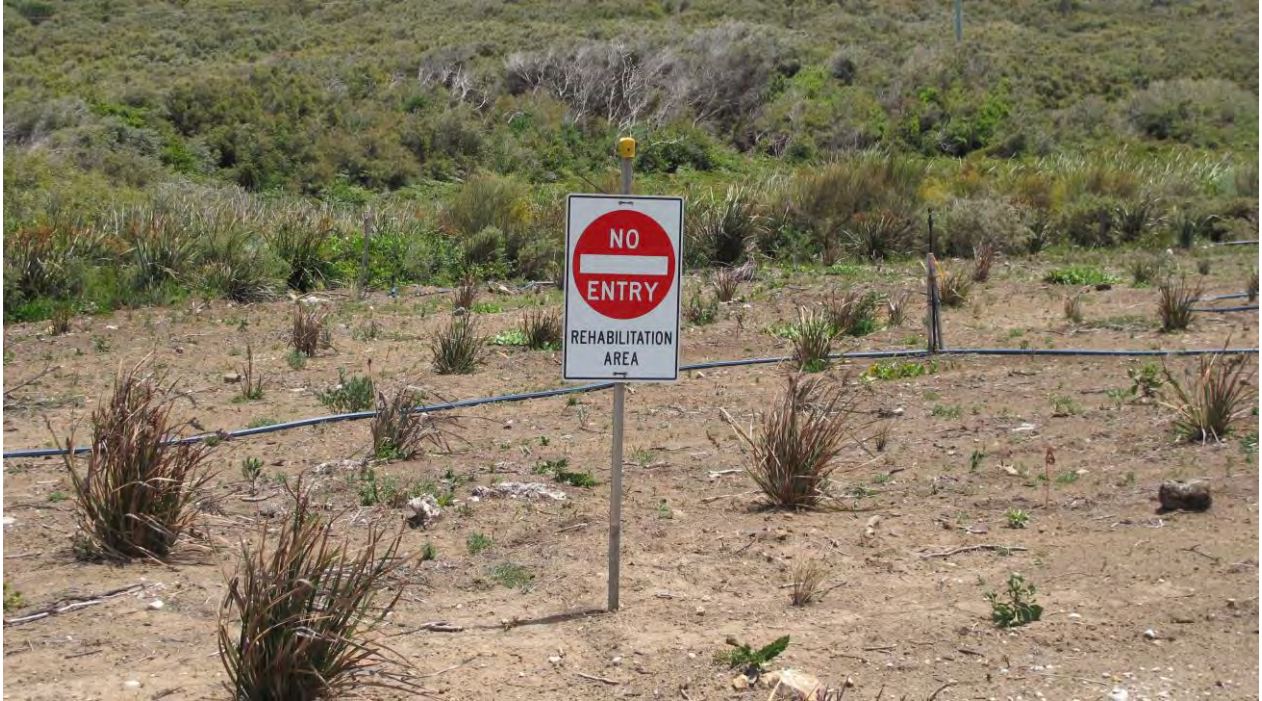
PLATE 3

2014 Rehabilitation Block - Old Site Office

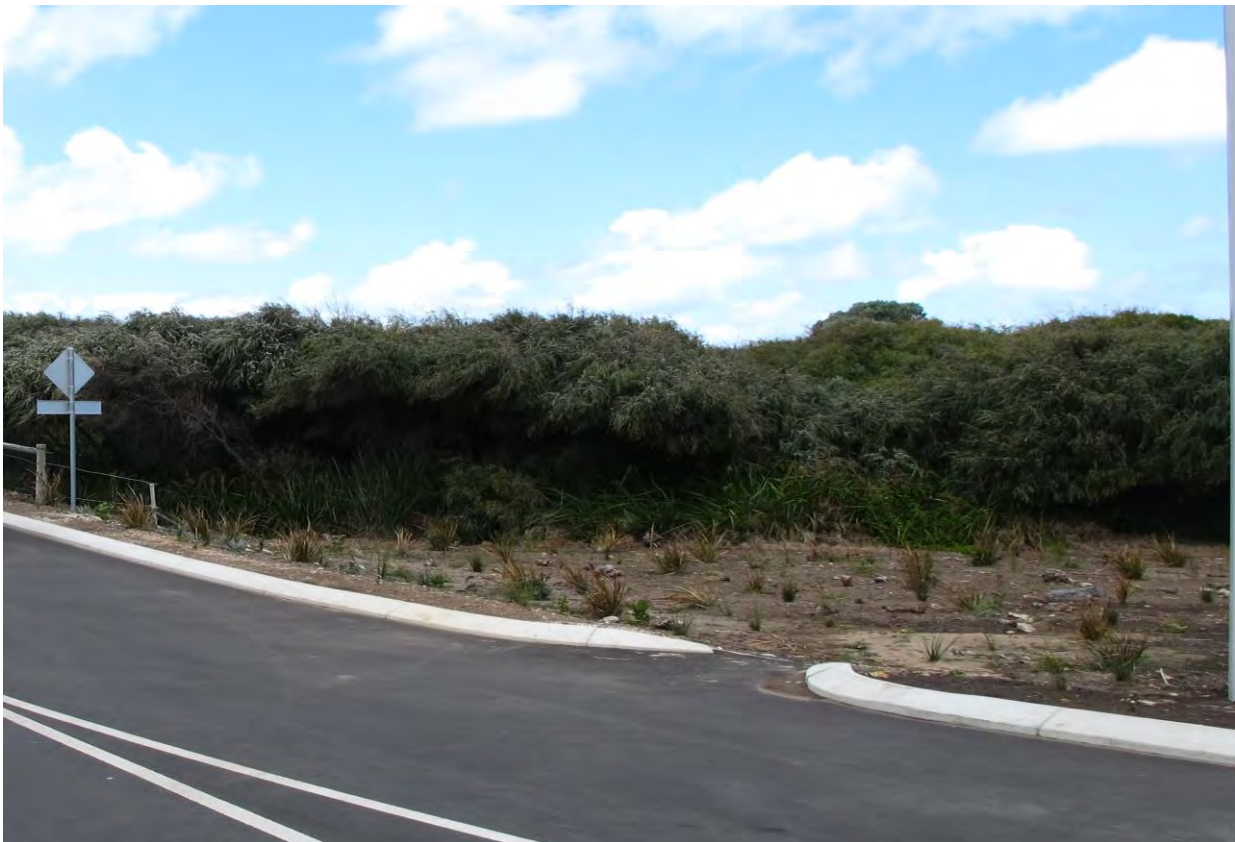
PLATE 4

2014 Rehabilitation Block - Front Gate

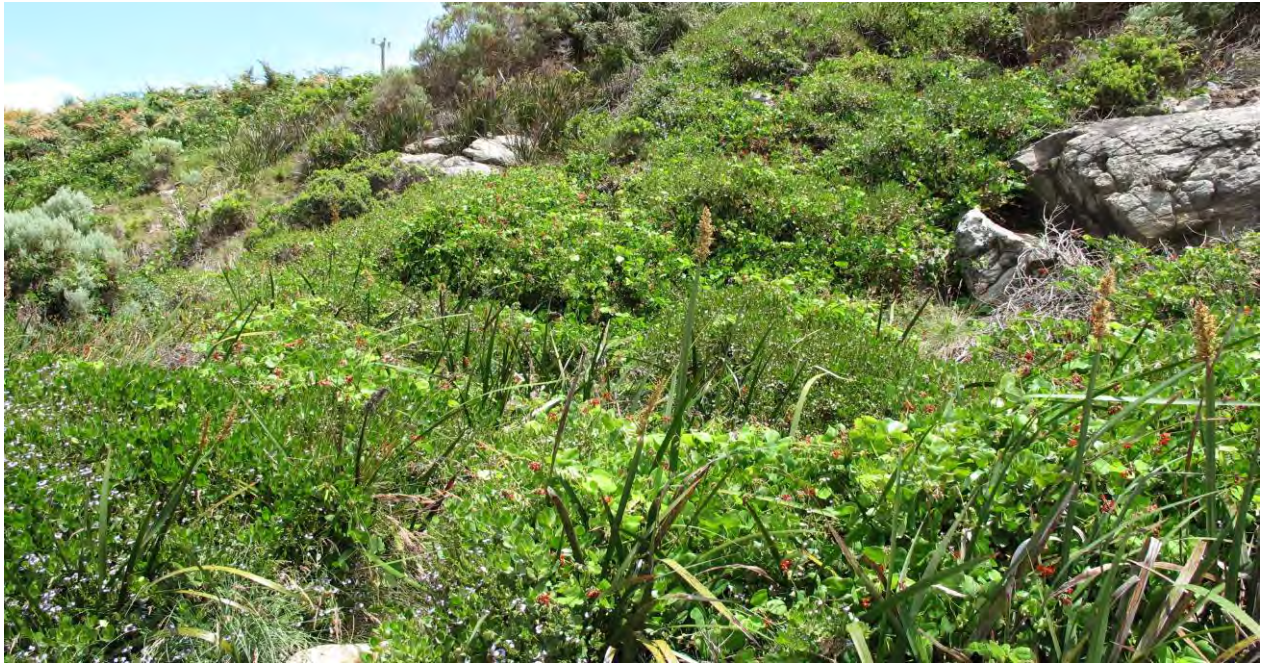
PLATE 7            2012 Rehabilitation Block

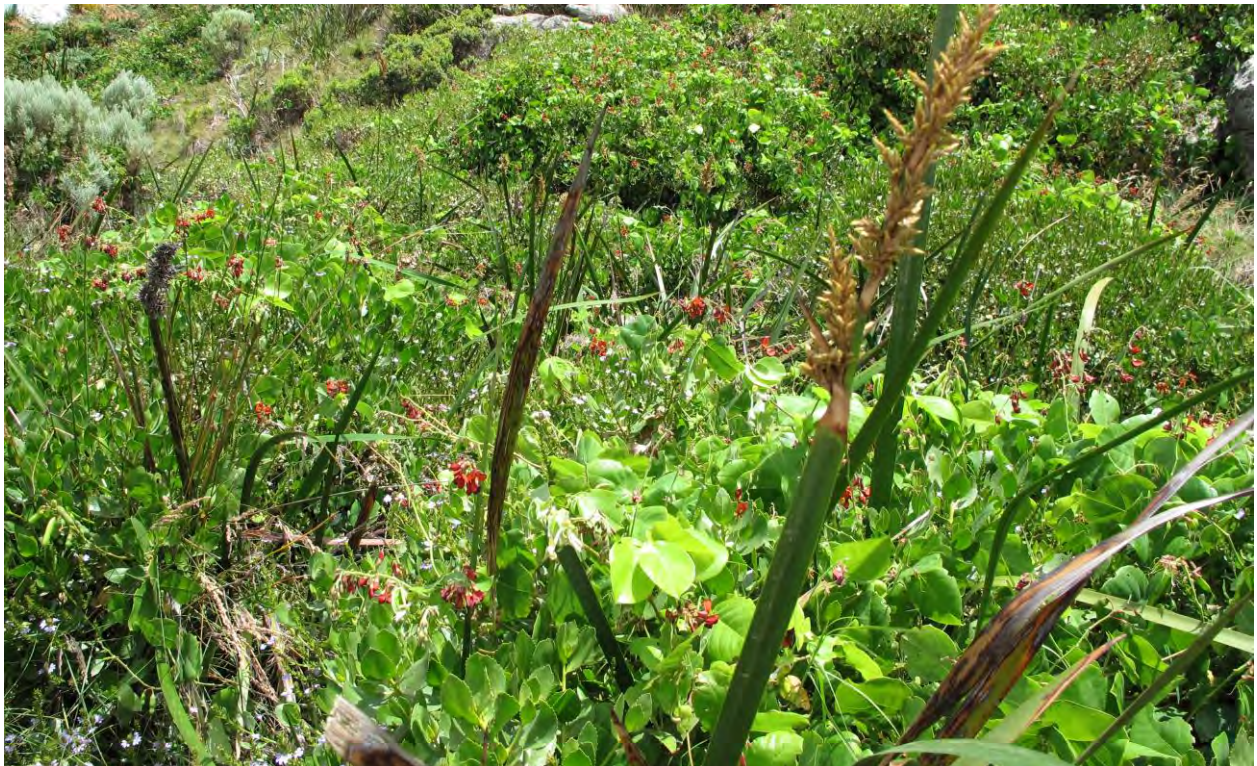
PLATE 10

2012 Rehabilitation Block - *Kennedia lateritia*

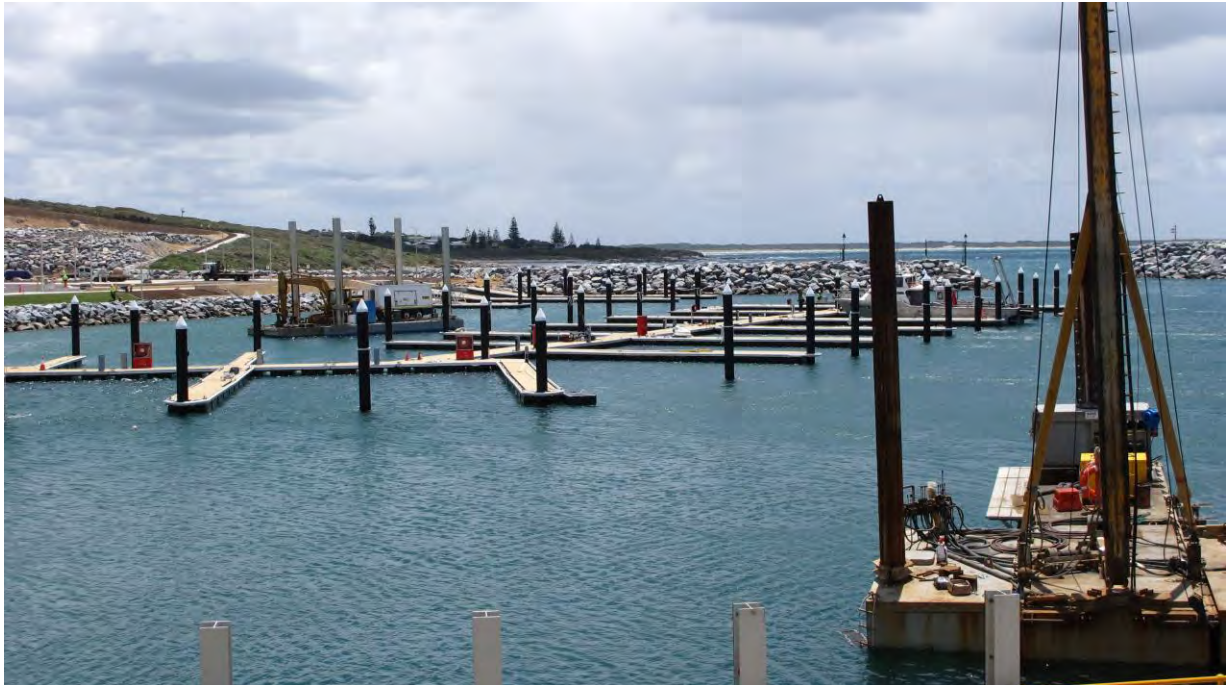
PLATE 12      Harbour Site 2014

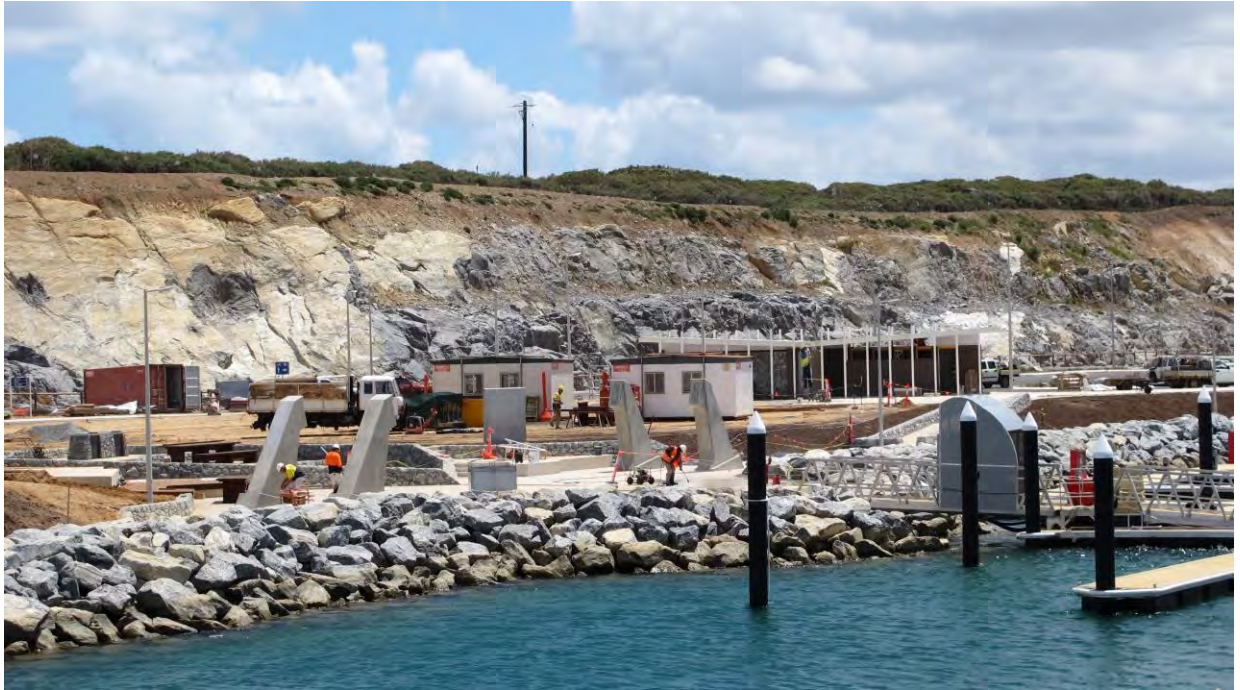
PLATE 13

Harbour Construction Site - 2014

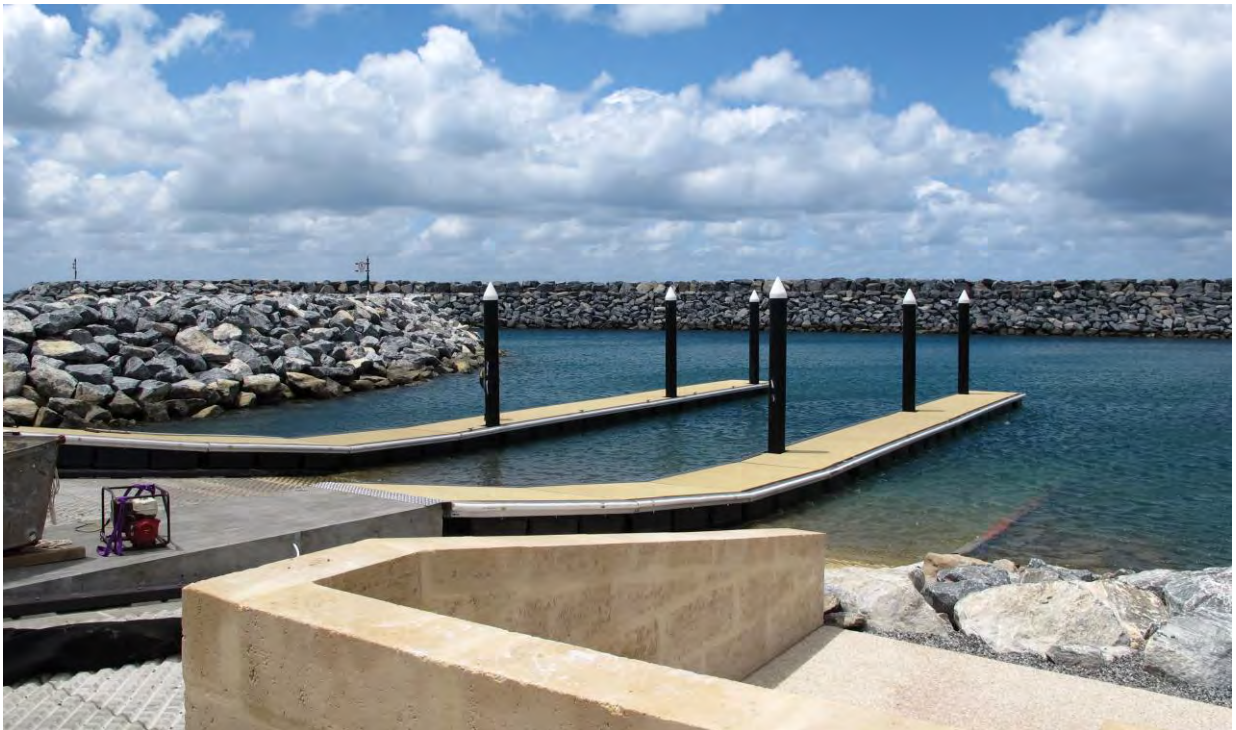
PLATE 14

Harbour Boat Ramp - 2014

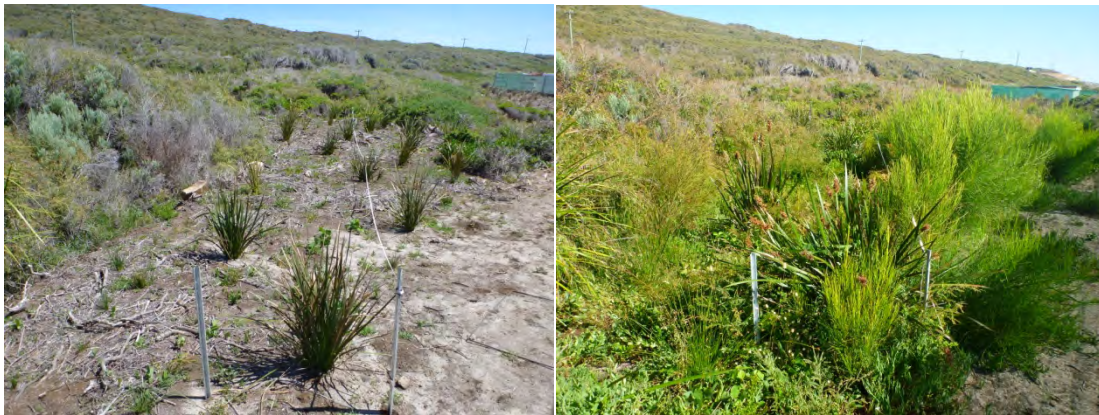
The Shannon-Wiener diversity index (H) for transects in the 2012 rehabilitation block ranged from 2.88 to 3.53 (mean 3.21) at November 2013, compared to a range of 2.16 to 2.93 (mean 2.59) recorded at November 2012. The Evenness value (E) ranged from 0.83 to 0.91 (mean 0.87) at December 2013, compared to a range of 0.71 to 0.96 (mean 0.85) recorded at November 2012. The H mean value for the two analogue sites remained lower (2.01) than the rehabilitation block reflecting the significantly lower species richness. The E value for the analogue transects was comparable to the rehabilitation area (0.80).

Plate 1 Transect 1, 2012 rehabilitation – comparison at 5 and 17 months old.

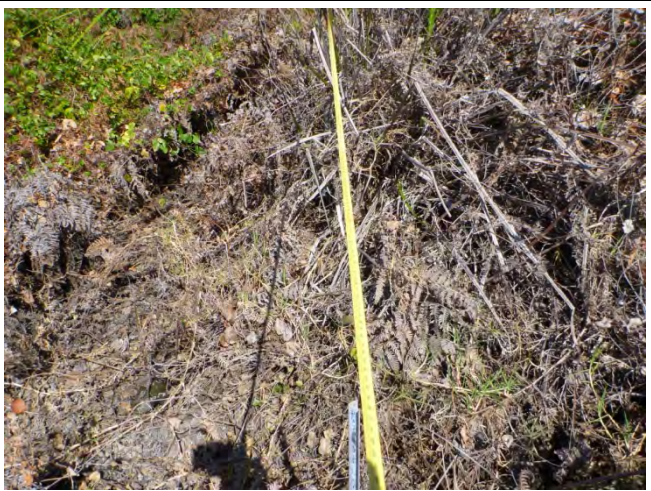
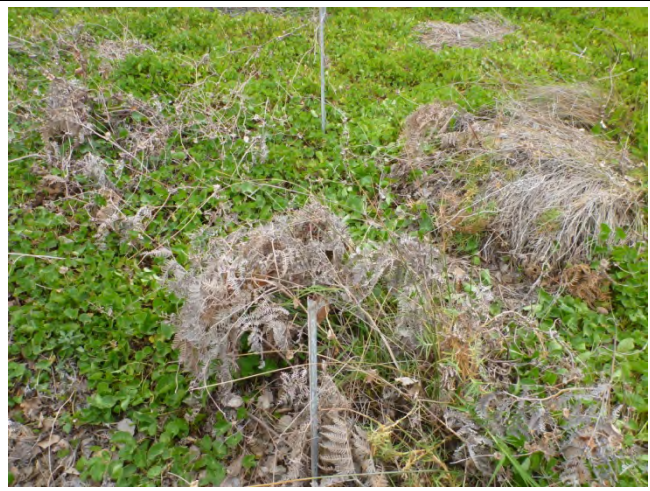
Interval (m) T1	Health Score Nov13	Representative Photograph 15/11/13	Health Score Feb14	Representative Photograph 05/02/14
10-12	5

5

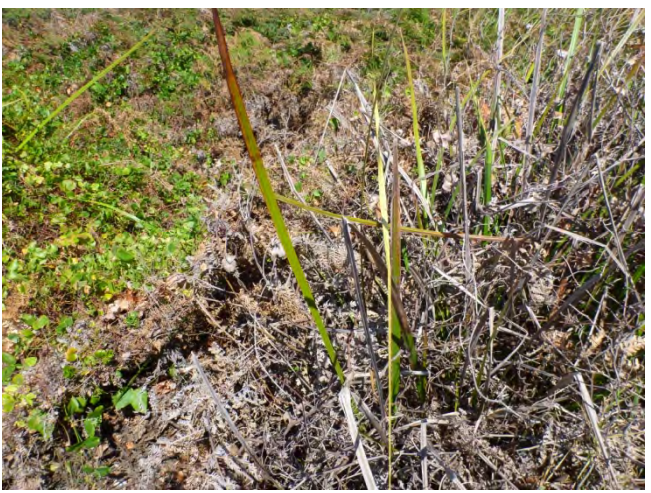
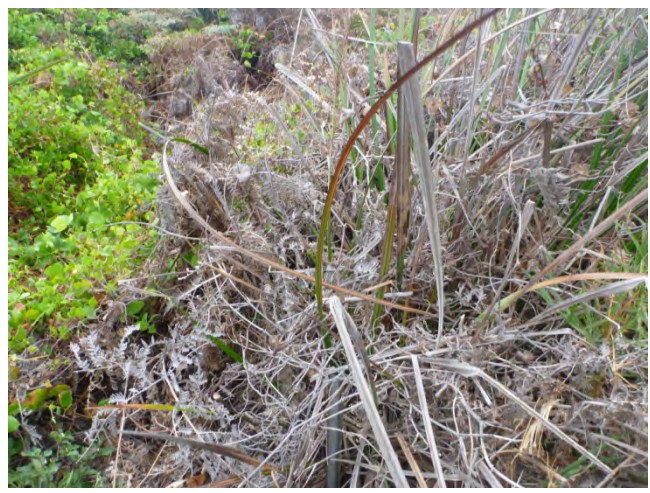
8-10	4

3

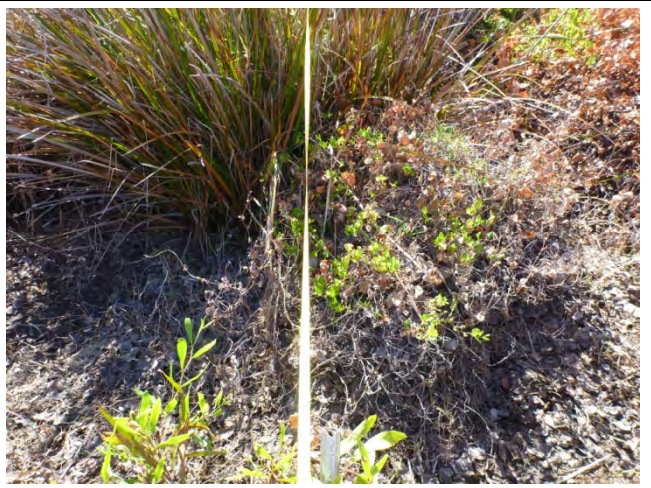
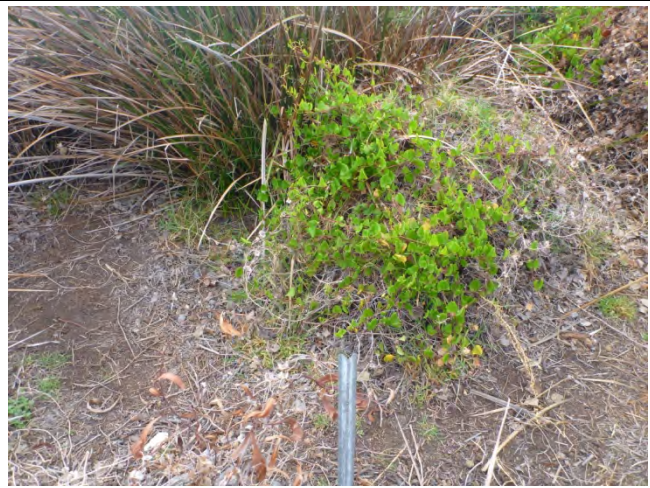
Interval (m) T2	Health Score Nov13	Representative Photograph 15/11/13	Health Score Feb14	Representative Photograph 05/02/14
24-26	5

5

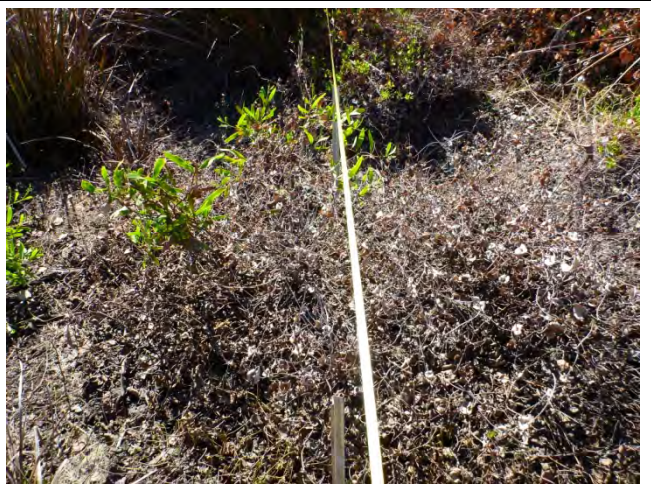
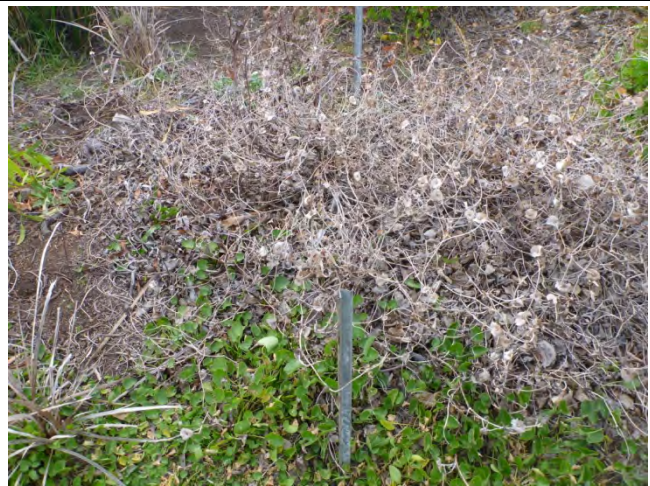
22-24	5

5
