CONDITION REPORT
SHEDS 6, 7 & 8
OUTER HARBOUR PORT, BUNBURY

WML
Consulting Engineers

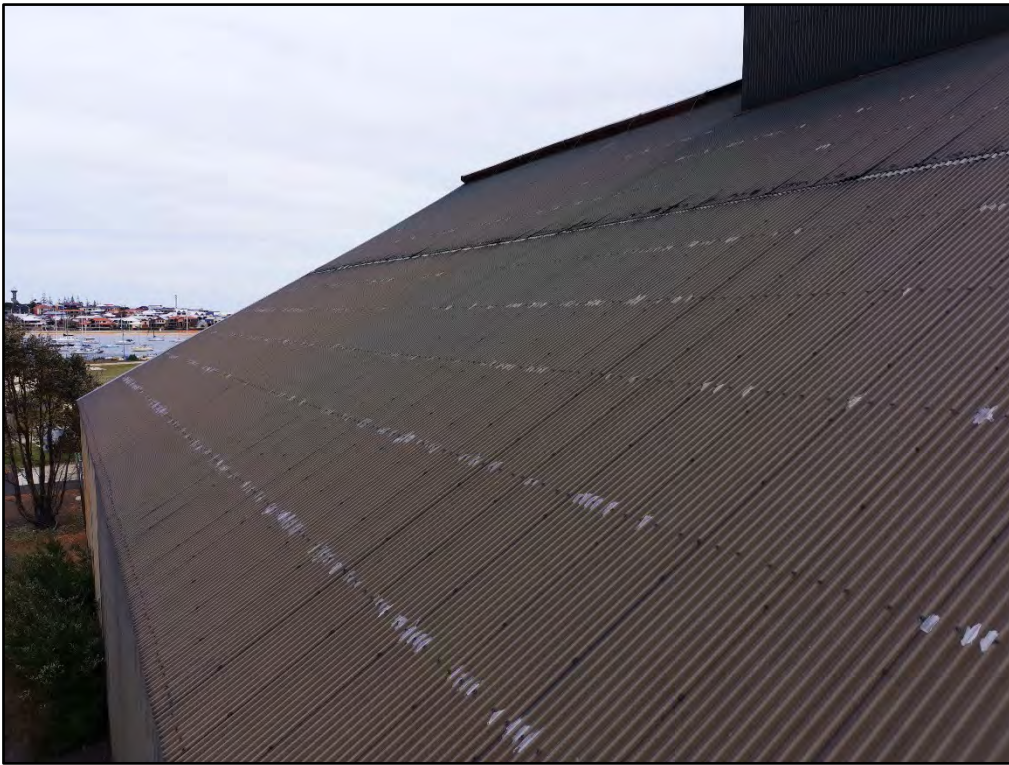
Photograph 10 Roof Sheeting

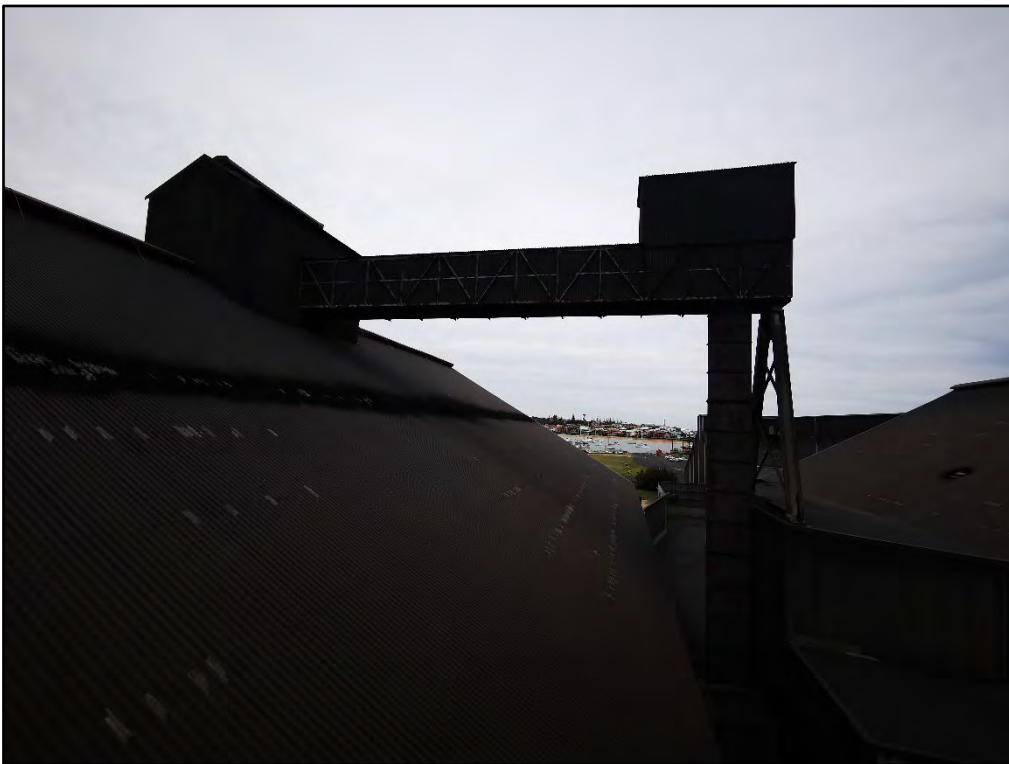
Photograph 11 Roof Sheeting

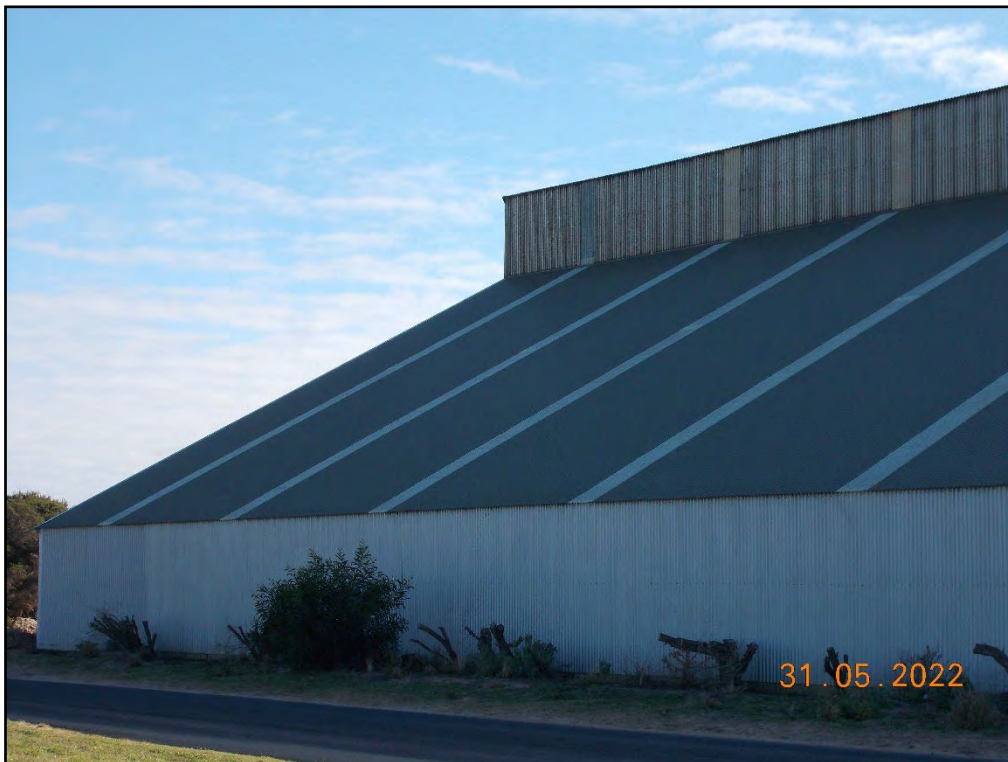
Photograph 129 No Damage

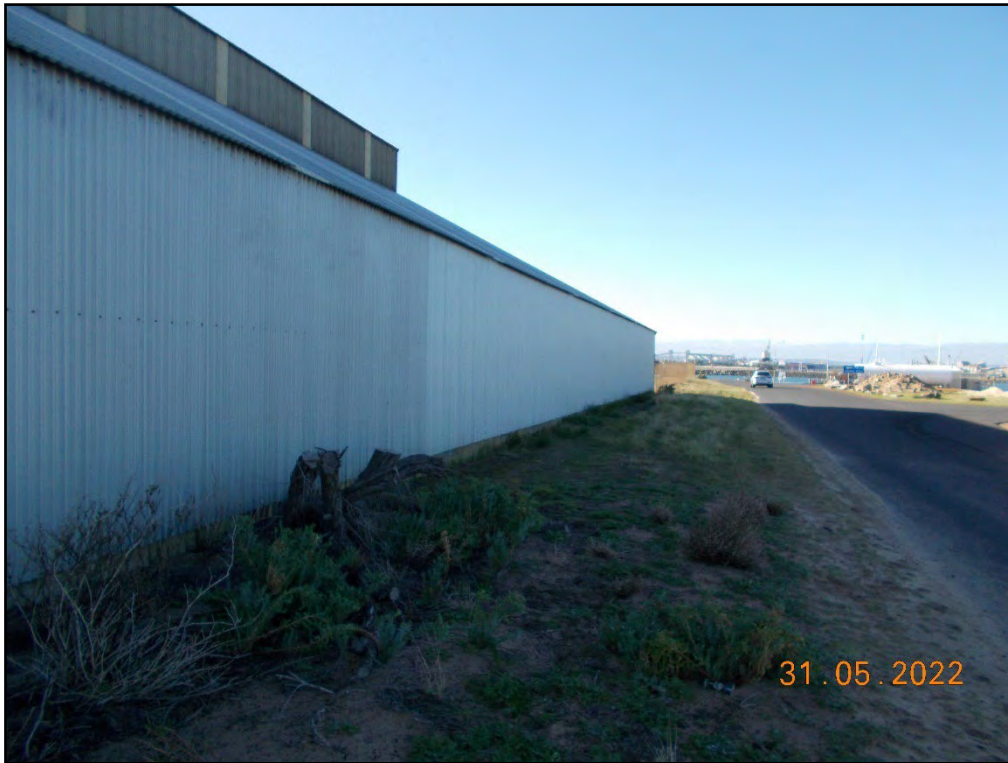
Photograph 130 No Damage
